October 15, 2008

**Re: FIN 419811-1-2-01;
SR 31 (Arcadia Rd) and SR 78 (Bayshore Rd)
DRB Recommendation For – *Special Design Mast Arm: Drilled Shaft Issues***

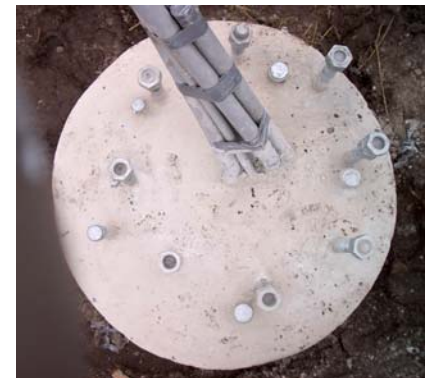
- A number of the anchor bolts are excessively out of plumb (1-½ inches over a 8-inch span).

Unsatisfactory drilled shaft

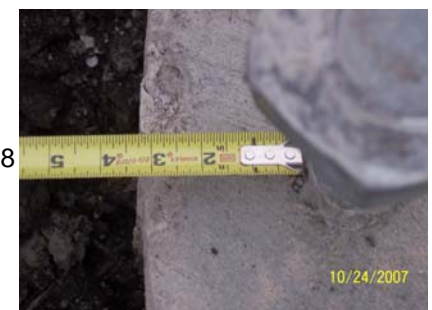
Supplemental Specification 455-20, Construction Tolerances, paragraph (d) also states, “Ensure that concrete cover is 6-inches plus or minus 1-½ inches unless shown otherwise in the plans.”

Insufficient concrete cover
