DISPUTE REVIEW BOARD RECOMMENDATION

RE: FPN: 197701-4-52-1
Contract No: T1393
SR 559 Ext. over CSX RR & SR 655
Polk County
Disputes Review Board Recommendation

Issue: Kamminga & Roodvoets, Inc.'s (on behalf of Denson and Case) entitlement to payment for overcoming differing subsurface conditions and fulfilling FDOT's requirements for acceptance of End Bent 4, Shaft No. 1

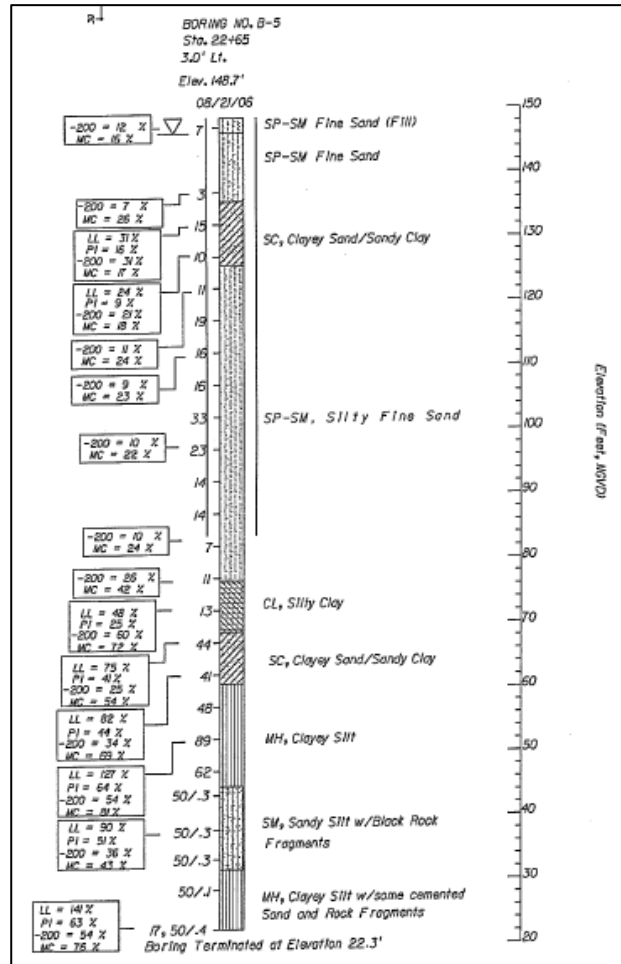
Figure 3: Report for Boring B-5 from Drawing B1-6

Boring B-5 is located at Station 22+65, seven (7) feet away from End Bent No. 4. There is no indication in this boring of large voids or other conditions which would cause a drilled shaft to drop substantially well after removal of casing following completion of concrete placement (see Figure 3 at right and **EXHIBIT 4**). Similarly, none of the other borings indicate or suggest that such large voids would be present.

- *Prior to letting, borings were taken as part of the bridge design plans and included in the original contract documents. Boring #B-5 (less than 15 feet from the shaft in question) at EB #4 showed hard sandy clay/silt materials in the area of the drilled shaft construction. (Exhibit # 10 – Page 722 - 724)*
- *During construction, pilot core hole were performed in the center of shaft # 1 and #3 of EB #4, prior to the drilled shaft installation, which showed hard sandy clays in the drilled shaft area. It should be noted that the pilot holes extended past the plan bottom elevation of the drilled shafts. (Exhibit # 11 Pages 753-758 and 765-770)*
- *During construction, the drilled shaft excavation logs for shaft #1 on EB #4 showed hard sandy clays throughout the shaft. (Exhibit # 1 – Pages 22-24)*

The Board's review of the borings and pilot holes drilled for this project did not show evidence of anomalies, large voids or site conditions that would account for the drop experienced. The contractor did not identify a specific site condition that caused the top of the shaft to drop.
