RE: SR-50 from CR 485/SR-50A to SR 700 (US-98) and SR-45 (US-41) from VFW Road to Benton Avenue. F.P.ID 254805-1-52-01, 254805-1-56-01, 254816-1-56-01, 254816-1-56-02, & 254816-1-52-01.
SPN: 08002-3501 & 08010-3526.
Contract No: 20358
District 7

DISPUTE: Request for Time and Compensation Adjustment – US-41 Pavement Repairs.

DISPUTE REVIEW BOARD RECOMMENDATION 2

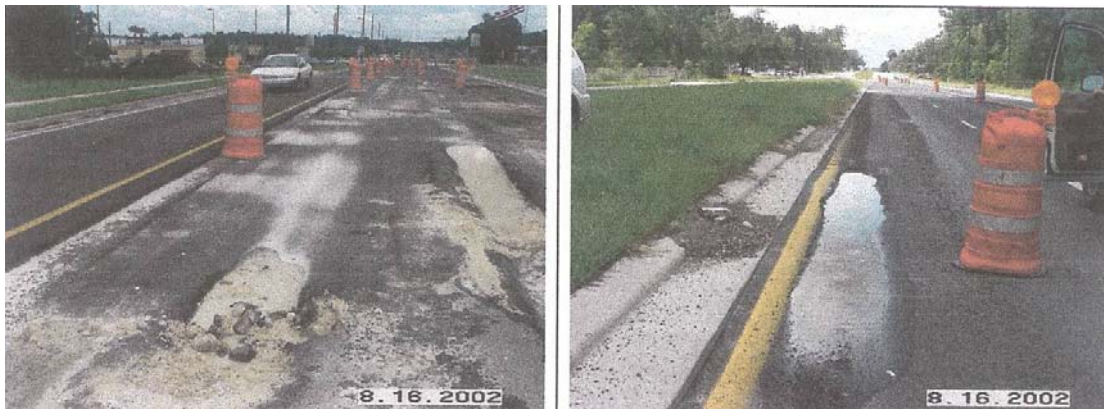
Pavement Failure Station 308+05 & 309+42 inside.left roadway.

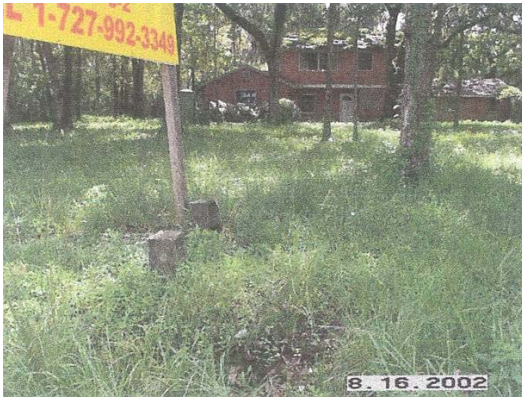
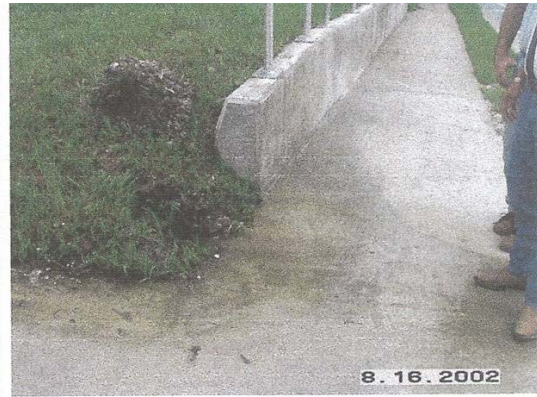
"Properties on the east side of the US 41 R/W were higher than the existing roadway. As a result the ground waters from these areas would flow toward the roadway and into the area between the base and A-7 material..."

In summary, Mr. Ramos expert opinion was "that this area should have had an underdrain system installed when the existing roadside ditches were eliminated. ... An underdrain system, if installed along the east side and connected to the roadway drainage system could provide the best insurance to prevent future failures."

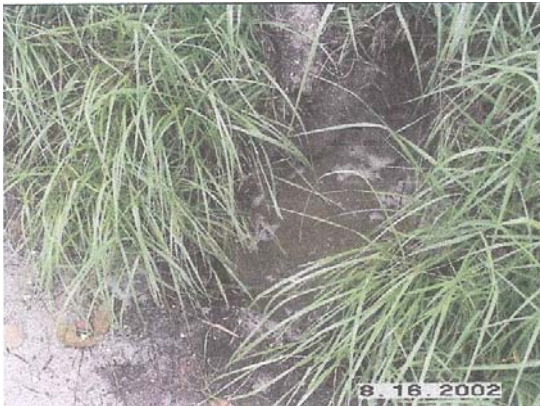
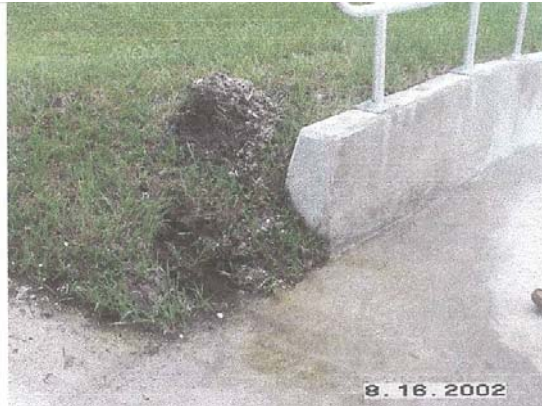
"Test holes by project personnel ... showed ground water present."

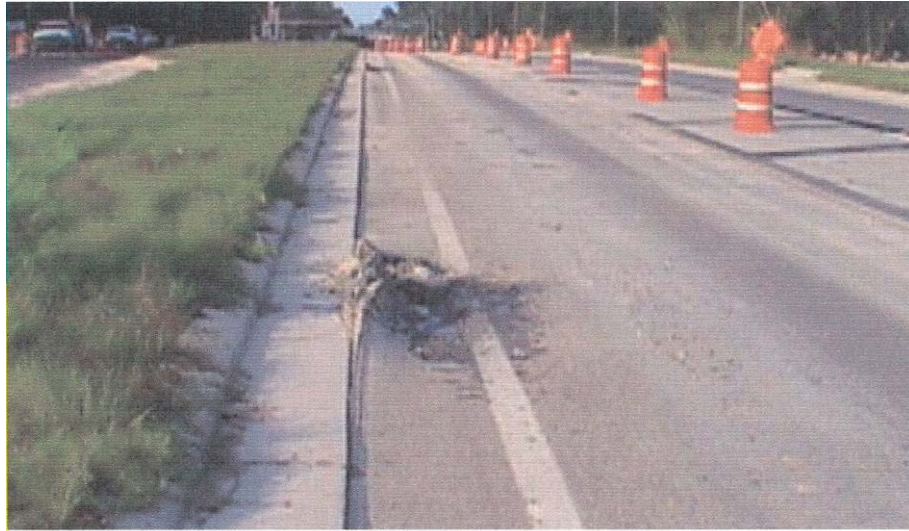
Prior to replacing the asphalt mentioned above, some failures had occurred in L-1 (exhibit 1) adjacent to the median curb. These failures occurred when traffic was temporarily placed in L-1. The failures occurred in the areas of trapped water in the median. In the Department's attempt to remedy the situation, a cost for an under drain system was requested (ref 3-1). Also the removal and replacement of the previously placed acceptable limestone-based old design Superpave asphalt with a granite-based new design mix Superpave asphalt was also requested (ref 4-2). After the replacement of the asphalt and failures occurred, the root cause of the failures was determined to be the trapped water caused by the contractor's construction methods and thus the request for an under drain system was rescinded. (ref 4-3).

Exhibit 1 – Failure of old mix design asphalt.

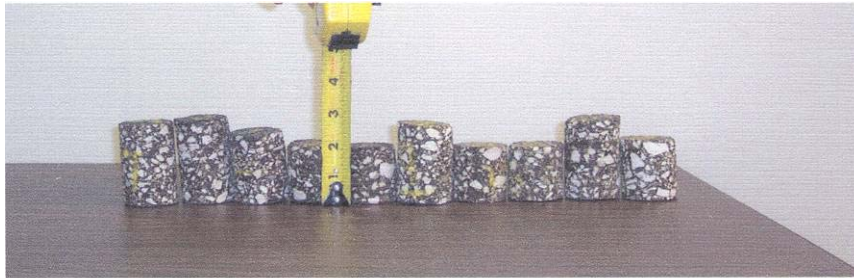
Exhibit 2 (Original cores will be presented at hearing.)

The entire area of pavement replaced was from just south of SR50 in the three southbound lanes of US41. The failures predominantly occurred from Horse Lake road south to Wiscon Road. (ref section 2). The asphalt south of Wiscon Road heading south to the begin project was also replaced. This area was shy in thickness and needed to be replaced at the contractor's expense. The photo in exhibit 2 shows cores that were obtained in the asphalt prior to replacement. The Department chose to fully participate in the replacement of the asphalt in this area to replace the limestone-based old mix design Superpave asphalt with a new design mix granite-based asphalt. Failures occurred at two locations south of Wiscon Road after the replacement. One of the areas was adjacent to the curb and the other area had previously been shy in thickness and flat (ref section 2). During the replacement of the outside lane (L-3) south of Wiscon Road, some rain occurred on the exposed base and this area did not fail. The moisture readings obtained met specifications in this area. This once again shows that the root cause of the failures was the trapped water in the median and water sitting on areas without proper cross slope.

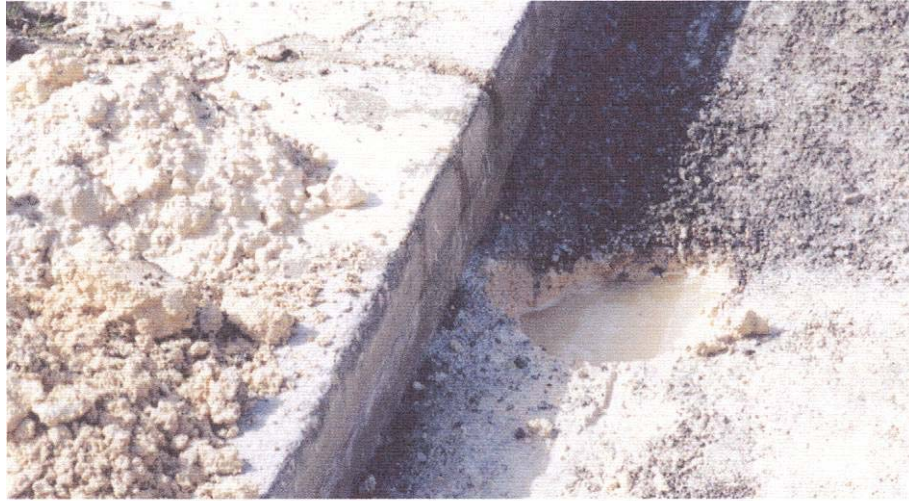
Exhibit 3 – Water seeping under curb from median

The trapped water in the median occurred predominantly after the construction of the type 'E' curb on the northbound roadway which created a closed median area. The backfilling and grassing of the median area was not completed in a timely manner after both sides of the median curb were complete. To maintain driveways from the southbound travel lanes across the median to the businesses adjacent to the northbound lanes required the contractor to bridge the type E curb (ref 5-1). The areas between driveways were not filled and created pooled water areas. These areas eventually seeped under the curb and into the base causing the limerock to become saturated and caused the roadway failures.

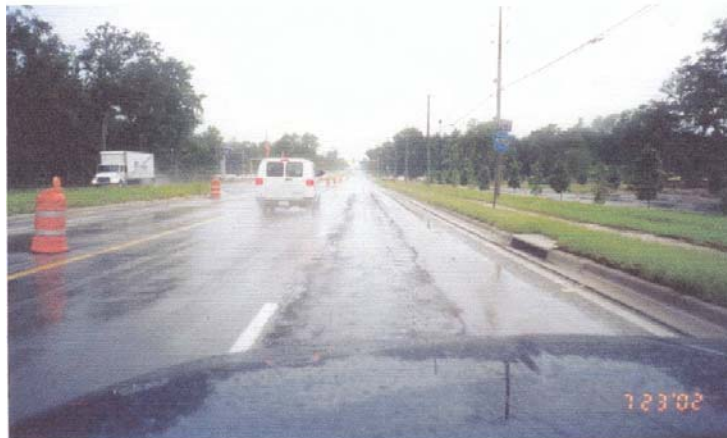
The refusal of the contractor to use the temporary drains for the curb inlets along with the incorrect cross slope was another contributing factor to the failures. During the construction of the base and structural course, the temporary drains were not used and this allowed water to stand along the edge of the gutter (ref 5-4). Some of the failures occurred in L-3 which is the outside southbound lane where the water remained standing because of the non use of the temporary drains. The L-3 lane also had failed density testing and permeability and was in need of replacement. Previous to the replacement, this lane had numerous failures which had been patched (see photo exhibit 4). After the replacement of this asphalt, the failures occurred in the same locations as the previous failures.

Exhibit 4 – Patched old design mix due to previous failure.

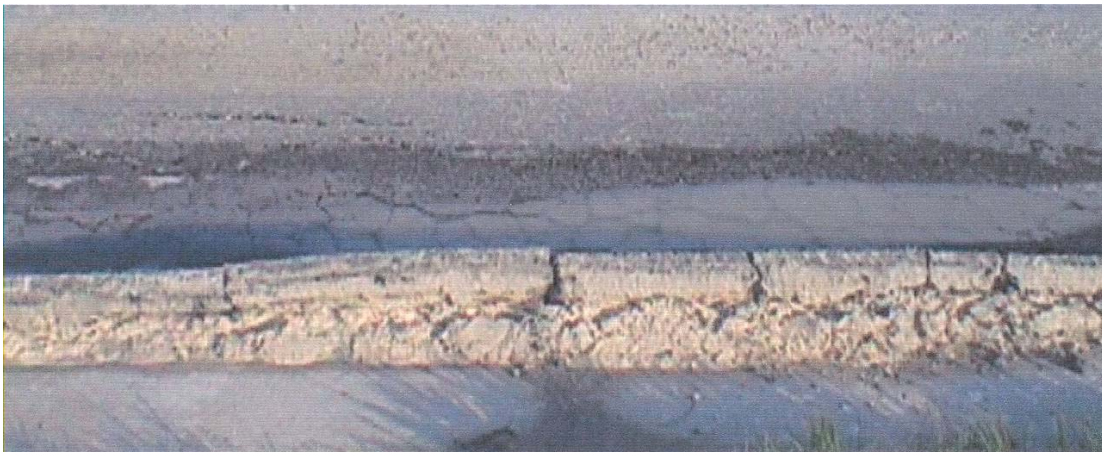
Exhibit 5 – Failed old design mix roadway
