DISPUTES REVIEW BOARD RECOMMENDATION

RE: West Florida Intelligent Transportation Systems (ITS) Improvements (Florida's Turnpike) which includes the Veterans Expressway, (SR-589 - Hills. Cty; 14.1 miles), the Suncoast Parkway, (SR-589 - Hillsborough, Pasco and Hernando counties; 41.39 miles), and the Polk Parkway (SR-570 - Polk County; 24.4 miles).

Contract No.: E8H33

Subject: Disputes Review Board hearing regarding the worksite shoulder restoration limits.

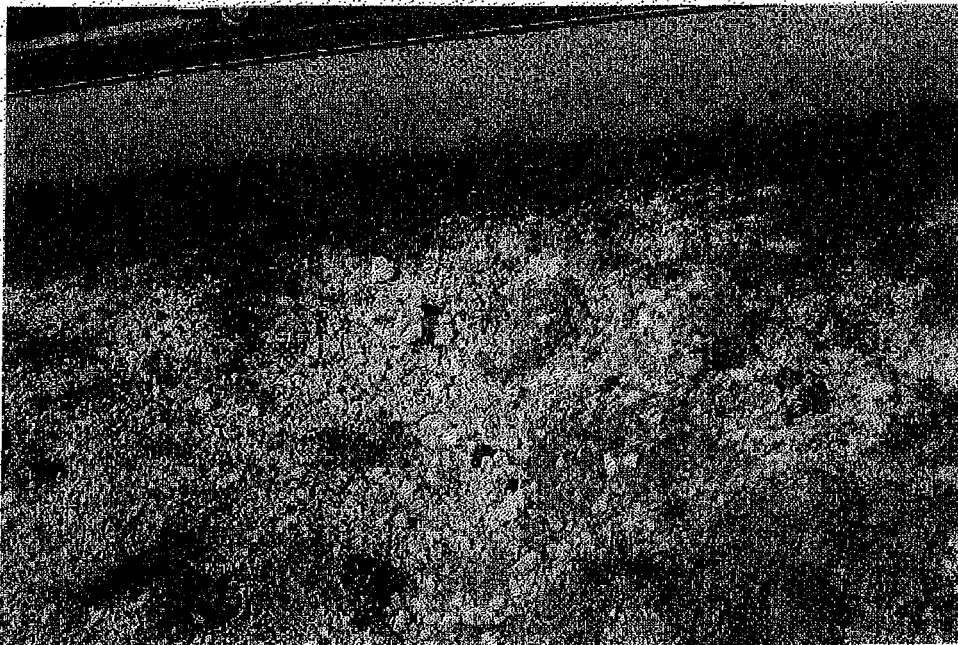
Introduction of limerock

As noted in the aforementioned pictures, the introduction of limerock, multiple layers of geotec fabric, and the fact that TPK has and continues to resod other areas on the project, these efforts appear to have varying degrees of success and numerous failures, all by no fault of MEC.

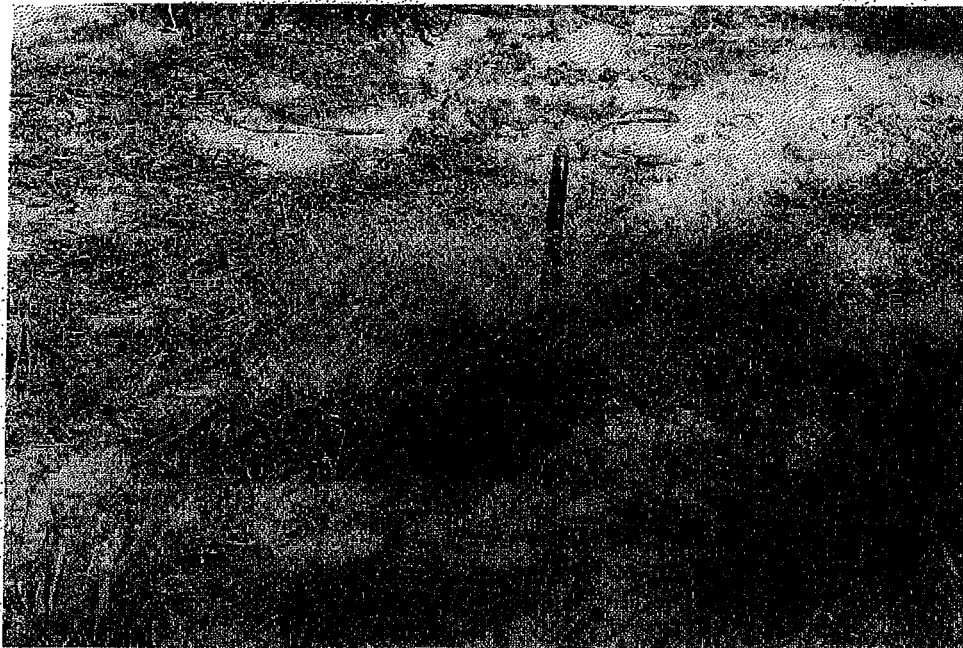
Multiple layers of Geotec Fabric

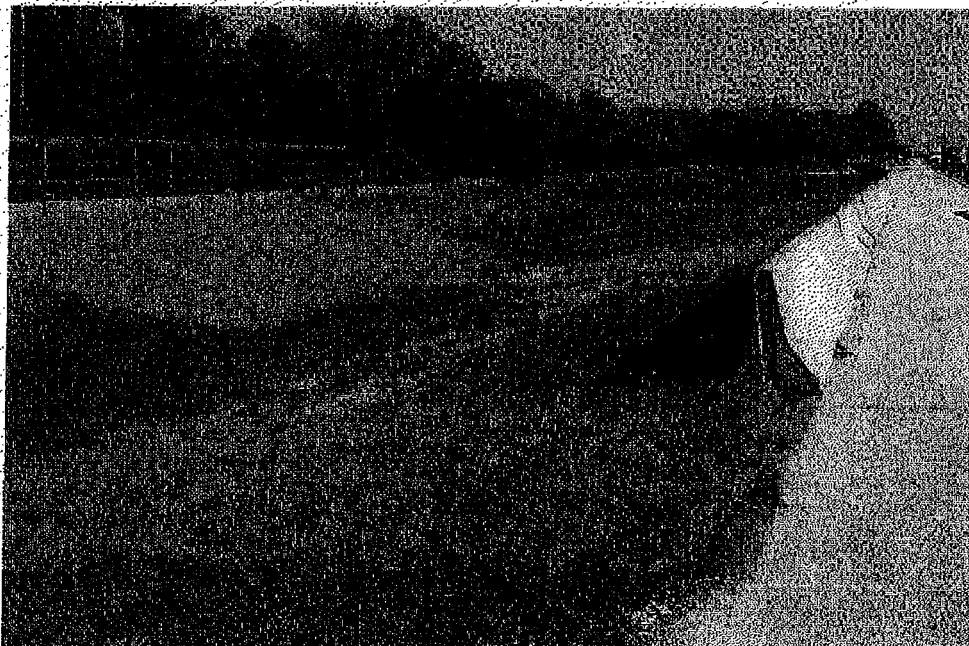
Other areas being resodded by TPK
