## **PERFORMANCE EVALUATION OF CRACK-AND- SEAT REHABILITATION PROJECTS ON I-10**

**Research Report  
FL/DOT/SMO/00-443**

**August 2000**

**STATE MATERIALS OFFICE**

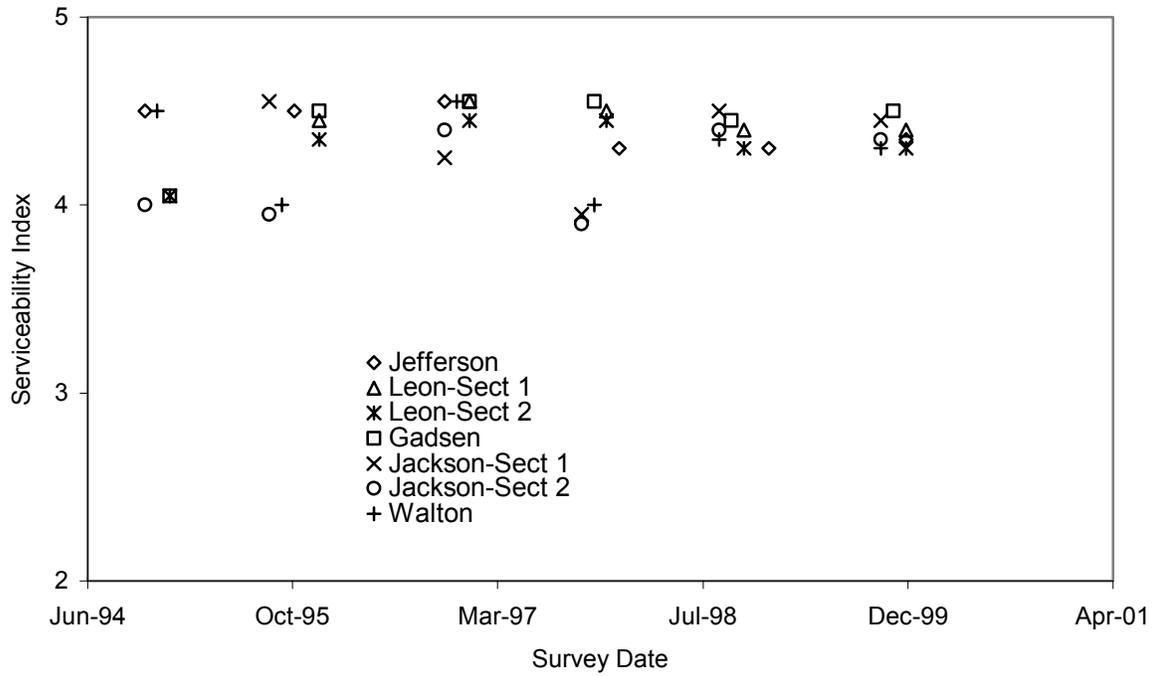
Figure 2 Ride quality vs. time as measured on the eastbound direction

The trends in the performance data collected during this study are illustrated in Figures 2 through 7. The ride quality was rated in terms of the present serviceability. The latter rating was derived from readings taken with an automated profiler that measures deviations in a pavement surface. These deviations provide a measure of the smoothness or roughness of the pavement. The ride quality is rated on a scale of 0 to 5, with 0 being very poor (undriveable) and 5 being very good (new surface). The ride rating data, summarized in Figures 2 and 3, indicate that all the projects still have very good to good ride characteristics after seven years of service.

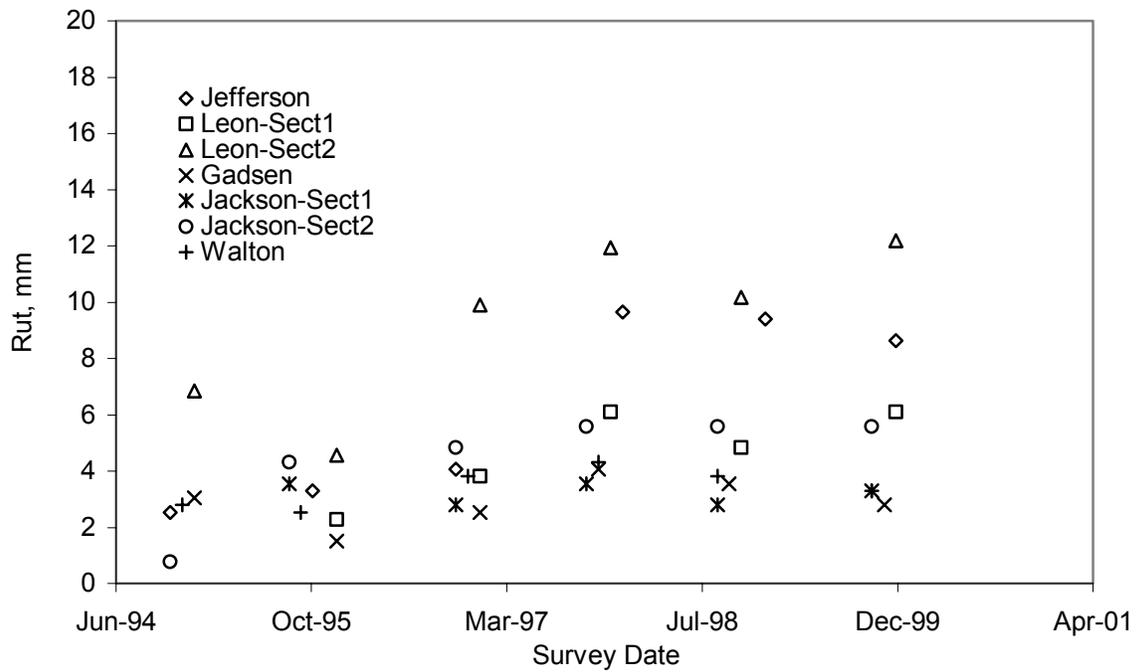
Figure 4 Rut depth vs. time as measured on the eastbound direction

The rut depth measurements as plotted in Figure 4 and 5 show presently at most 6 mm rut on the majority of the sections considered in this evaluation. Typically, asphalt pavements in Florida average approximately 2.8 mm (0.11 in.) of rutting after one year of service (5). This is mainly the result of consolidation of the structural layers. The two projects that seem to exhibit relatively higher levels of deformation are those located in Jefferson and Leon (second project) Counties where rut depths averaging approximately 12 mm (0.5 in) were recently recorded. It is likely that this rutting is due to problems with the asphalt mix since a number of problems were encountered during production, and the same mix was placed on both projects. Critically low in-place air voids (ranging from 0.2 to 1.9 percent) were measured on the Leon County project (6). This resulted in the removal and replacement of a substantial amount of pavement on this project before its completion in August of 1993. It is also probable that the fine graded, 50-blow Marshall designed mixes were inadequate to withstand current loading conditions. Over the past 10-15 years, a significant number of asphalt pavements on Interstate projects in north Florida have experienced premature failures, primarily due to rutting (7).

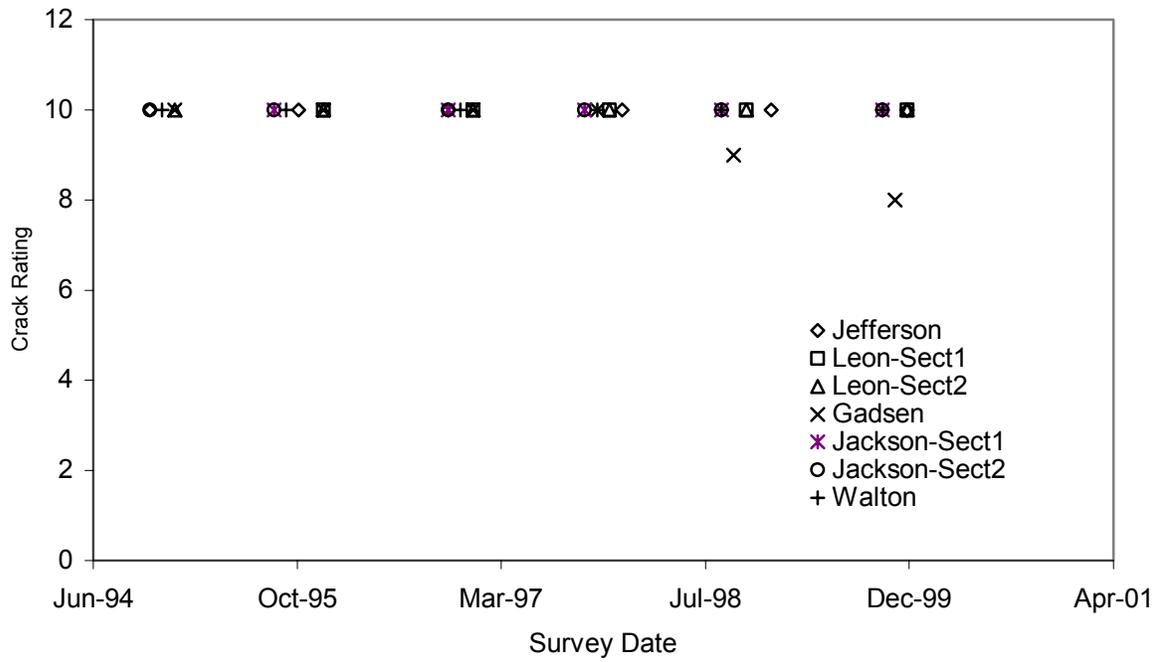
Figure 6 Crack rating vs. time as measured on the eastbound direction

and-seating method reduced reflection cracking during the first few years after construction, but after 4 to 5 years the cracking increased, thus questioning the effectiveness of such a rehabilitation procedure (4). However, as illustrated in Figures 6 and 7, in combination with visual inspections, the overall performance, in terms of cracking and patching, of the Florida crack-and-seat projects is still highly rated. In most cases, this rating is equal or better than one would expect on asphalt overlays after approximately seven years of service. Although it should be noted that, within the last 18 months, an increase in the amount of cracks was observed on the Gadsen County project (in both directions) and, to a lesser extent, on the second project in Jackson County (westbound side), visual surveys still indicate that the amount of cracking is relatively insignificant on most of the sections.
