## **PERFORMANCE EVALUATION OF CRACK-AND- SEAT REHABILITATION STRATEGY: A 10-YEAR PERSPECTIVE**

**Research Report  
FL/DOT/SMO/05-482**

**Bouzid Choubane  
Abdenour Nazef**

**April 2005**

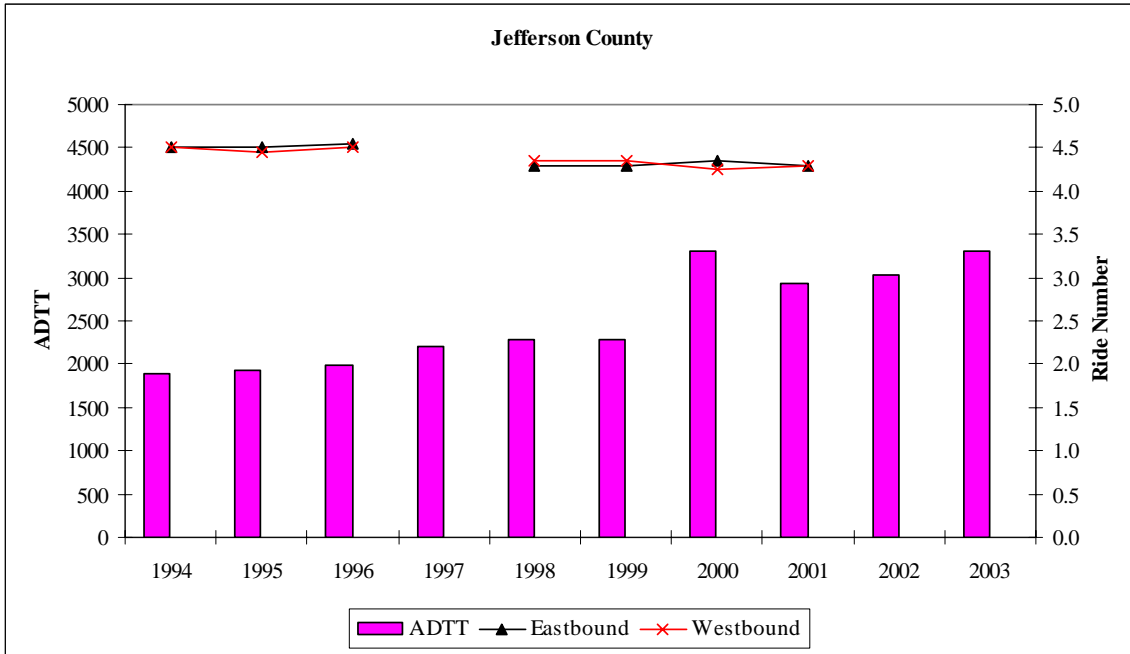
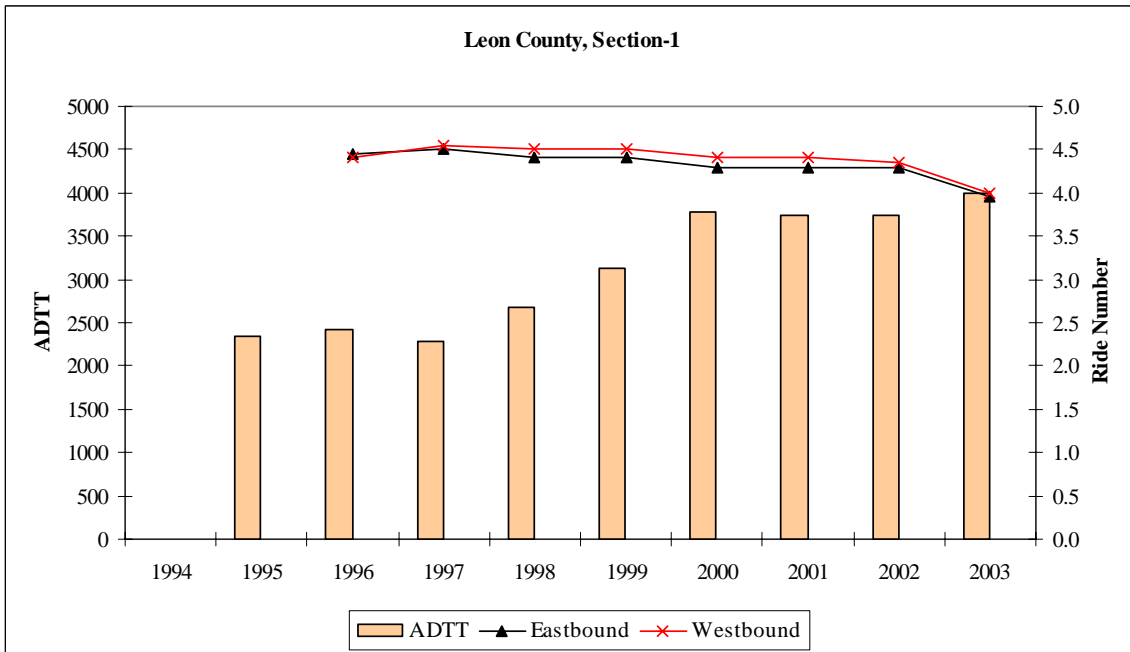
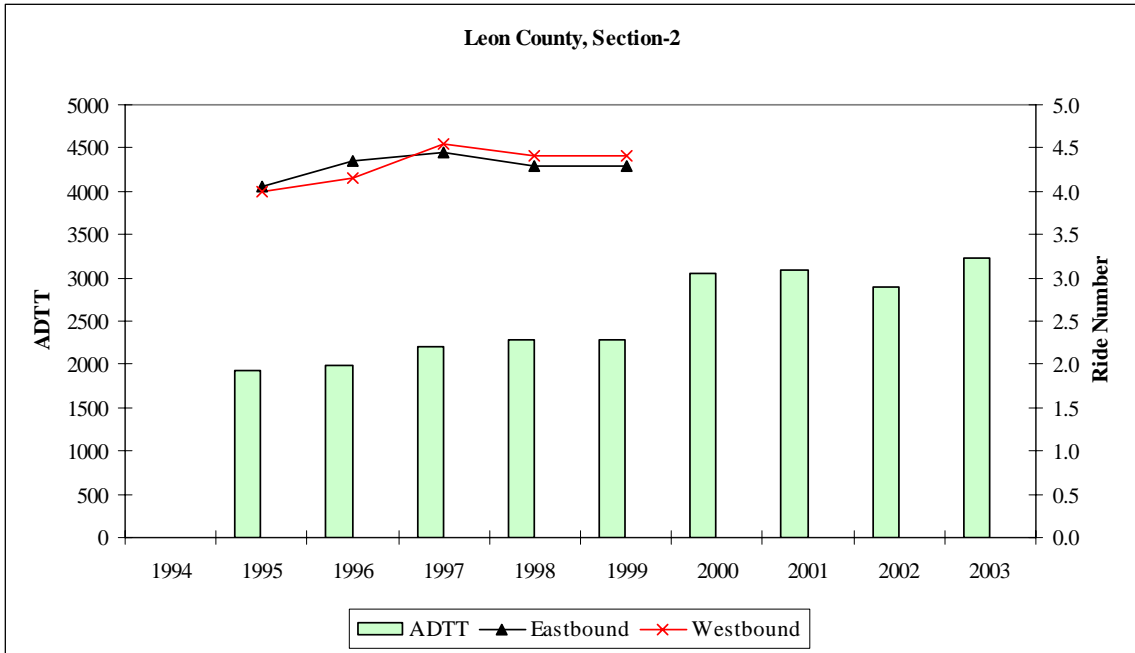
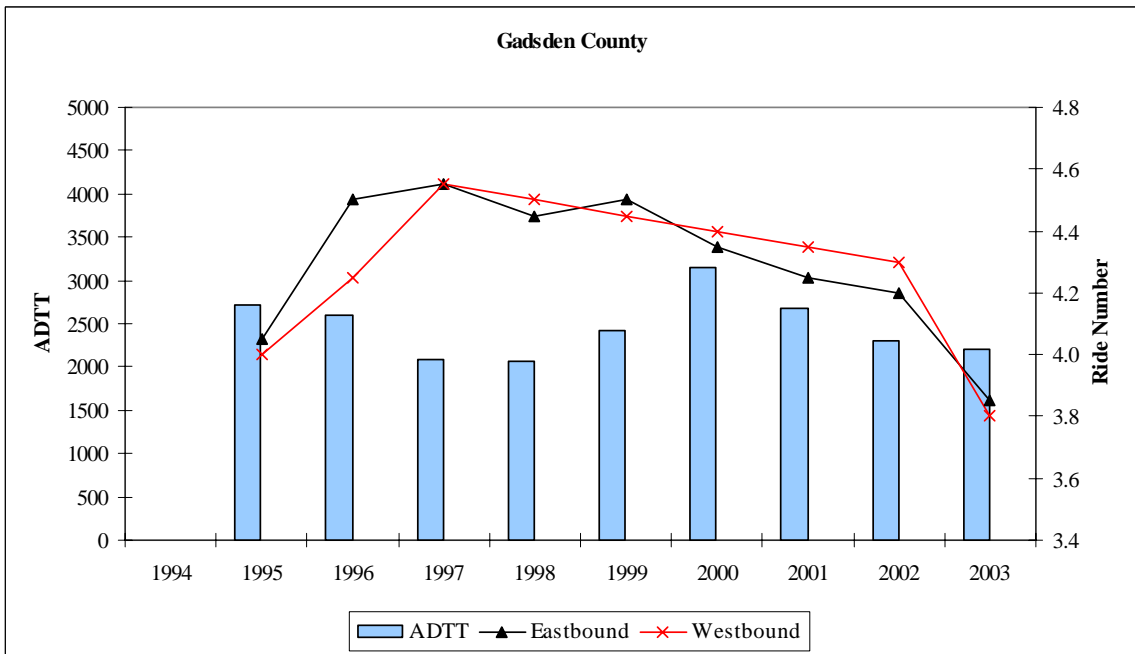
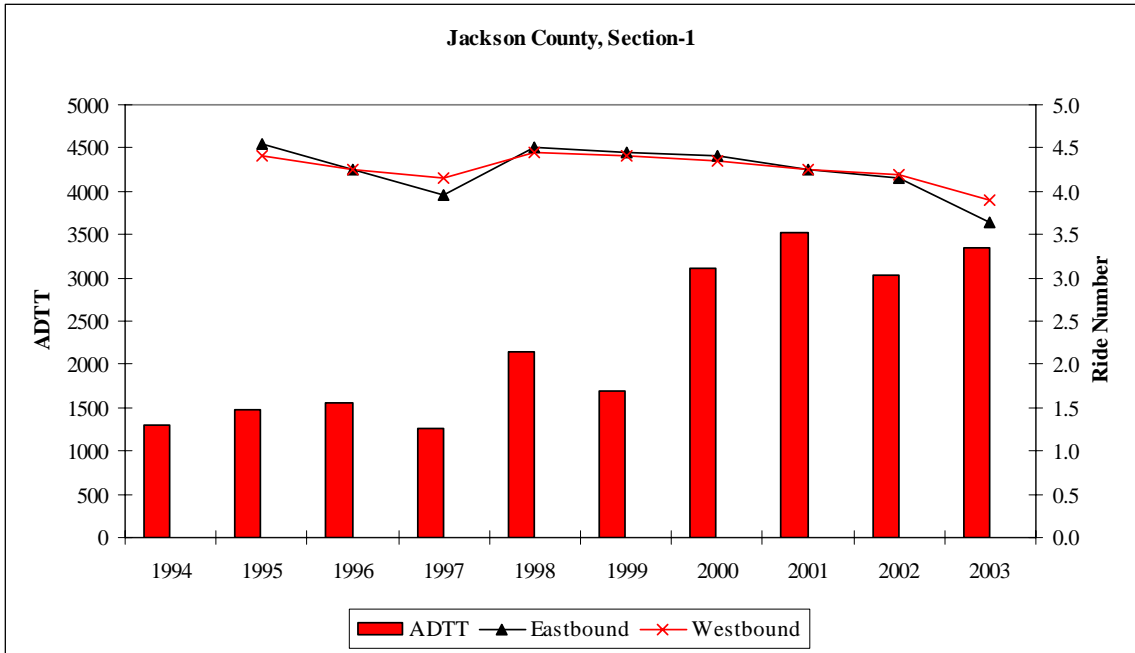
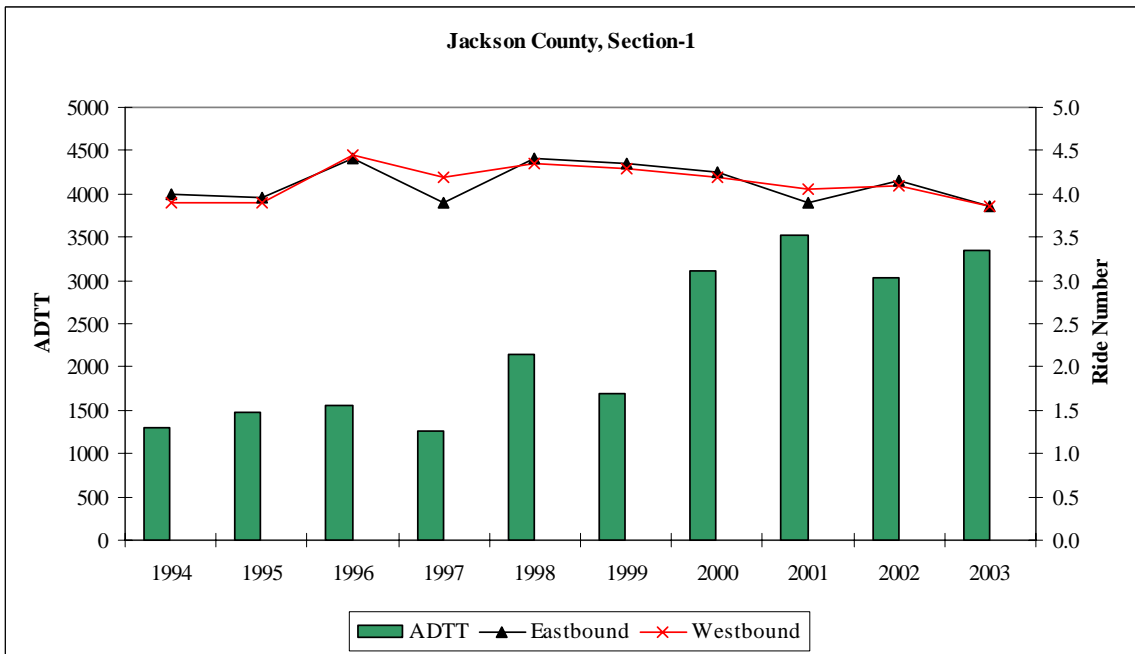
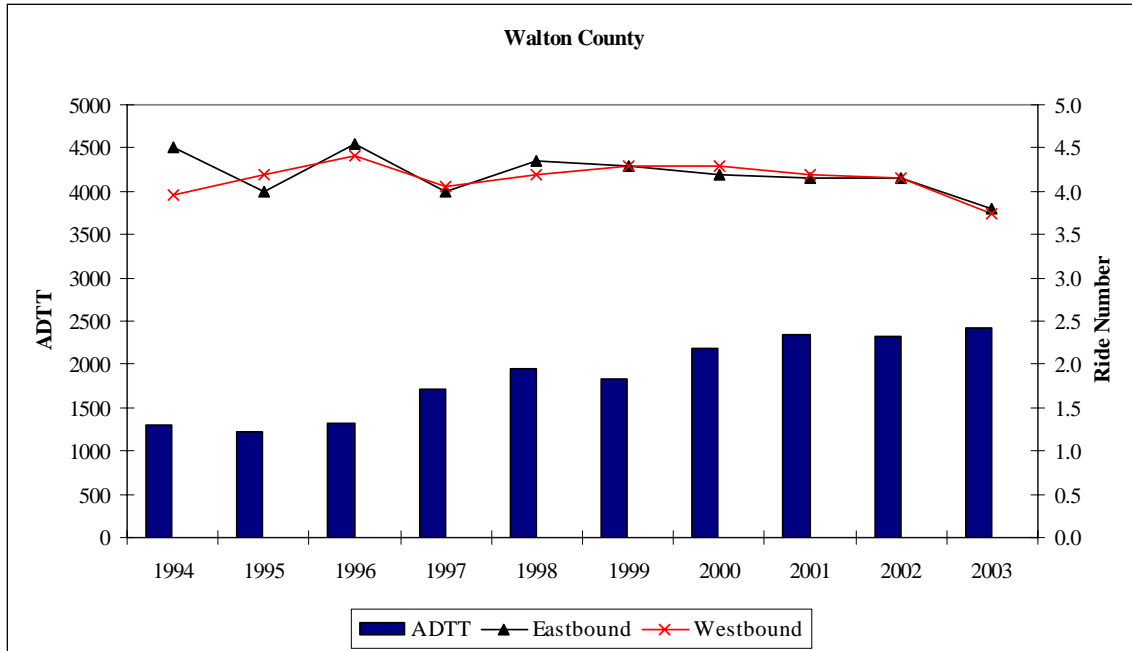
**Figure 2 Ride Quality Measurements and ADTT.**

A high-speed inertial profiler was used to measure the longitudinal profile from which the rideability is determined. The rideability was expressed in terms of Ride Number (RN), which is rated on a scale of 0 (maximum possible roughness) to 5 (perfectly smooth). Ride Number is an index resulting from non-linear transform of roadway profiles which represents the roughness of a pavement. The ride number data was plotted against the Average Daily Truck Traffic (ADTT) for each of the seven projects and has been summarized in Figure 2. In Figure 2, the ADTT is plotted on the primary y-axis, and the ride number data for both the eastbound and westbound directions has been plotted on the secondary y-axis. It should be noted that the ADTT plotted in this and subsequent figures is for both east and westbound directions combined. The ride

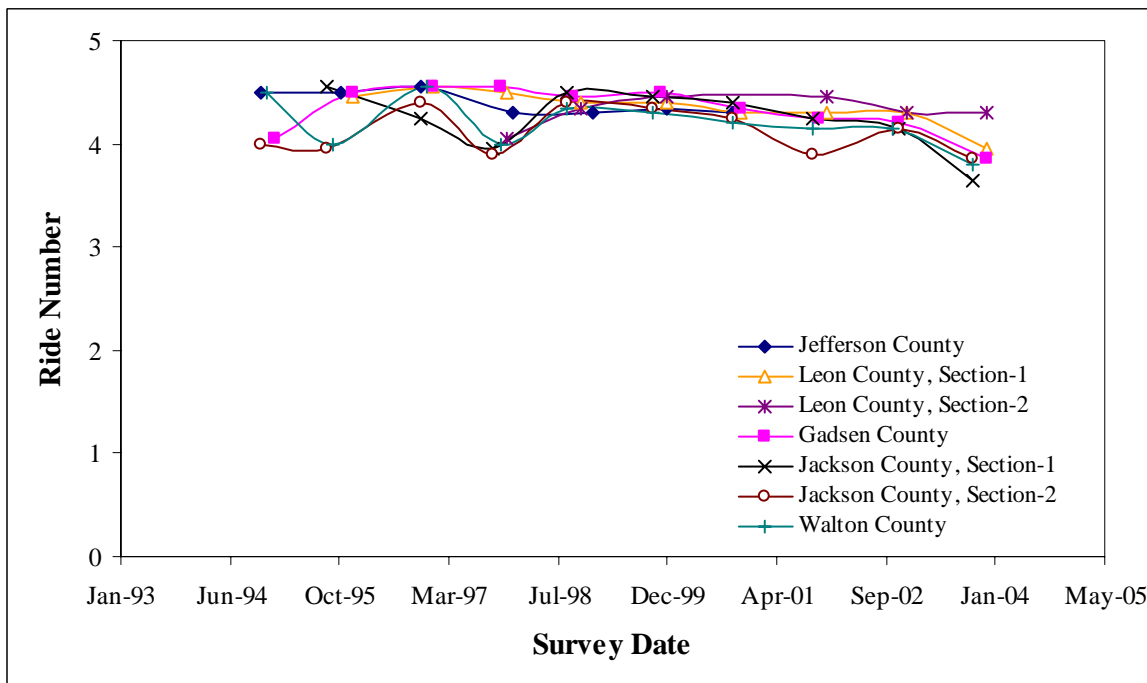
**Figure 3 Ride quality measurements in the east bound direction.**

number data has also been summarized in Figures 3 and 4 to illustrate the comparative ride performance for all the projects. The ride number data indicates that most of the projects have performed well in terms of ride quality and have been rated better than 4.0 for most of the ten years of service.

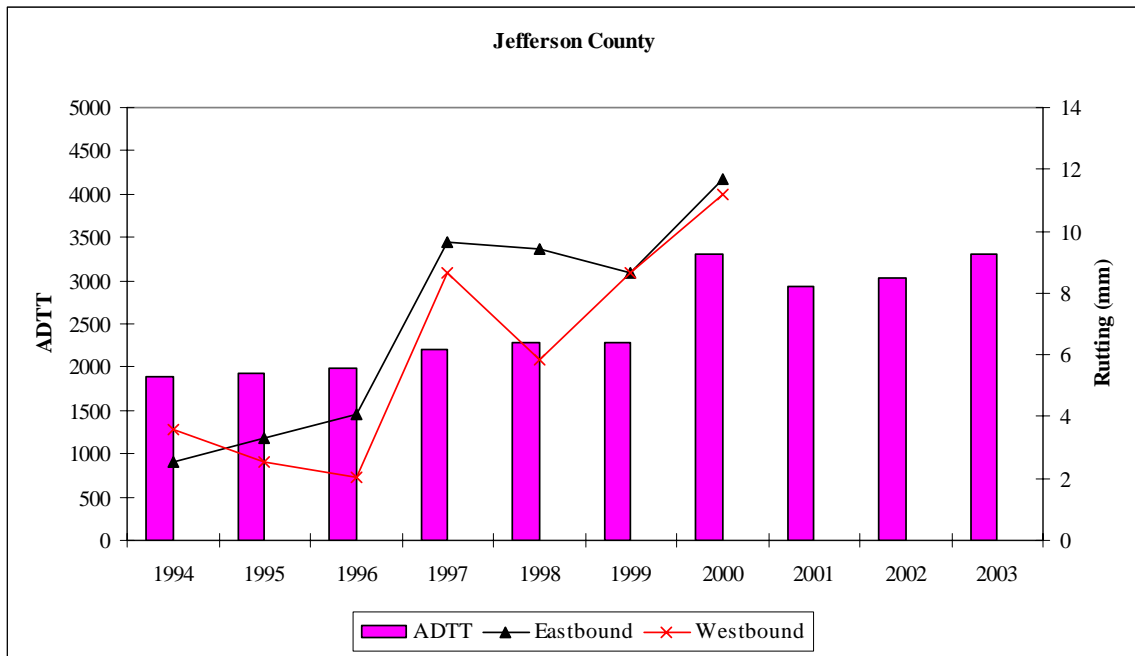
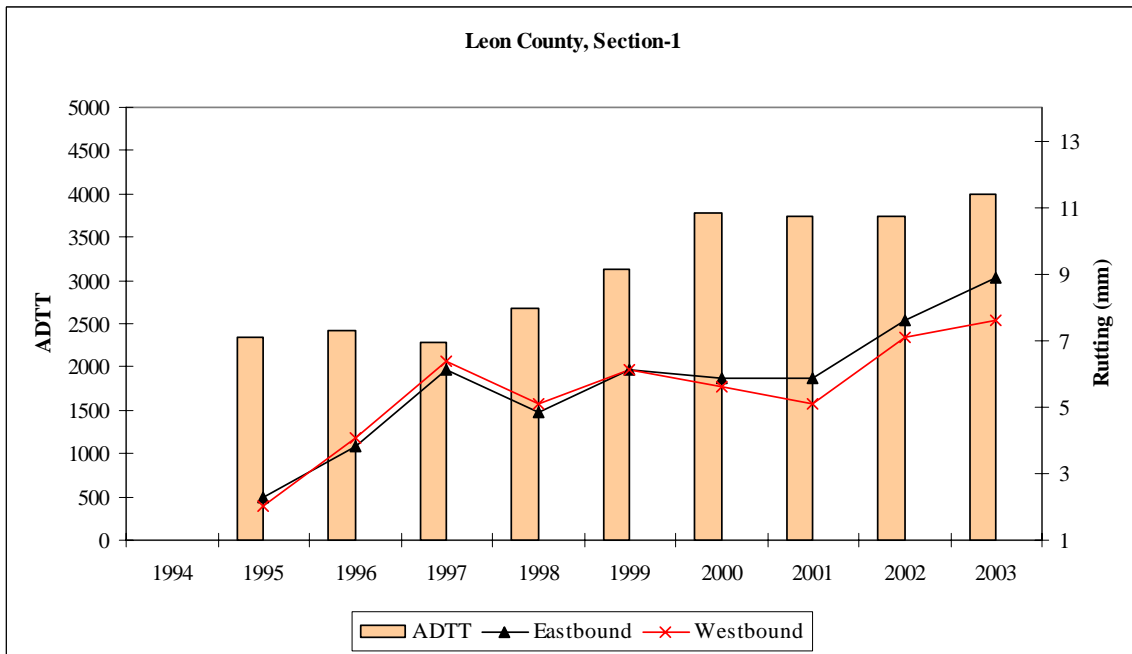
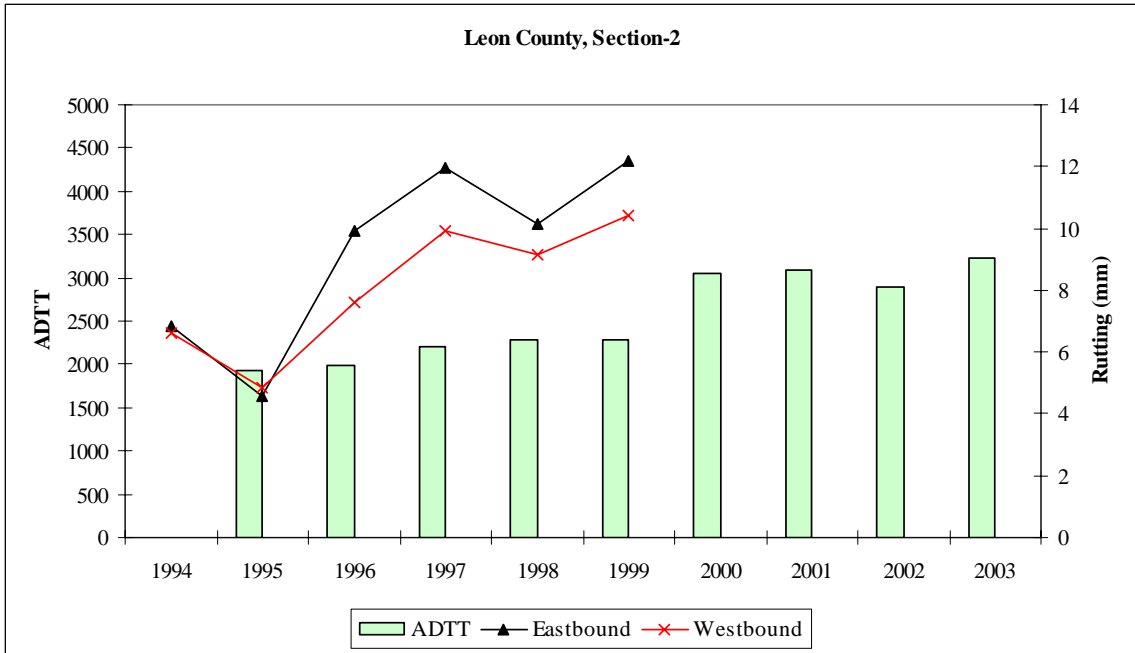
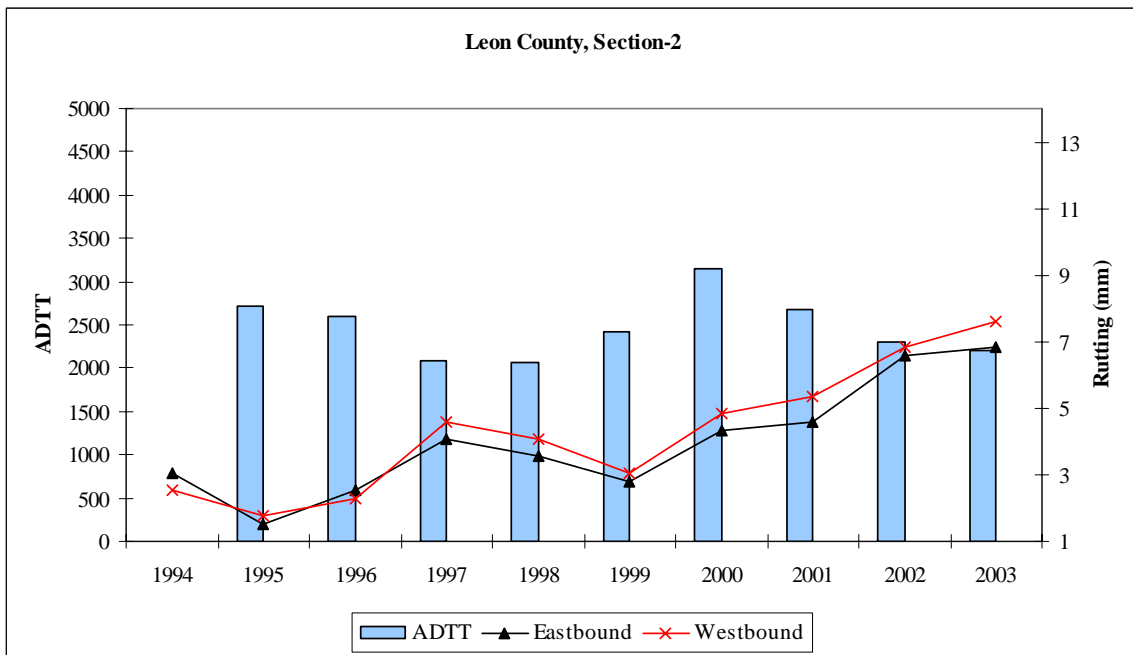
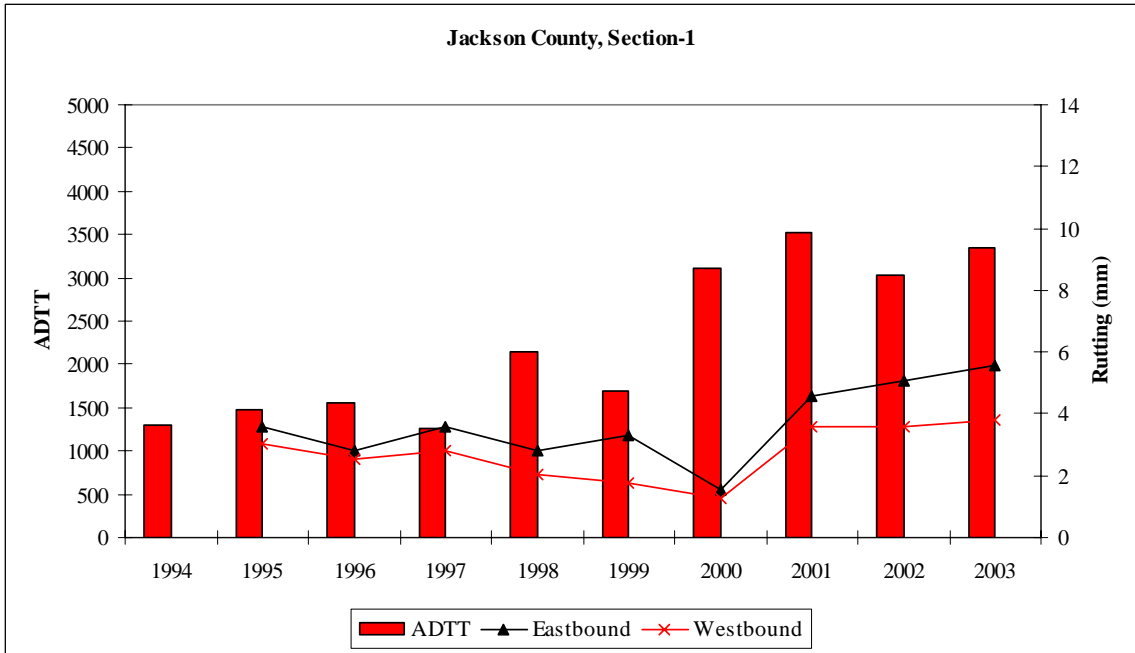
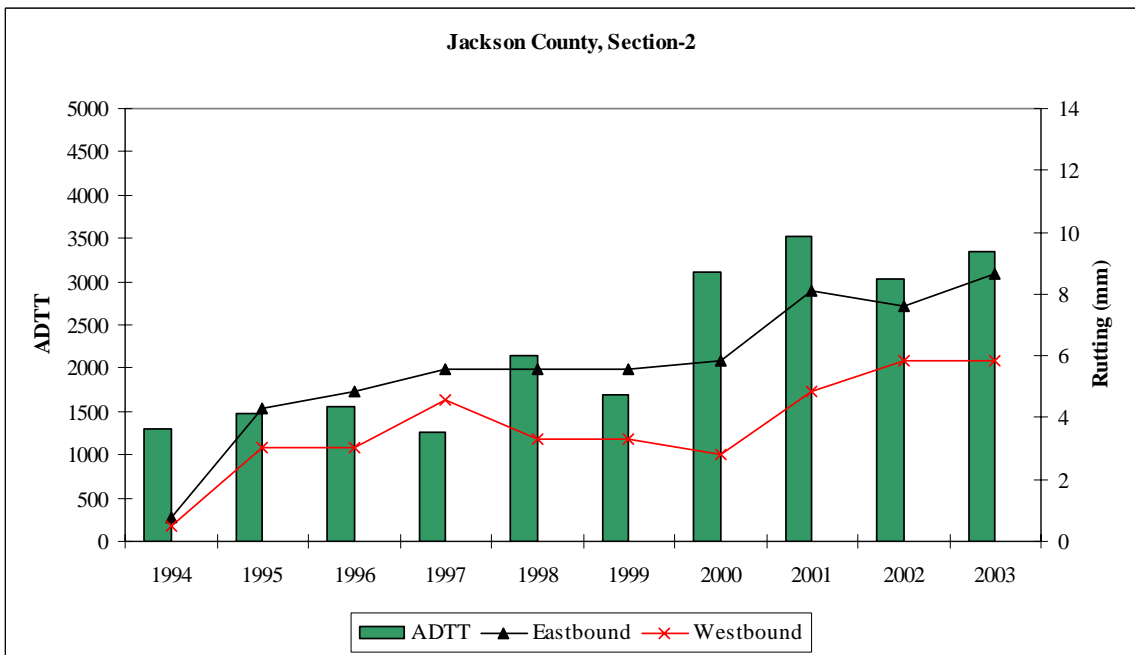
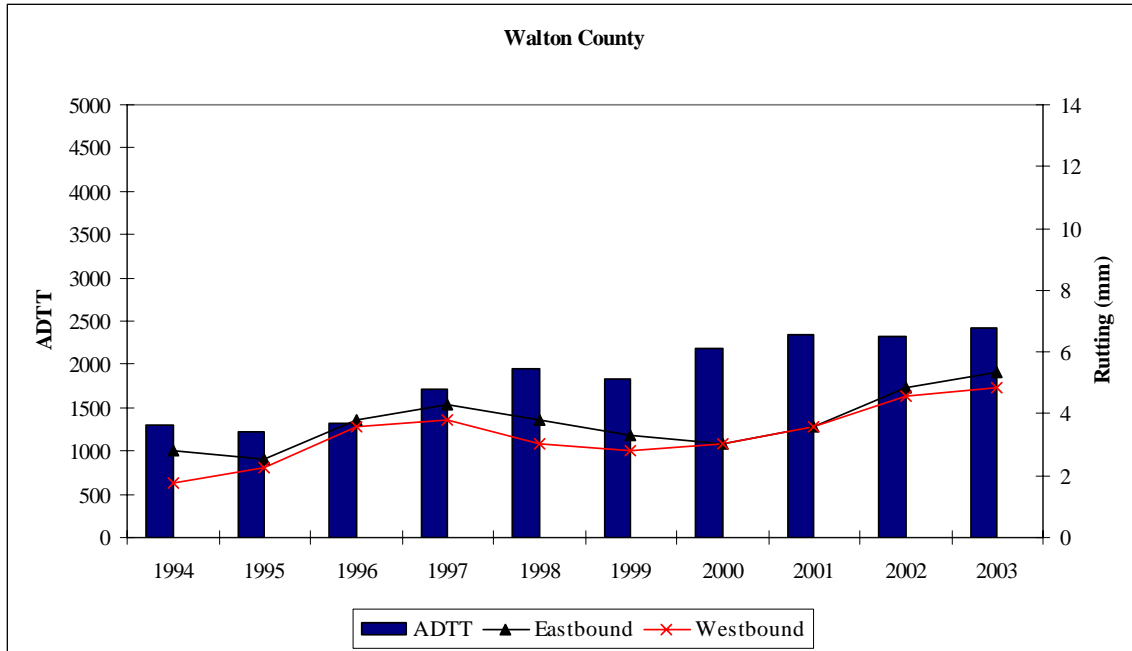
**Figure 5 Rutting measurements and ADTT.**

Rutting in HMA overlays of concrete pavements occur entirely in the overlay. The long term rutting tends to develop slowly, following the initial rutting due to compaction of the mix. The rutting measurements used in this study were acquired with an ASTM 950 class 1 high-speed laser profiler using a three laser system, and represents the average rut value of both wheelpaths. These measurements are illustrated in Figures 5 through 7, which show a maximum rut depth of approximately 0.35 inch on the majority of the test sections. The two projects that exhibited the highest levels of deformation are those in Jefferson and Leon (second project) Counties, where rut depths averaging 0.4 inch were recorded between December of 1999 and April of 2001. It is likely that this rutting is due to problems with the asphalt mixture since a number of issues were encountered during production, and the same mixture was placed on both projects. Critical low in-place air voids (ranging from 0.2 to 1.9 percent) were measured on the Leon County project (13), which resulted in the removal and replacement of a substantial amount of pavement on this project before its completion in August of 1993. It is also probable that the fine-graded, 50-blow Marshall designed mixes were inadequate to withstand the actual loading conditions. Over the past 10 to 15 years, and before the implementation of Superpave, a significant number of asphalt pavements on interstate projects in North Florida have experienced premature failures, primarily due to rutting (14). The Jefferson County project was resurfaced in 2001 and the Leon County (second project) was resurfaced in 2000. The survey measurements which were taken after the resurfacing of these projects are not included in this evaluation.

- All seven projects (14 sections) have performed well in terms of ride quality in both the eastbound and westbound directions.
- Five out of seven projects exhibited an average rutting of approximately 0.35 inch after ten years of service. Two projects, located in Jefferson and Leon (second project) Counties, showed higher levels of deformation, averaging approximately 0.5 inch, and appear to be asphalt mix related. These two sections were resurfaced in 2001 and 2000 respectively.

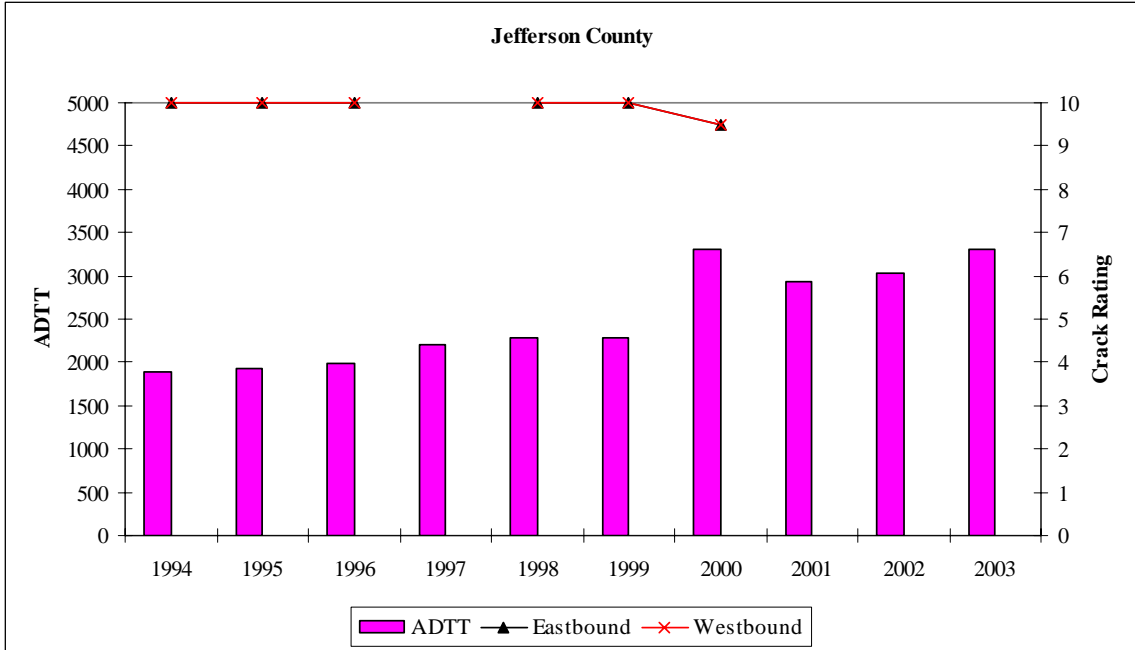
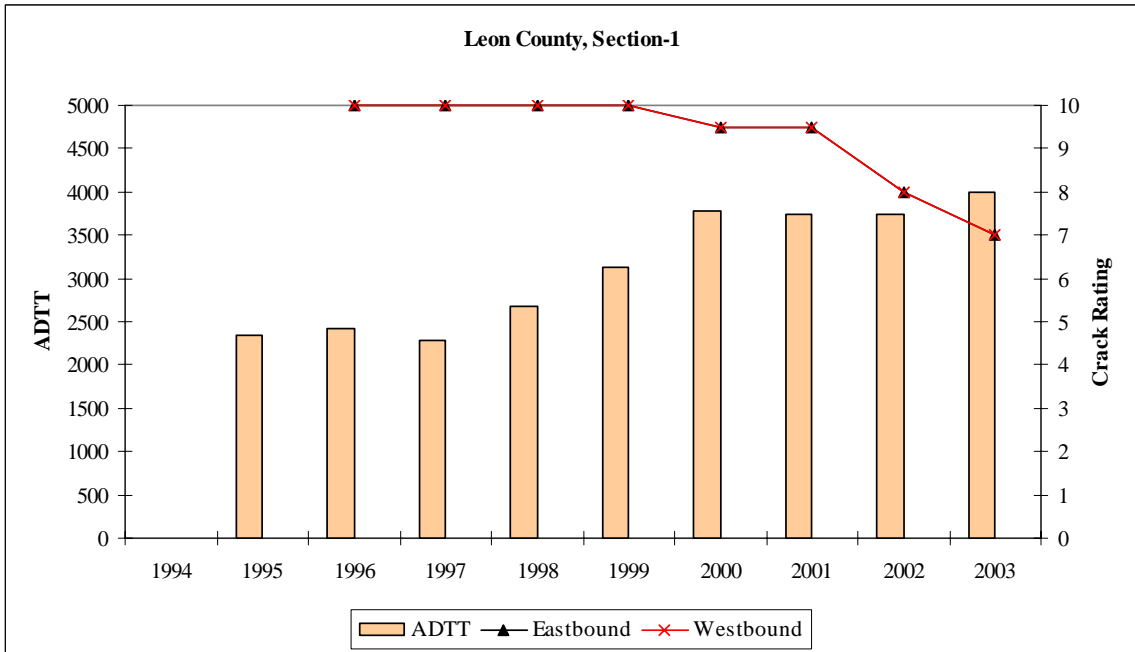
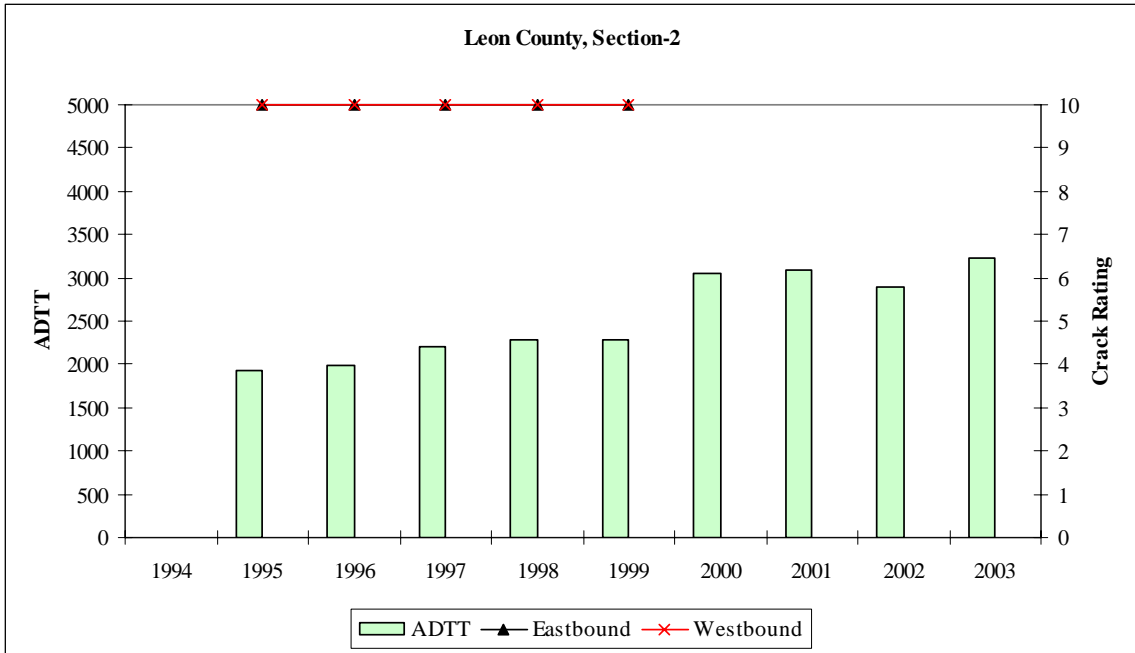
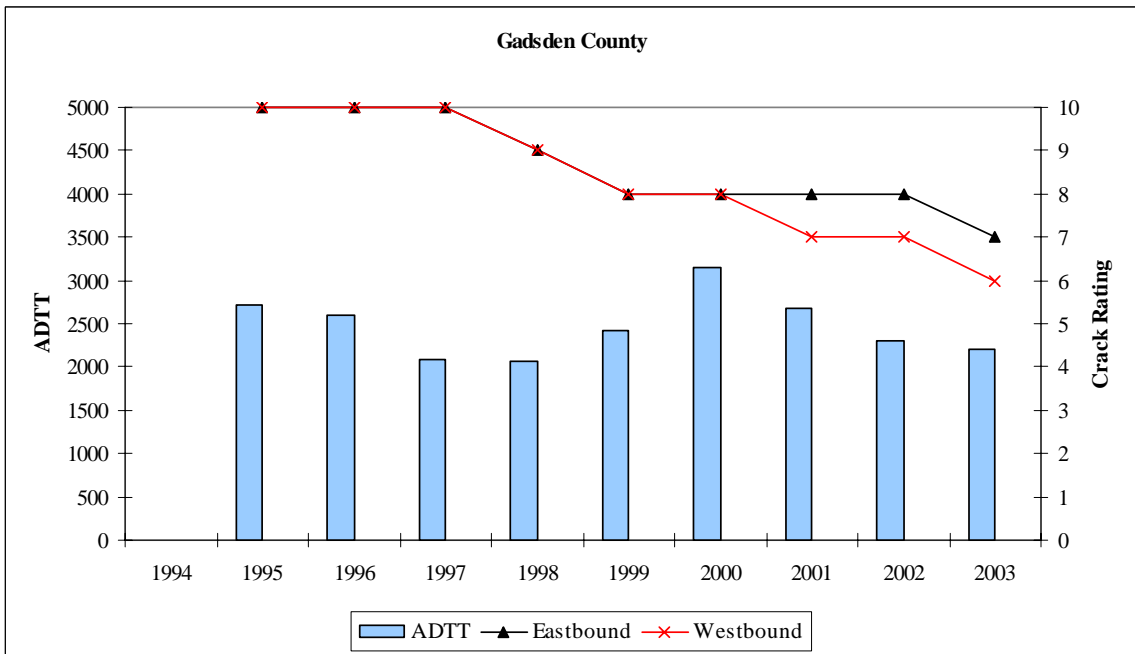
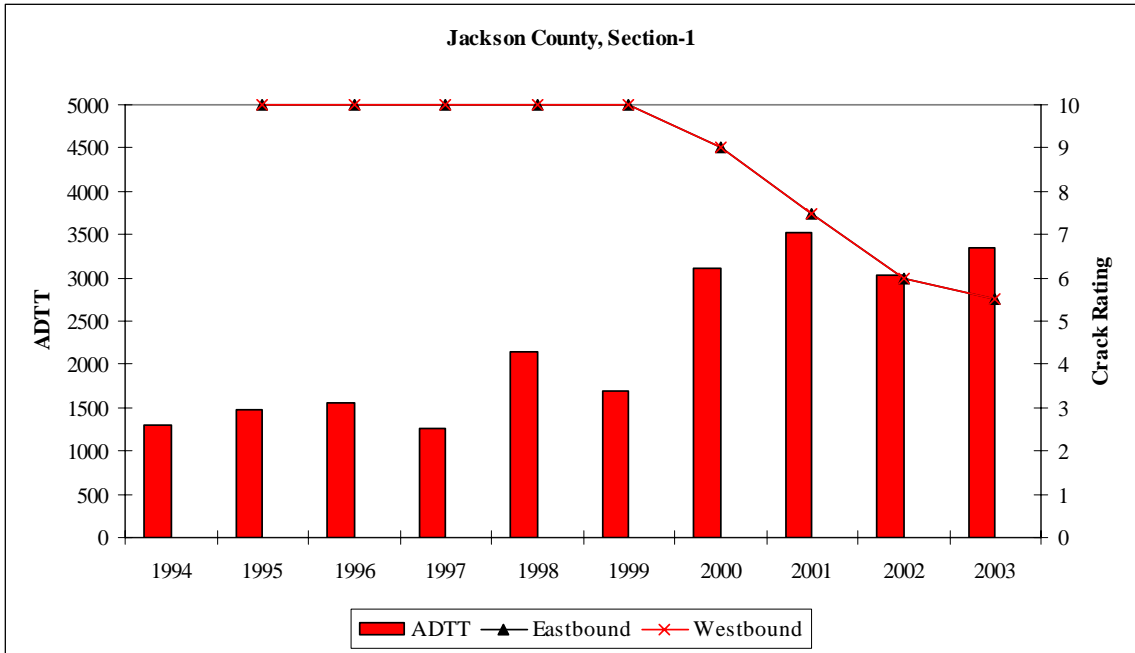
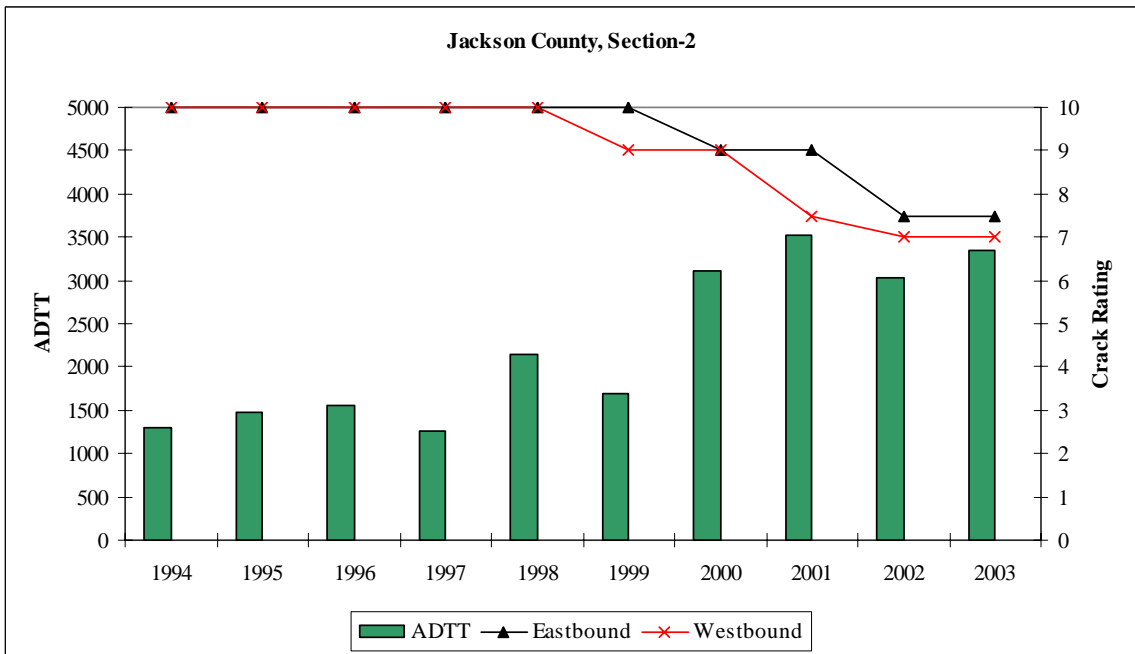
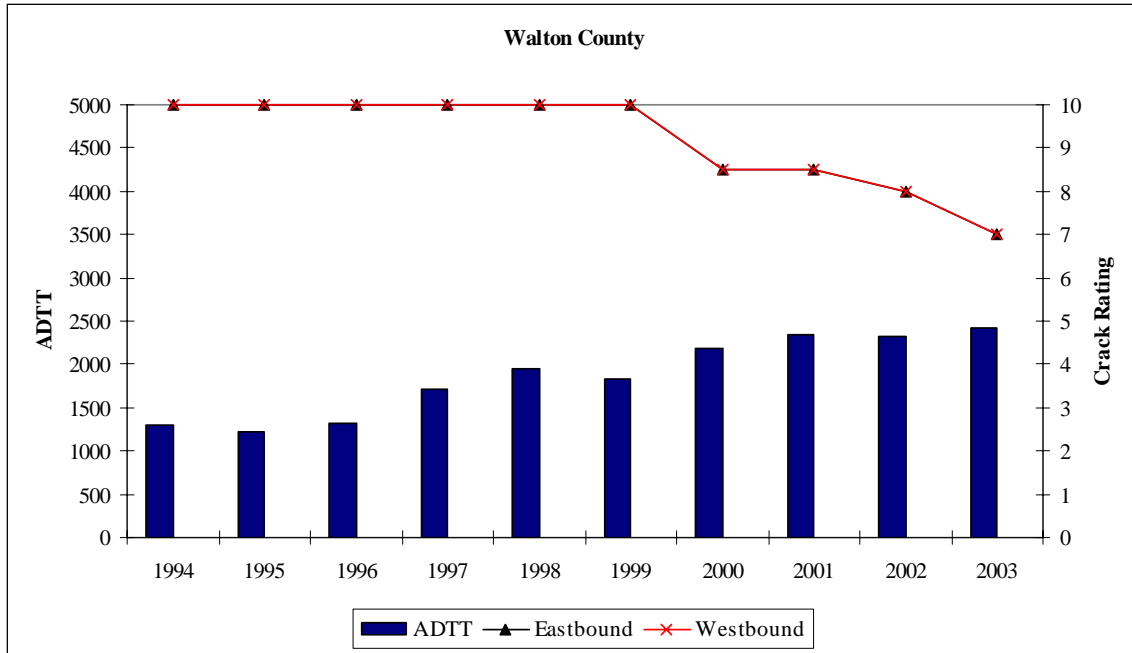
**Figure 8 Crack rating and ADTT**

The results from earlier investigative studies performed by others indicated that the cracking-and-seating method reduced reflection cracking during the first few years after construction, but then increased after 4 to 5 years of service (7, 9). Performance of the Florida crack-and-seat projects appear to show somewhat better performance as illustrated in Figures 8, 9 and 10. The first project to experience cracking was Gadsden County five years after rehabilitation; this was followed by Leon County (section 1) after six years. The other counties all experienced cracking

in the seventh year. Visual surveys indicate that the amount of cracking is greatest in both directions of the second project in Jackson County, and to a lesser extent the westbound direction of the Gadsden County project.

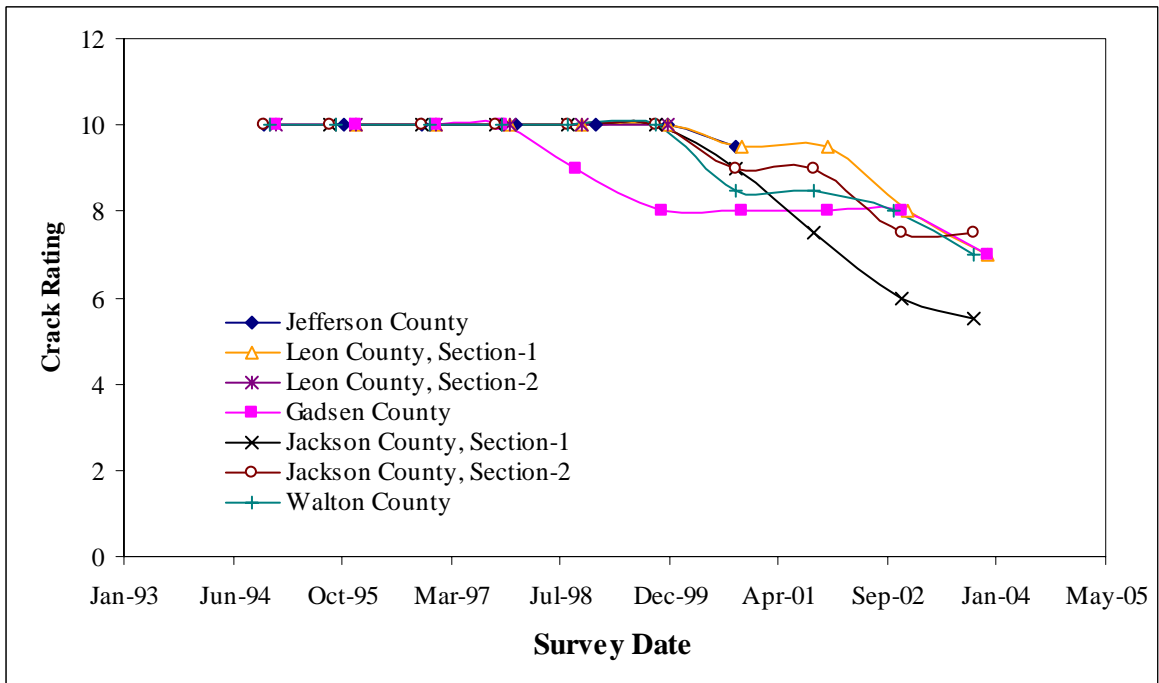
**Figure 9 Crack rating in the eastbound direction.**

- No cracking was observed for the first four years for all sections. However, cracking was evident on all sections by the seventh year, indicating that all sections performed as good as if not better than what literature suggested. Visual surveys indicate that the amount of cracking is greatest in both directions of the second project in Jackson County and to a lesser extent the westbound direction of the Gadsden County project.
