US 27/SR 25 Pavement Evaluation

State Materials Office

FL/DOT/SMO/11-542

May, 2011

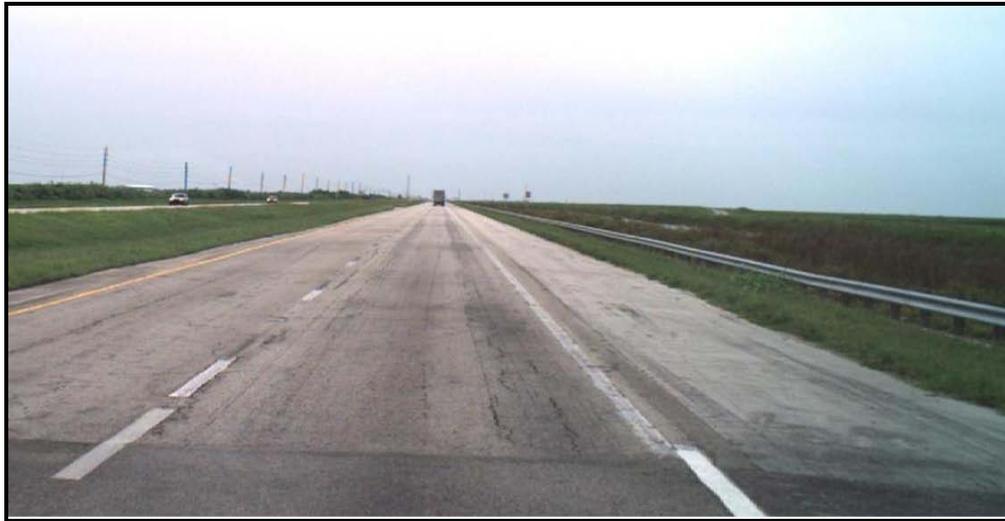
The section is a rural four-lane divided roadway (two lanes in each direction) with 12 ft lanes, 4 ft paved inside shoulder, 10 ft paved outside shoulder, and a grassy median. It borders a drainage canal to the east of the facility and has a posted speed limit of 65 mph (Figure 2). The section is in the middle of a sugar cane farming area with an Average Annual Daily Traffic (AADT) between 7,200 and 9,100 vehicles. The truck factor ranged between 30 and 41% for the past ten years, 63% of which was in the two northbound lanes. The northbound passing lane (R1) was reconstructed in the late 1980's at the same time as the two southbound lanes (L1 and L2). The northbound travel lane (R2) was resurfaced several times in the past and is built over the same muck embankment.

Figure 2 US 27/SR 25 Northbound Lanes (MP 11.916)

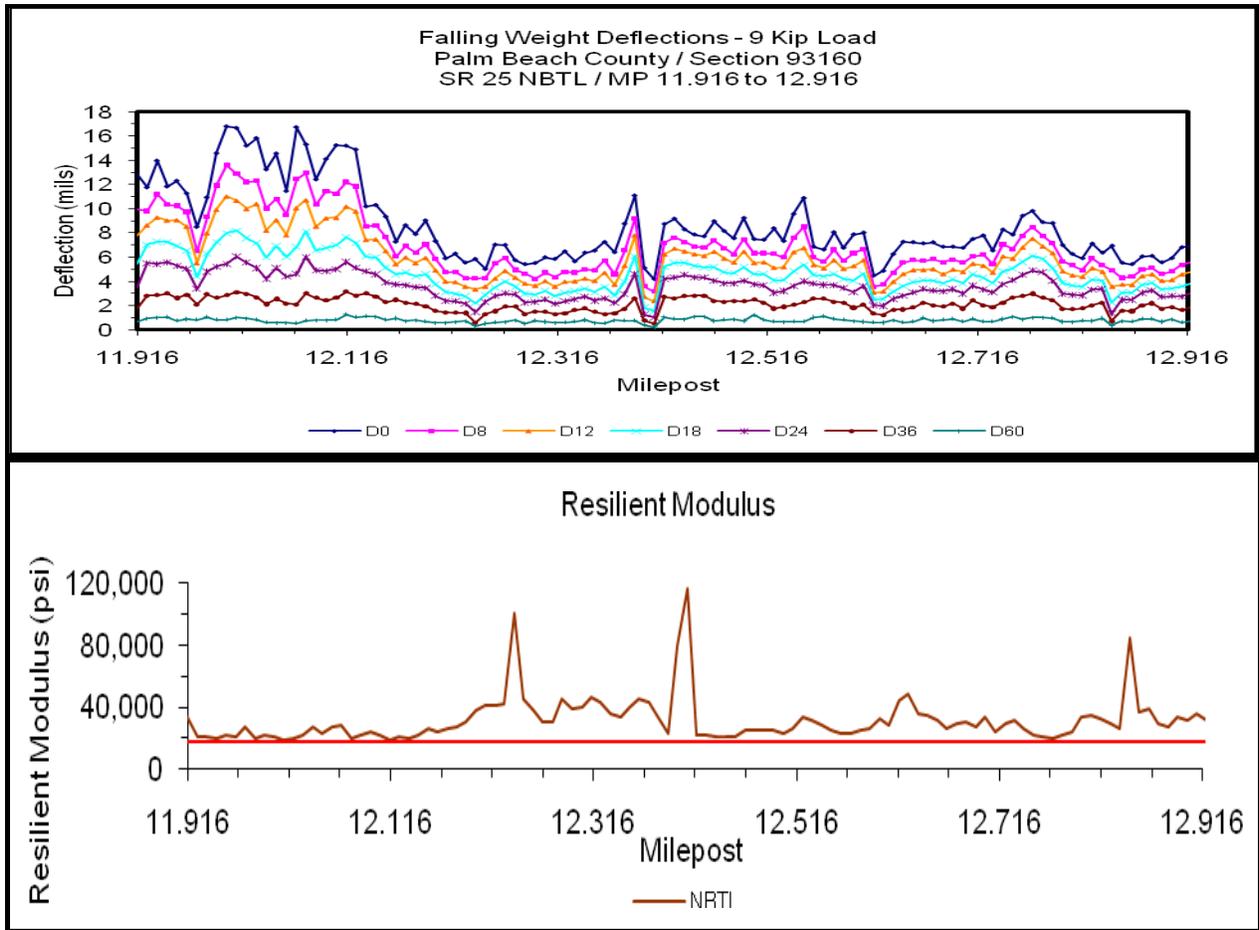
Figure 5 illustrates the pavement system deflection response and corresponding stiffness. A modulus (M_r) value of 18,000 psi was determined to represent the subgrade in-situ stiffness as determined according to the Florida Flexible Pavement Design Manual.

Figure 5 FWD deflections and in-situ subgrade modulus

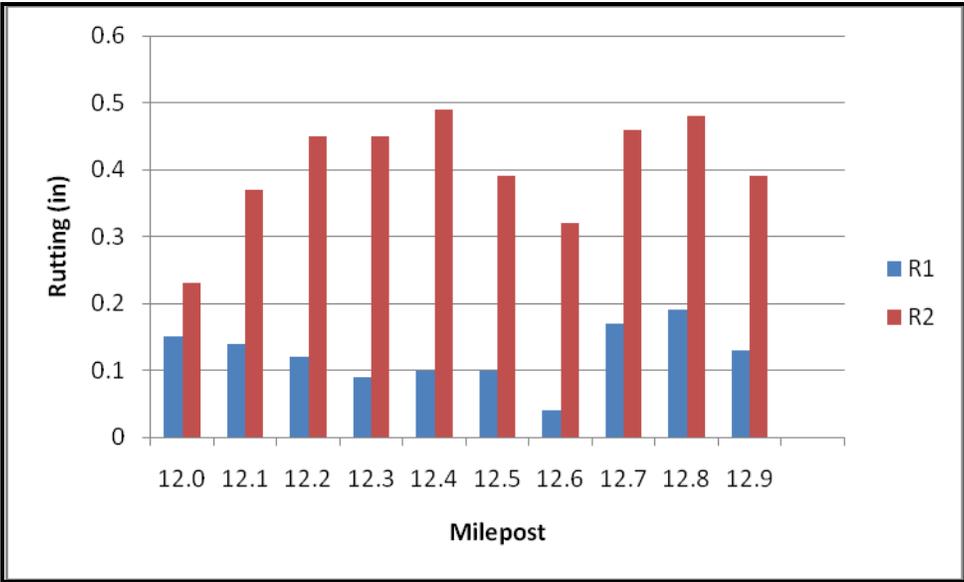
Permanent deformation expressed as the average rut depth in both wheel-paths was collected automatically using an inertial profiling system on board of the MPSV, with a profile sampling rate of 0.68 in reported at tenth-mile intervals. As Figure 6 shows, rutting was much more significant in R2, which contributed to the higher roughness. Severe rutting results in surface water retention and potentially hazardous driving conditions and hydroplaning (2).

Figure 6 Rutting

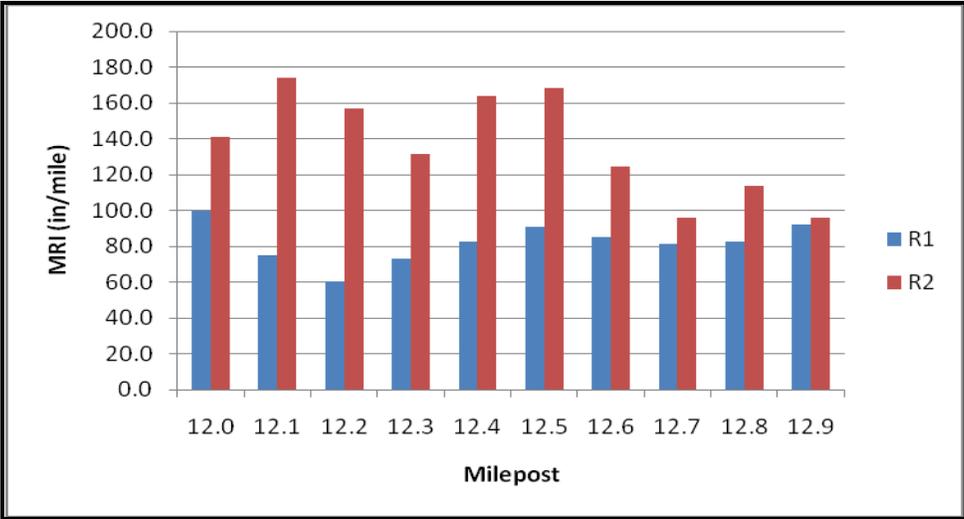
Roughness (or lack of smoothness) is expressed here in terms of the Mean Roughness Index (MRI), which represents the average International Roughness Index (IRI) for both wheel-paths, reported for every tenth-mile interval. The higher the MRI, the rougher the ride quality. As Figure 7 clearly illustrates, roughness was much more severe in R2. This explains the reason drivers on this roadway prefer to stay in the inside lane which provides a smoother ride quality.

Figure 7 Roughness

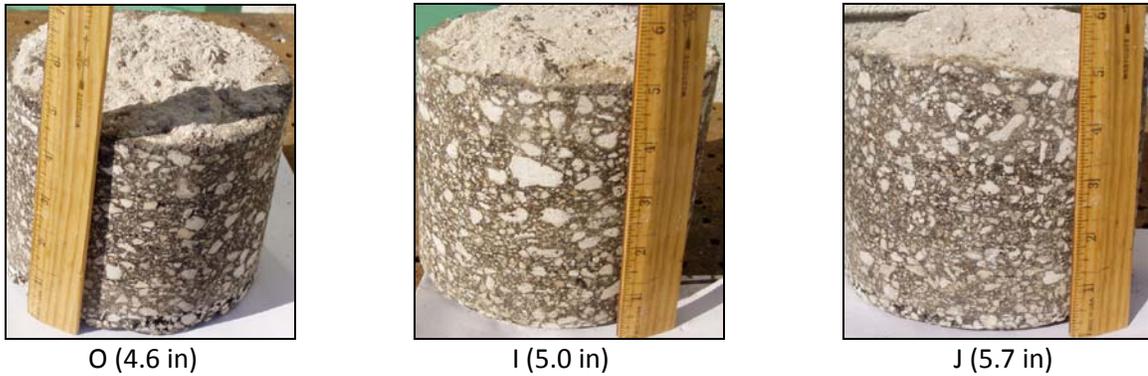
Figure 8 illustrates the sampled cores and modes of cracking observed. In general, cracks in pavements with asphalt thickness greater than 8 inches tended to originate at the surface as a result of excessive stresses due to binder aging and tire-pavement interaction. Pavement areas with HMA between 6 and 8 inches, failure was typically evidenced by bottom-up cracking due to higher tensile strain at the bottom of the HMA. Cores with full depth cracking had transverse surface cracking typically associated with thermal stresses. These cracks were wide, with a fair amount of trapped fines, an indication that failure may have occurred earlier on compared to the rest of the cores. Laboratory analysis of core tensile strength and modulus would have been desirable, but is beyond the scope of this evaluation.

Figure 8 Cracking in Cores (a) No cracking, (b) Bottom up; (c) Top-down; (d) Full depth

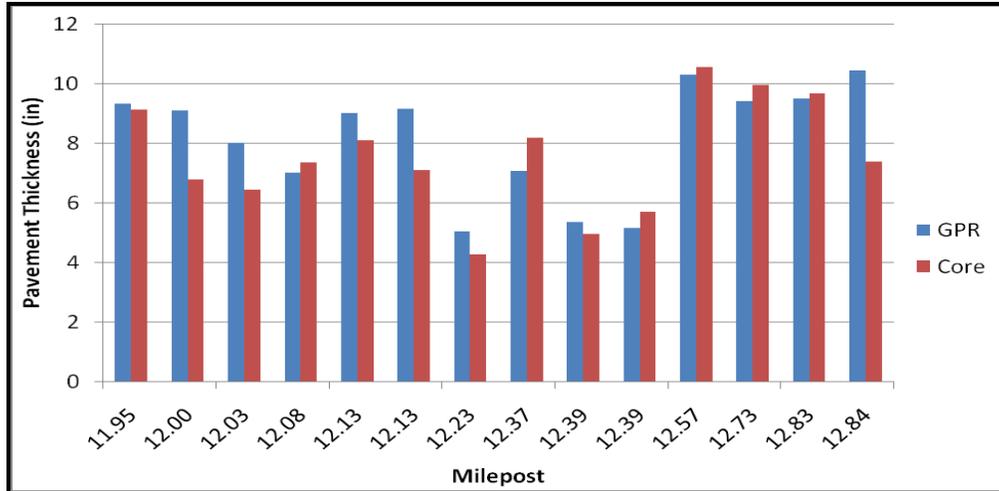
Data was collected at 55 mph, using a 1ft sampling interval with the antennas positioned along the inside and outside wheel-paths (Figure 9). HMA thickness was estimated by averaging the six GPR readings closest to each core location and was then compared to actual core thickness (Figure 10). On average, the GPR estimated HMA thickness deviated by 1.0 inch from core thickness. A previous FDOT study on the accuracy of the GPR system showed that on average the system can predict asphalt thickness within approximately 8%. The GPR estimated thickness for US 27 is a relatively good match considering the GPR system was not calibrated against a core value, in addition to compensating error due to data averaging.

Figure 10 HMA thickness by GPR

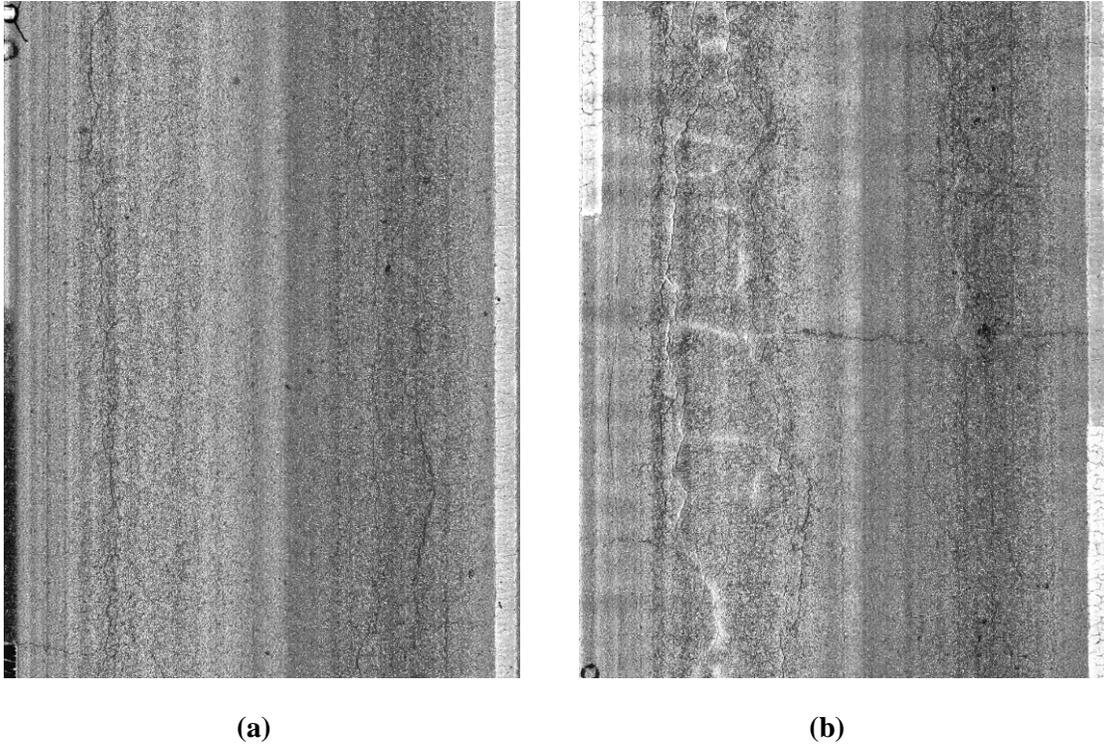
Surface cracking was evaluated using the Labview Image Crack Analysis Program, an in-house program developed for experimental projects. Pavement images collected with the MPSV in R2 were imported and scanned by the program. In the manual mode, the user analyzes each image by tracing the extent of the distress, selects the distress and severity types using a drop down menu and mouse activated selection tools. The program tallies and summarizes the measurements in an Excel spreadsheet. The cracking was of the fatigue type confined mainly to the wheel-paths, 75% of which was moderate and 15% was light severity (Figure 11). Pumping was also observed mainly in the wheel-paths.

Figure 11 Fatigue cracking in wheel-paths (a) light, (b) moderate

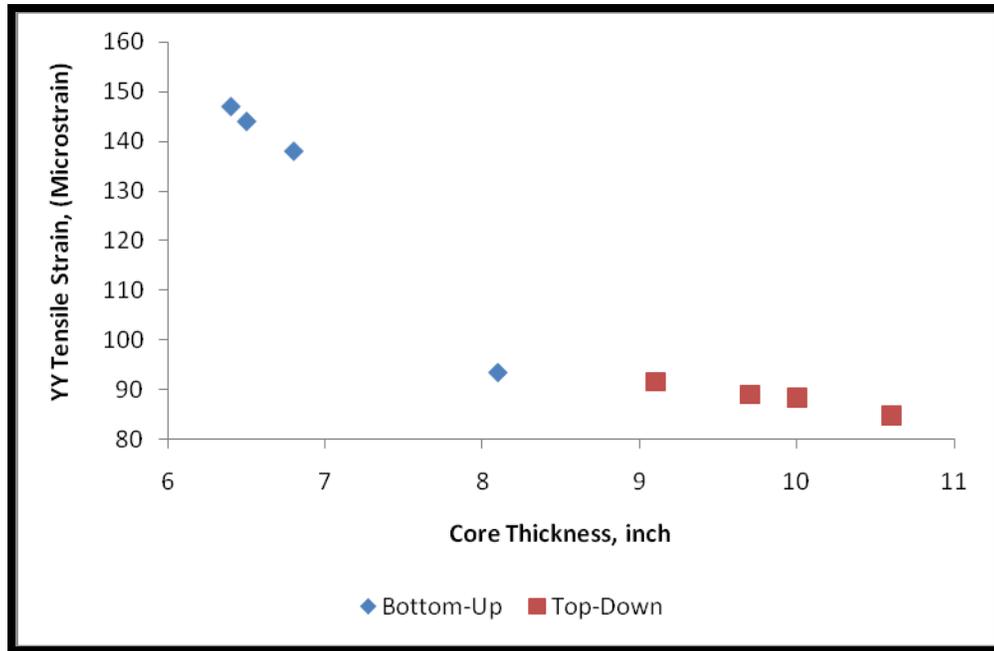
A mechanistic analysis of the existing pavement system was performed using the BISAR computerized elastic-layer pavement analysis program. This was done to estimate the critical stresses and strains at the bottom of the HMA to verify the cracking mechanism observed in the core samples. The pavement was modeled as a three-layer linear elastic system consisting of an HMA surface and structural layer represented by the core length, a composite base and subgrade layer of 24 inches, and a semi-infinite layer for the embankment. All layers were assumed to be homogeneous, isotropic and linearly elastic. The static loading configuration consisted of a dual-tire represented by two circular areas loaded at 4,500 lb/tire each and an assumed 100 psi tire pressure. As Figure 10 shows, the tensile strains were higher in the mid-size cores resulting in bottom-up cracking compared to the top-down cracking observed in the thickest cores.

Figure 12 Critical tensile strain at bottom of HMA
