# **Evaluation of Green Colored Bicycle Lanes in Florida**

FDOT Office State Materials Office

Report Number FL/DOT/SMO 17-581

Date of Publication April 2017

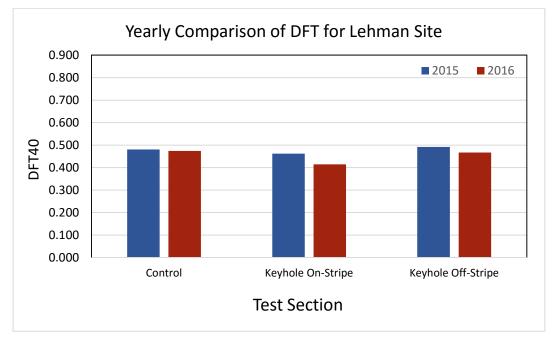
FIGURE 5. Yearly Comparison of DFT40 for Lehman Site

Lehman Causeway test site is identified as a rigid pavement with transverse grooved surface texture. The colored bike treatment is an epoxy modified green colored coating. Figures 5 and 6 present the results of yearly comparisons of the coefficient of friction measured at 40 mph (DFT40) and the surface texture (MPD), respectively. As shown, the DFT40 at both the control and keyhole on- and off-stripe sections meet the minimum friction number requirements of 40 as specified in FM 5-592, Friction Measuring Protocol for Patterned Pavements. Overall friction decreased for year 2016 when compared to 2015 at the control and keyhole (on- and off-stripes) sections due to traffic effects. Overall average texture measurements across all sections indicate a decrease in MPD values in year 2016 when compared to 2015. Detail DFT and CTM test results for year 2015 and 2016 are presented in Appendices A and B, respectively.

- Lehman Causeway (Site 1) Identified as a rigid pavement with transverse grooved surface texture. The colored bike treatment is an epoxy modified green colored coating. The control and keyhole sections meet the minimum friction number requirement at DFT40 (FN of 40) for both years. However, overall friction decreased for year 2016 when compared to 2015 at the control and keyhole (on- and off-stripes) sections due to traffic effects. Overall average texture measurements across all sections indicate a decrease in MPD values in year 2016 when compared to 2015.

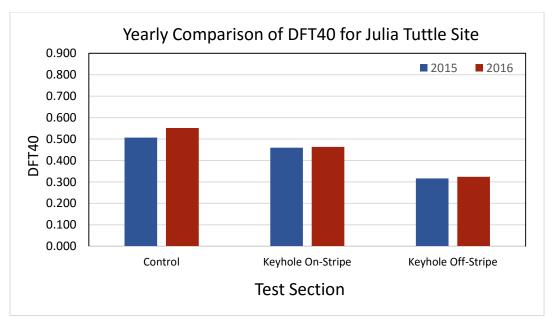
FIGURE 7. Yearly Comparison of DFT40 for Julia Tuttle Site

Julia Tuttle Causeway test site is a dense graded friction course surface with an epoxy modified green colored coating treatment for the bike lane. Figures 7 and 8 present the results of yearly comparisons of the coefficient of friction measured at 40 mph (DFT40) and the surface texture (MPD), respectively. As shown, the DFT40 at both the control and keyhole on-stripe sections meet the minimum friction number requirements of 40 as specified in FM 5-592, Friction Measuring Protocol for Patterned Pavements. Friction values at the keyhole off-stripe section were lower than normal ranges. No change in friction values was observed at the keyhole on- and off-stripes over the two year period, however there was a slight increase in friction from year 2015 to 2016 at the control section. The friction value at the control section is higher than at the keyhole off-stripe sections due to traffic effects. Overall average texture measurements across all sections indicate a slight decrease in MPD values in year 2016 when compared to 2015. Detail DFT and CTM test results for year 2015 and 2016 are presented in Appendices A and B, respectively.

- Julia Tuttle Causeway (Site 2) Is a dense graded friction course surface with an epoxy modified green colored coating treatment. The friction values for both years at the control and keyhole on-stripe sections meet the minimum requirement at DFT40. Friction values at the keyhole off-stripe was lower than normal ranges. No change in friction values was observed at the on-and off-stripe keyholes over the two year period, however there was a slight increase in friction from year 2015 to 2016 at the control section. The friction value at the control section is higher than at the keyhole off-stripe section. Overall average texture measurements across all sections indicate a slight decrease in MPD values in year 2016 when compared to 2015.

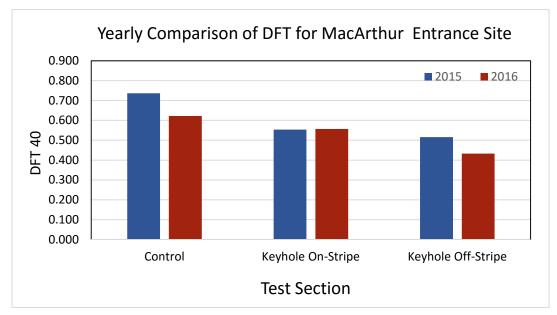
FIGURE 9. Yearly Comparison of DFT40 for MacArthur Entrance Site

MacArthur Causeway test site is identified as a dense graded friction course surface with a thermoplastic green colored treatment for the bike lane. Tests were conducted at the entrance and exit ramps at this site. Figures 9 to 12 present the results of yearly comparisons of the coefficient of friction measured at 40 mph (DFT40) and the surface texture (MPD), respectively. As shown,

the DFT40 at both the control and keyhole on- and off-stripe sections meet the minimum friction number requirements of 40 as specified in FM 5-592, Friction Measuring Protocol for Patterned Pavements. Slight decrease in friction values was observed at the keyhole (on- and off-stripes) than the control sections over time due to traffic effects at both the entrance and exit ramps. Overall average texture measurements across all sections at the entrance ramp indicate a slight increase in MPD values in year 2016 when compared to 2015. However, at the exit ramp there was no change in surface texture over the two year period. Detail DFT and CTM test results for year 2015 and 2016 are presented in Appendices A and B, respectively.

- MacArthur Causeway Entrance and Exit Ramps (Site 3) Identified as a dense graded friction course surface with a thermoplastic green colored treatment. Friction values meet minimum requirements specified for DFT40 (FN of 40) for both years at the control and keyhole sections. Slight decrease in friction values was observed at the keyhole (on- and off-stripes) than the control sections over time due to traffic effects at both the entrance and exit ramps. Overall average texture measurements across all sections at the entrance ramp indicate a slight increase in MPD values in year 2016 when compared to 2015. However, at the exit ramp there was no change in surface texture over the two year period.

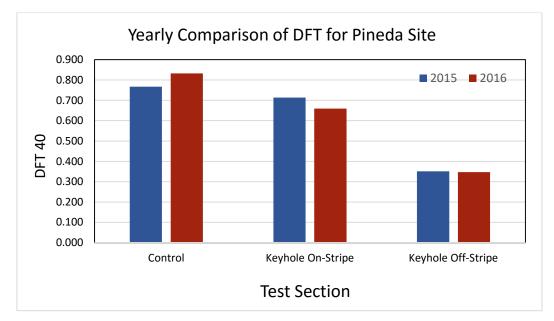
FIGURE 13. Yearly Comparison of DFT40 for Pineda Site

Pineda Causeway test site is identified as an open graded friction course surface with a high friction surface treatment (HFST) application for the green colored bike lane. Figures 13 and 14 present the results of yearly comparisons of the coefficient of friction measured at 40 mph (DFT40) and the surface texture (MPD), respectively. As shown, the DFT40 at both the control and keyhole on-stripe sections meet the minimum friction number requirements of 40 as specified in FM 5-592, Friction Measuring Protocol for Patterned Pavements. However, friction value on the keyhole off-stripe section was lower than normal ranges. Friction values decreased slightly over time at the keyhole on- and off-stripes compared to the control section due to traffic effects. Overall average texture measurements across all sections indicate a slight increase in MPD values in year 2016 when compared to 2015. Detail DFT and CTM test results for year 2015 and 2016 are presented in Appendices A and B, respectively.

- **Pineda Causeway** (Site 4) Identified as an open graded friction course surface with a high friction surface treatment (HFST) application for the green colored bike lane. Friction values meet the minimum requirements specified for DFT40 (FN of 40) at the control and keyhole on-stripe sections for both years. However, friction value on the keyhole off-stripe section was lower than normal ranges. Friction values decreased slightly over time at the keyhole on- and off-stripes compared to the control section due to traffic effects. Overall average texture measurements across all sections indicate a slight increase in MPD values in year 2016 when compared to 2015.

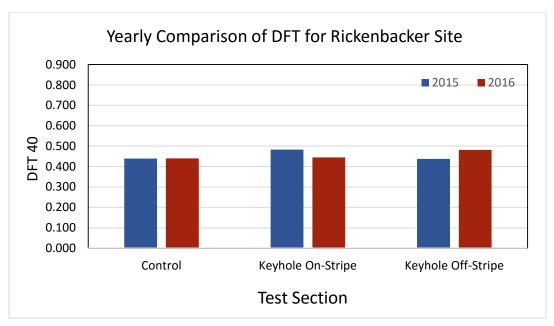
FIGURE 15. Yearly Comparison of DFT40 for Rickenbacker Site

Rickenbacker Causeway test site is identified as an open graded friction course surface with an epoxy modified green colored coating treatment for the bike lane. Figures 15 and 16 present the results of yearly comparisons of the coefficient of friction measured at 40 mph (DFT40) and the surface texture (MPD), respectively. As shown, the DFT40 at both the control and keyhole on-and off-stripe sections meet the minimum friction number requirements of 40 as specified in FM 5-592, Friction Measuring Protocol for Patterned Pavements. Friction values decreased slightly in year 2016 when compared to year 2015 at the keyhole on-stripe. However, friction value at the off-stripe keyhole section slightly increased in year 2016 compared to 2015. Overall average texture measurements across all sections indicate a decrease in MPD in year 2016 when compared to 2015. Detail DFT and CTM test results for year 2015 and 2016 are presented in Appendices A and B, respectively.

- **Rickenbacker Causeway (Site 5)** Identified as an open graded friction course surface with an epoxy modified green colored coating treatment for the bike lane. Friction values meet the minimum requirements specified for DFT40 (FN of 40) at the control and keyhole

sections for both years. Friction values decreased slightly in year 2016 when compared to year 2015 at the keyhole on-stripe. However, friction value at the off-stripe keyhole section slightly increased in 2016 compared to 2015. Overall average texture measurements across all sections indicate a decrease in MPD in year 2016 when compared to 2015.
