I-295/SR9A Joints Evaluation

State Materials Office

FL/DOT/SMO 18-590

04/30/2018

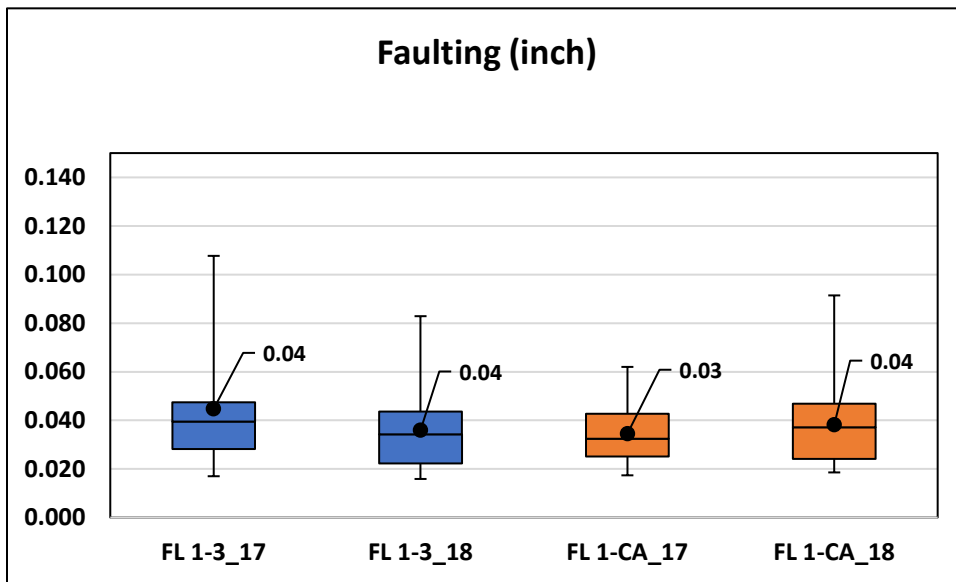
Figure 3 2017 and 2018 Faulting including joints

Faulting in the right wheel-path was calculated from the right wheelpath profile trace using the FDOT Automated Faulting Program (AFP). From the 2017 data, the AFP detected 42% of the joints (16 out of 38) in FL 1-3, and 74% of the joints (28 out of 38) in FL 1-CA; from the 2018 data, AFP detected 50% of the joints (19 out of 38) in FL 1-3, and 71 % of the joints (27 out of 38) in FL 1-CA. As illustrated in Figure 3, faulting was low in both years, averaging 0.04 inch in both sections. The low faulting magnitude agrees with the relatively low transverse joint detection

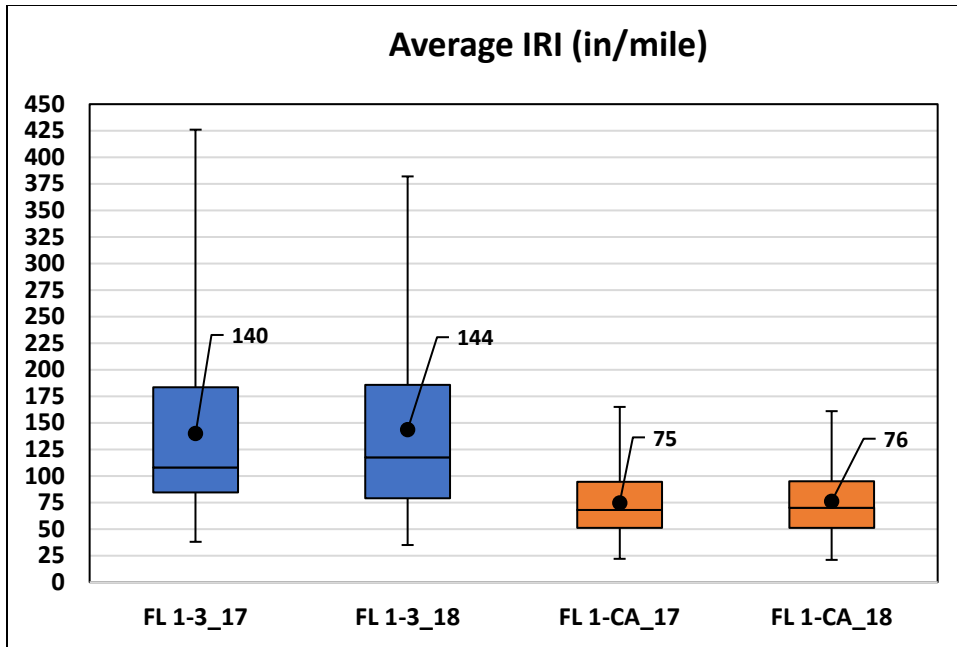
Figure 4. 2017 and 2018 roughness

Profile testing was conducted in October 2017 and March 2018 by the same operator. Due to the on-going construction, the profiler operator had to straddle both lanes with the survey vehicle to avoid driving over the asphalt surface covering the outside portion of the outside lane (L2). Thus, data collection in the left wheel path was conducted in the inside lane (L1), while right wheelpath data collection was conducted in the outside lane (L2). As shown in Figure 4, the average IRI for FL 1-3 for 2017 and 2018 was almost double that of FL 1-CA. This is opposite to what is normally expected given that FL 1-CA has the wider joints.

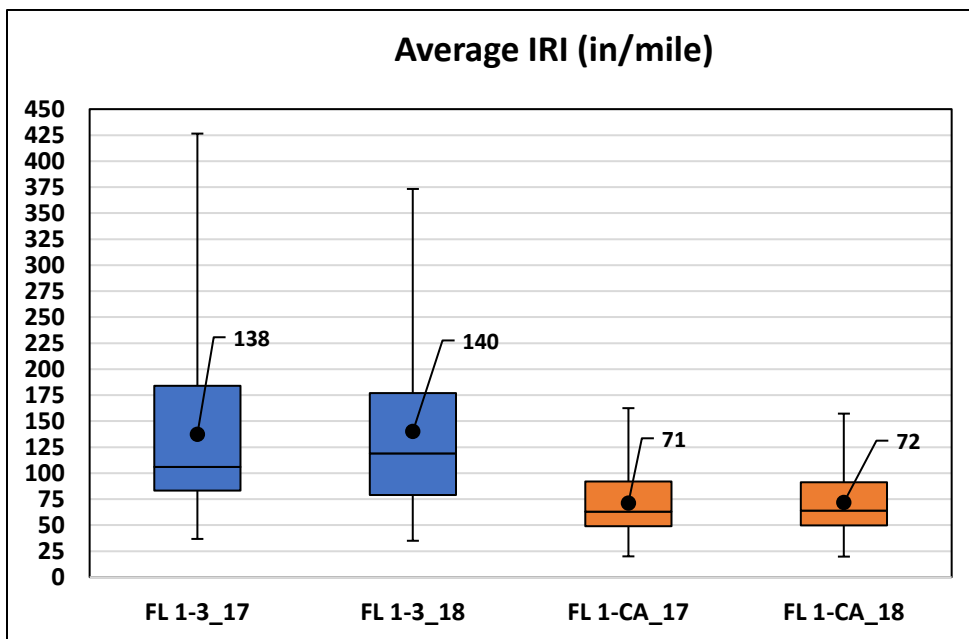
Figure 5. 2017 and 2018 roughness excluding joints

The profiles were again processed but this time excluding profile data at the detected transverse joints. Although the resulting average IRI dropped in both sections, it did not change significantly as illustrated in Figure 5. This indicates that the contribution of the detected transverse joints to overall roughness is not significant. This is consistent with field observations during data collection noted by the absence of “joint slap”, notable difference in “seat-of-the-pant” roughness, and faulting.

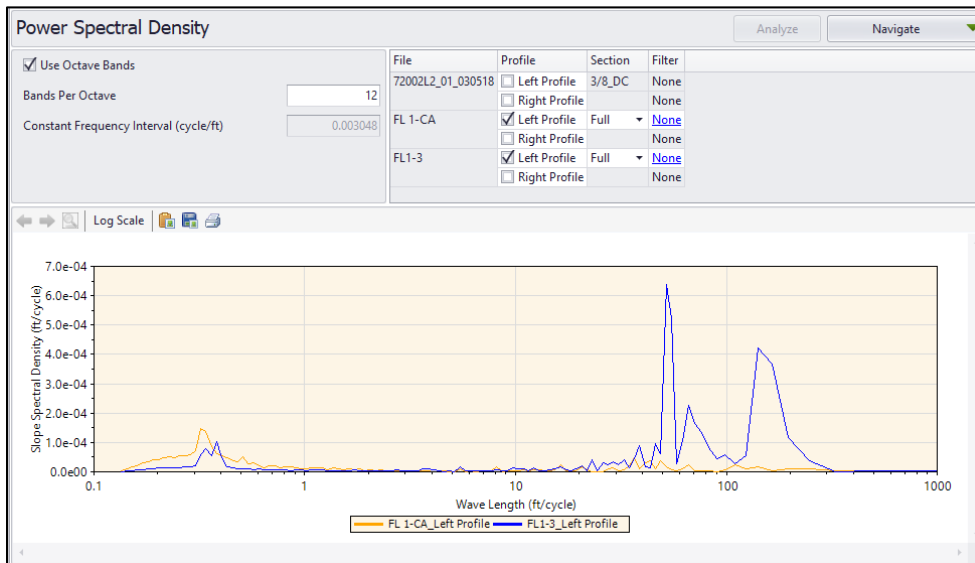
Figure 6. PSD for LWP profile

Power Spectral Density (PSD) plots were generated for each wheelpath profile trace using ProVAL 3.61 Software to further investigate the difference in average IRI between the two sections. The PSD function of road profiles is a statistical representation of the importance of various wave numbers (or wave lengths) (2). The PSD plots in Figure 6 and Figure 7 clearly show a relatively high frequency of 55 ft wave length content in FL 1-3 illustrated by a spike at that frequency, for the Left Wheelpath (LWP) and Right Wheelpath (RWP) profile, respectively, which is a major contributor to the relatively large IRI in this section.

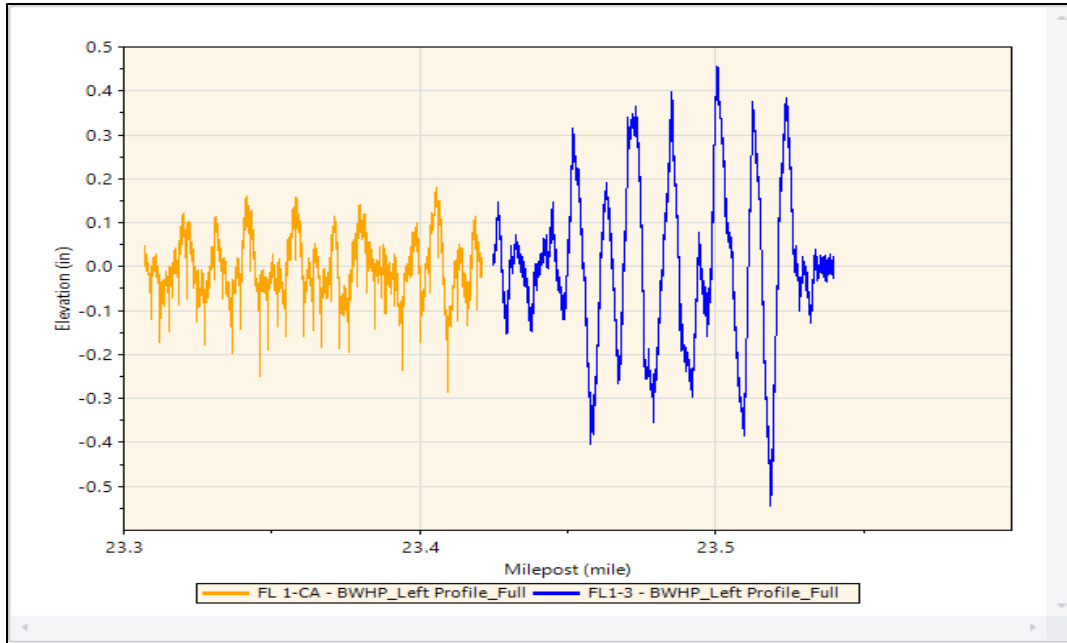
Figure 8 LWP Profile with Butterworth Filter @ 100 ft cutoff

The original profiles were also filtered using a Butterworth filter set at 100 ft cutoff. The resulting filtered profile clearly shows a relatively high-profile pattern for FL 1-3 in the LWP (Figure 8) and in the RWP (Figure 9) when compared to FL 1-CA.

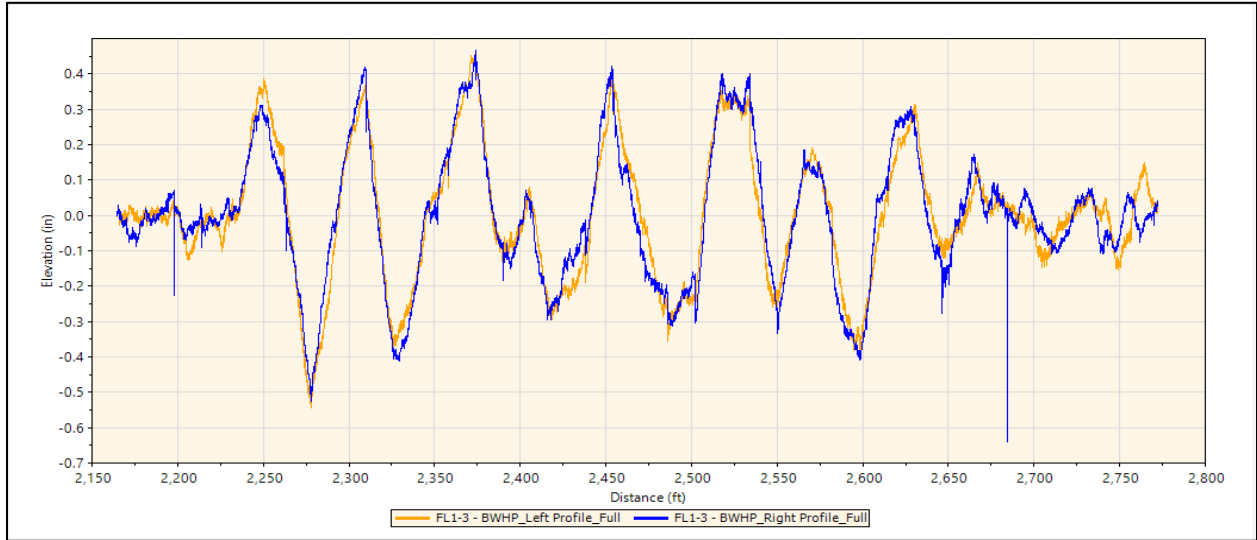
Figure 10 FL 1-3 LWP and RWP profile with Butterworth Filter @100 ft cutoff

As observed from the plots in Figure 10, FL 1-3 left and right profiles show a similar pattern, which indicates this is very likely due to a construction issue. One plausible theory is that it may have been caused by a sag in the paving string-line, survey error(s) in setting string-line elevations, or a combination of both.

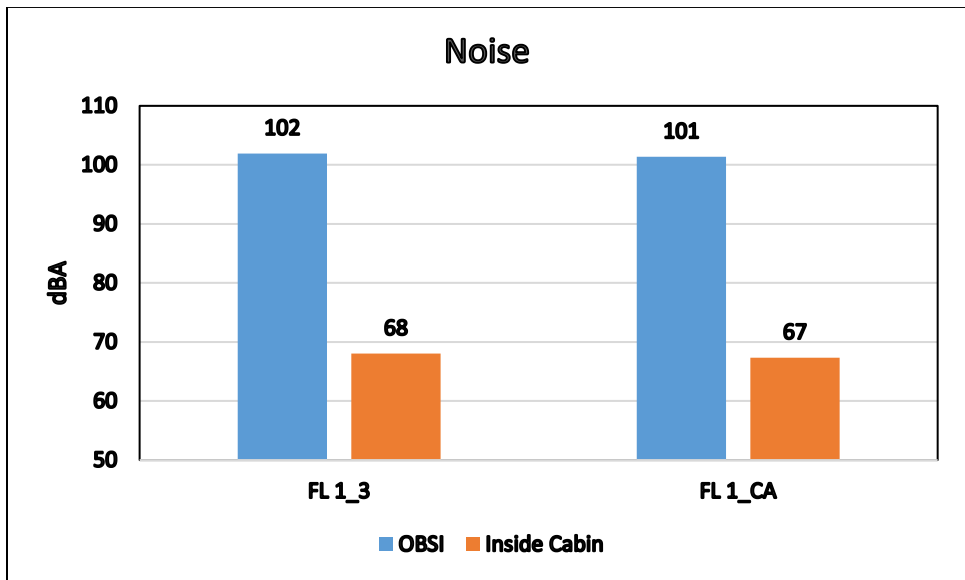
Figure 11 Noise in FL 1_3 and FL 1_CA

Noise data was collected in the inside travel lane (L1) and recorded OBSI as well as noise inside cabin of survey vehicle. Data was collected at 60 mph and recorded for 5 seconds in each section. Repeat measurements were conducted in each section, three for OBSI and two for inside cabin noise. The results in Figure 11 show no significant difference between the 1/8- inch (FL 1_3) and the 3/8-inch (FL 1_CA) joint sections.
