Aluminized Pipe Evaluation

FL/DOT/SMO 15-572

FDOT Office State Materials Office

Date of Publication 01-2015 Several recent aluminized pipe failures in the State of Florida prompted the Department to take a closer look at the quality of the pipe being produced today. Sections of pipe were sampled from all plants currently producing aluminized steel pipe for Department projects. These samples were sent to the State Materials Office, Corrosion Laboratory to perform an evaluation on the condition of the aluminum coating after fabrication. A total of nine pipe samples were acquired. See Table 1 for a list and description of these pipe samples.

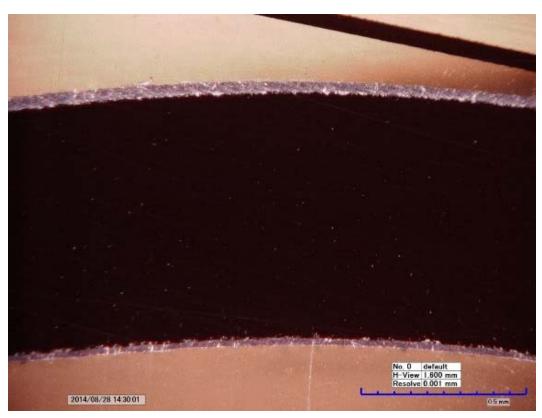
Figure 1. Pipe #2014-08-036 – 24" section of pipe. Eleven areas had visible damage, samples were removed for metallographic analysis

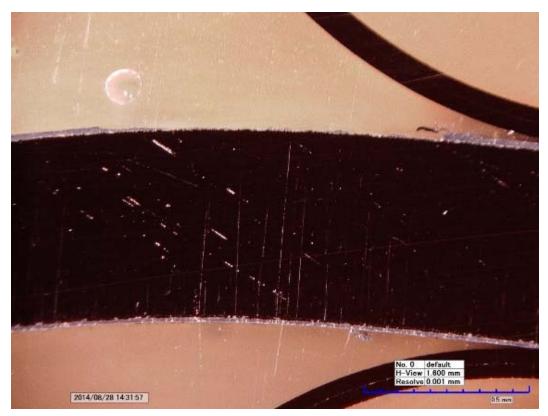
Figure 5. Pipe #2014-08-036 – Cross section of a scratched area showing visible damage to the aluminum layer. 70x

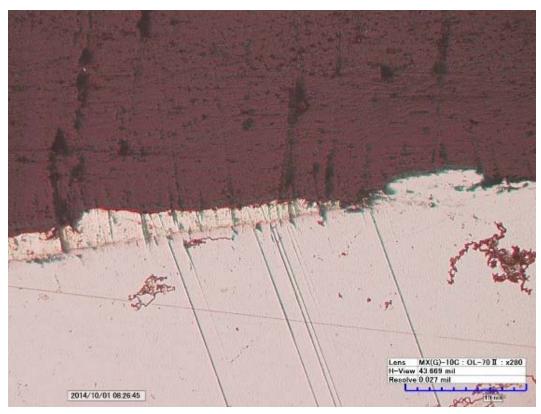
Figure 6. Pipe #2014-08-036 – Cross section of a scratched area. When examined under further magnification, there is visible damage to the inner metallic layer. 280x

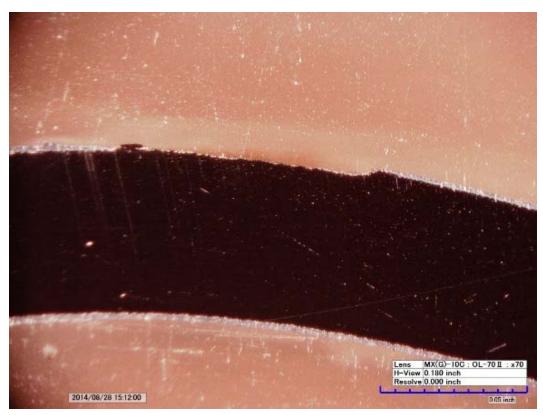
Figure 8. Pipe #2014-08-036 – Cross section of the gouged area showing visible damage to the aluminum layer. 70x

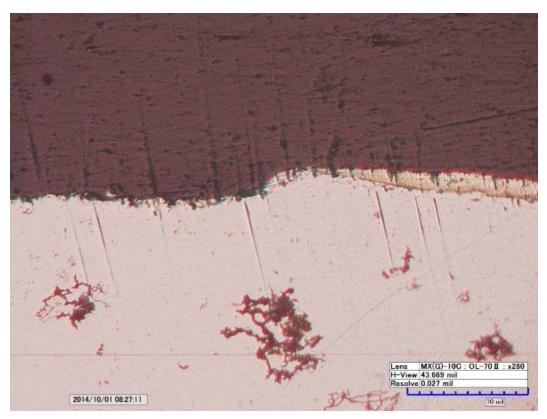
Figure 9. Pipe #2014-08-036 – Cross section of the gouges area. When examined under further magnification, there is visible damage to the inner metallic layer as well. 280x

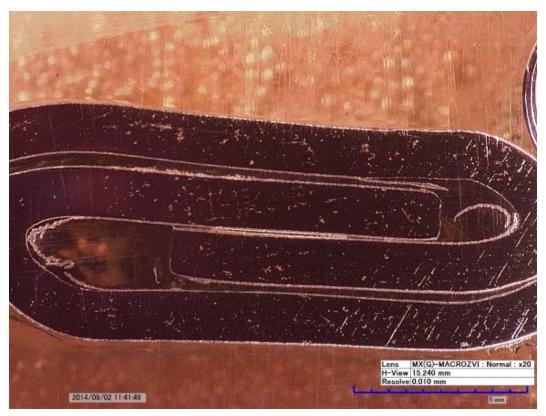
Figure 11. Pipe #2014-08-036 – Low magnification of the lock seam. There was no visible damage to the exterior, but there was damage in the folds to the aluminum layer. This type of damage is common, but poses little concern.

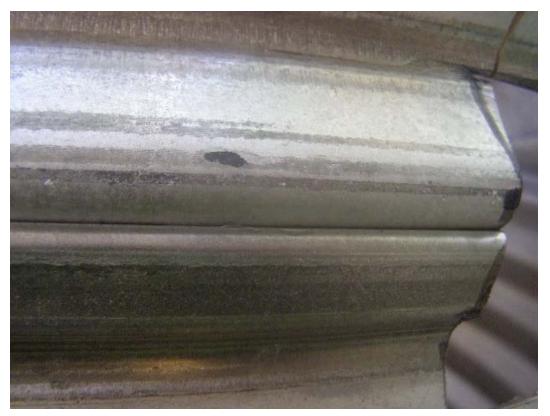
Figure 19. Pipe #2014-08-037 – Close up of a gouge in the pipe. This shows apparent damage to the aluminum coating.

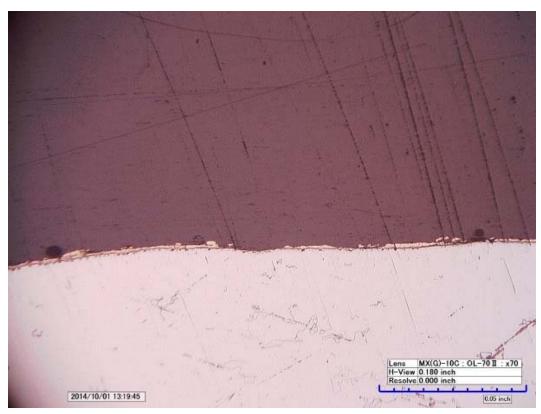
Figure 20. Pipe #2014-08-037 – Cross section of the gouged pipe showing visible damage to the intermetallic layer. 70x

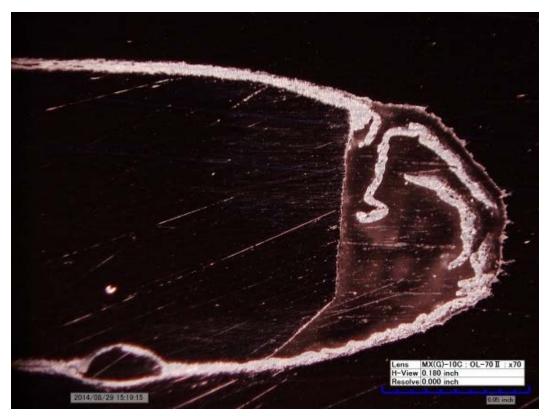
Figure 23. Pipe #2014-08-037 – Cross section of the lock joint. A clear separation of the aluminum layer is seen. 70x

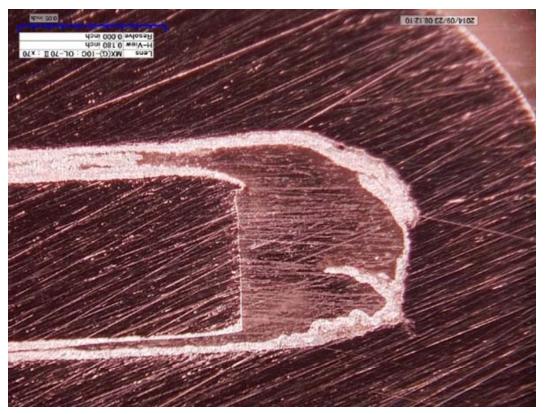
Figure 33. Pipe #2014-09-008 – Cross section of the lock joint. As previously noted the aluminum layer has some damage in the bend region. 70x

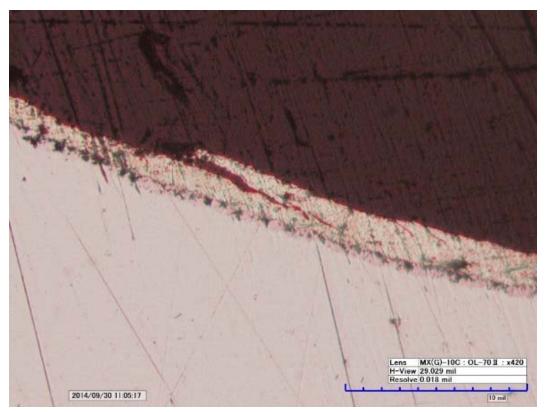
Figure 40. Pipe #2014-09-009 –Further magnification of the corrugation shows minor damage to the aluminum layer. 420x

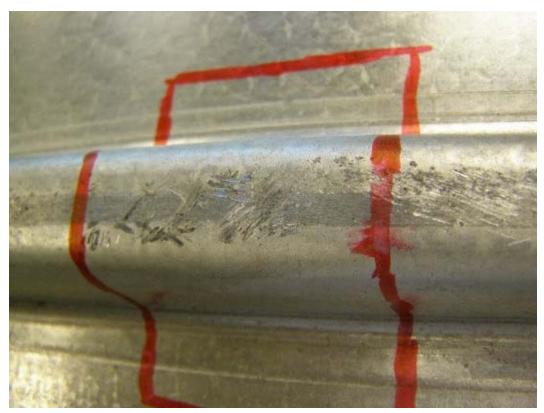
Figure 44. Pipe #2014-09-009 – Close up of scraping on the corrugation showing possible damage to the aluminum layer.

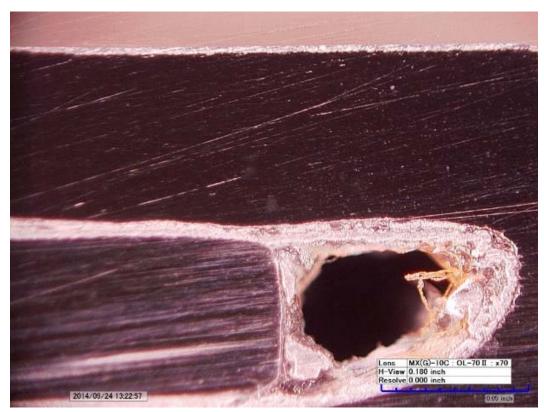
Figure 48. Pipe #2014-09-009 – Cross section of the lock joint. As previously noted the aluminum layer has some damage in the bend region. 70x

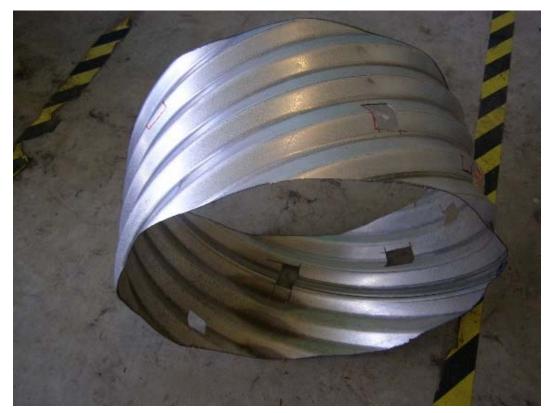
Figure 50. Pipe #2014-09-010 - 24" section of pipe. Four areas had visible damage, and samples were removed for metallographic analysis.

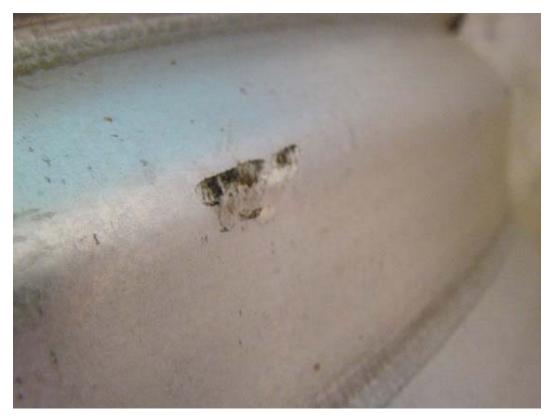
Figure 55. Pipe #2014-09-010 – Close up of a gouge in the pipe. This shows apparent damage to the aluminum coating.

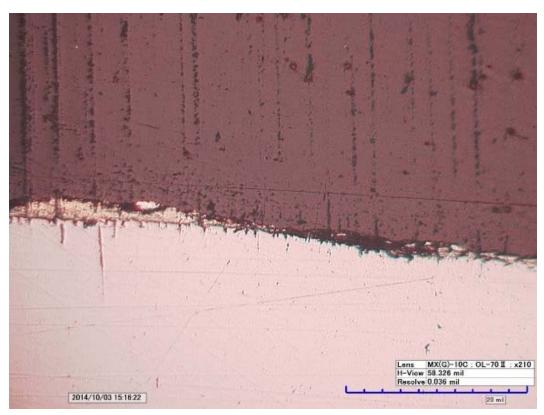
Figure 56. Pipe #2014-09-010 – Cross section of the gouge in the pipe showing damage to the inner metallic layer and possible the steel substrate. 210x

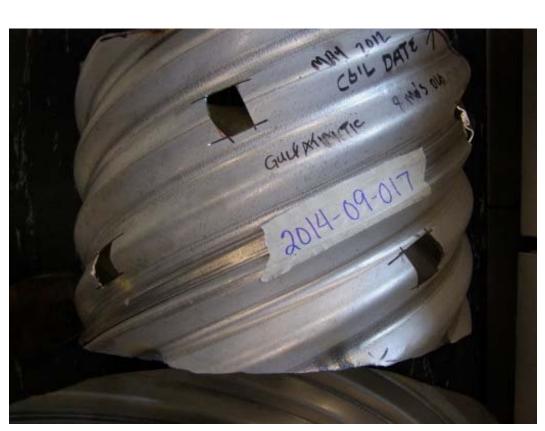
Figure 60. #2014-09-017 – 24" section of pipe. Two areas had visible damage, and samples were removed for metallographic analysis

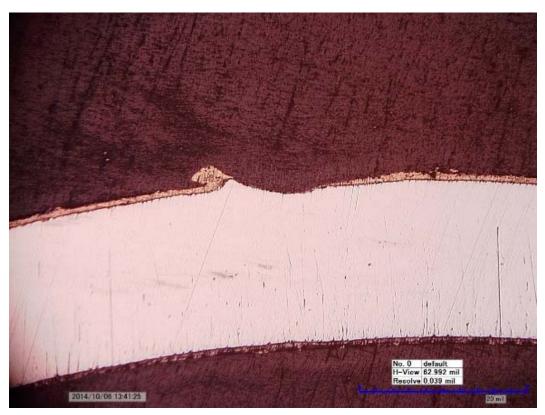
Figure 66. #2014-09-017 – Cross section of the gouge in the pipe showing damage to the aluminum layer, inner metallic layer and the steel substrate; 140x

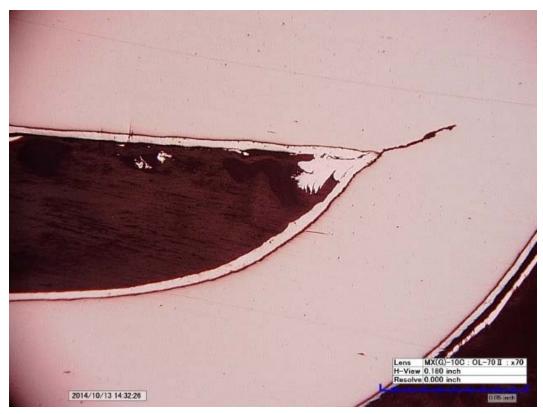
During the analysis of the lock joint on pipe sample 7, a crack was found in the lock joint fold. See Figure 81. This crack is most likely the result of excessive force applied during the crimping process. Two additional locations along the lock joint of the pipe sample were evaluated and the metallographic analysis showed evidence of the crack at these locations as well. See Figures 82 and 83.

Figure 81. #2014-09-018 – The right fold in the lock seam shows a visible crack in the steel substrate. 70x

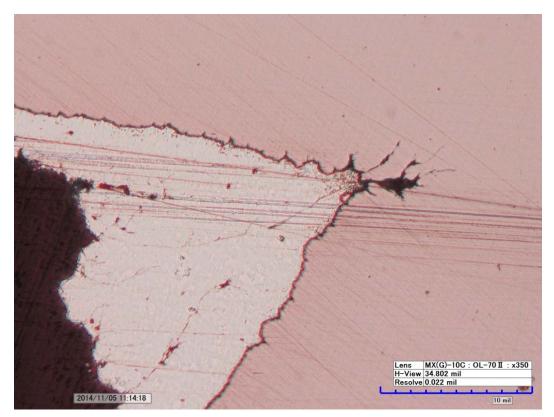
Figure 83. #2014-09-018 – A third lock seam location was examined and again showed a visible crack in the steel substrate. 350x

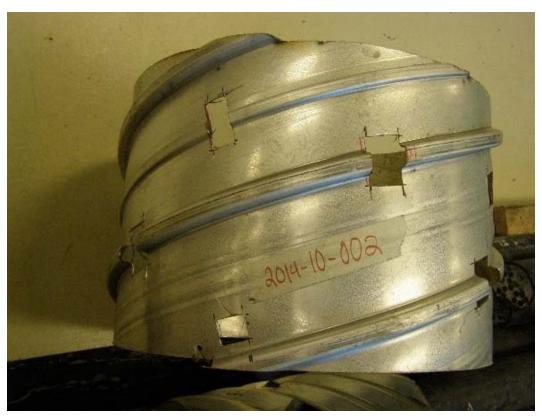
Figure 96. #2014-10-02 – 24" section of pipe. Two areas had apparent coating damage. Samples were removed for metallographic analysis

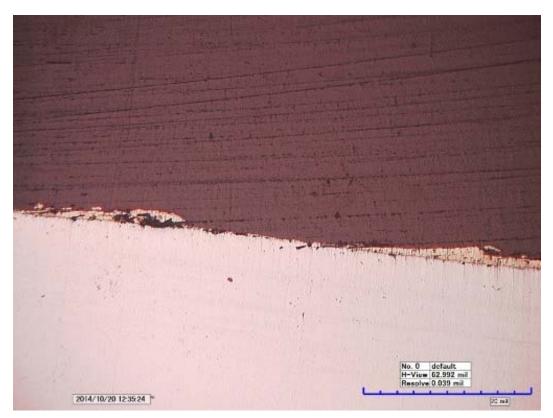
Figure 105. #2014-10-02 – Cross section of the scraped area showing visible damage to the aluminum layer as well as the inner metallic layer. 70x

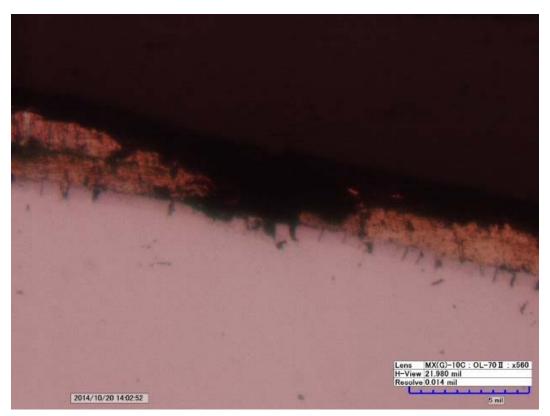
Figure 107. #2014-10-02 – Cross section of the scraped area showing visible damage to the aluminum layer as well as the inner metallic layer. 560x

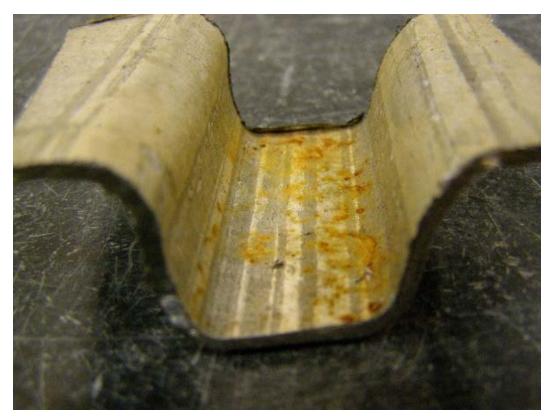
Figure 108. #2014-10-02 – Close up of the inside corrugation showing visible rust staining.

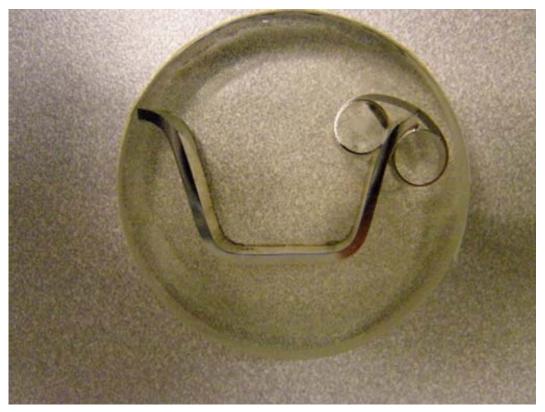
Figure 109. #2014-10-02 – Low magnification cross section of the corrugation with visible rust staining.
