SR 331 Experimental Project *Performance Evaluation of a Geocomposite Drainage Layer and Black Base*

October 2010

SR 331 (Alachua County)

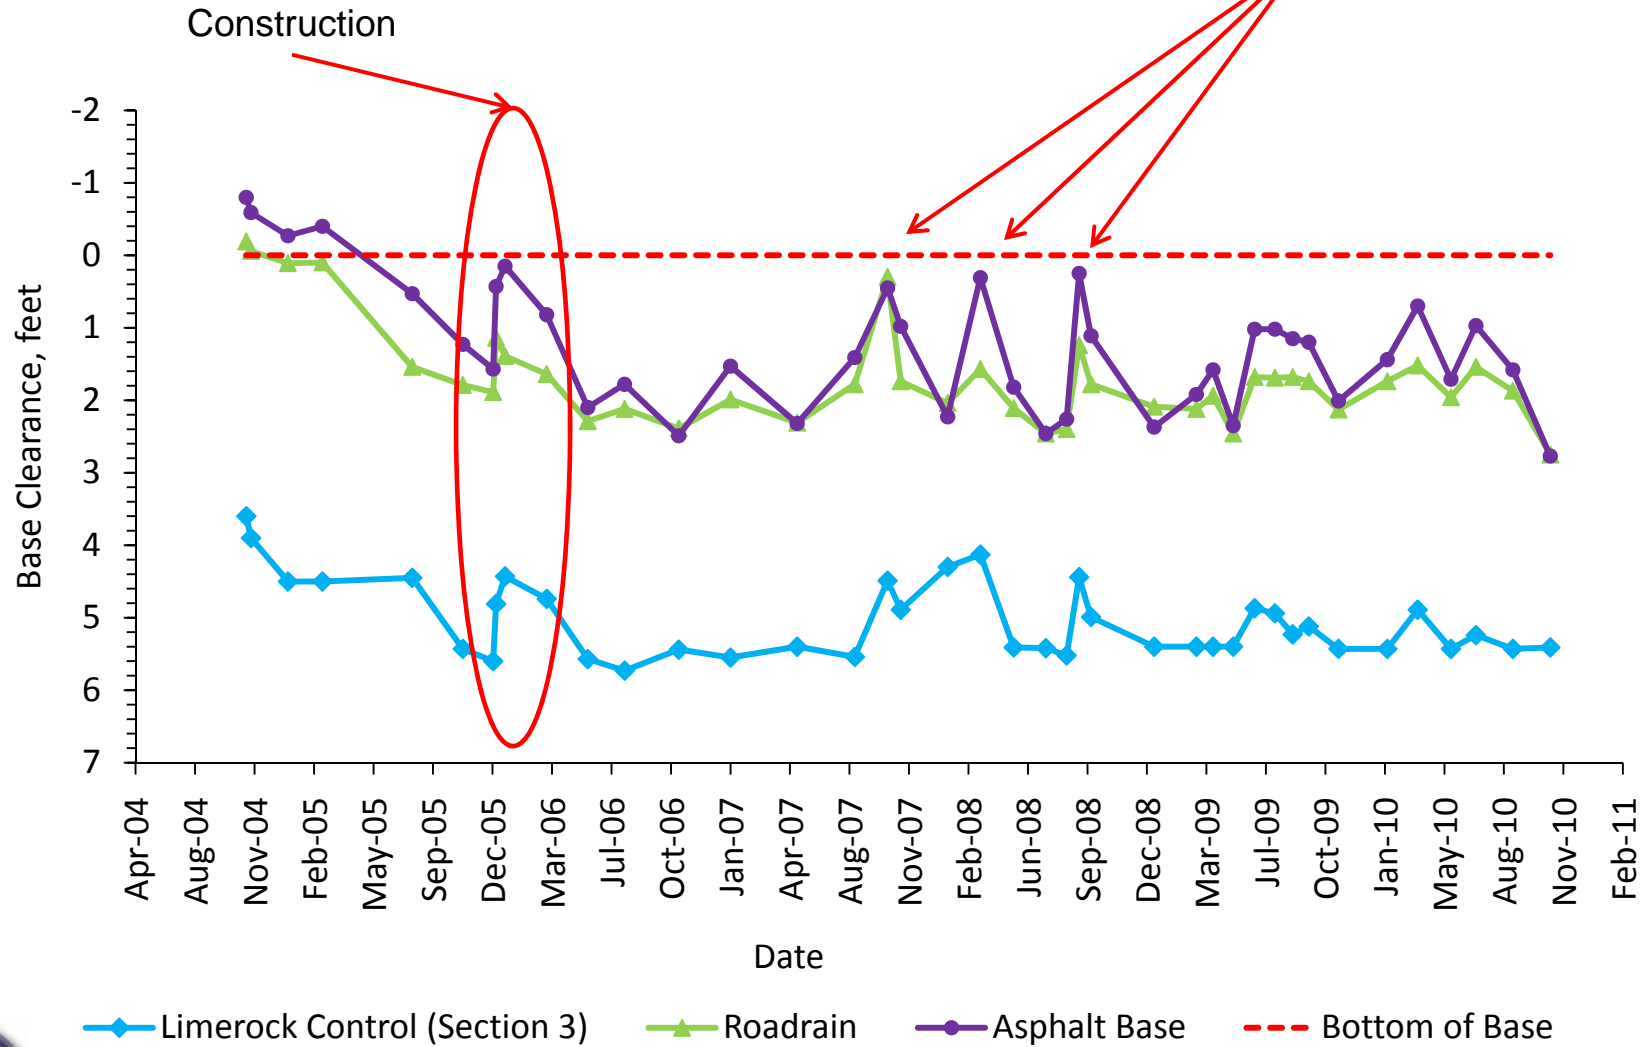
Base Clearance

1 ft avg base clearance & WT occasionally approaches base

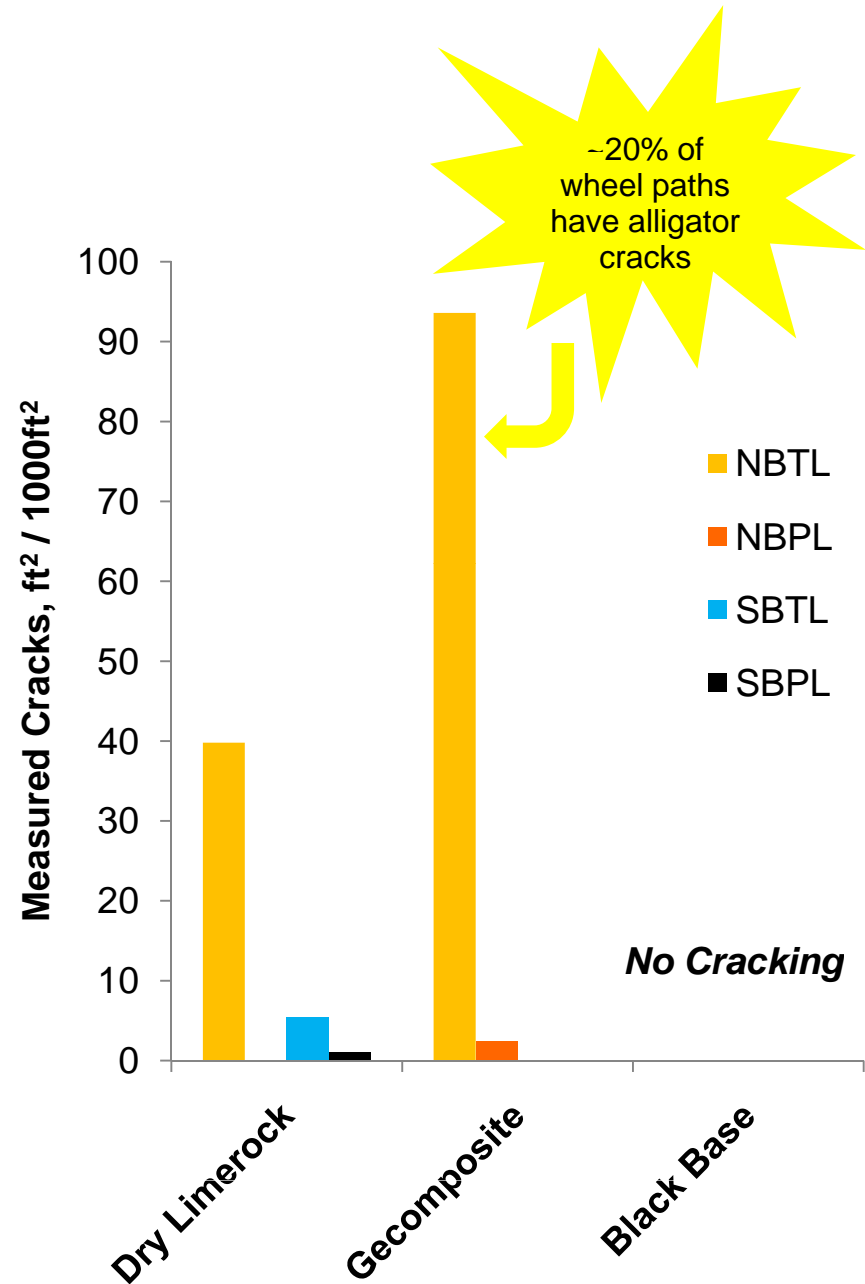
2010 Crack Survey

- ◆ The first crack was observed in the geocomposite section 3 years after construction
- ◆ The first crack was observed in the dry limerock section 4 years after construction
- ◆ No cracks have been observed in the black base section

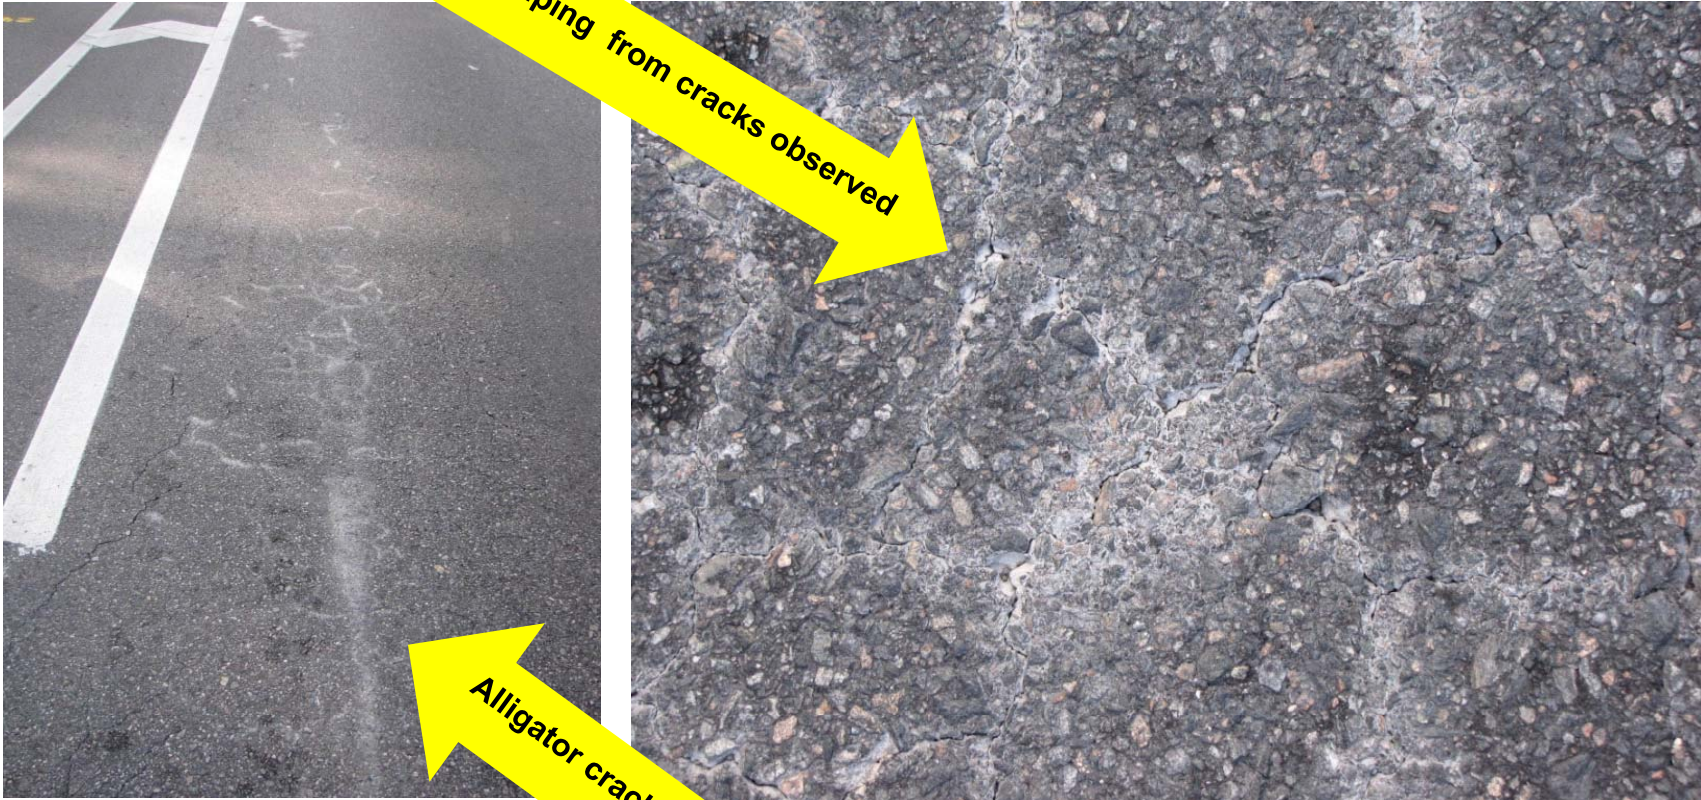
Geocomposite Travel Lane

Pumping from cracks observed

Alligator cracks in wheel paths
