# Evaluation of Reclaimed Concrete Aggregate (RCA) as Base Material

## Experimental Project Interim Report

FDOT Office	<b>State Materials Office</b>
District	<b>1</b>
County	<b>Manatee</b>
Financial Project	<b>422603-1-58-01</b>
Roadway ID	<b>13020000</b>
State Road No.	<b>43</b>
US Road No.	<b>301</b>
Report Date	<b>11/14/2016</b>

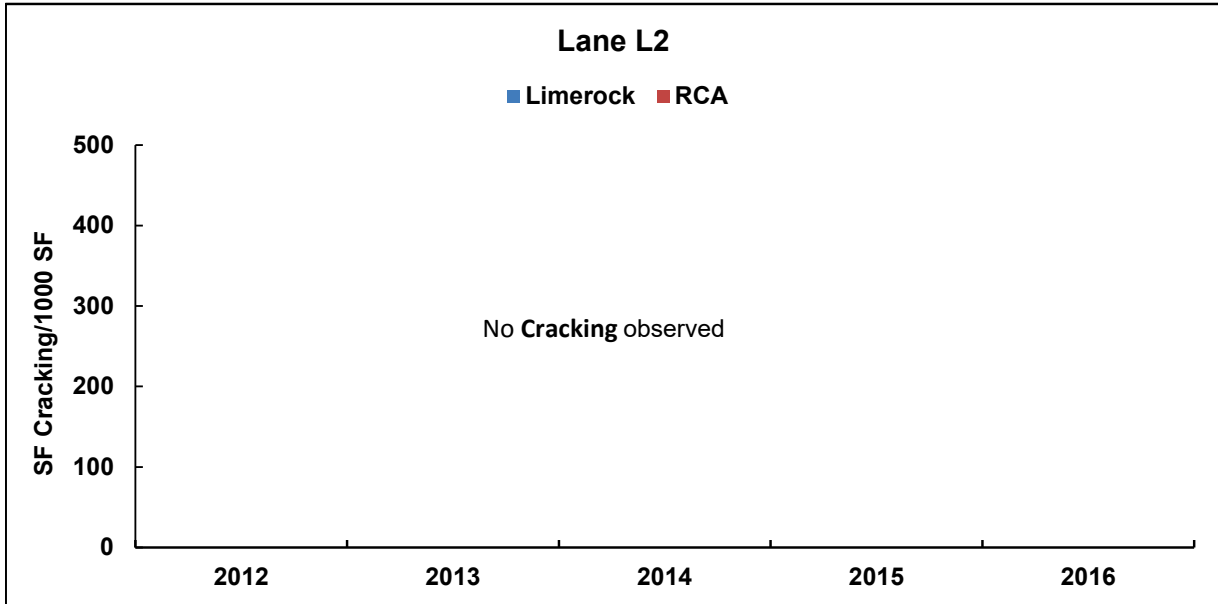
Note: No cracks were observed on either test section
