# Open-Graded Crack Relief (OGCR)

## Experimental Project Interim Report

FDOT Office	<b>State Materials Office</b>
District	<b>7</b>
County	<b>Hernando</b>
Financial Project	<b>431143-1-52-01</b>
Roadway ID	<b>08010000</b>
State Road No.	<b>45</b>
US Road No.	<b>41</b>
Report Date	<b>11/18/2016</b>

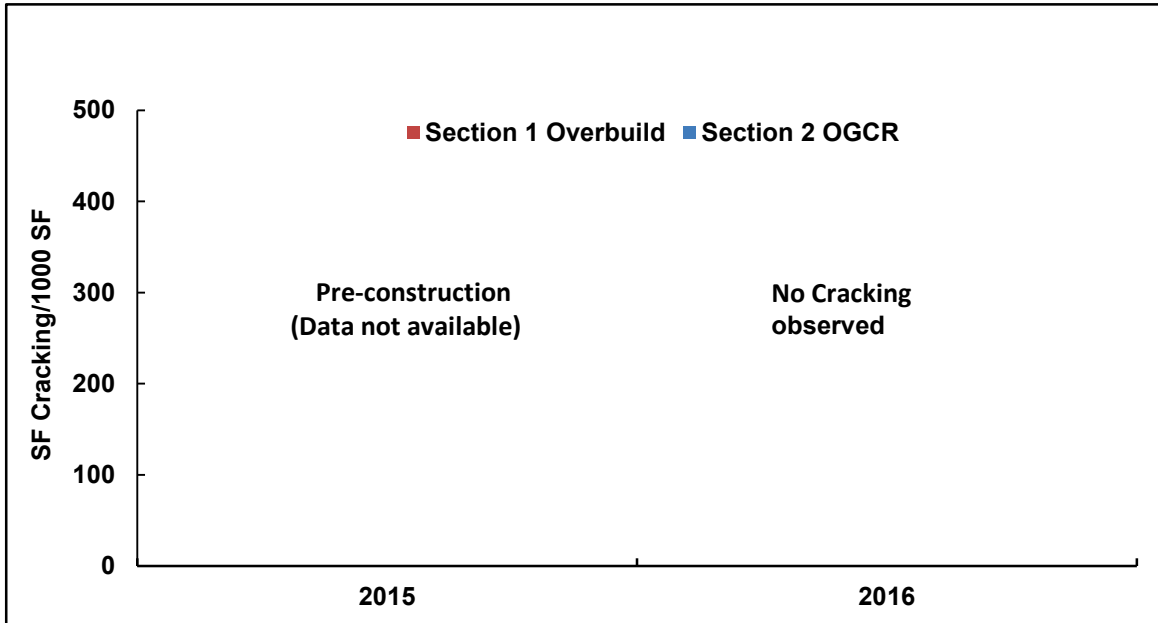
# Cracking

Note: No cracks were observed on either test section
