Repair of Construction-Related Deterioration in Precast Deck-Panel Bridges

Atiq H. Alvi, Ivan Gualtero, Rajan Sen, and Gray Mullins

Transportation Research Record: Journal of the Transportation Research Board, No. 2292, Transportation Research Board of the National Academies, Washington, D.C., 2012, pp. 104–112.
DOI: 10.3141/2292-13

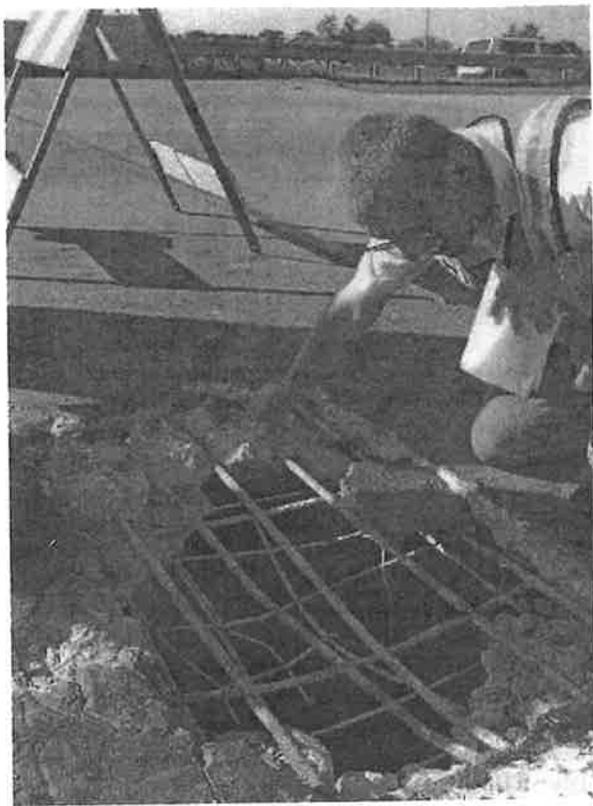
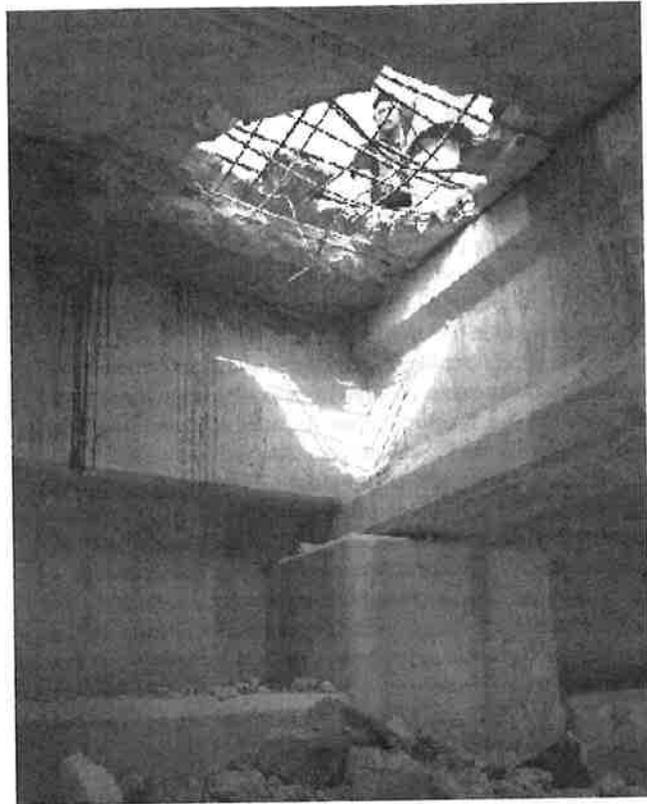
FIGURE 3 Failed panel on Bridge No. 170086: (a) View 1 and (b) View 2. (Source: *Sarasota Herald*.)

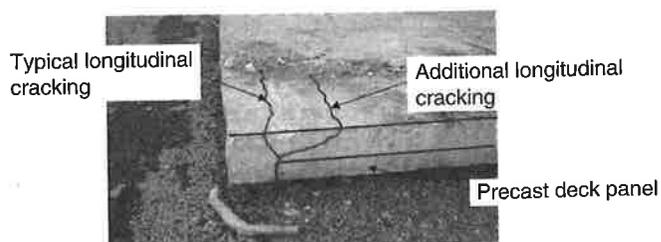
Shear in beams and slabs is associated with diagonal tension. If a diagonal tension crack extended through the CIP slab to the surface, it would appear as a crack that was parallel to the original longitudinal crack. In the case of shear failure, a second parallel crack would emanate, in addition to the longitudinal cracking first observed (Figure 4).

Shear capacity of the compromised section was exceeded when lane markings coincided with the longitudinal panel joints in the traffic lane that carried the heaviest load (i.e., right lane). With this configuration, wheel loads from trucks needed to be transferred to the prestressed girder through the fiberboard. Code-based calculations indicated that the punching shear capacity in this case was lower than the maximum wheel load, which resulted in localized failure (7). In these calculations, the capacity of the CIP concrete was disregarded because of the spalling.

FIGURE 4 Additional longitudinal cracking from shear.

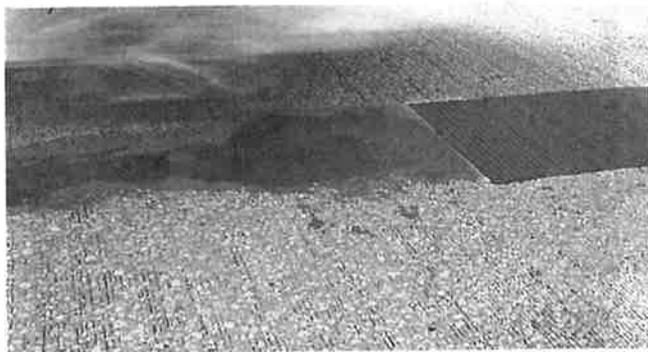
After a second, parallel crack occurs (Figure 4), the concrete trapped between the two cracks, which already is internally cracked, starts to crumble; a spall develops and is repaired by patching. The Florida DOT classifies deck patching on the basis of the depth of the repair (14). The most common and simplest repair method is maintenance spall patching, which is used to repair spalls in the CIP portion of a deck. When a deficiency such as a spall appeared on the bridge deck, it was common practice for Florida DOT maintenance crews to patch the spall with flexible, "cold patch," asphaltic concrete.

To patch with asphaltic concrete is not labor-intensive and can be done in a matter of minutes with minimal disruption to the traveling public. It is also an inexpensive procedure. The maintenance crew closes a lane temporarily, if necessary; cleans debris out of the spall with hand tools; and patches the spall with a ready-mix bag. The asphalt patch is intended to minimize immediate danger to the motoring public as well as to avoid an increase in the size and intensity of the spall (Figure 5).

In the worst cases, the pounding punched a hole through the lower deck panel. Six of the seven punching failures (Table 1) occurred after rainfall. Water filled the crevices between the panel and patch material in which subsequent wheel loading caused pumping action between the asphalt and the precast panel until failure (15). Four

FIGURE 5 Spalls patched with asphalt and walking spalls.

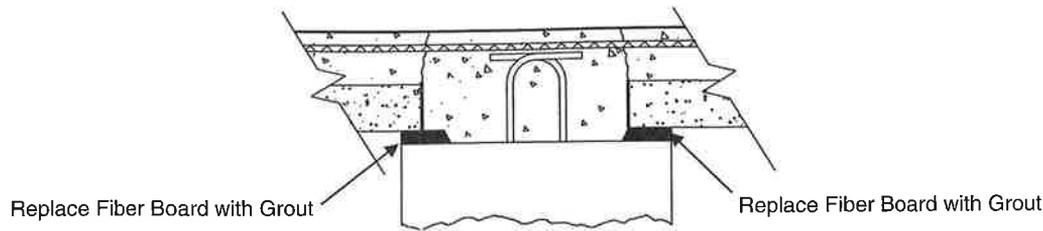
Most deck-panel bridges in Florida were built with fiberboard bearing material to support the precast deck panels on the girders. With this method of construction, no positive (rigid) bearing is provided at the ends of the precast panel. As a result of the effects of creep and shrinkage, initial separation and longitudinal cracks are inherent in precast deck-panel construction. However, the few bridges in Florida that used positive bearing have performed much better and consequently have had longer service lives. The most important conclusion drawn from the forensic study (7) was that the lack of positive panel bearing was clearly the main factor responsible for the occurrence of major deck deterioration, such as cracking, delamination, spalling, failing repairs, and, in the worst case, localized punch-through deck failures.

FIGURE 6 Bearing detail after grout packing repair.

Grout packing is a form of repair in which the fiberboard bearing material is replaced with nonshrink Portland cement grout or epoxy grout to provide positive bearing (Figure 6). Grout packing is more cost-effective than other, more involved repair methods and causes little to no disruption to traffic because the work can be performed with a bucket truck or scissor lift from beneath the bridge.

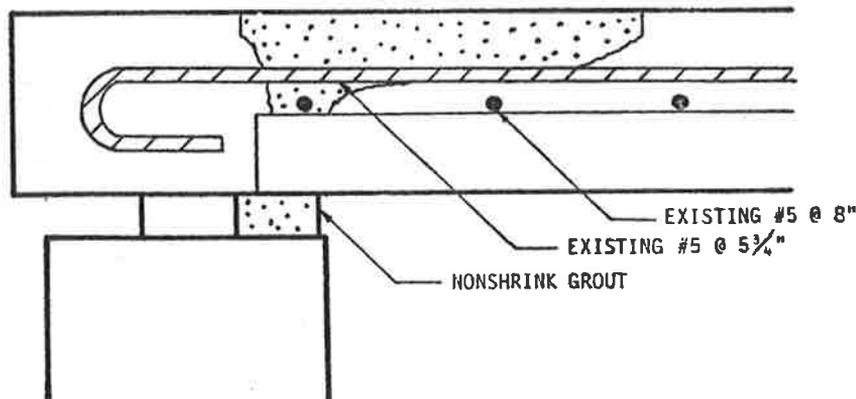
FIGURE 7 M1 with grout packing repair detail (4).

This somewhat modified M1 repair also was used to repair longitudinal spalling along the edge of a beam. The difference is that the CIP concrete portion on top of the precast beams is fully removed, and additional steel is added to the area on top of the beams. The fiberboard bearing material is replaced with nonshrink Portland cement grout or epoxy to provide positive bearing. This repair is extended longitudinally throughout the length of the span.

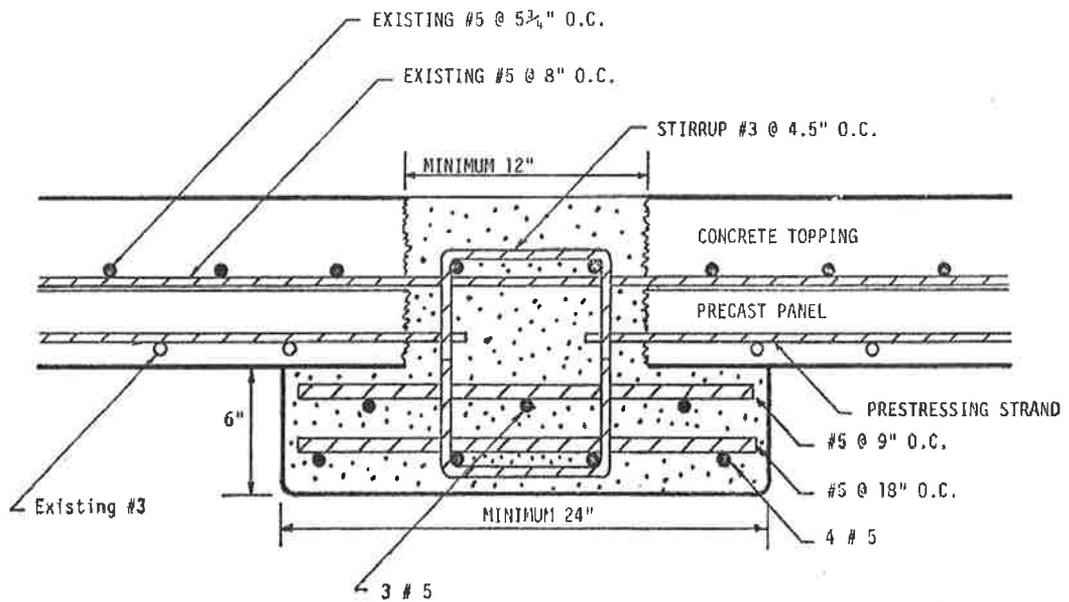
FIGURE 8 M2 repair (4).

The M2 repair method, which was developed specifically for precast deck-panel deficiencies, was not encountered in any of the inspections. M2 repair (Figure 8) is used to fix cracks and spalls along transverse joints of the precast panel. The unsound material is removed approximately 6 in. on each side of the transverse joint,

and an inverted T-beam is formed with the bottom of the precast panel that sits on the flange of the inverted T-beam. The flange of the T-beam is required to be at least 24 in. wide. The inverted T-beam is provided a positive bearing on the girders (4). M2 repairs are more costly than other repair methods and have an adverse impact on traffic flow.

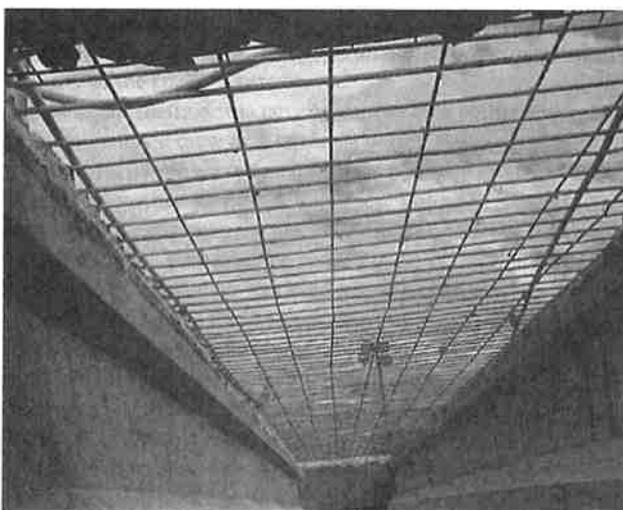
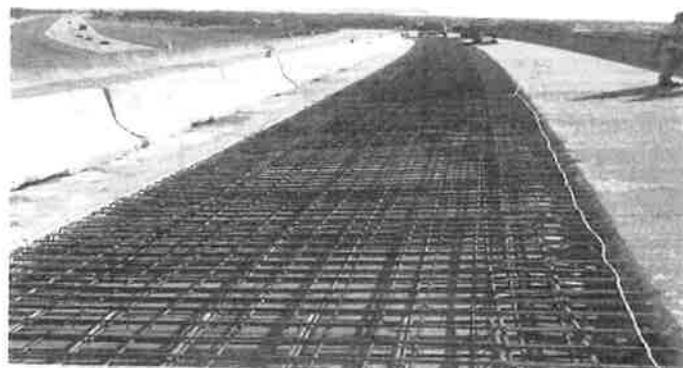
FIGURE 9 Full-depth bay replacement repair: (a) existing and (b) new steel.

Full-depth bay replacement is the most effective repair method for deficient precast deck-panel bridges (Figure 9). As stated previously, it is the directive of the District Structures Maintenance Office to use this method for all permanent repairs. At a minimum,

When only one bay is replaced, the CIP concrete and precast panel are demolished, which leaves only the reinforcing steel grid originally within the CIP section for continuity. A new bottom steel mat is designed (Figure 9) and placed as an alternate to the precast panel. A standard compression test is performed to verify that the concrete has gained the required strength before the bridge or repaired area is opened to traffic. None of the failures reported in Table 1 occurred on decks that had been repaired by full-depth bay replacement.

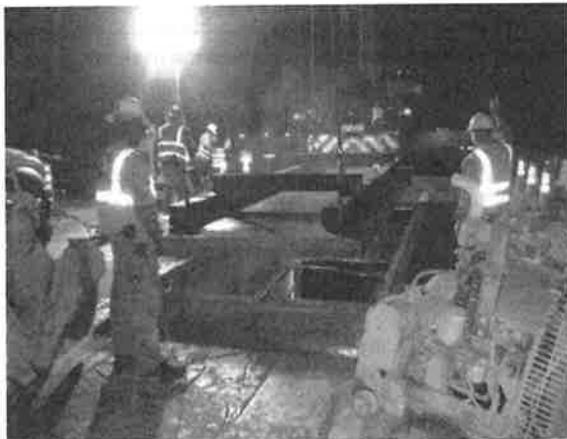
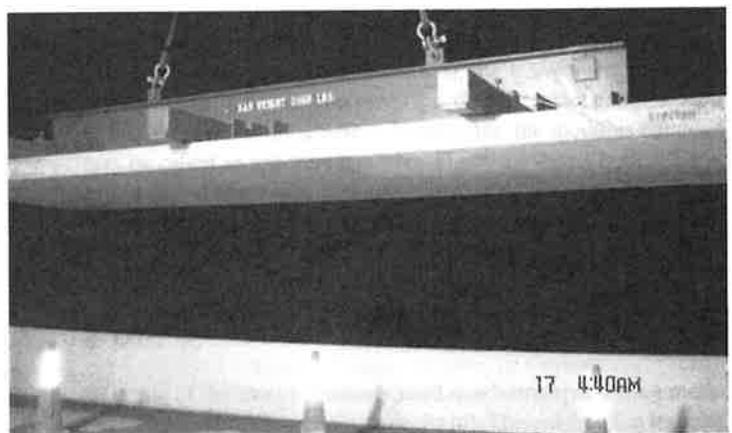
FIGURE 10 Full-depth panel: (a) removal of existing deteriorated deck and (b) new installation.

was devised (18) on the basis on the successful findings of a similar system used in other states (19). The deteriorated deck was removed and replaced in 30-ft long sections with full-depth, precast concrete panels at night only (Figure 10). Near-surface-mounted bars of reinforced carbon polymer fiber were installed to transfer shear into the existing deck.

Construction took place during the fall of 2009 and was the first time that this method was applied in Florida. The method was unique, in that it transferred forces between the full-depth, precast panels longitudinally, rather than transversely, with the near-surface-mounted bars of reinforced carbon polymer fiber (19). The project was successfully completed in spring 2010.
