*Florida Department of Transportation
Central Structures Office*

**TEST AND ASSESSMENT OF NDT METHODS
FOR POST-TENSIONING SYSTEMS IN SEGMENTAL
BALANCED CANTILEVER CONCRETE BRIDGES**

DMJM HARRIS

February 15, 2003

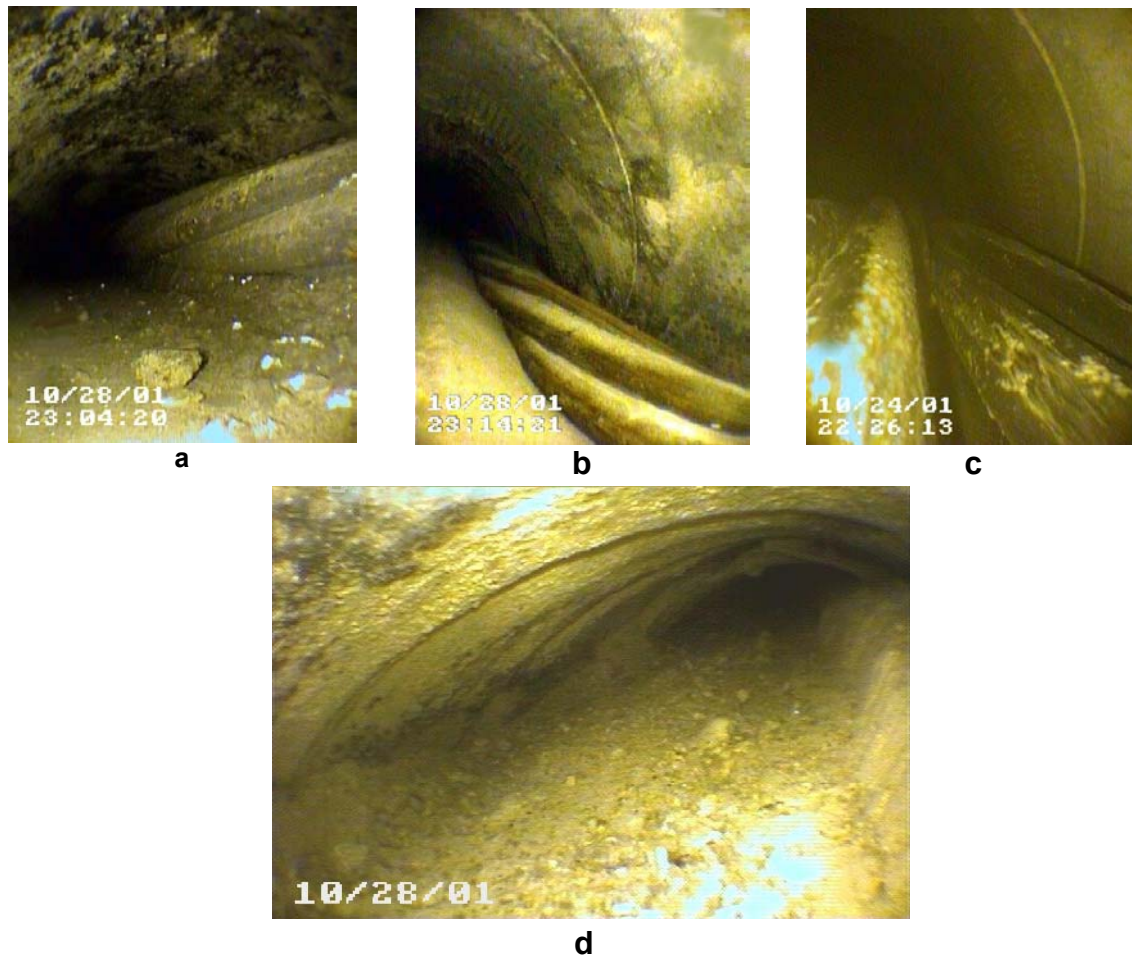
Figure 2.6 – Photos a and b show duct partially grouted with strand exposure. Photo c shows voided duct with strands fully exposed. Photo d shows partially grouted duct, no strands exposed.

It appears that the small voids were the result of bleed water accumulation and subsequent evaporation. The large voids with exposed tendons were the obvious result of poor grouting procedure. In most of these locations the strands presented moderate signs of superficial corrosion. Voids with water present were probably due to deck cracks at duct joint locations, and in these cases it was not possible to assess the conditions of the strands (exposure and signs of corrosion) due to the difficulties of using the endoscope in a humid environment.

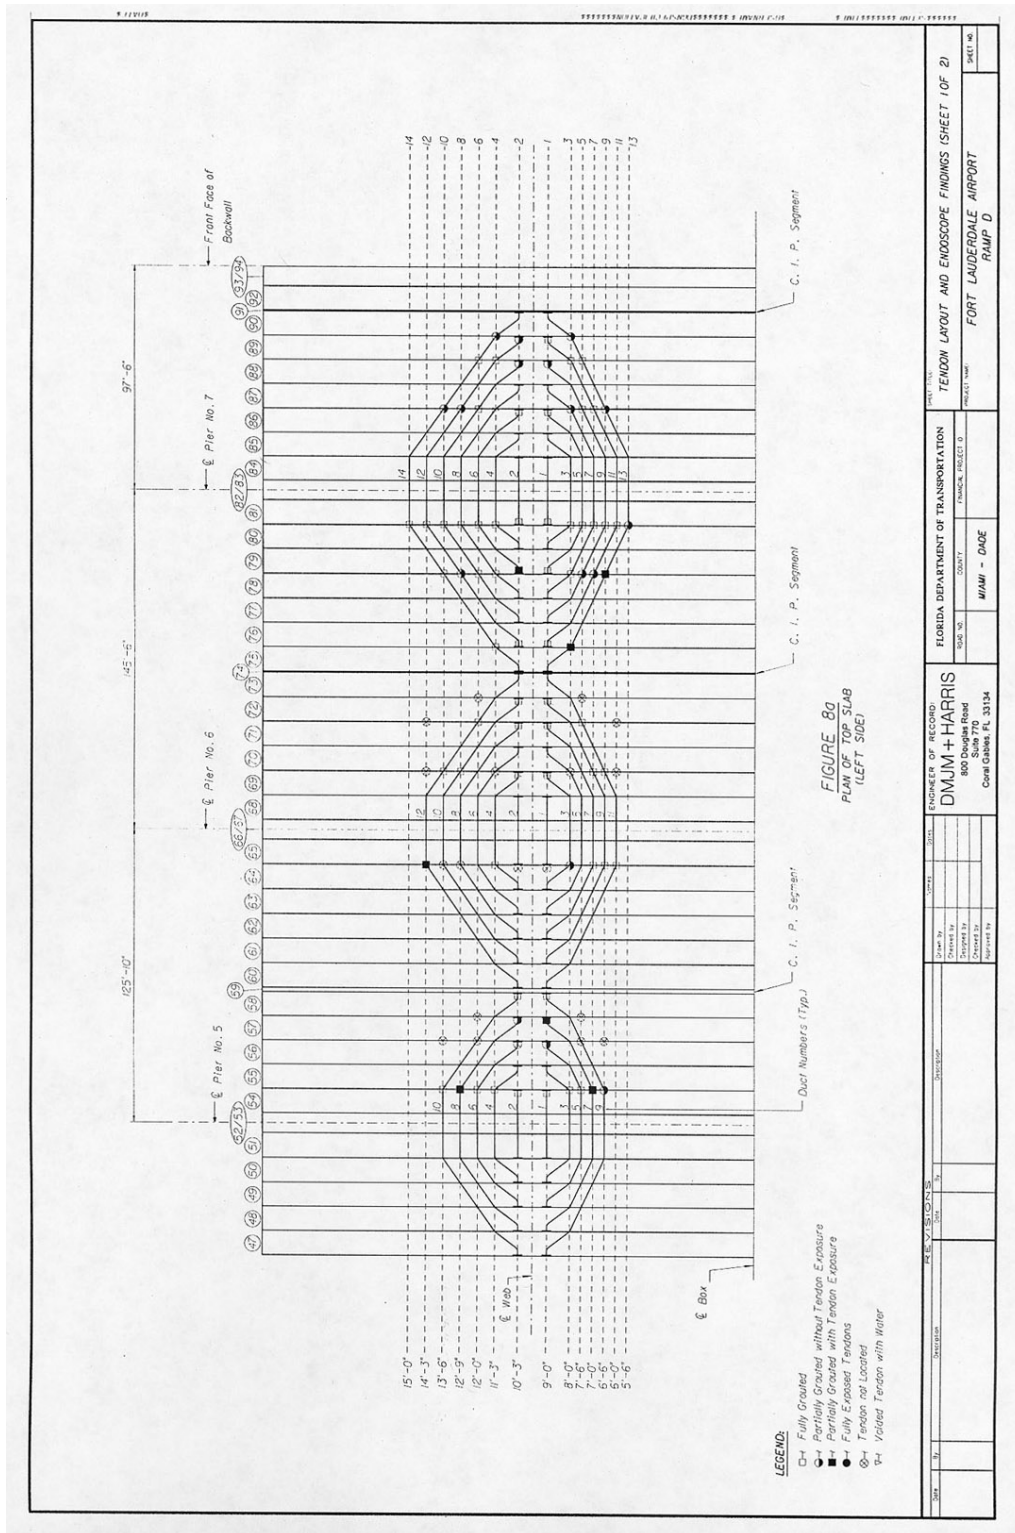
Figure 2.8a – Endoscope inspection findings

The results of the endoscope inspection revealed that approximately 40% of the inspected locations were voided. However, most of these voids were small and in most of the cases, the strands were not exposed. Approximately 7% of the testing locations corresponded to large voids in which a large portion, if not all, of the duct's cross section was ungrouted. But, even in these situations, the strands were found to be in good condition and with no significant signs of corrosion or section loss.

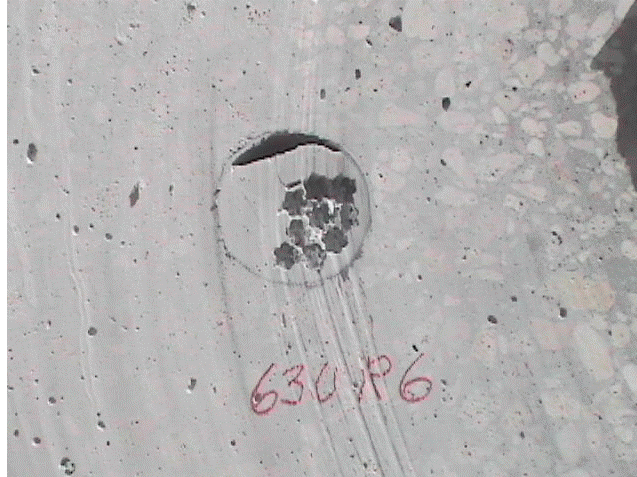
Figure 4.8 - View of duct with void

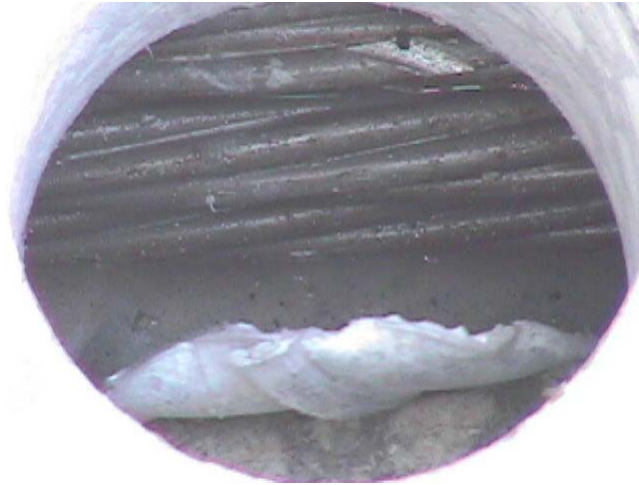
tendon ducts. This would explain why no clear wave reflections from the voided ducts were found in some areas.

Figure 4.9 - Tendon 10, core drilled at Segment 54.

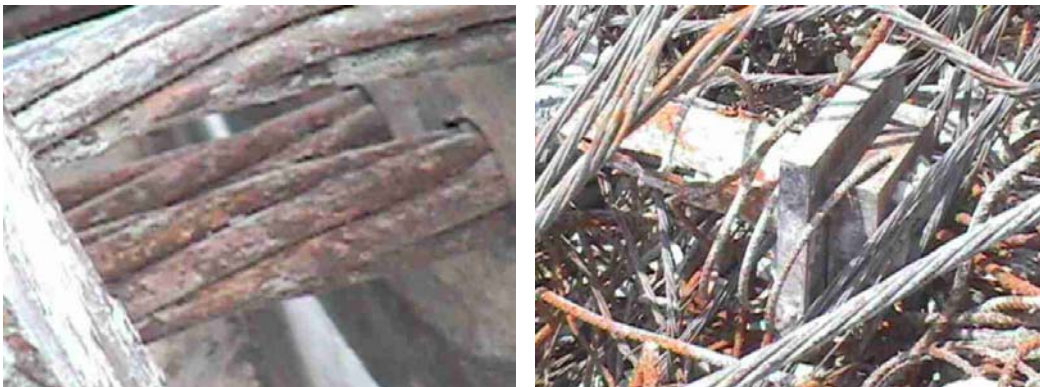
Figure 7.29 and 7.30 – Surface corrosion on remains after exposure to environment

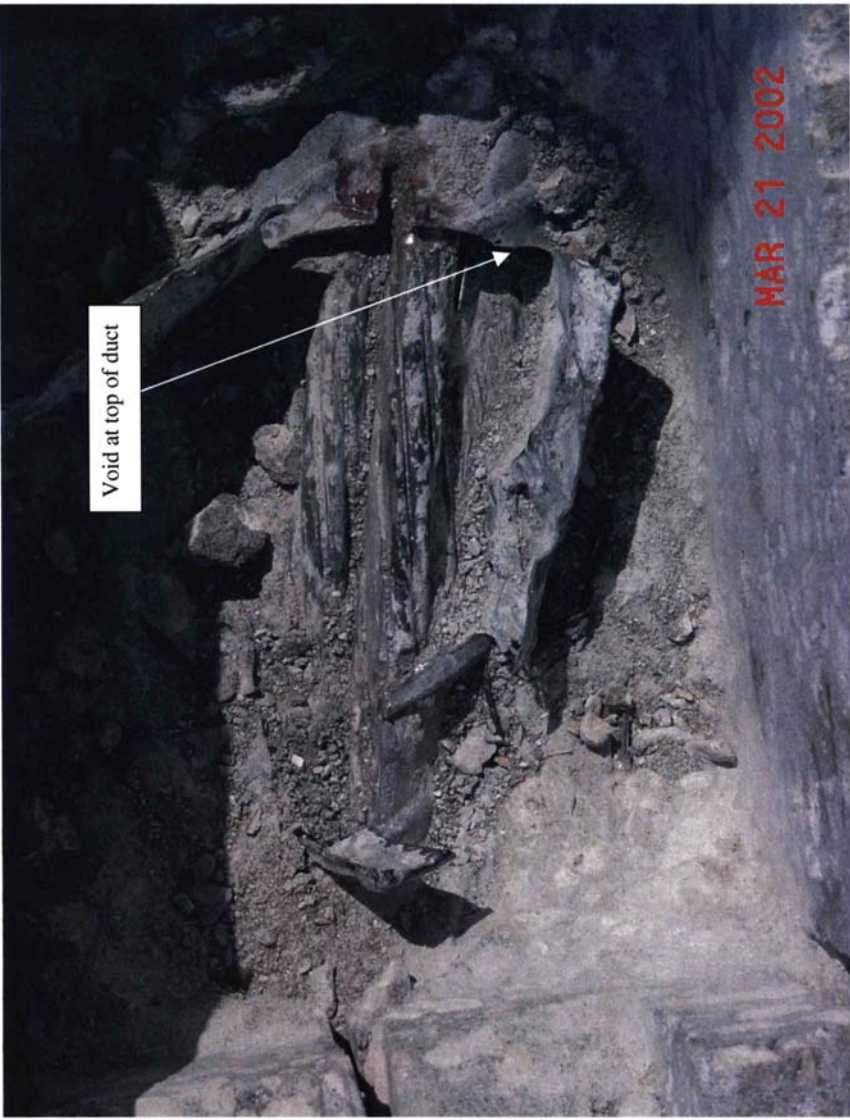
<p>Exposed tendon in voided duct, I-E test point 4D, Box 69 North Fort Lauderdale/Hollywood International Airport, Ramp "D" Florida DOT Contract C6912 DMJM-Harris, Tallahassee, Florida</p>	Date: 04/15/02	Fig. D.1
		CTL Project No: 320233

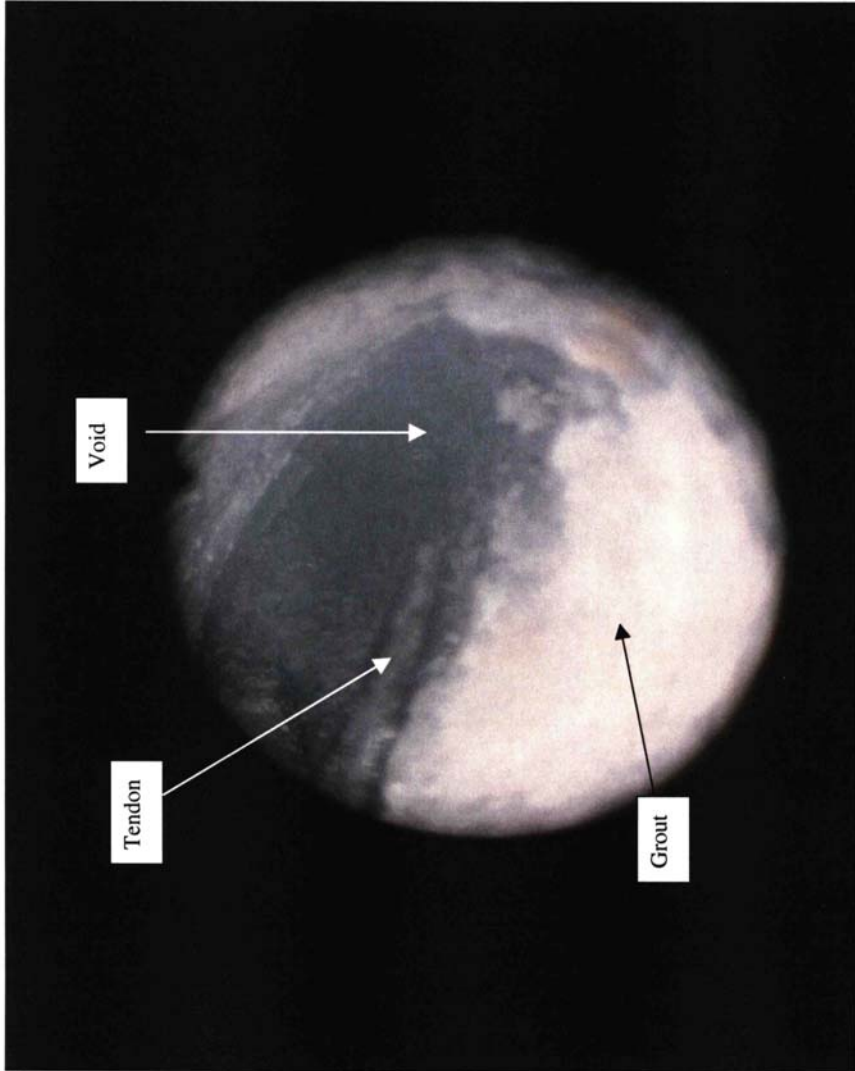
<p>Borescope Image of exposed tendon in voided duct, I-E test point 4D, Box 69 North</p>	Date: 04/15/02	Fig. D.2
		CTL Project No: 320233	
<p>Fort Lauderdale/Hollywood International Airport, Ramp "D" Florida DOT Contract C6912 DMJM-Harris, Tallahassee, Florida</p>

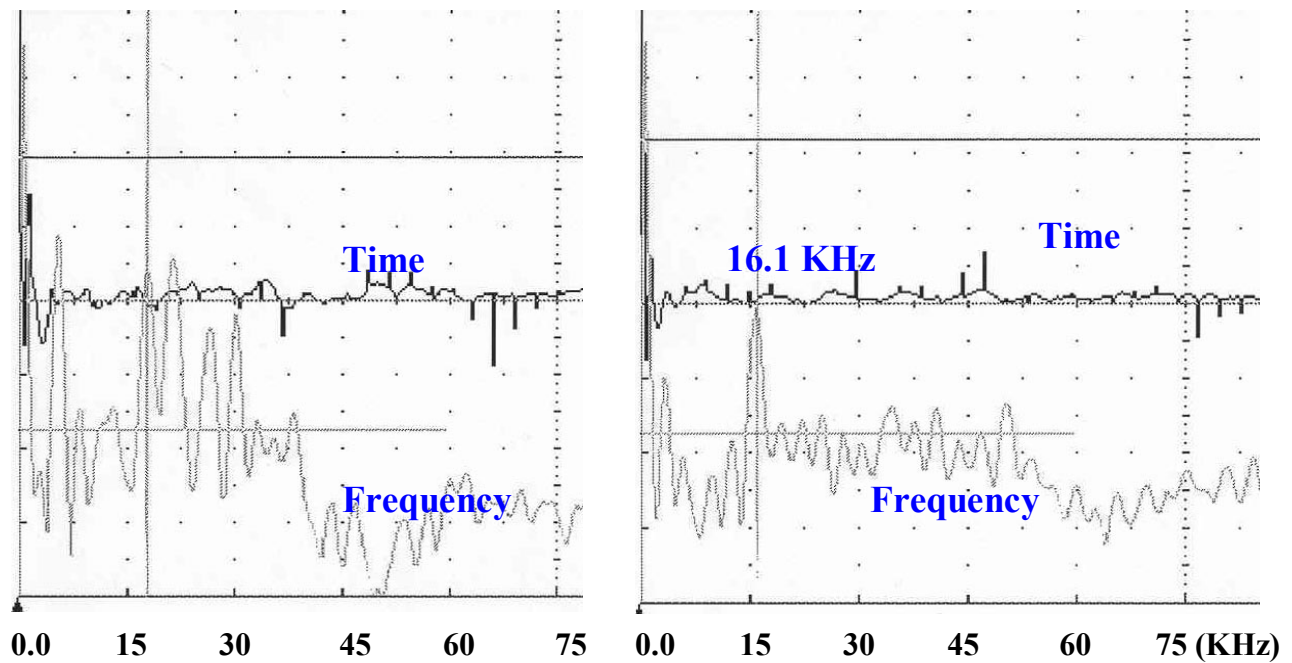
Figure 18 – (a) IE data at test point 4 for tendon # 11 (no grout void) and, (b) at test point 4 for tendon # 6 (grout void).

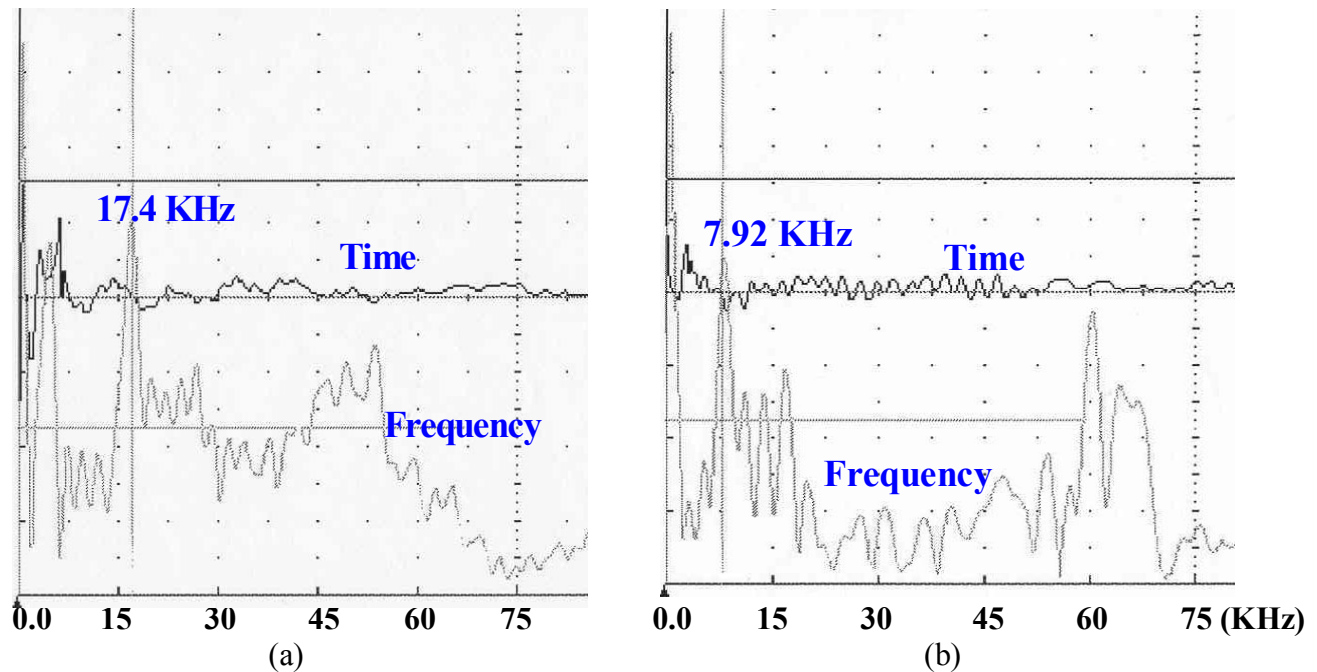
Figure 19 – IE data for tendon # 10 (a) 3'-0" West of the joint between segments 56 and 57 (void), (b) 9'-0" West of the joint between segments 55 and 56 (no void).
