DETENSIONING AN EXTERNAL PRESTRESSING TENDON

By: Jack O. Evans, P.E., Assistant State Structures Design Engineer, and
Henry T. Bollmann, P.E., Senior Structural Design Engineer,
Florida Department of Transportation, Tallahassee, Florida.

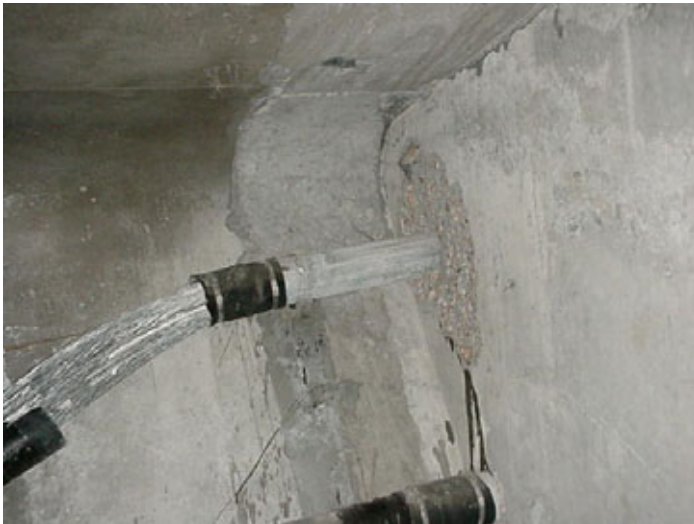
PHOTO 1

The routine maintenance inspection of the Mid - Bay Bridge revealed that one tendon in span 57 was completely slack, as evidenced by its geometry, which allowed it to drape, making contact with the floor of the box superstructure (See Photo 1). It was later found that corrosion had taken place in the top tendon anchor at the expansion joint end of this span. At this time it is presumed that the existence of a void space within the anchor region and 'grout bleed water' created the corrosive condition.

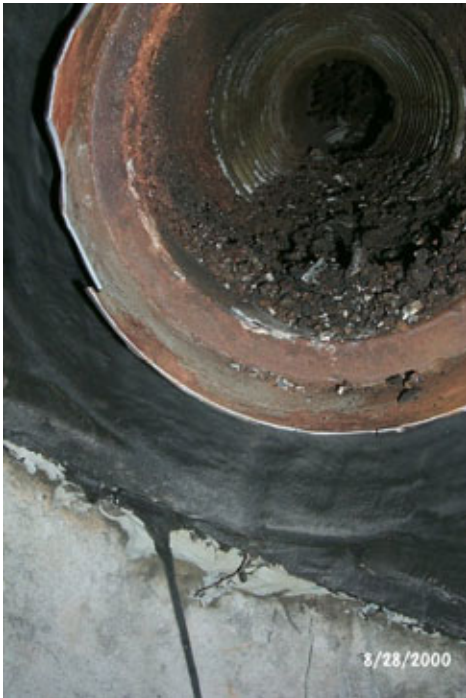
PHOTO 2

(See photo 2) Photo 3 shows that all strands broke in the trumpet region or at the trumpet to steel pipe transition.

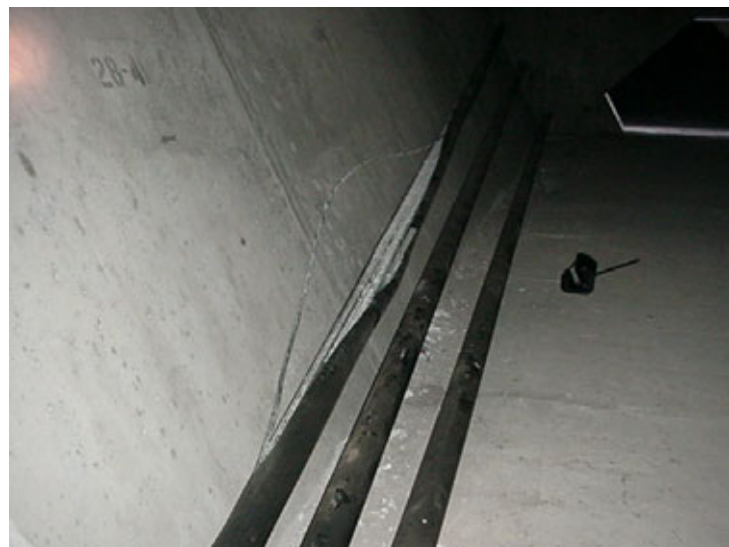
PHOTO 4

The toll bridge was immediately closed to all traffic, resulting in a 30 mile detour for those who normally used the bridge. A further detailed inspection revealed that in span 28, 6 of 19 strands in one tendon were severed due to corrosion. This was detected because several ruptured strands had split the protective grout and polyethelene pipe and were thus partially protruding at a location 13 feet from the anchor head at the expansion end of the span. (See photo 4)

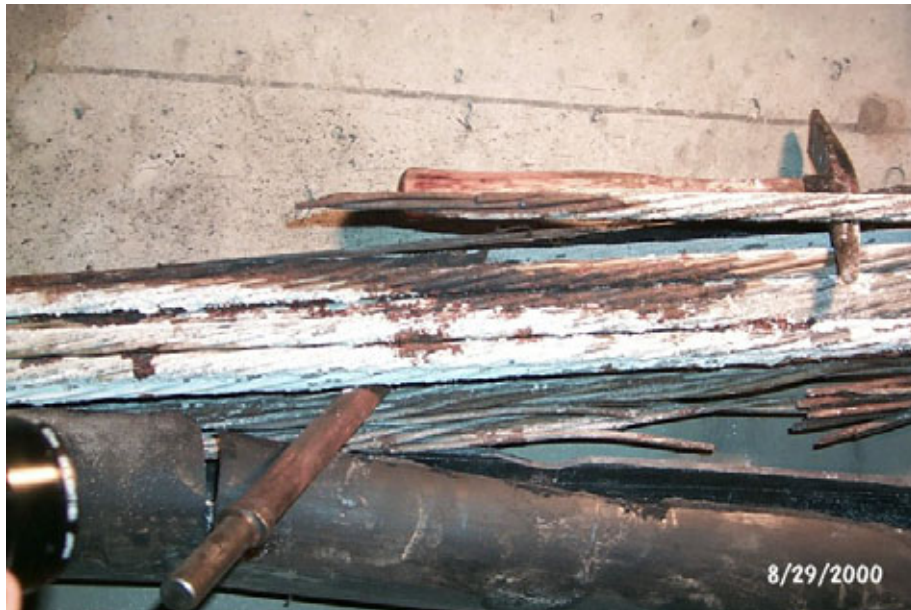
PHOTO 5

Significant corrosion of the tendon in span 28 was observed once the PE pipe and visible grout were removed (see photo 5). Although only 6 of 19 strands were ruptured the degree of corrosion on other strands indicated that other strands in this tendon might rupture. It was thus decided to proceed quickly with slackening and removal of this partially corroded tendon in span 28, the removal of the slack tendon in span 57 and then to replace both tendons during the same contract.

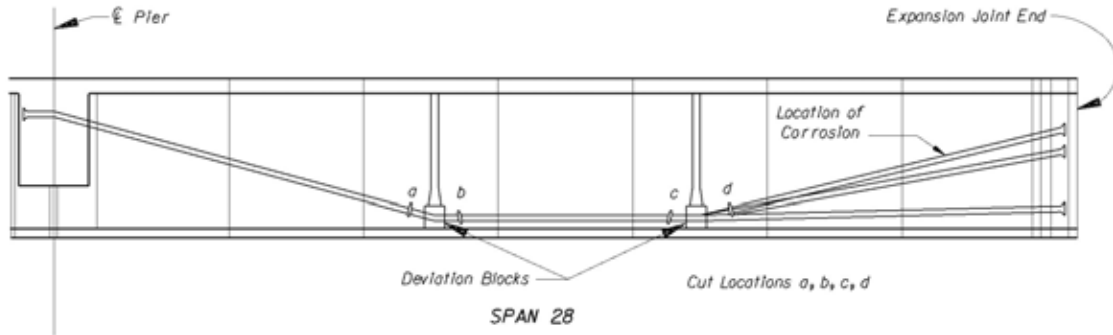
FIGURE 1

There are two tendon deviators per web located at about the third points of each span (see figure 1). These deviation blocks, located at the box floor, are designed to carry the vertical component of the deviated tendons. We knew from observations at this bridge and another similar occurrence that a sudden rupture of a tendon would cause unbalanced forces at the nearest deviation block, causing cracking in the block and sliding of the embedded deviation pipe within the deviation block. Damage to the deviation blocks had to be avoided so as not to compromise the integrity of the bridge.

- f) For the purposes of this procedure, the tendon sections to be cut are labeled a,b,c and d in figure 1.
- g) Cut one strand at location a. (leaving enough strand length so that a mono-strand jack can be used to grip the strands and remove them later)

- k) Now it is required to cut the tendon in an alternating pattern at locations a, b, c and d, with never more than one cut strand out of balance on any side of a deviation block until all strands are cut.

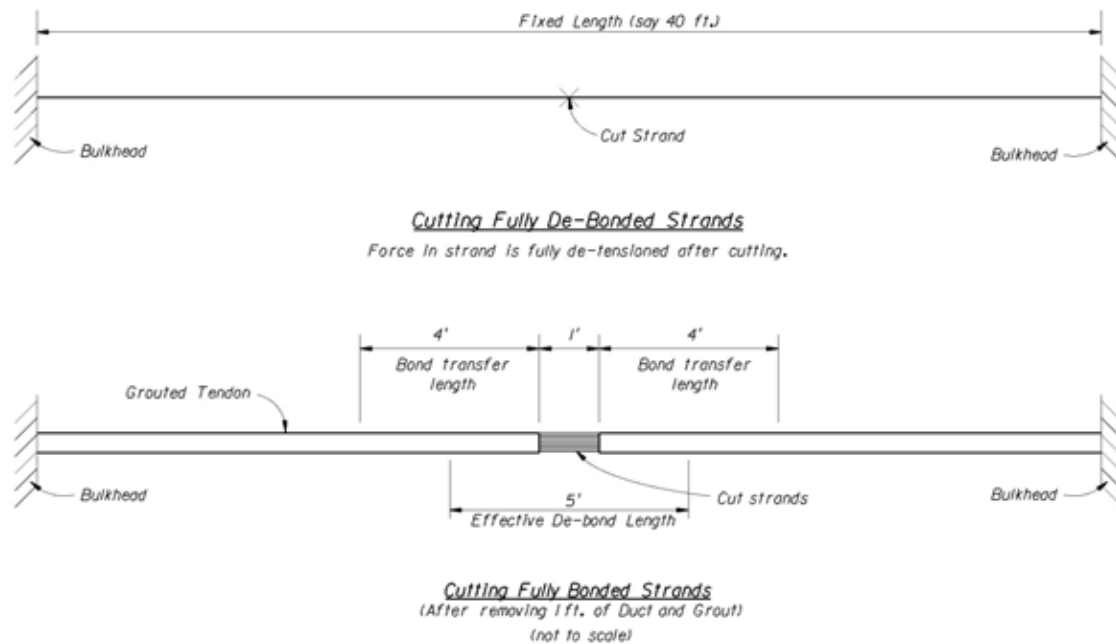
FIGURE 2

Consideration was given to removing the P.E. pipe and grout over a one foot length between each anchorage/deviation point. One strand would be cut at each location until all the strands were cut (see figure 2). However due to bond transfer within the P.E.

pipe/grout system, the tendon force from each cut strand would be transferred to the remaining strands. These strands will elongate, due to the increase stress and corresponding strain, over approximately 5 feet of tendon. This elongation will be distributed over the remaining tendon length (~35 feet) resulting in a reduced tendon force. However this reduction will only be about 1/7 (5 feet/35 feet) of the increase stress in the cut area. Since the increase to ultimate stress in the cut area will be approximately $(1.0-0.63)f^{\prime}s$, the reduction in stress for the over all tendon will only be $(0.37/7) = 0.053 f^{\prime}s$; which is about 8% of the initial tendon force. After cutting just 7 of the 19 strands, the stress in the remaining 12 strands would begin yielding. This yielding would continue until 15 strands had been cut, at which time the strain in the remaining 4 strands would exceed the 3.5% elongation guaranteed by the ASTM Specifications. The force in these remaining strands would be at their ultimate (58.6 kips/strand). Any further cutting could result in sudden rupture of the remaining strands, which was deemed to be unsafe for the workers.
