# **Florida Department of Transportation**

## **Galvanic Testing of Stressed Strands Inside Carbon Steel Pipe**

### **Final Report**

**Report Date:**                      **January 3, 2002**

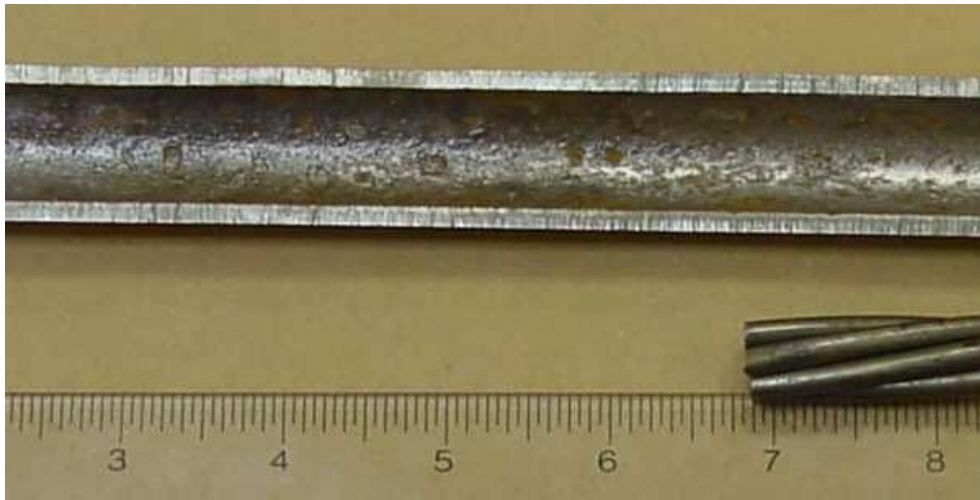
As shown in Table 2, the 10-day and 35-day exposures showed significant corrosion rates on the pipe. Corrosion pitting on the strands was significant but markedly less. As shown in Table 3, the pipe was predominantly anodic to the strands based on the macro-cell current readings. These readings, along with the much higher corrosion rates measured on the pipes, clearly show that the galvanic couple was unfavorable for the pipe. The exceptionally heavy pitting (0.61mm@35 days) on the pipe was the only surprise in the experiment. Pitting rate:  $[0.61/(35/365)]=6.4\text{mm/year}$ .

Figure 3 Condition of Pipe- 35 days

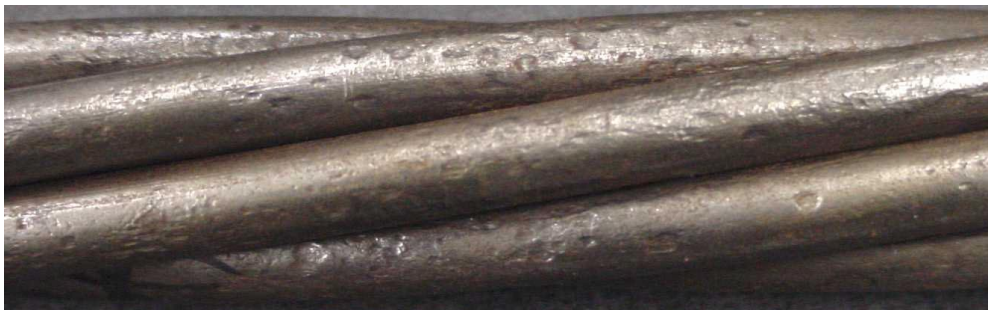
the predominantly anodic pipe did not provide sufficient current to prevent corrosion on the strands. The deepest pit observed on the strands (0.10mm) translates to an annual pitting rate of >1mm. This is significant because its depth is ~23% of the wire diameter. In the grouted trumpet tests, the maximum pitting rate on the strands was ~0.70mm/year while the average pitting rate of 18 wires was 0.53mm/year or >10% of the individual wire diameter. These are very significant corrosion rates that underscore the extreme importance of avoiding any grout voids and significant amounts of water (including fresh-water) coming into contact with any portion of the PT system.

Figure 4 Condition of Strand- 35 days
