REMEDIAL ACTION FOR FAILED POLE/BASE PLATE WELD ON HIGH MAST  
LIGHTING POLE (HMLP)

FDOT Contract Number: BD-015-023

Final Report

December 2009

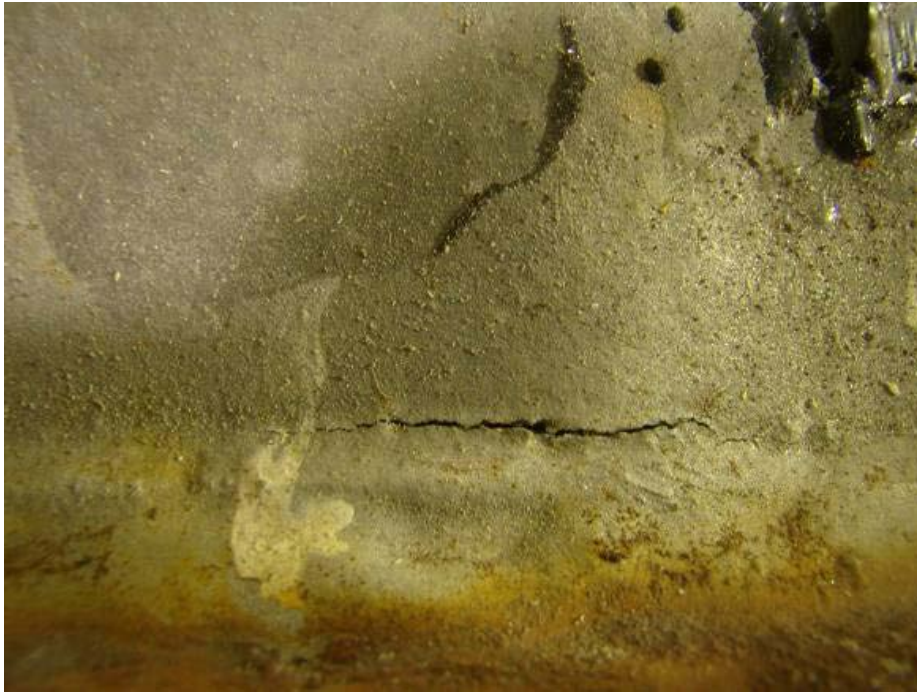
The Florida Department of Transportation (FDOT) District 4 recently had to issue a Declaration of Emergency for the replacement of sixty-one (61) high mast lighting poles (HMLPs) after the detection of fatigue cracks in the weld of the pole to the base plate. The fatigue cracks propagated as far as 25% of the total welds length and were deemed to seriously compromise the structural integrity of the HMLPs, which could lead to a disastrous collapse of the HMLPs. Figure 1 illustrates typical cracks observed on these poles. These cracks are very similar to HMLPs failure in Colorado and South Dakota where the fracture initiated at the same location, i.e., weld toe in the connection of the base plate to the pole wall, and then propagated around the pole wall until the structure collapsed. Thus, the only reasonable precaution measure for FDOT was to remove all poles at the site to prevent a catastrophic failure. The problem with the removal of these HMLPs is that lighting in the area will be affected and the visibility of the drivers who are travelling at night or during a thunderstorm will be greatly compromised. Therefore, there is a need to temporarily repair the cracked poles until they are replaced.

Figure 1. Weld Cracks

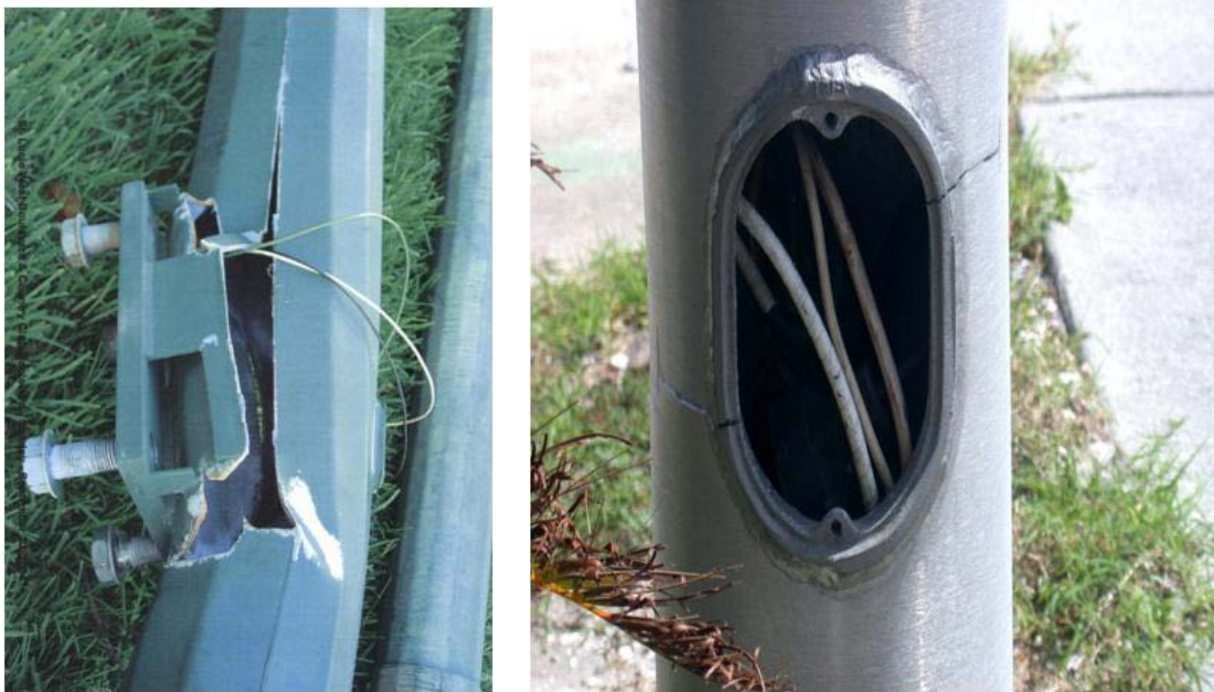
It has been observed that fatigue in structural supports caused by hurricane gusts is a real problem. During the 2004 hurricane season with Charley, Frances, and Jeanne making landfall in Florida [13], both FPL and FDOT reported numerous fatigue failures in their lifeline infrastructure. Figure 2 illustrates some of the fatigue cracks encountered by FDOT. In the figures, the red arrows indicate fatigue crack growth retardation, which can only be explained with variable-amplitude loading. The fact that failures were spotted after the hurricane indicates the need for fundamental research to alleviate future fatigue failure under variable-amplitude loading fluctuation resulting from hurricane gusts. Therefore, in area of high wind, such as South Florida, there is a vital need to remedial cracked HMLPs before the next hurricane hit to prevent major failure that may directly or indirectly lead to a loss of life.

Figure 2. Inspected fatigue failure of mast arm and light poles after 2004 hurricane season  
(Photographs from Sardinias et al., 2009 [13])

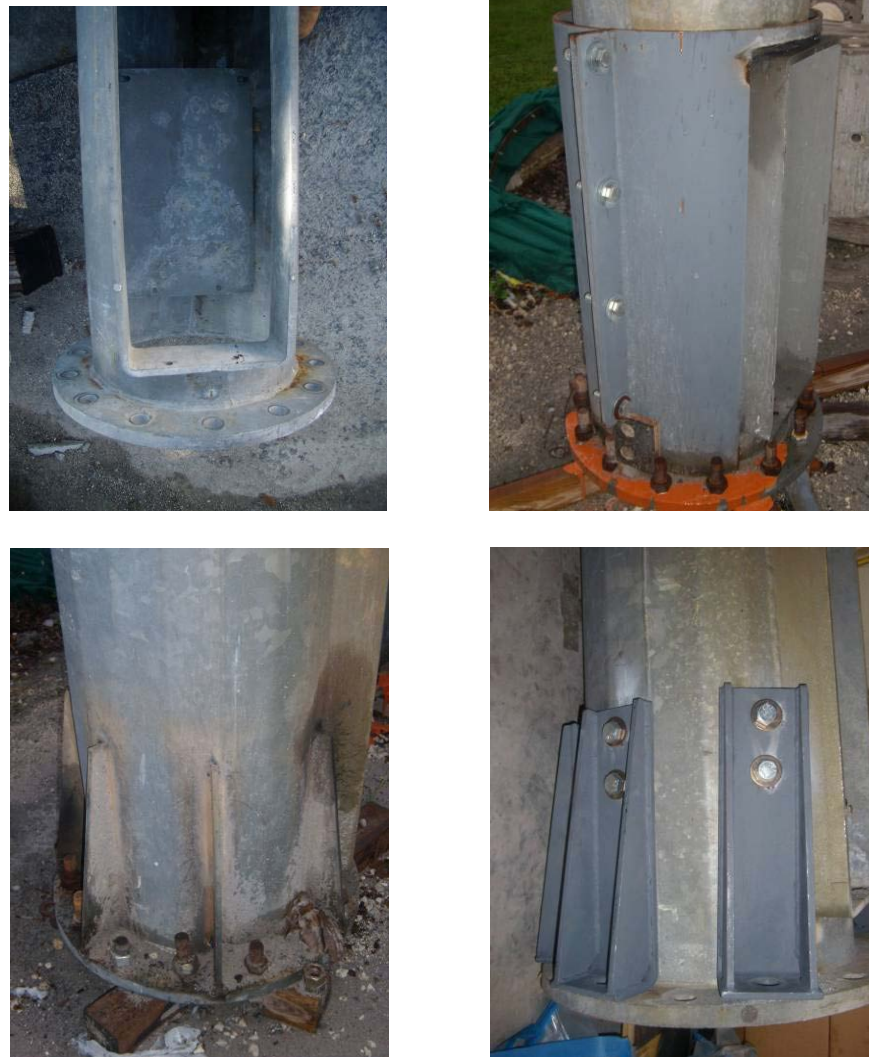
Figure 3. Installed Specimens (Clockwise from top left: Reweld, Steel Jacket, Welded Plate, Bolted Plate)

The reweld of cracks repair method was adopted from the contractor who insisted on using this approach to temporarily remediate the fatigue cracks in the HMLPs. The reweld of cracks was a very simple method, where the contractor simply provide extra fillet weld at the area where cracks were observed. Similar method was recommended by Dr. Karl Frank from University of Texas for Texas HMLPs. However, there are significant differences between the welding detail recommended by Dr. Frank and the one performed in this project on the repaired poles. The detail suggested by Dr. Frank requires the existing weld to first be removed to minimize any internal cracks within the existing weld. The welder should also perform multiple weld passes with surface wire brushed in between. The cracks need to be checked using magnetic particle tests or other nondestructive methods to ensure that the cracks are properly closed. Furthermore, the Texas HMLPs have a 3 in base plate, whereas the FDOT HMLPs have a 1 in base plate. Thus, in order for this repair method to perform well, quality control and quality assurance as well as training is needed.

The welded plate stiffeners consist of six  $\frac{3}{8} \times 3 \frac{1}{2} \times 16$  in triangular steel plates welded to the sides of the HMLPs. The FDOT welder favored this method as it was easy to install. The welding took a few hours and could be done without removing any bolts. However, the utilities would have to be shielded in the field to prevent damage and the welding needs to be of a better quality than the one performed here as evidence by rough welds profile and the undercutting. Additionally, Dr. Frank also recommended that the galvanizing should be cleaned off the surface before welding. This can be done using a flap type sanding disk, which will remove the coating and not grind into the mast.

The bolted stiffener consists of two  $\frac{3}{8} \times 3 \frac{1}{2} \times 16$  in triangular steel plates welded to a steel plate backing that can be bolted onto the HMLPs. Six of these bolted stiffeners were installed on the cracked HMLPs. According to Dr. Frank, this repair method is a promising retrofit and should be able to handle fatigue. However, because of the unique dimensions of the HMLPs, installation becomes a challenge in the field. One problem encountered during the installation was the metal backing may not lay flat against the mast. Another problem was the holes on the mast were difficult to drill. The FDOT staff had to torch the holes rather than the recommended drilling. The torched surface prevents the bolt and nuts from being fully engaged. The third problem is the back plate or the panel mount inside the HMLPs did not allow easy access to the bolt locations. However, all these problems could be resolved through training as well as using twist off bolts.

The steel jacket was an expensive option that proved to be impractical for installation. The jacket consist of two steel half pipes bolted together to form a jacket that encases the mast and the base welded to the base plate. The gaps between the jacket and mast were sealed using Chockfast Orange. The problem with this repair method was the hand hole of the HMLPs was very low, which requires the half pipe to have a U-opening. The U-opening was so large that lead the leakage of Chockfast Orange. Furthermore, the fact that the mast may be different sizes makes it impossible to mass produce the sleeve. Because the installation of this repair method was not possible under field condition, the specimen was not tested.

1. The welded and bolted plate stiffeners are recommended as temporary remedial action for cracked HMLPs. However, the bolted plate stiffeners will be easier to inspect and install.

2. A slotted hole on the base plate of bolted stiffener should be used to allow the stiffener to be located against a flat on the mast. A plate washer should be used between the nut and the slotted hole to provide bearing for the nut.

3. The holes in the mast for the bolts attaching the stiffener to the mast need to be drilled instead of torched. The surface should also be cleaned from oil before installing the stiffener to prevent lubrication of the faying surfaces of the bolted connection. The drilled hole will provide better fatigue performance and prevent the slag build up around the burned hole.

4. A twist off bolt should be used for the bolted stiffeners to facilitate a one sided installation and to ensure no slippage.
5. It is very important to clean the galvanizing off of the surface before welding. This can be done using a flap type sanding disk which will remove the coating and not grind into the mast.

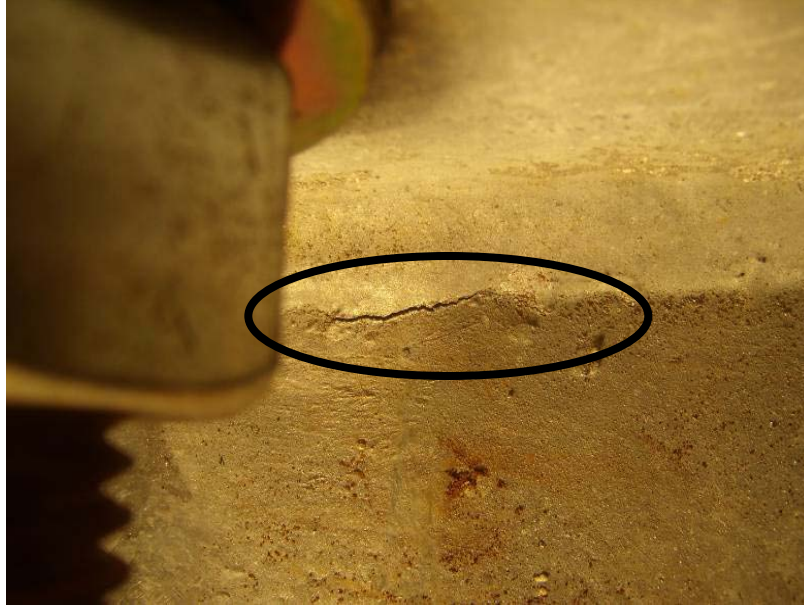
All specimens were tested as a cantilever to failure, which was determined by the strain gages and/or significant crack growth. Figure 7 illustrates a failed specimen after loading to failure. The loading was either applied using displacement control using a loading rate of approximately 0.06 in/min (a value that was approximated from previous load control conditions) or load control at a rate of 25 or 50 lbs/s.

Figure 7. Cracking in the Toe Weld

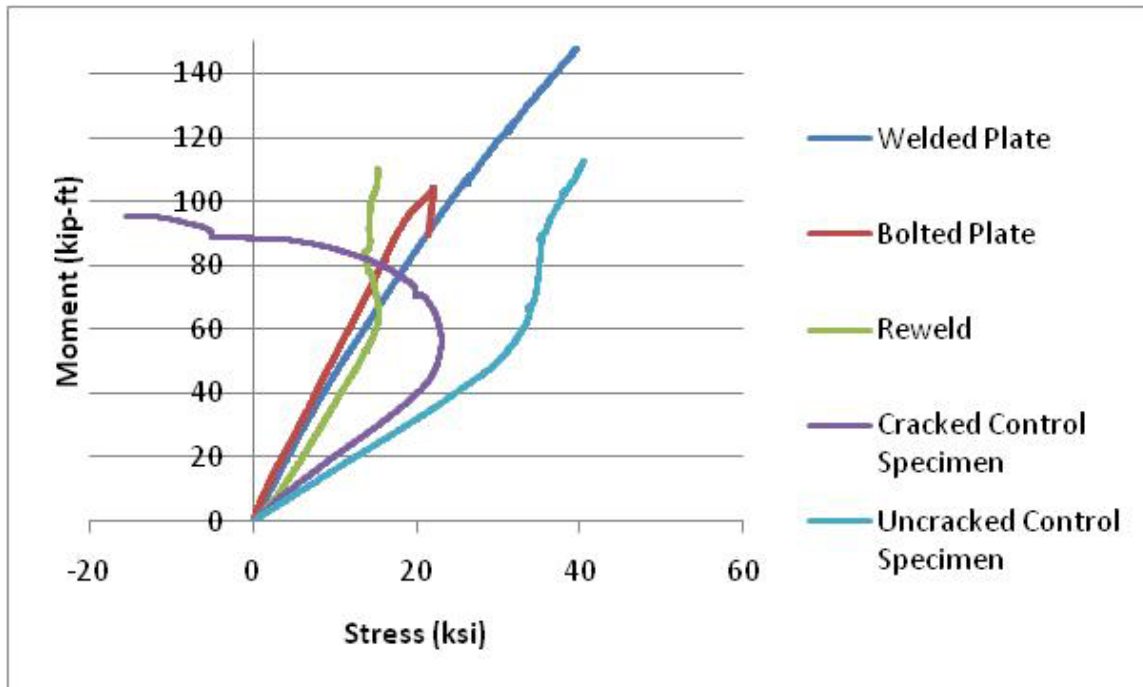
Figure 8 illustrates the moment versus maximum stresses curve. The stresses were taken from the top strain gages, where the maximum positive moment occurs. It should be noted that the steel jacket retrofitted specimen was not tested due to the impracticality with the installation of the jacket onto the pole. Overall, the bolted and welded stiffeners performed the best. In fact, for the welded plate stiffener, the test was stopped after the mast had yielded and the moment reached the design moment of 140 ft-kips. No cracking between the base plate and the steel mast was observed. Nor was there any cracking in the weld around the plate stiffener.

The bolted plate stiffener performed very well exceeding the capacity of the controlled specimen until the bolt began to slip at a moment of 90 ft-kip. Once the bolts were loosened and disengaged cracking at the base plate occurred. The reason for this as explained earlier is two folds: (1) torched holes and (2) regular structural bolts were used instead of twist off bolts to ensure no slippage in the connection. If the slippage can be eliminated with twist off bolts, one advantage of this repair method over the welded stiffener is the ease of inspection. The engineer simply has to verify the tightness of the bolts.

Initially, the rewelded specimen demonstrated slightly better performance than the cracked specimen in term of stiffness, but after the moment reaches 60 ft-kip, cracking was observed. In fact, the specimen cracked at the same moment as the controlled cracked specimen. Therefore, reweld of cracks should not be recommended as a remedial action in the field. It should be avoided all together because it is impossible to inspect without resourcing to expensive non-destructive tests as there is no way to visual inspect the cracks covered by the reweld.

Figure 8. Moment Versus Maximum Stress

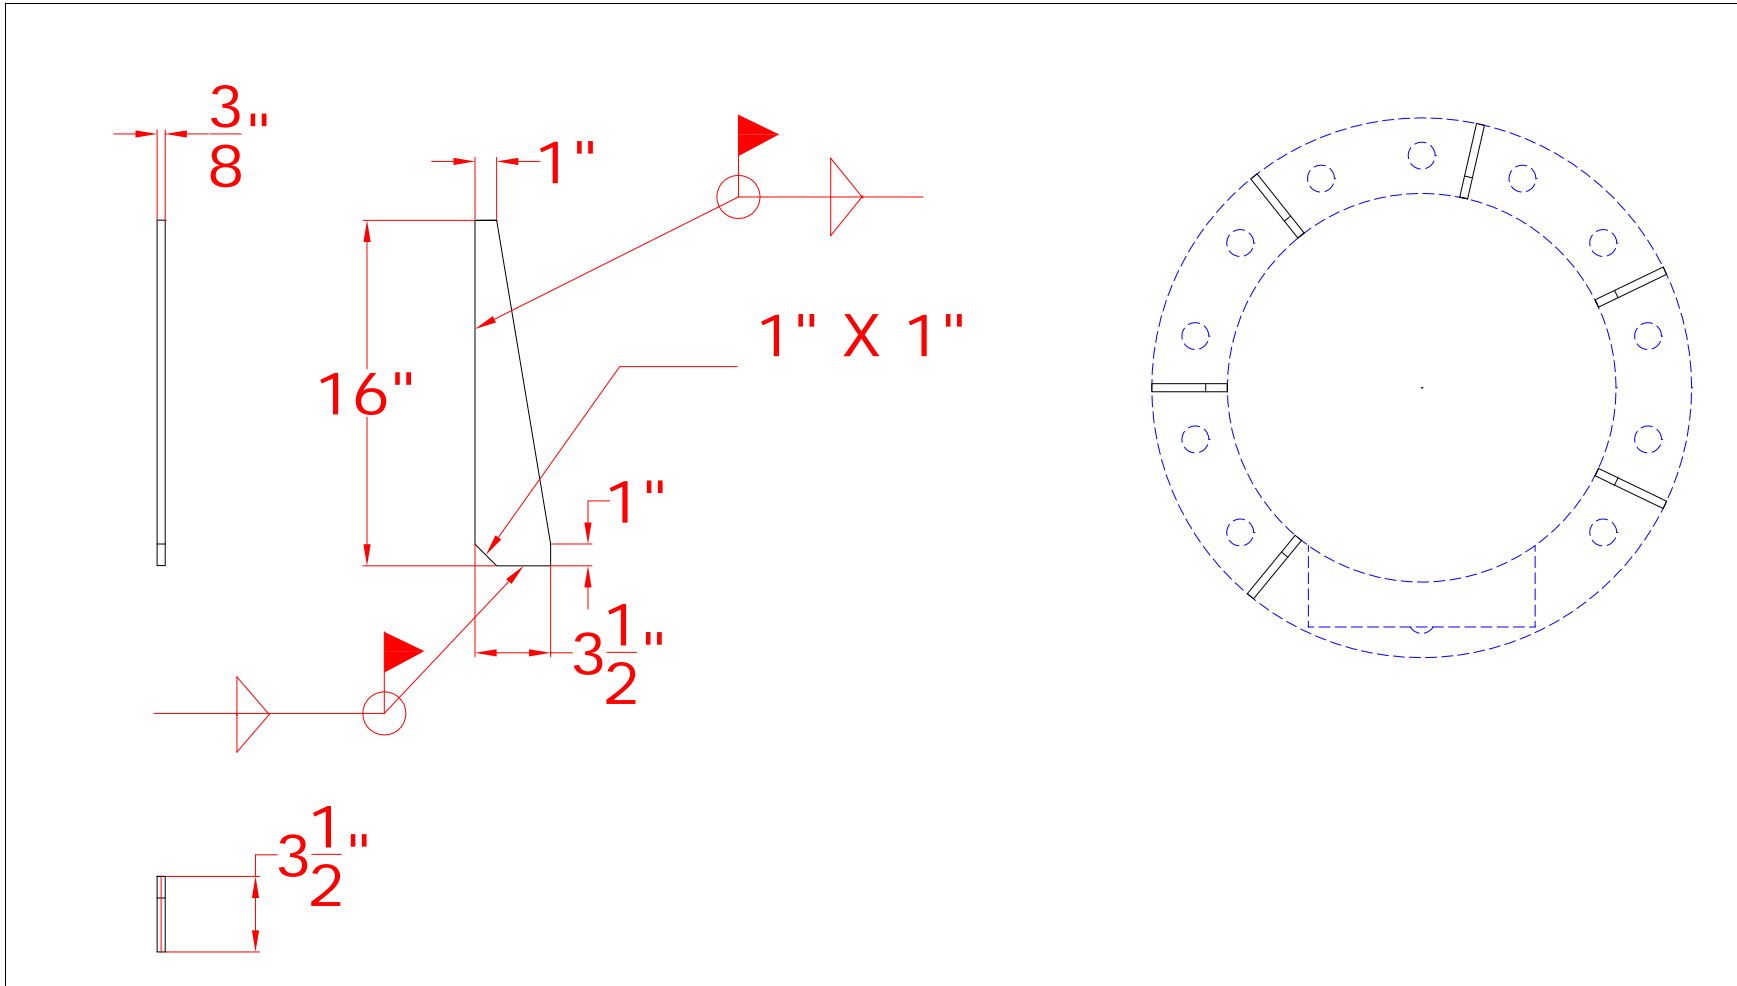
Option 2. Welded Plate Stiffeners

6. The rough weld profile and undercut in test specimens do not meet the current bridge welding specifications. Care should be taken when welding the plate stiffeners.
