Final Report

June 2006

UF Project No. 00051711
Contract No. BD545, RPWO #27

ST. GEORGE ISLAND BRIDGE PILE TESTING

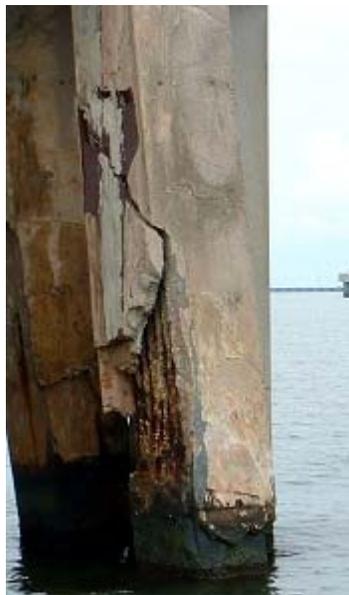
Figure 1 – Corrosion Damaged Pile

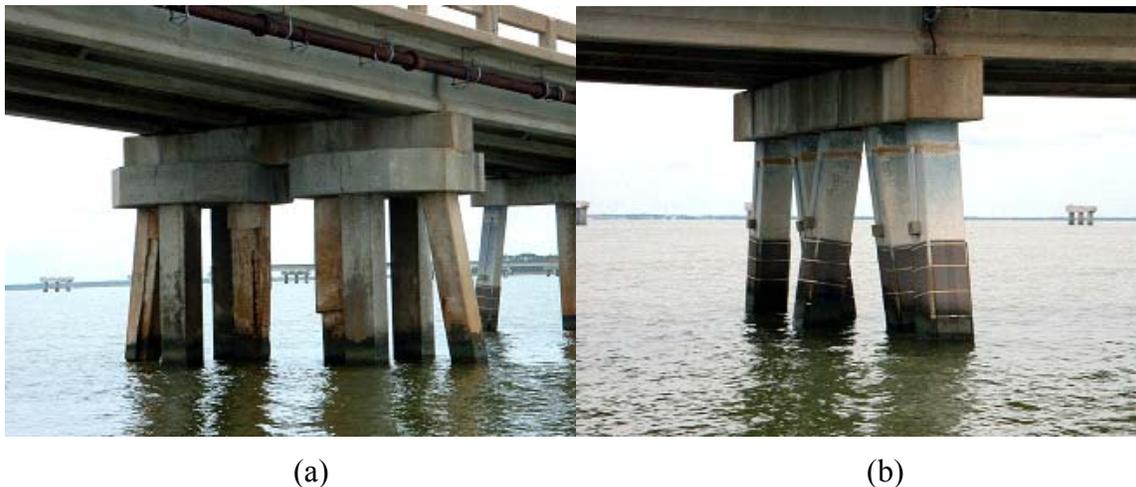
Figure 3 – Prestressed pile bents before bridge demolition. (a) “crutch bents” installed to relieve piles damaged by corrosion (b) cathodic protection system on existing piles

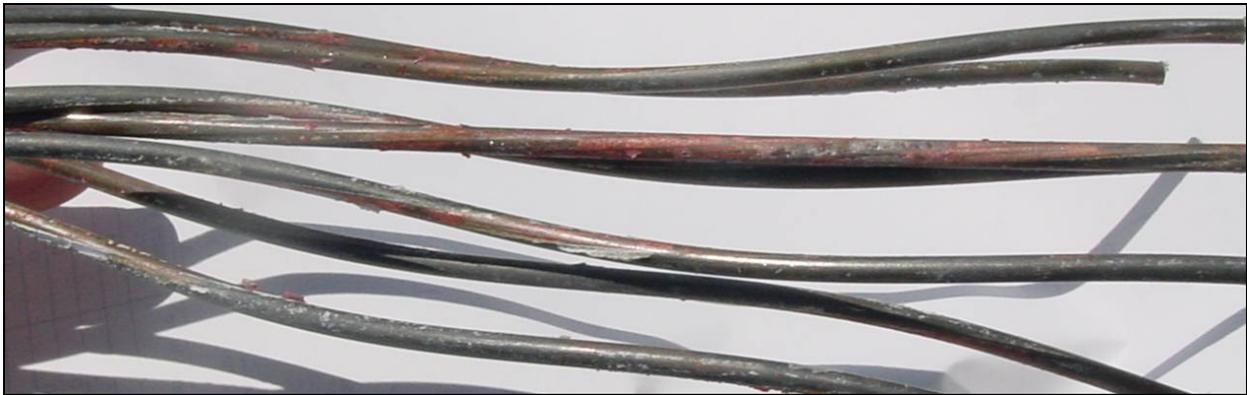
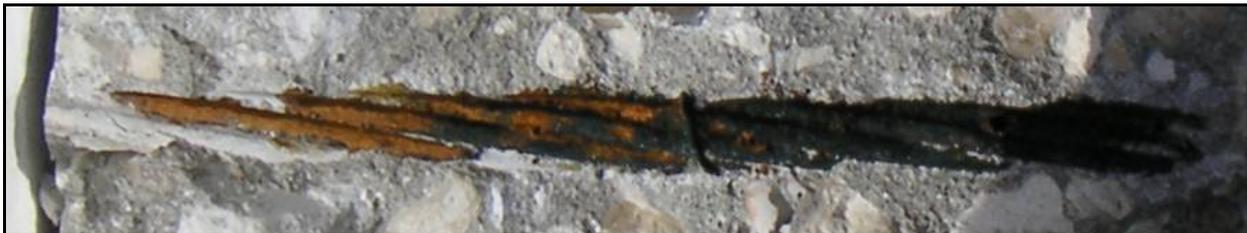
Strand samples taken from both piles generally exhibited light to moderate surface corrosion with spotty mild pitting (Figure 13a). The strand samples from Pile 21-4 showed corrosion primarily in the interstitial space between the outside and center wires. This pattern was consistent at all sample locations. In general, the cathodic protection system appeared to have done a reasonable job of protecting the reinforcement. Some of the strand samples pulled from pile 44-2 (Figure 13b) had surface corrosion on the outer wires. The strand shown in the figure exhibits some bleeding of corrosion product into the concrete as well as black corrosion product indicating a low oxygen environment. Note that the corrosion has the appearance of emanating from the tie wire.

Figure 13 – Corrosion on strand pulled from (a) pile 21-4 (b) pile 44-2.

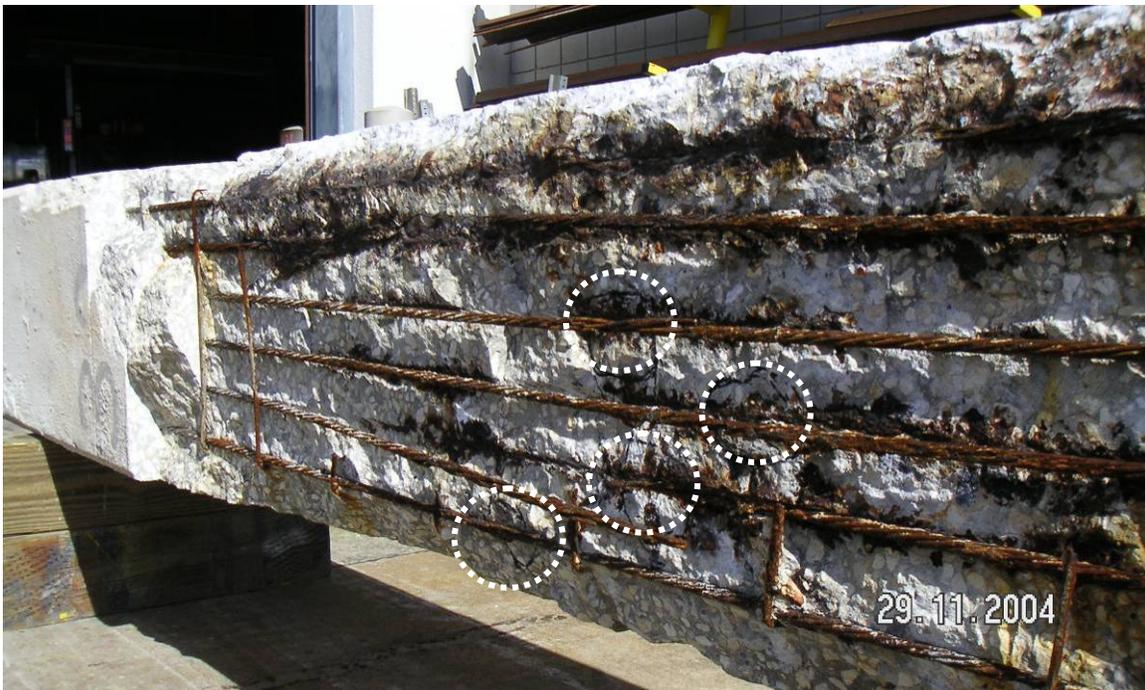
Figure 28 – Pile 32-3J after excavation. Wire breaks are circled.

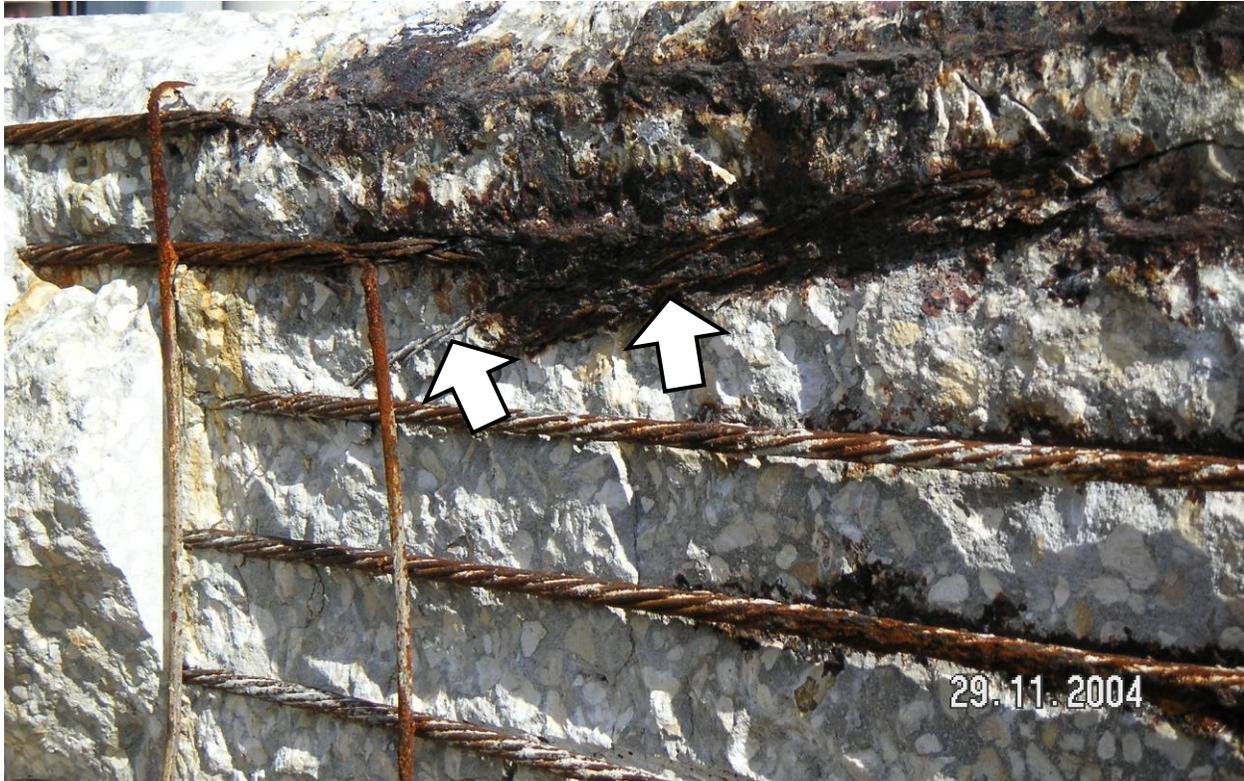
Severe corrosion was also noted in strand that appears to have been used for pick up points during pile construction and handling. Pick up points were noted in both 32-3J and 44-2. Figure 29 shows an example in which the pick-up point strand and pile strand have been nearly completely consumed by corrosion. The pick-up point strand, however, was in bright condition away from the pile strand and farther into the pile. Corrosion at these locations likely was initiated by chloride intrusion along the pick-up point strands where they exited the pile. The fact that the pick-up point was located in the splash zone accelerated this behavior.

Figure 29 – Severely corroded strand from pick up point on Pile 32-3J. Prestressing strand in this area has been completely consumed by corrosion. Moderate to severe corrosion on the remaining strands as they enter the splash zone.

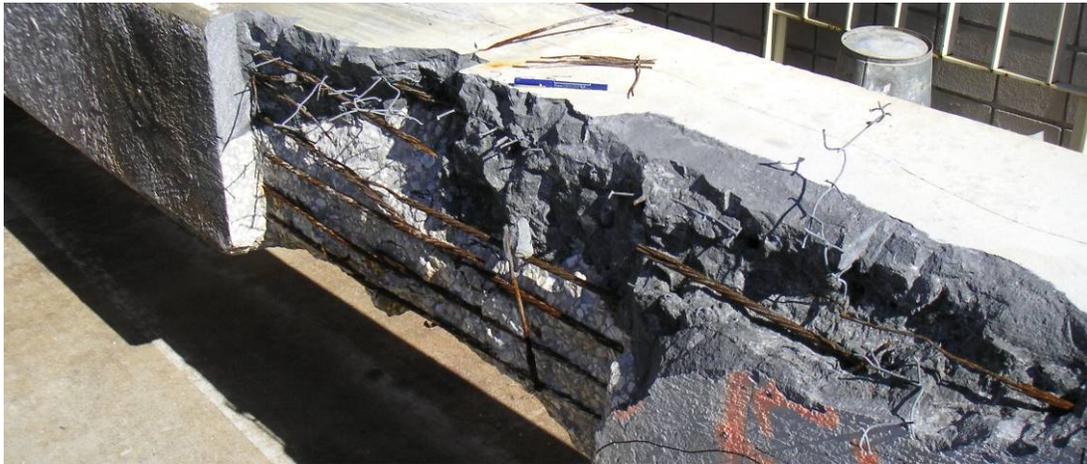
Figure 30 shows pile 44-3CP after excavation. The repair material used to replace the original concrete that spalled due to corrosion appears darker and devoid of coarse aggregate. The patch was reinforced with a galvanized steel welded wire fabric, which did not have significant corrosion (Figure 31). Closer inspection of the prestressing strand showed that there was significant loss of cross-section at the time of the repair. Figure 31 shows the severe elongated pitting associated with corrosion of prestressing strand. The pits are filled with grout indicating that the corrosion products were likely mechanically removed before patching. Corrosion product was present on the remainder of the prestressing strands to varying degrees. Figure 32 shows four of the strands from the bottom strand layer of pile 44-3CP highlighting the variation in corrosion severity across the width. The top strand has light to moderate surface corrosion. The strand below it has moderate to significant corrosion with some significant pitting. The bottom two strands have severe corrosion with significant loss of cross-section and have rupture where they intersect a flexural crack in the concrete.

Figure 30 – Pile 44-3CP after excavation. Darker concrete is patch material placed during the 1994 repairs.

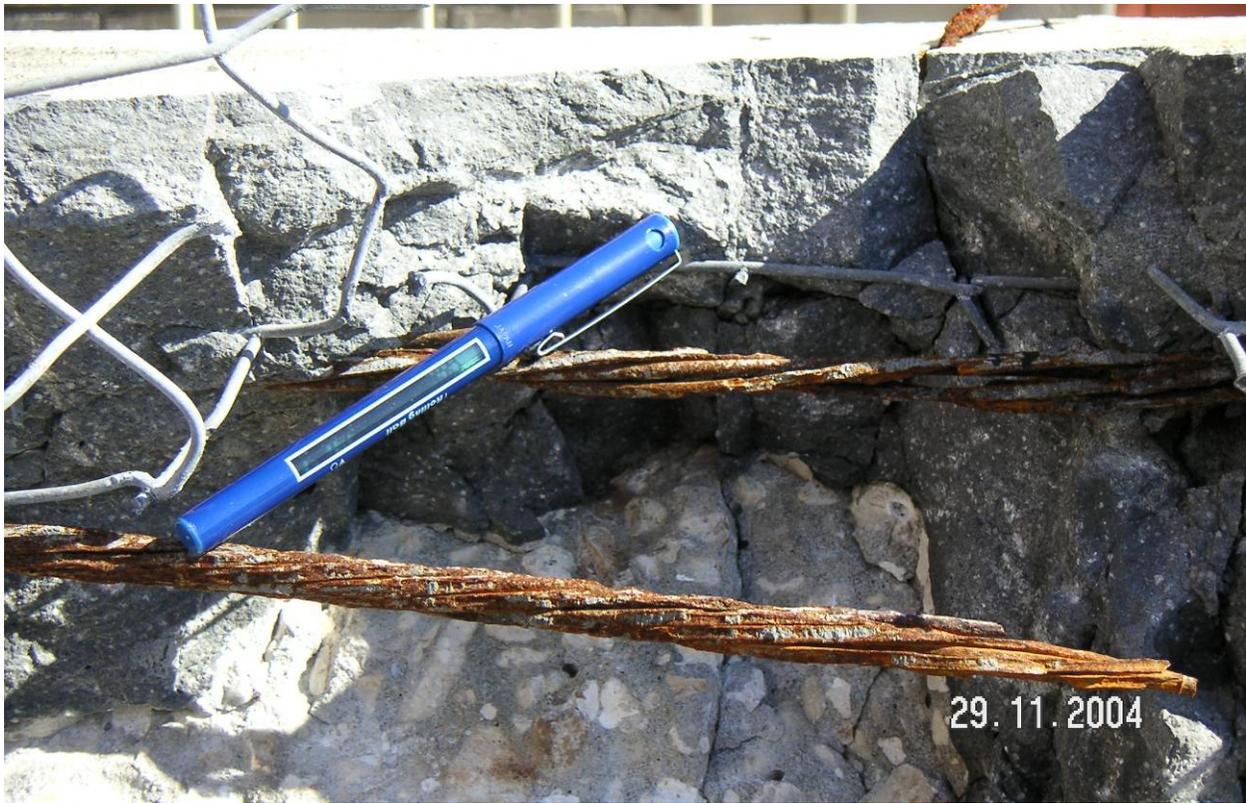
Figure 31 – Interface between existing pile concrete and patch material. Galvanized steel mesh was used in patch. Prestressing strand in foreground appears to have had significant section loss before repair.

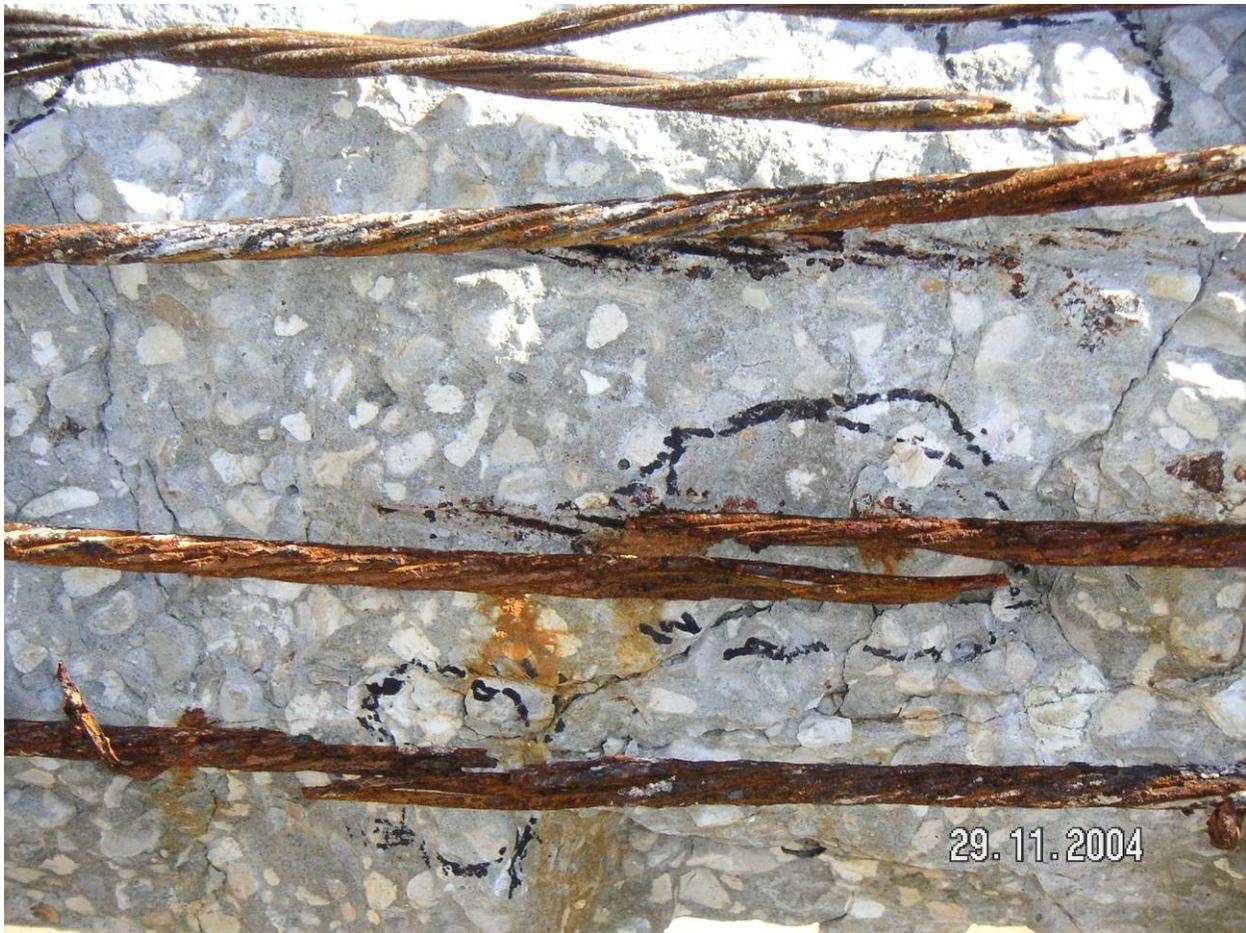
Figure 32 – Strand in bottom of pile 44-3CP. Corrosion severity increases in intensity from top to bottom. Wire breaks are distributed along a major flexural crack in the more heavily corroded strands.

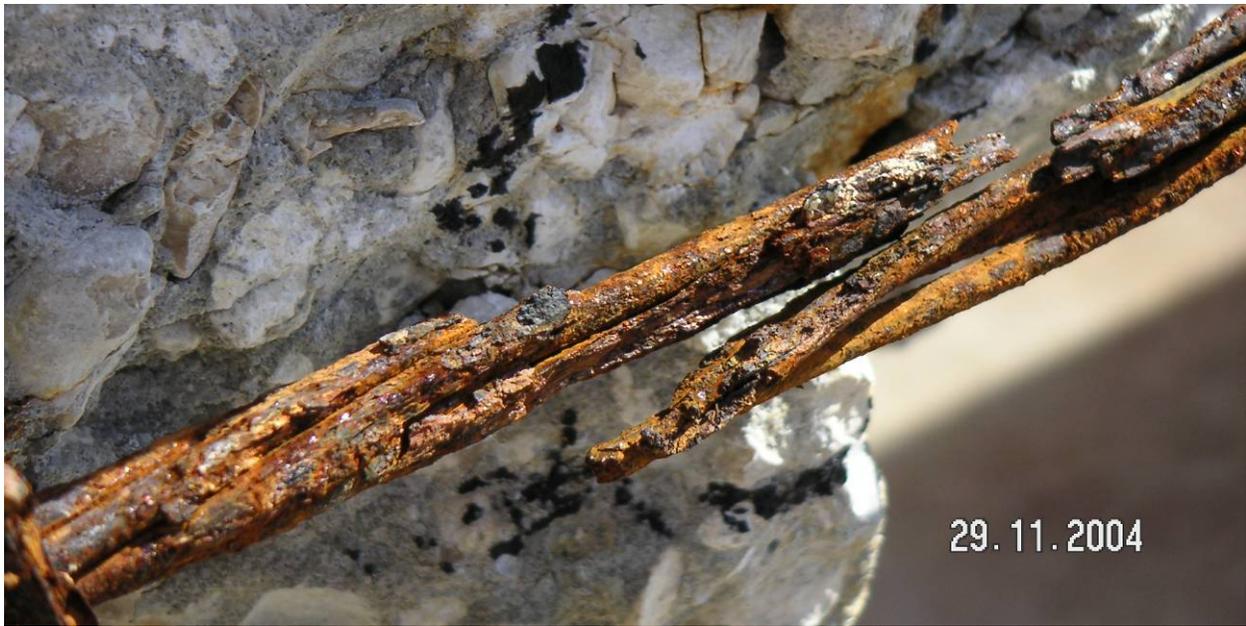
Figure 33 shows the behavior of a severely corroded strand when loaded to rupture. The wires generally ruptured at varying locations along the length of the strand. In contrast, Figure 34 shows the rupture pattern of an uncorroded strand taken from the piles in which the individual wire ruptures occur in very close proximity to each other. Furthermore, each wire exhibits the ductile necking and cup/cone fracture surface.

Figure 33 – Typical rupture pattern of severely corroded prestressing strand exhibiting fingernail splitting.

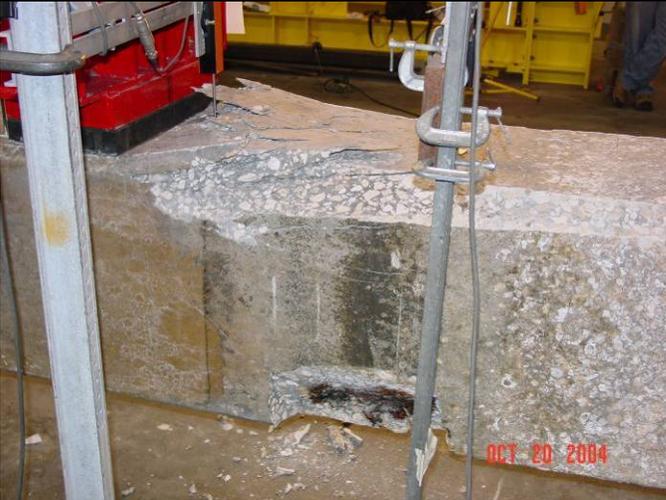
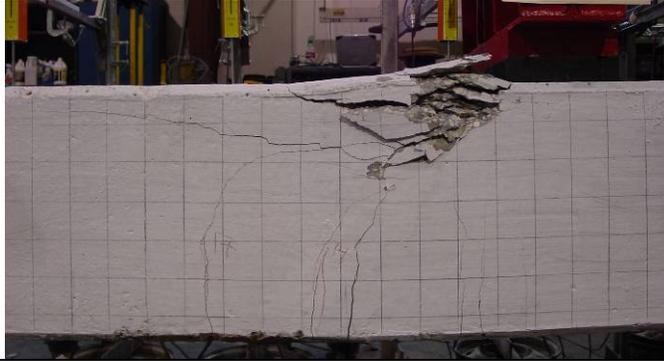
Post-Test Condition	
First crack appeared at 14 kips. Concrete 6 in below the top face of the pile just north of the north load point was crushed severely. Flexural cracks were present after unloading	
Post-Test Photos

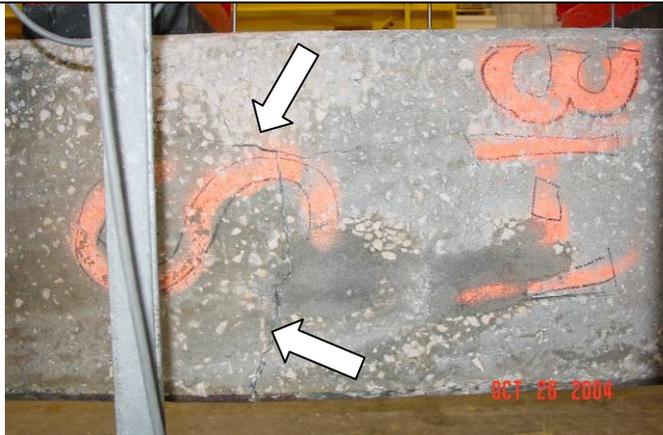
31-1

First crack appeared at 28 kips. The compression zone concrete was only slightly crushed. The pile showed compression zone crushing to a limited extent. The flexural cracks mostly closed after unloading.

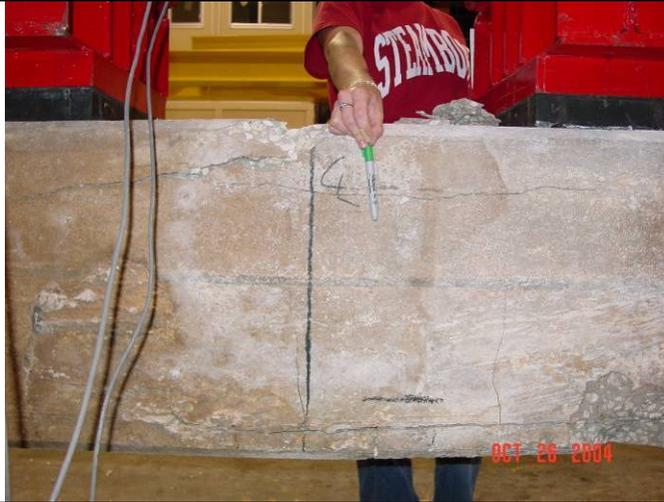
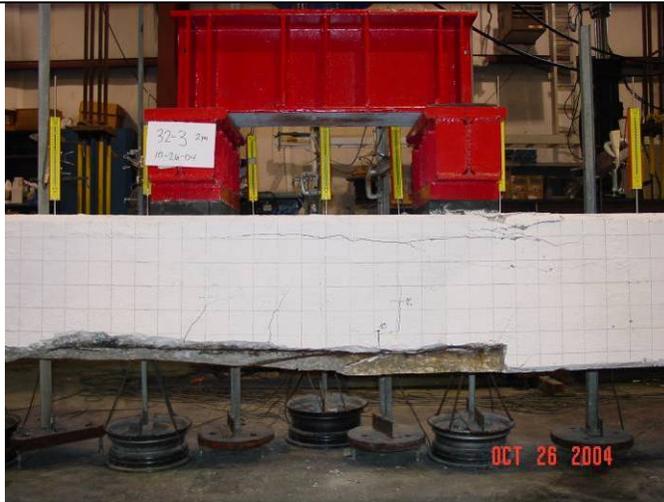
32-3J

The first crack occurred at 10 kips. The failure of this pile included a long horizontal crack from the north to the south support. Flexural cracks were also emanating from the missing concrete section in the tension zone. The concrete just to the south of the south load point was crushed in compression. The concrete in the tension region of the splash zone was removed after testing. All of the strands in this location were severely corroded. Five of the six strands had been corroded completely through and all of the wires broken.

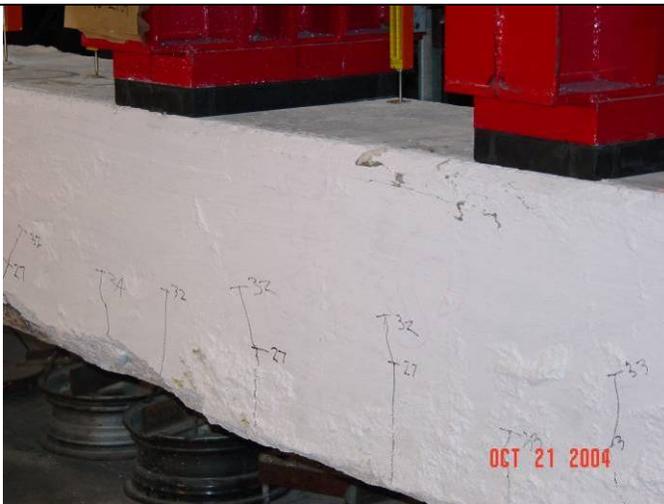
33-4J

There were flexural cracks visible on the pile. The concrete in the compression zone was only slightly crushed at the completion of the test.

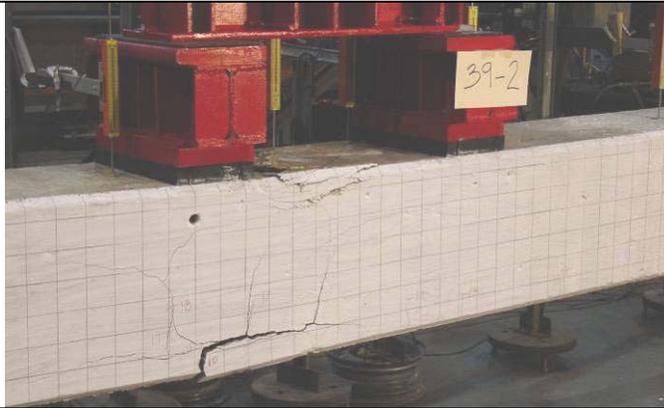
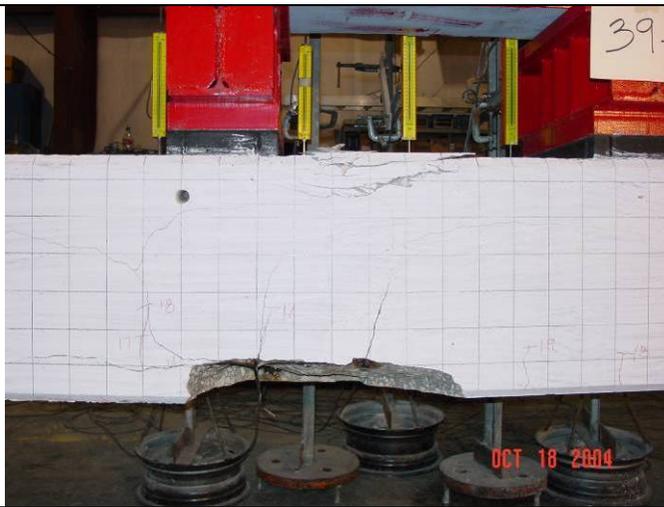
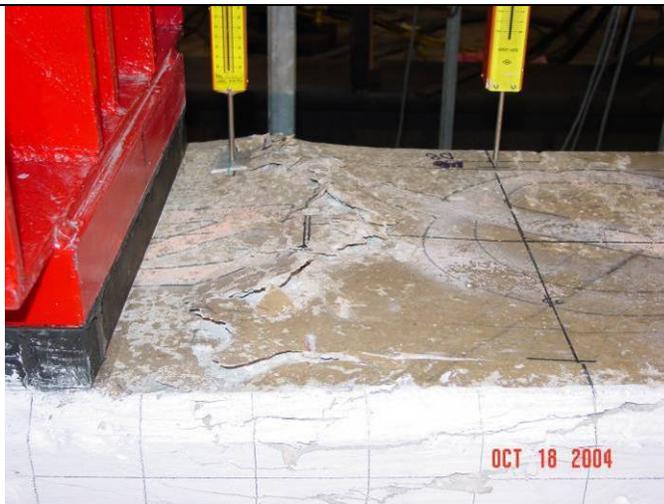
39-2

First crack appeared at 10 kips. Concrete 4 in below the top face of the pile began to crush. Flexural cracks emanating from one major crack just below the north support. This crack caused a large piece of concrete on the bottom face of the west corner to come off. This revealed corroded strands. After testing, the concrete in the tension zone of the pile was removed. This revealed that all of the strands had broken wires and one of the strands was severely damaged by corrosion. All of the strands had corrosion damage.

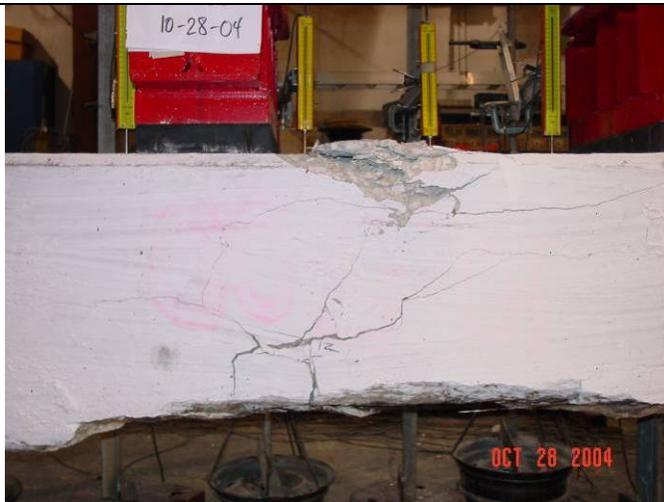
40-3J

First crack appeared at 12 kips. Flexural cracks appeared mostly under the North load point. The concrete of the top face began to crush. Large pieces of concrete spalled off on the east side of the pile exposing more corroded strands.

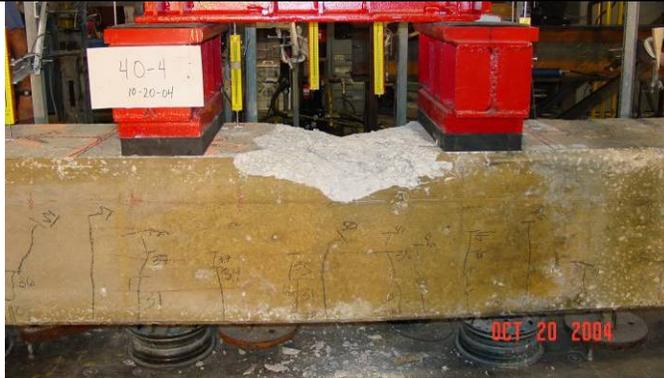
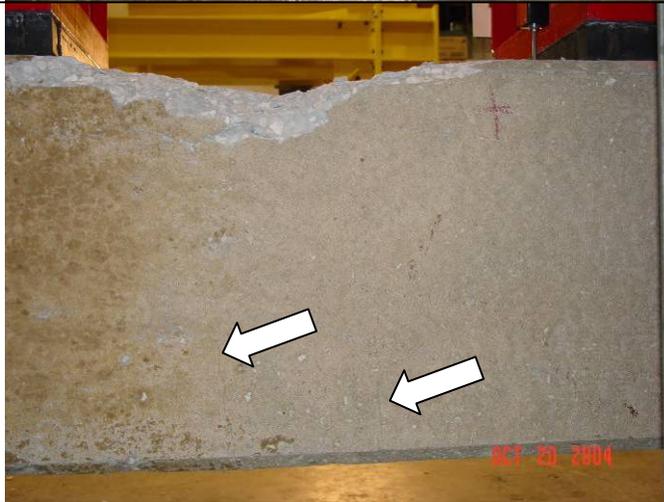
40-4

First crack appeared at 10 kips. Concrete on the top face of the pile, in between the load points was crushed. Flexural cracks were present but were not very large.
