Condition Assessment of External P-T Tendons in the Mid Bay Bridge

Al Ghorbanpoor, Ph.D., P.E.

University of Wisconsin-Milwaukee

November 14, 2000

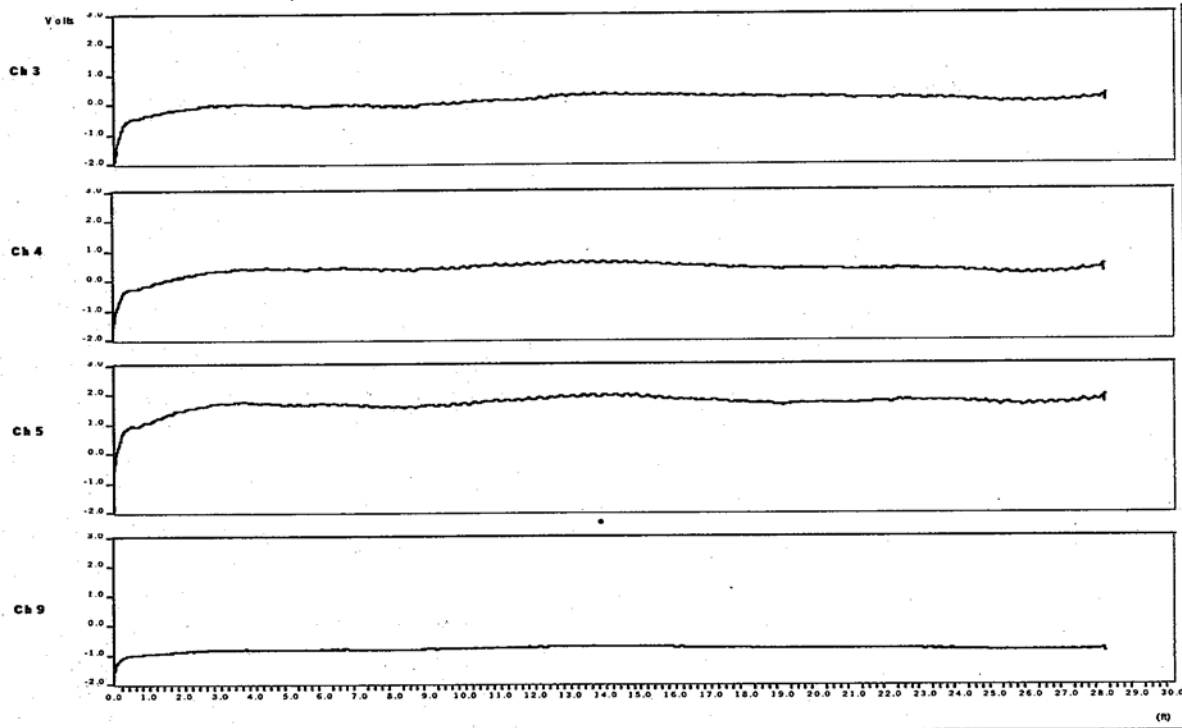
Figure 9 – MFL signals indicating no loss of cross sectional area
(span 25, tendon 25-3b)

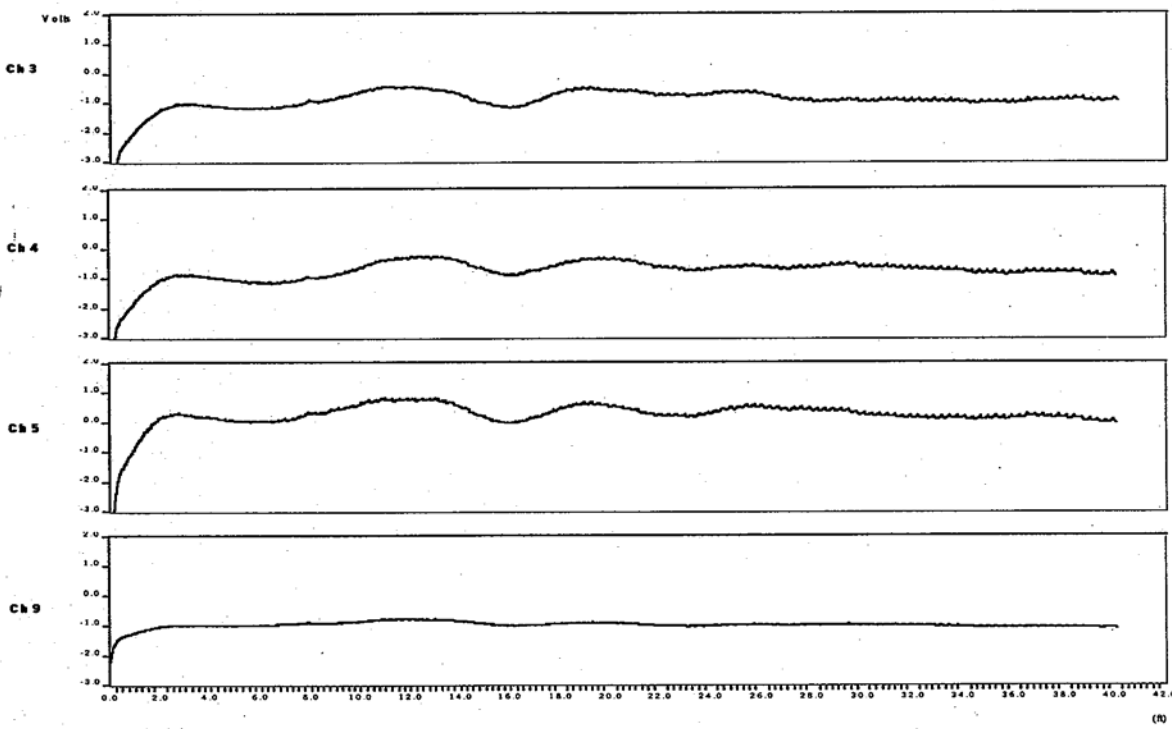
Figure 10 – MFL signals indicating no loss of cross sectional area
(span 132, tendon 132-2c)

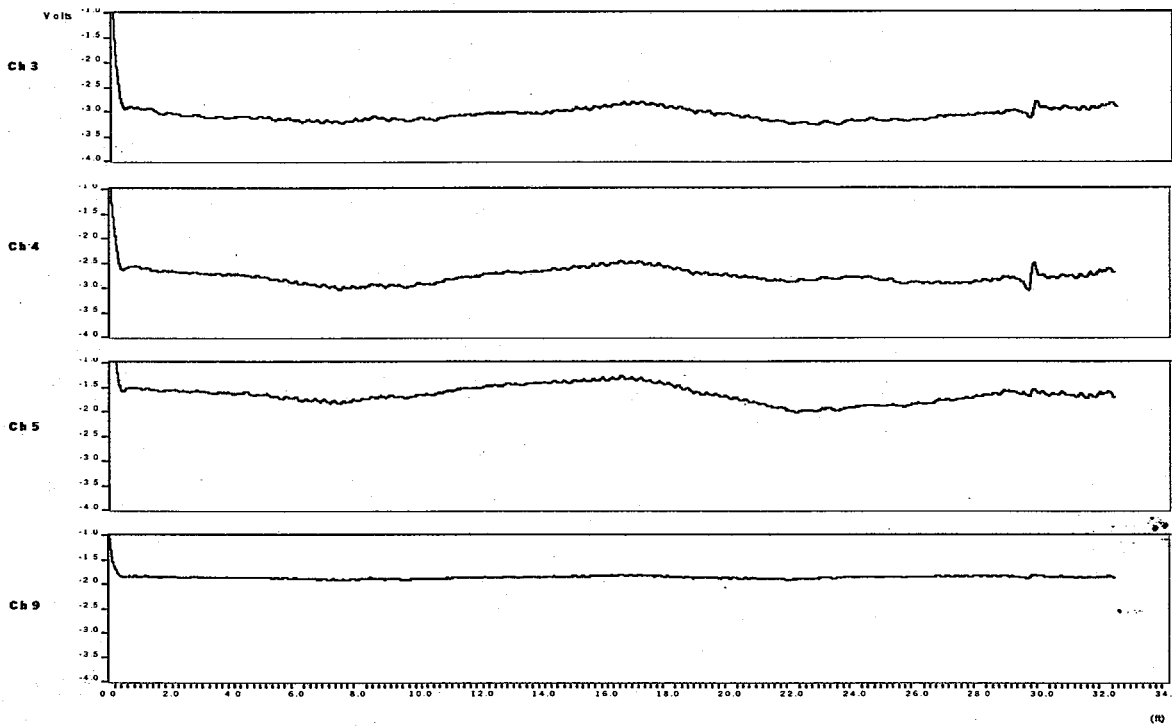
During the MFL testing of the tendons of the Mid Bay bridge, indications of corrosion of pre stressing steel were observed at two locations along the length of two tendons. The corrosion indications were recorded for tendons located in spans 71 and 98. The tendon with corrosion in span 71 is designated by FL DOT as tendon 71-1a and that in span 98 is identified as tendon 98-5c. The MFL data indicated that both tendon corrosion cases, particularly in span 71, were concentrated in a relatively localized length of each tendon. In span 71, a corrosion indication was recorded during the MFL testing of tendon 71 -1a. The location of the corrosion indication was at a distance of 30 feet from the start of the test. The starting point of this test was at the edge of the rubber boot at the first deviation block. The magnets/sensors assembly of the MTTD was moved along the tendon in the direction of the tendon's end-anchorage area. With the addition of a fixed distance of 1 foot and six inches, or the distance between the end wheels and the center of the magnets/sensors enclosures, to the measurement from the MFL data, the detected corrosion spot was identified to be located at an actual distance of 31 feet and six inches from the edge of the rubber boot at the first deviation block. The MFL corrosion indication can be easily seen in the data plots from channels 3 and 4 in Figure 11. Flaw indications from the graphs of channels 5 and 9 are not prominent in the figure due to the graphs' scale factor and farther distance of the flaw to these sensors. Considering the output and corresponding position for each sensor (or channel), as well as the short signal duration, one can conclude that the flaw consists of limited surface corrosion in a local area. Upon a physical examination of the P-T duct at the suspected spot, it was found that a small hole was present in the polyethylene duct. The indication of a small corrosion and its location for this tendon were reported to the FL DOT personnel as the MFL testing was underway for the tendon. The indicated location was marked with yellow paint for subsequent verification. The FL DOT personnel opted to cut a small window, or opening, in the polyethylene duct at the indicated location to verify the MFL corrosion indication. After an opening was made in the tendon, it was observed that localized corrosion was present in the tendon. The corrosion was limited to four wires of a seven-wire strand in the prestressing bundle. Figure 12 shows the opening in the tendon at this location and a general view of the corroded tendon. The corroded area of the tendon was cleaned with a wire brush to observe the extent of the corrosion. Figures 13 and 14 show close up views of the corroded tendon. It is apparent that the cause of the corrosion at this location is due to the penetration of moisture and oxygen inside the tendon from the presence of the hole found on the polyethylene duct. The hole could have been made either to check the status of grout inside the duct during or after the grouting operation, or for other unknown reasons.

Figure 11 – MFL signals indicating localized corrosion at 30 feet from the start of the test (span 71, tendon 71-1a)

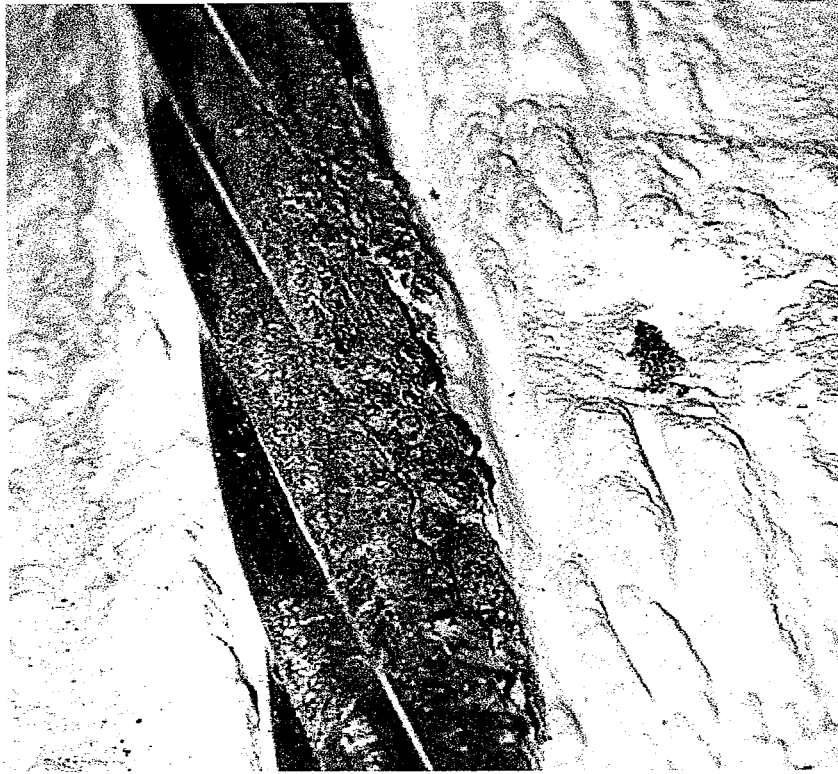
Figure 13 – Close up photograph of the corroded tendon
(span 71, tendon 71-1a)

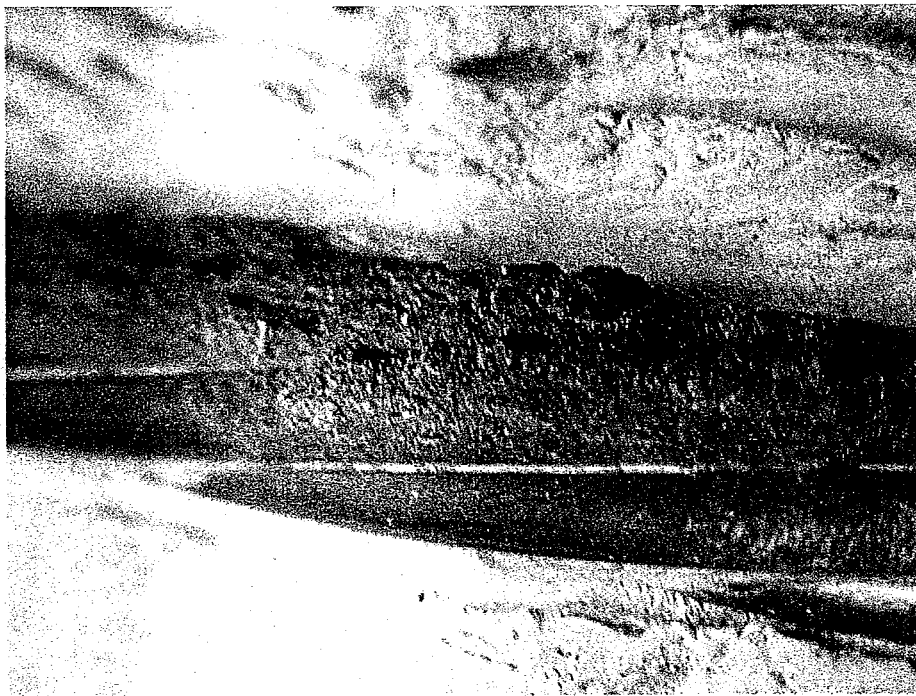
Figure 14 – Close up photograph of the corroded tendon
(span 71, tendon 71-1a)

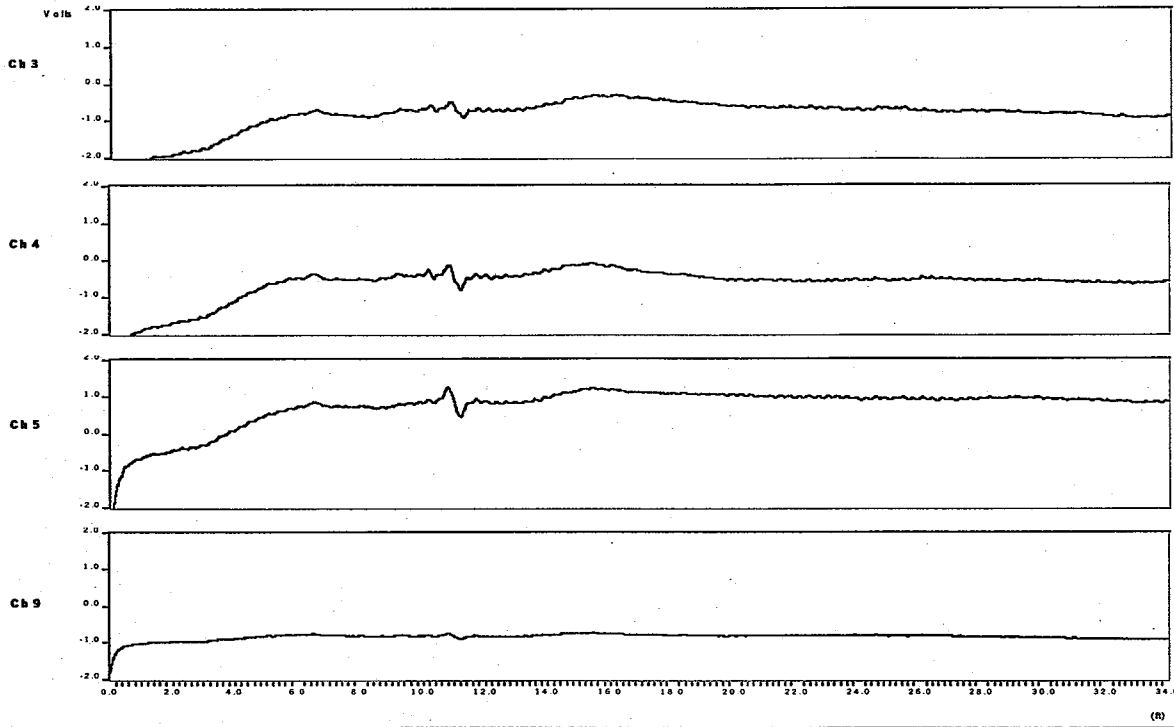
In span 98, indications of corrosion were recorded during the MFL testing of tendon 985c at locations from 9.0 to 10.5 feet from the start of the test. The starting point of this test was at the edge of the rubber, boot at the end-anchorage-block of the span in section "C" of the span. The span section designations are given by FL DOT. The magnets/sensors assembly of the MTTD system was moved along the length of the tendon in the direction of the first deviation block. The MFL corrosion indication can be easily seen in the data plots from channels 3, 4, and 5 in Figure 15. Flaw indications in the graph of data from channel 9 are not as strong as those shown for the other channels due to the graphs' scale factor and farther distance of the flaw to this sensor. Although the primary flaw indication is at the location of 10.5 feet, one can also see signal amplitude changes in the plots starting approximately at 9.0 feet from the start of the test. This indicates that the corrosion in the tendon is not limited to only a localized point but it also exists at locations in advance of the 10.5 feet location. In addition, a change in the shape of the MFL flaw signal in terms of a longer peak-to-peak duration can indicate a more gradual corrosion of the tendon than a localized one. This can be easily observed by comparing the MFL flaw signals for the corroded tendons in spans 71 and 98 (Figures 11 and 15, respectively). Upon a physical examination of the P-T duct at the corrosion suspected area, it was found that a small hole was also present in the polyethylene duct. The indication of the corrosion and its location for this tendon were reported to the FL DOT personnel as the MFL testing was underway for the tendon. The indicated location was marked with yellow paint for subsequent verification. The FL DOT personnel decided to cut a window, or opening, in the polyethylene duct at the indicated location to verify the MFL corrosion indications. After an opening was made in the tendon, it was observed that corrosion was present in the tendon in the region indicated. It was verified that a more extensive corrosion was present at the 10.5 feet location and less extensive surface corrosion existed for a two-foot distance in advance of this location. The corrosion was limited to four wires of four seven-wire strands in the prestressing bundle. Figure 16 shows the opening in the tendon at this location and a general view of the corroded tendon. The corroded area of the tendon was cleaned with a wire brush to observe the extent of the corrosion. Figures 17 and 18 show close up views of the corroded tendon.

Figure 15 – MFL signals indicating corrosion at locations 9.0 to 10.5 feet (span 98, tendon 98-5c)

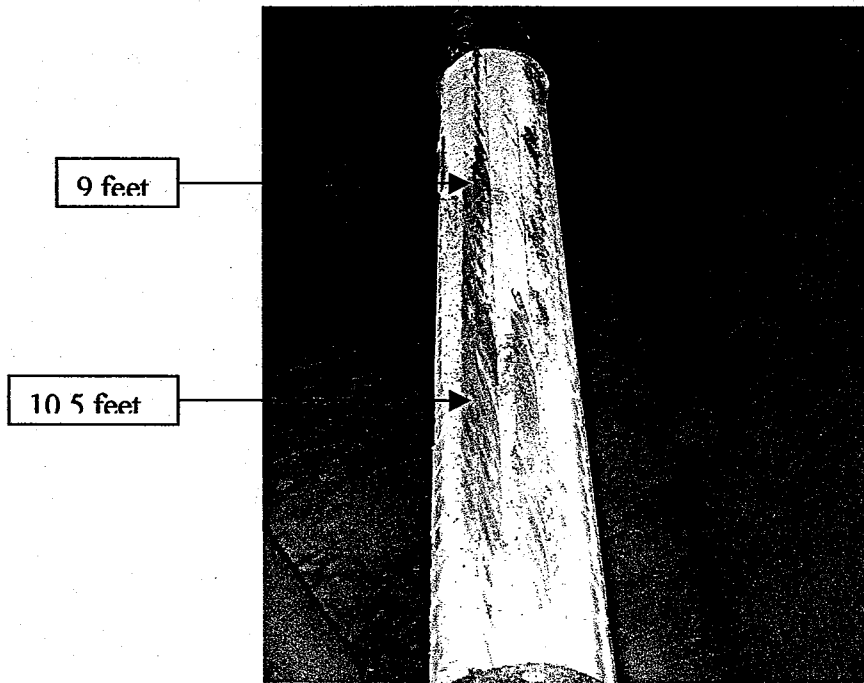
The cause of the corrosion at this location can also be associated with the presence of a small hole on the wall of the polyethylene duct that allowed penetration of moisture and oxygen inside the tendon. Again the hole could have been made either to check the status of grout inside the duct during or after the grouting operation or for other unknown reasons.

Figure 16 - Photograph of the opening in the P-T duct for MFL test verification (span 98, tendon 98-5c)

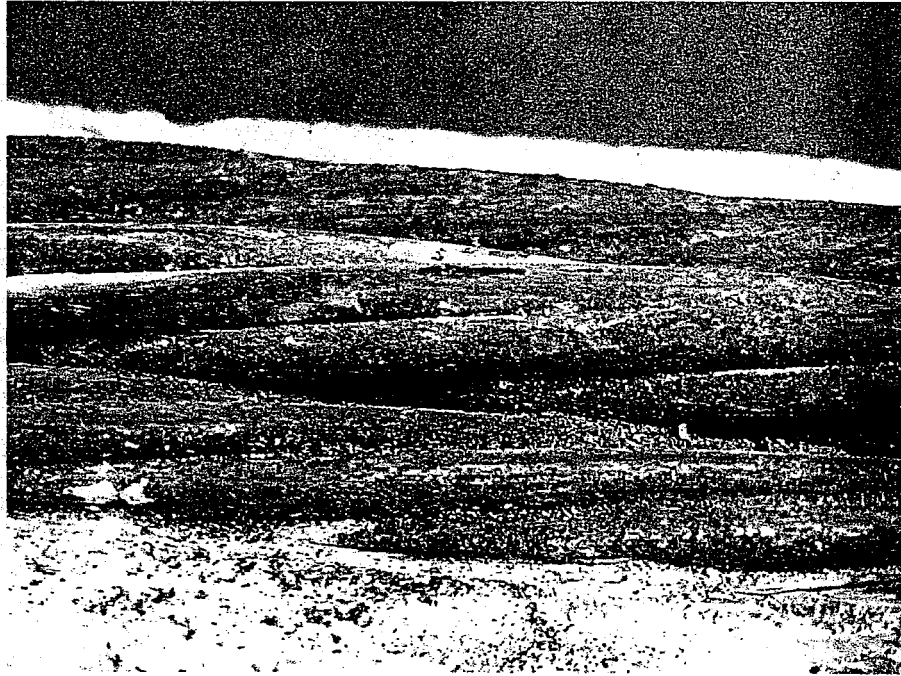
Figure 17 – Close up photograph of the corroded tendon at the 10.5 feet location (span 98, tendon 98-5c)

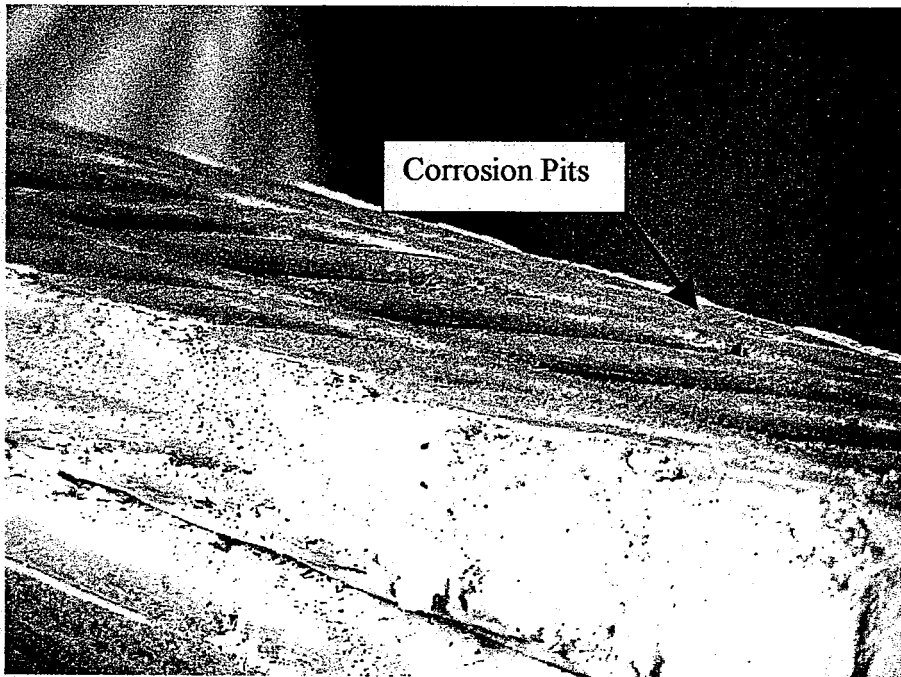
Figure 18 – Close up photograph of the corroded tendon cleaned with a wire brush (span 98, tendon 98-5c)
