1. Report No. WPI No. 0510837	2. Government Accession No.	3. Recipient's Catalog No.	
4. Title and Subtitle <b>STUDY OF BREAK-AWAY SIGN BASE CONNECTIONS, II</b>		5. Report Date

9. Performing organization Name and Address <b>Florida Institute of Technology</b> 150 W. University Blvd. Melbourne, Florida 32901-6988		11. Contract or Grant No. BB-511

13. Type of Report and Period Covered Final Report- 10/14/97 to 8/7/99	
		14. Sponsoring Agency Code	
12. Sponsoring Agency Name and Address Florida Department of Transportation 605 Suwannee Street Tallahassee, FL 32399-0450

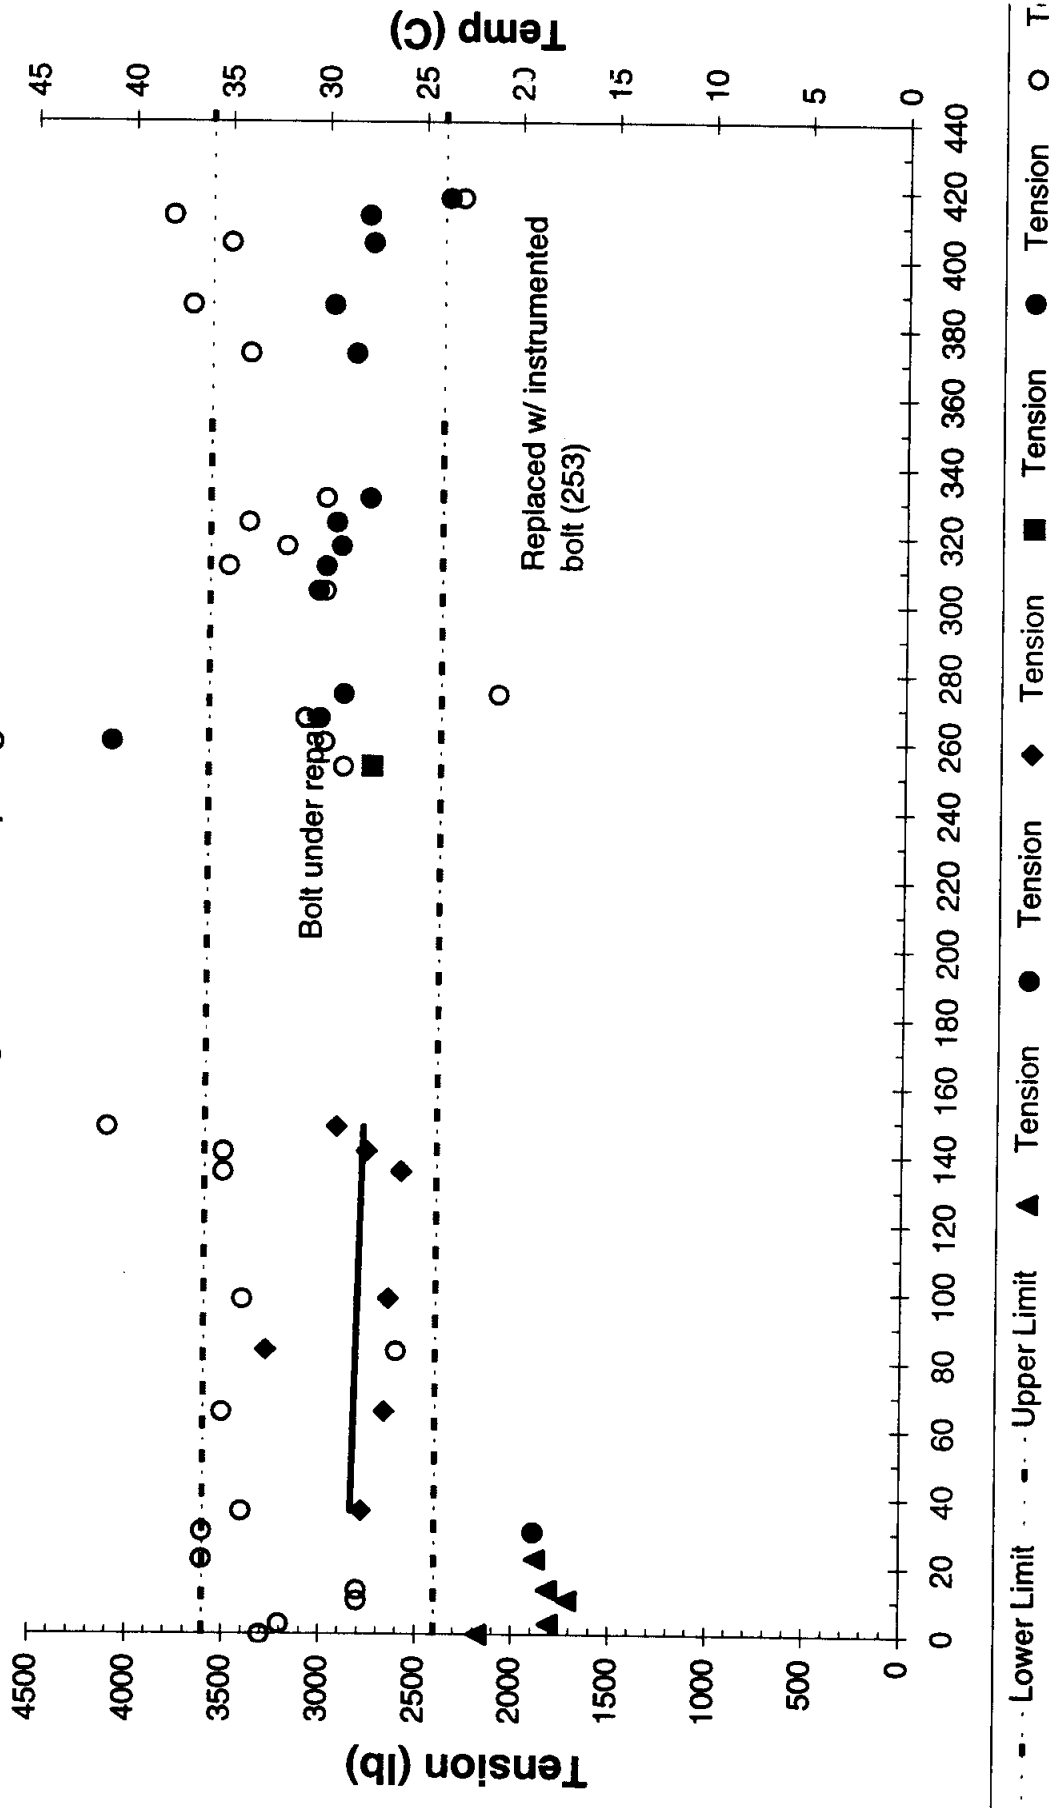
Figure 27 Tension vs Time, Tampa Sign, Bolt with Spring Washers

After the initial installation, the bolt with spring washers show readings were below the lower limit of 2400 lb. The right gage readings also registered negative strains. We suspected a

defective spring washer stack so the bolt was re-torqued on June 10 with a new spring washer stack.

The left wire was cut from the bolt head on October 23. The bolt was not replaced until February 2, 1999. One of the reasons why the bolt was not replaced for almost two months was that a FDOT crew was needed to assist in lifting the sign off the base. We also decided to focus on the other signs' bolts because most of them were damaged at that time.

The bolt was replaced on February 2, 1999 and the reading that day was in the acceptable range at 2755 lb. The reading increased to 4093 lb. the week after, on February 8. To date, the readings have kept within the acceptable range.

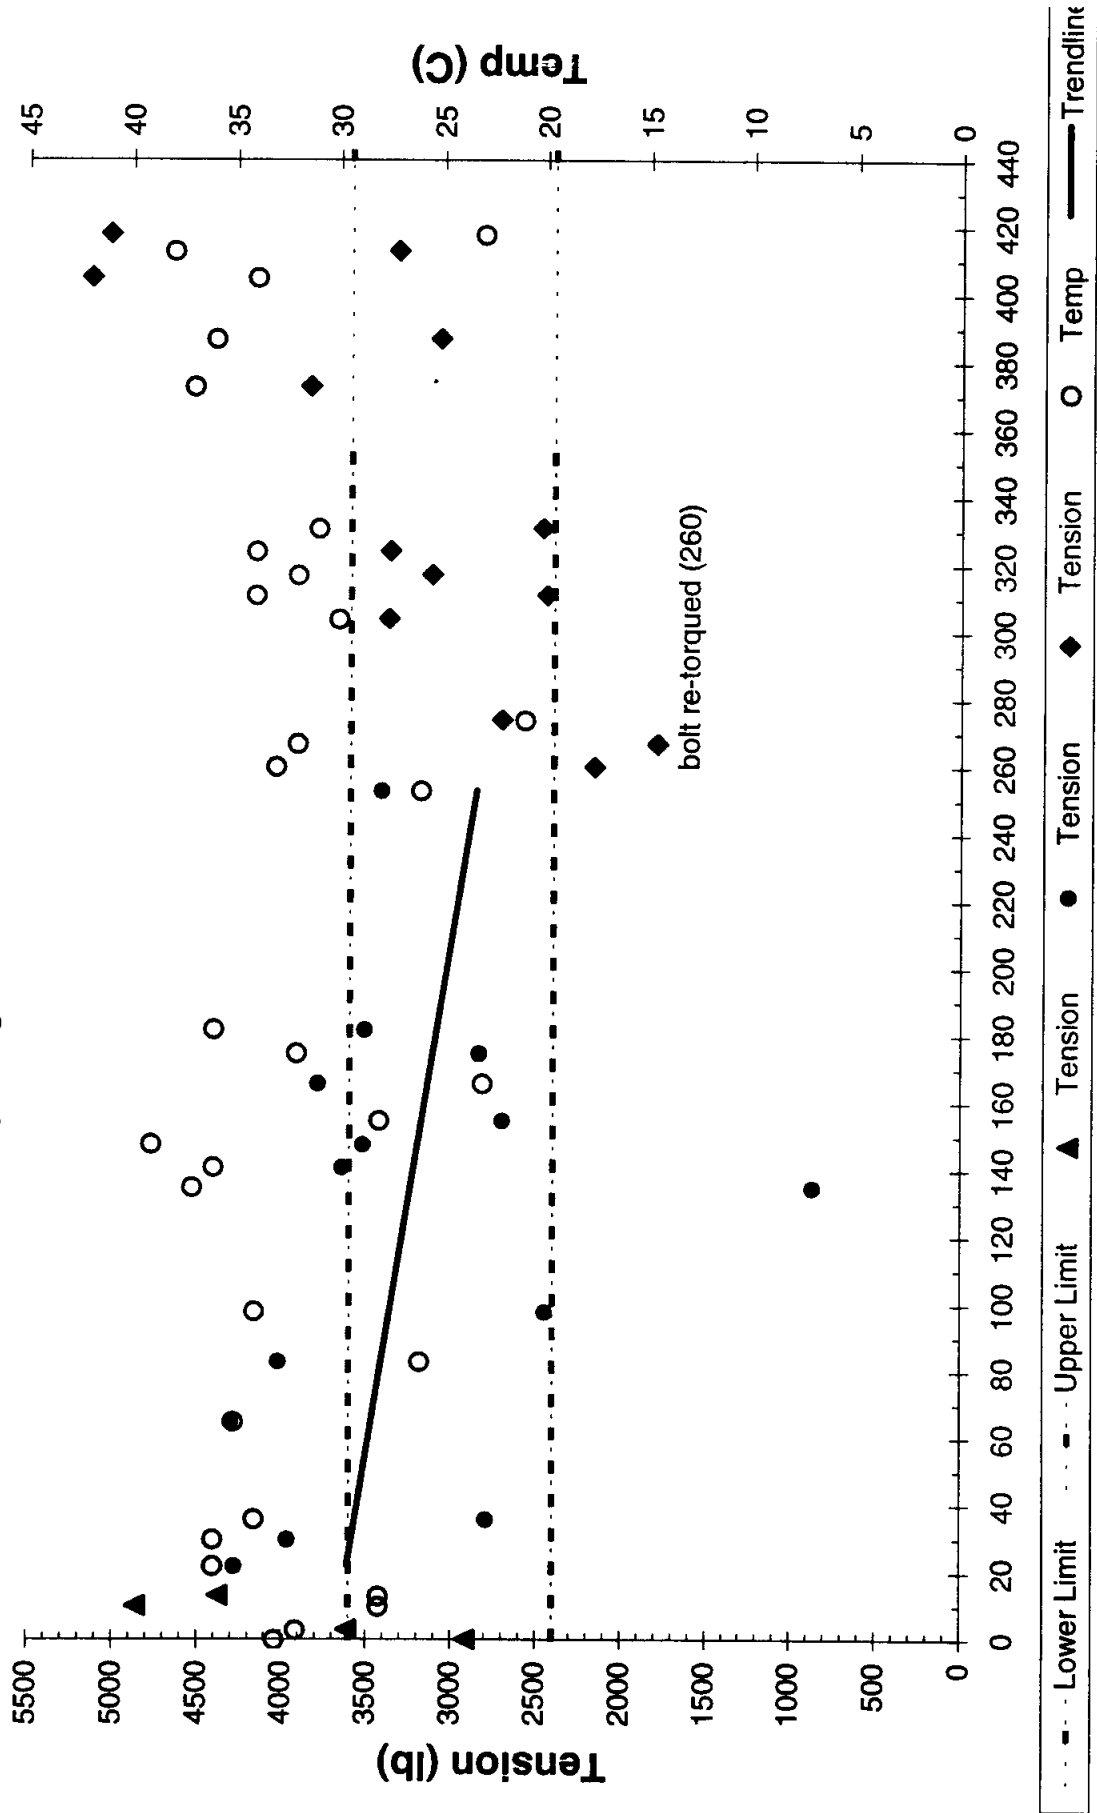
**Days**  
Figure 28 Tension vs Time, Tampa Sign, Bolt with Flat Washers

The bolt with flat washers was also installed on May 18, 1998. The tension readings on that day and on May 21 were 2915 lb. and 3613 lb. respectively. The tension readings increased to 4856 lb. and 4375 lb. on May 28 and June 1. The bolt was brought back to the lab to be re-tested and was re-installed on June 10. From June 18, 1998 to July 3, 1999 the tension readings were mostly in the acceptable range. The reading on October 3, 1998 was 865 lb. but this unusual reading was performed by a new research assistant and it could be disregarded. At the end of July, the gage was probably damaged and behaved erratically.

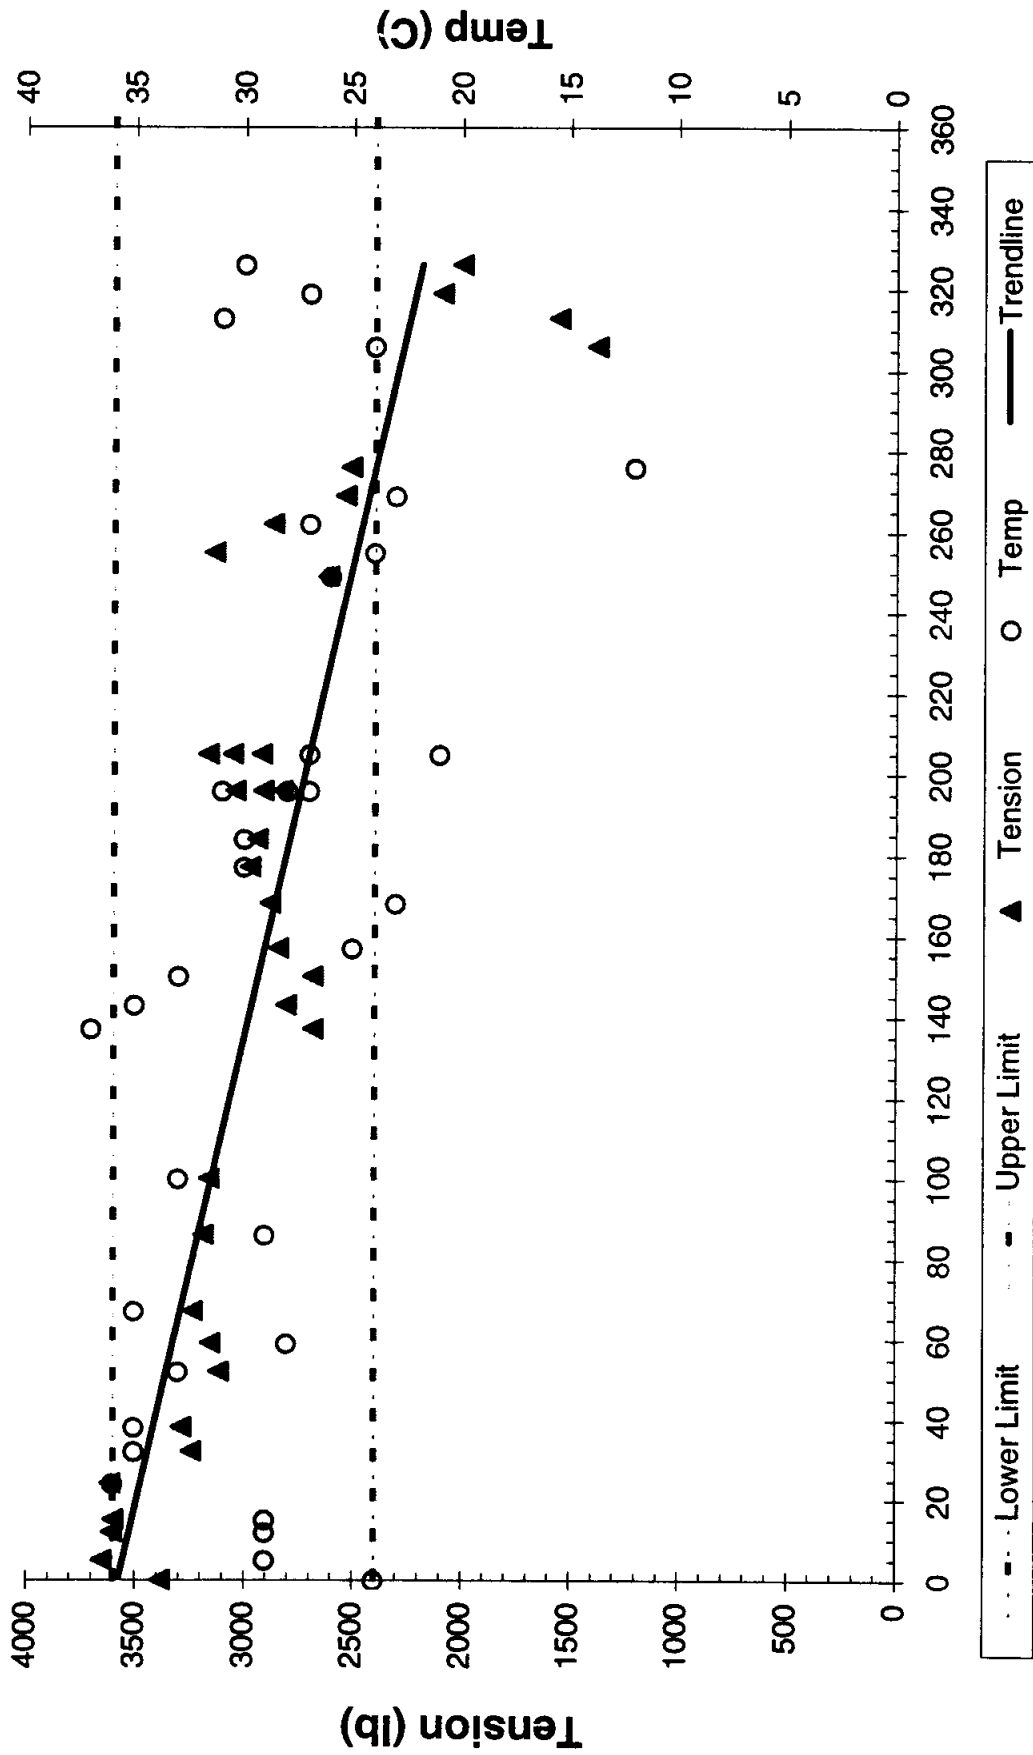
Figure 30 Tension vs Time, Orlando Sign, Bolt with Spring Washers

The bolt with strain gages was never replaced and the bolt was re-torqued. The spring washers were able to keep the tension within the acceptable range from May 16, 1998 to February 22, 1999. After that date, the readings were below the allowable range. On April 12, the bolt was removed. A tensile test in the lab yielded a value of 27,117 ksi for the modulus of elasticity, slightly below the expected value of 29,000 ksi, which might indicate a deterioration of the strain gage.

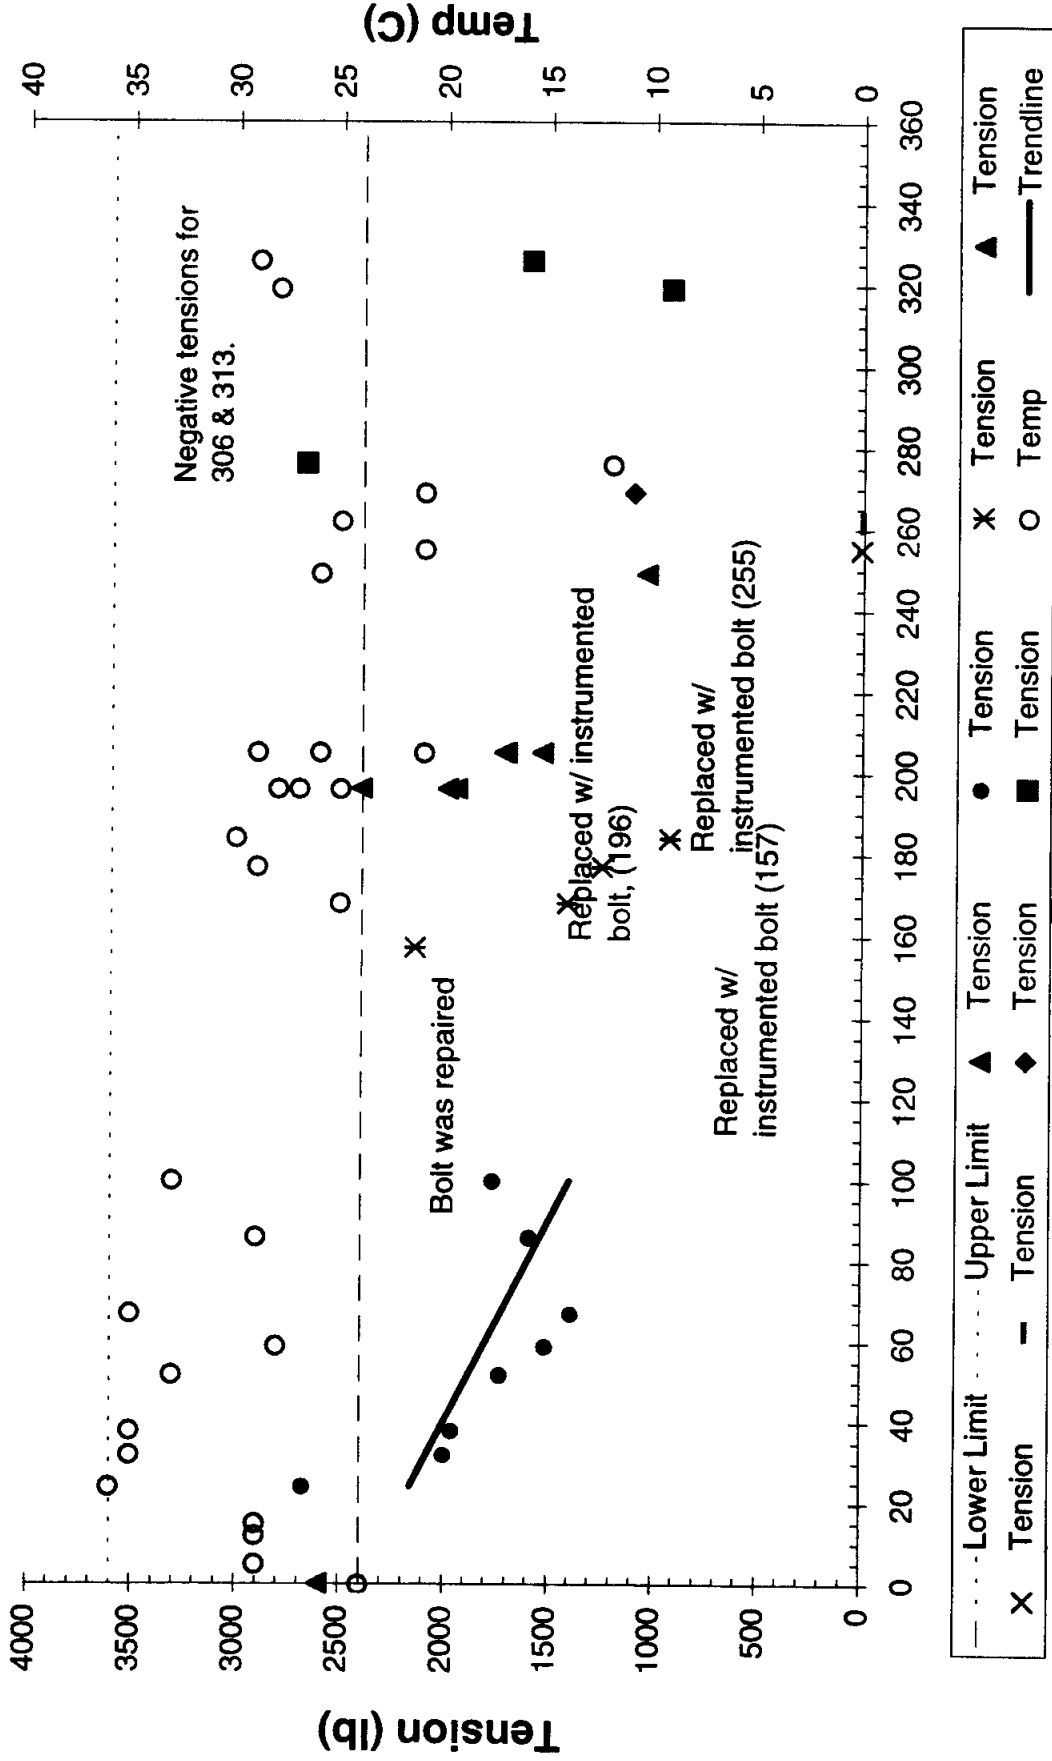
Figure 31 Tension vs Time, Orlando Sign, Bolt with Flat Washers

The bolt was re-installed and re-aligned on February 1, 1999. One can notice that one of the strain readings was always negative for most of the readings. This meant that the bolt was not aligned properly and as a result, the bolt was subjected to bending. This is the reason for the re-torquing of the bolt on February 8, 15, and 22. The bolt was finally removed and brought back to the lab. A tensile test revealed a modulus of elasticity of 36,047 ksi, a 33% increase over the value measured in January. This indicates a defect in the strain gage, probably in the bond between gage and bolt. This defect explains partially the erratic behavior of the bolt during the last weeks of testing.

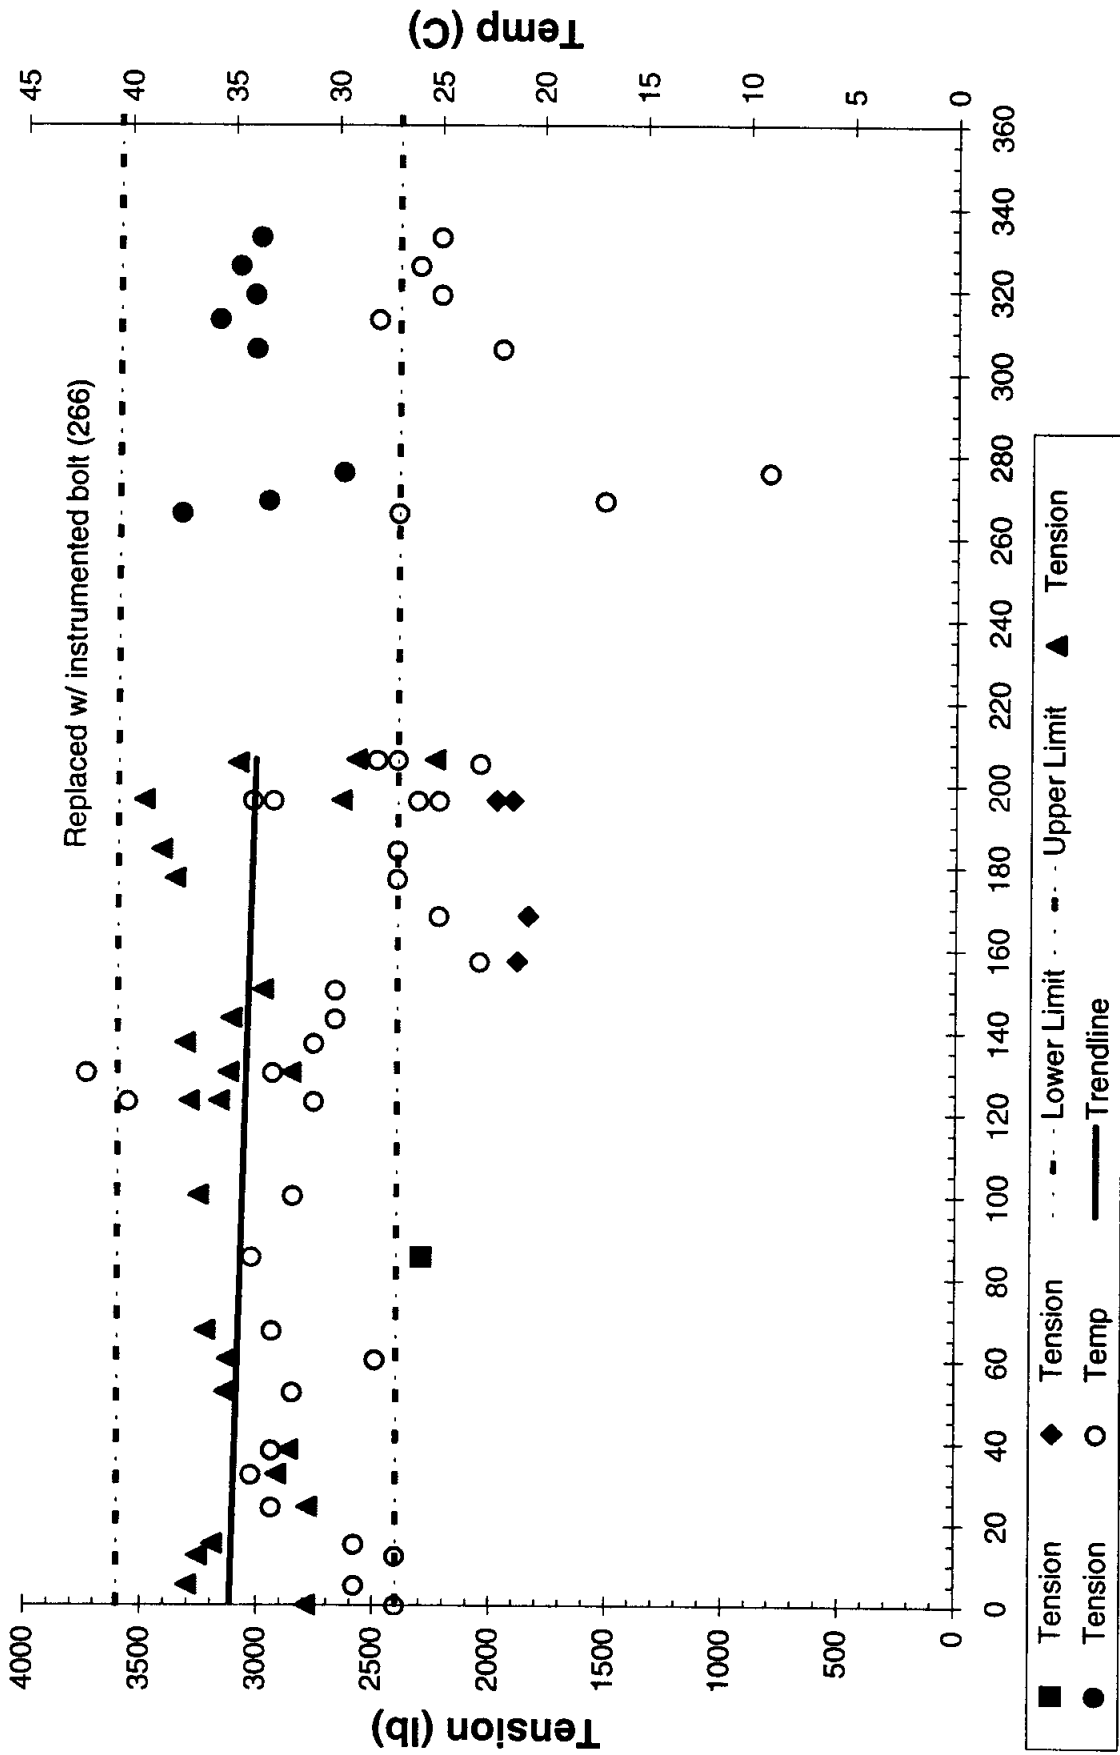
Figure 33 Tension vs Time, Brevard (2) Sign, Bolt with Spring Washers

The spring washers were able to hold the tension within the acceptable range from May 16, 1998 through November 20, 1998 except for two days: October 23 at 1883 lb. and November 4 at 1838 lb. These readings might have been affected by the drop in temperature in those days.

Consequently, multiple readings were done for two days to test whether the temperature had any effects on the strain gages. The readings taken on those two days, December 2 and 11, seemed to indicate that the tension varied with the temperature. However, temperature tests performed in the lab indicated that the temperature should have no effect on the strain gages. Thus, it was concluded that the gages or the adhesive might have some defects. The bolt was removed and brought back to be re-instrumented on January 25, 1999.

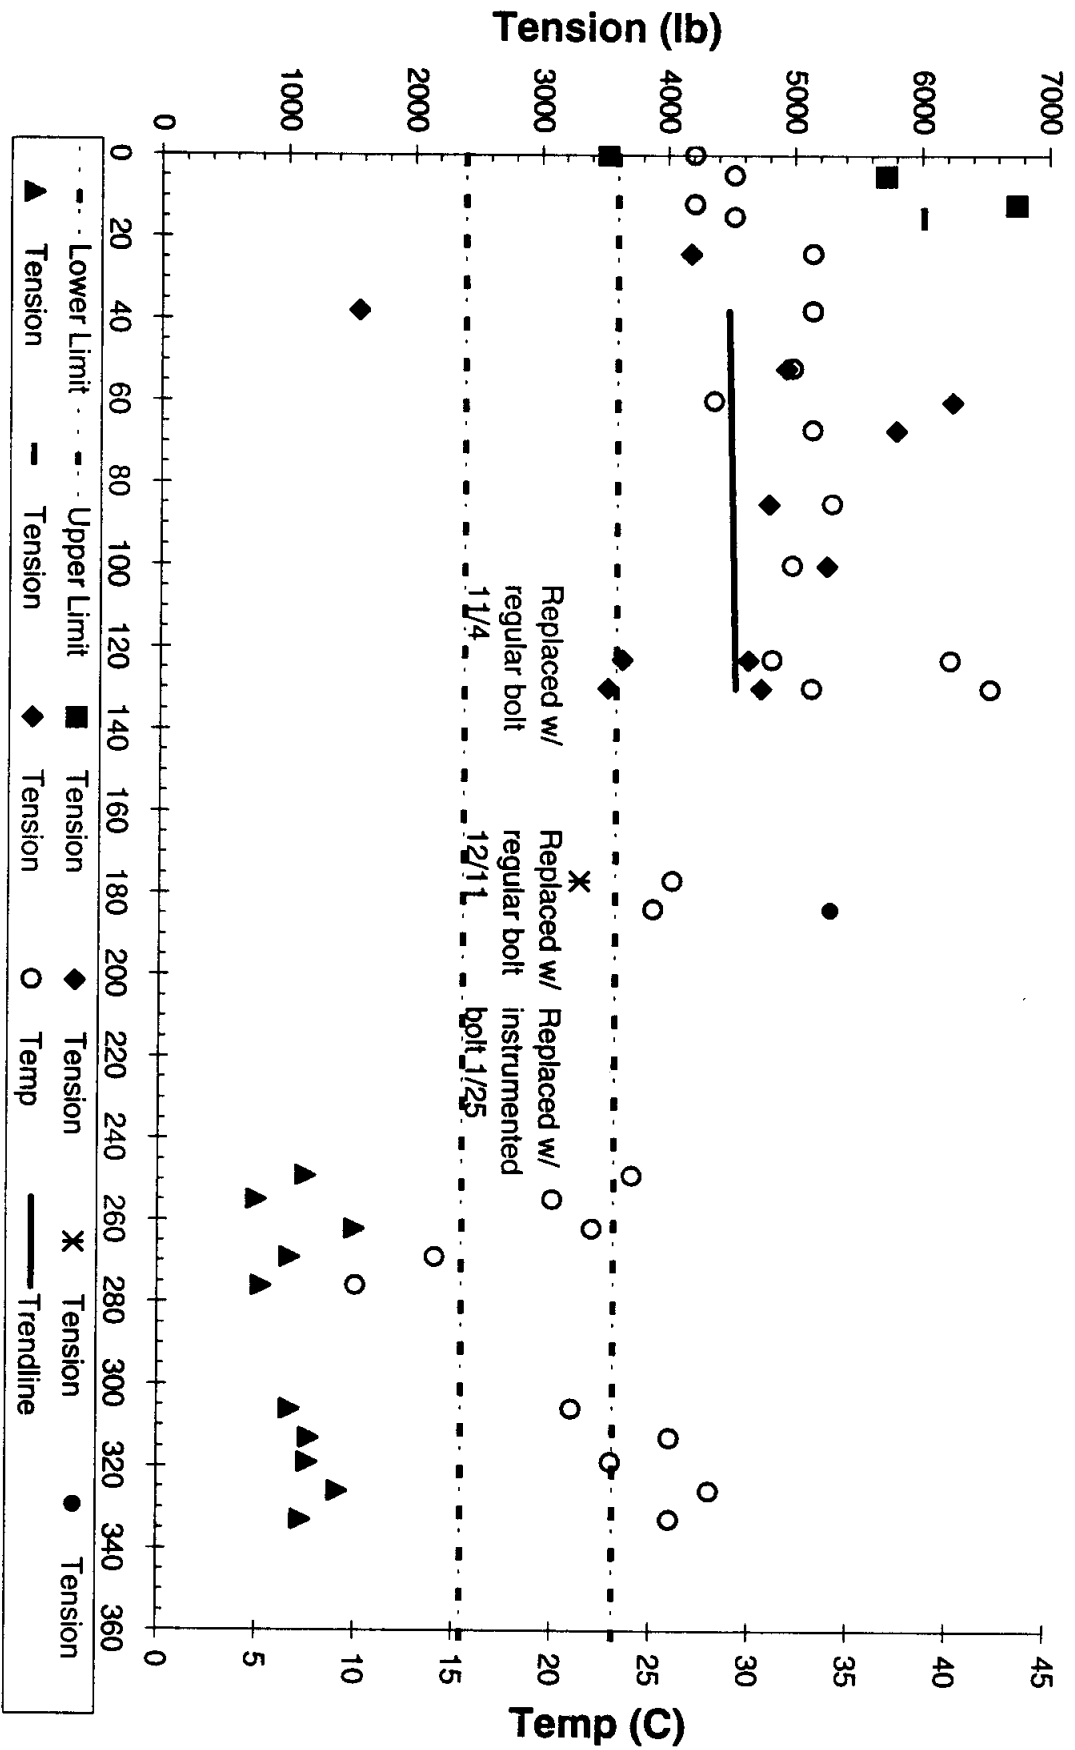
Figure 34 Tension vs Time, Brevard (2) Sign, Bolt with Flat Washers

From October 3 to October 23, 1998, the right gage registered an infinite resistance on the Strain Gage Tester which meant that it was disconnected. The bolt was removed on November 3 and was re-installed on November 13 with a measured modulus of elasticity of 28,112 ksi. After that date, the readings increased dramatically to 11060 lb. and 26565 lb. on December 2, 1998. The bolt was replaced and re-installed on January 25, 1999 with a modulus of elasticity of 28,112 ksi. The reading on that day was low at 1165 lb. The following reading on February 1 was even lower at 777 lb. The bolt was re-torqued using a new torque wrench on February 8. The readings have been decreasing until April 19, 1999, when the readings were discontinued. A tensile test in the lab showed a value of 28,115 ksi for the modulus of elasticity, with no change from the value measured before installation in the field. The gage was then judged to be sound.

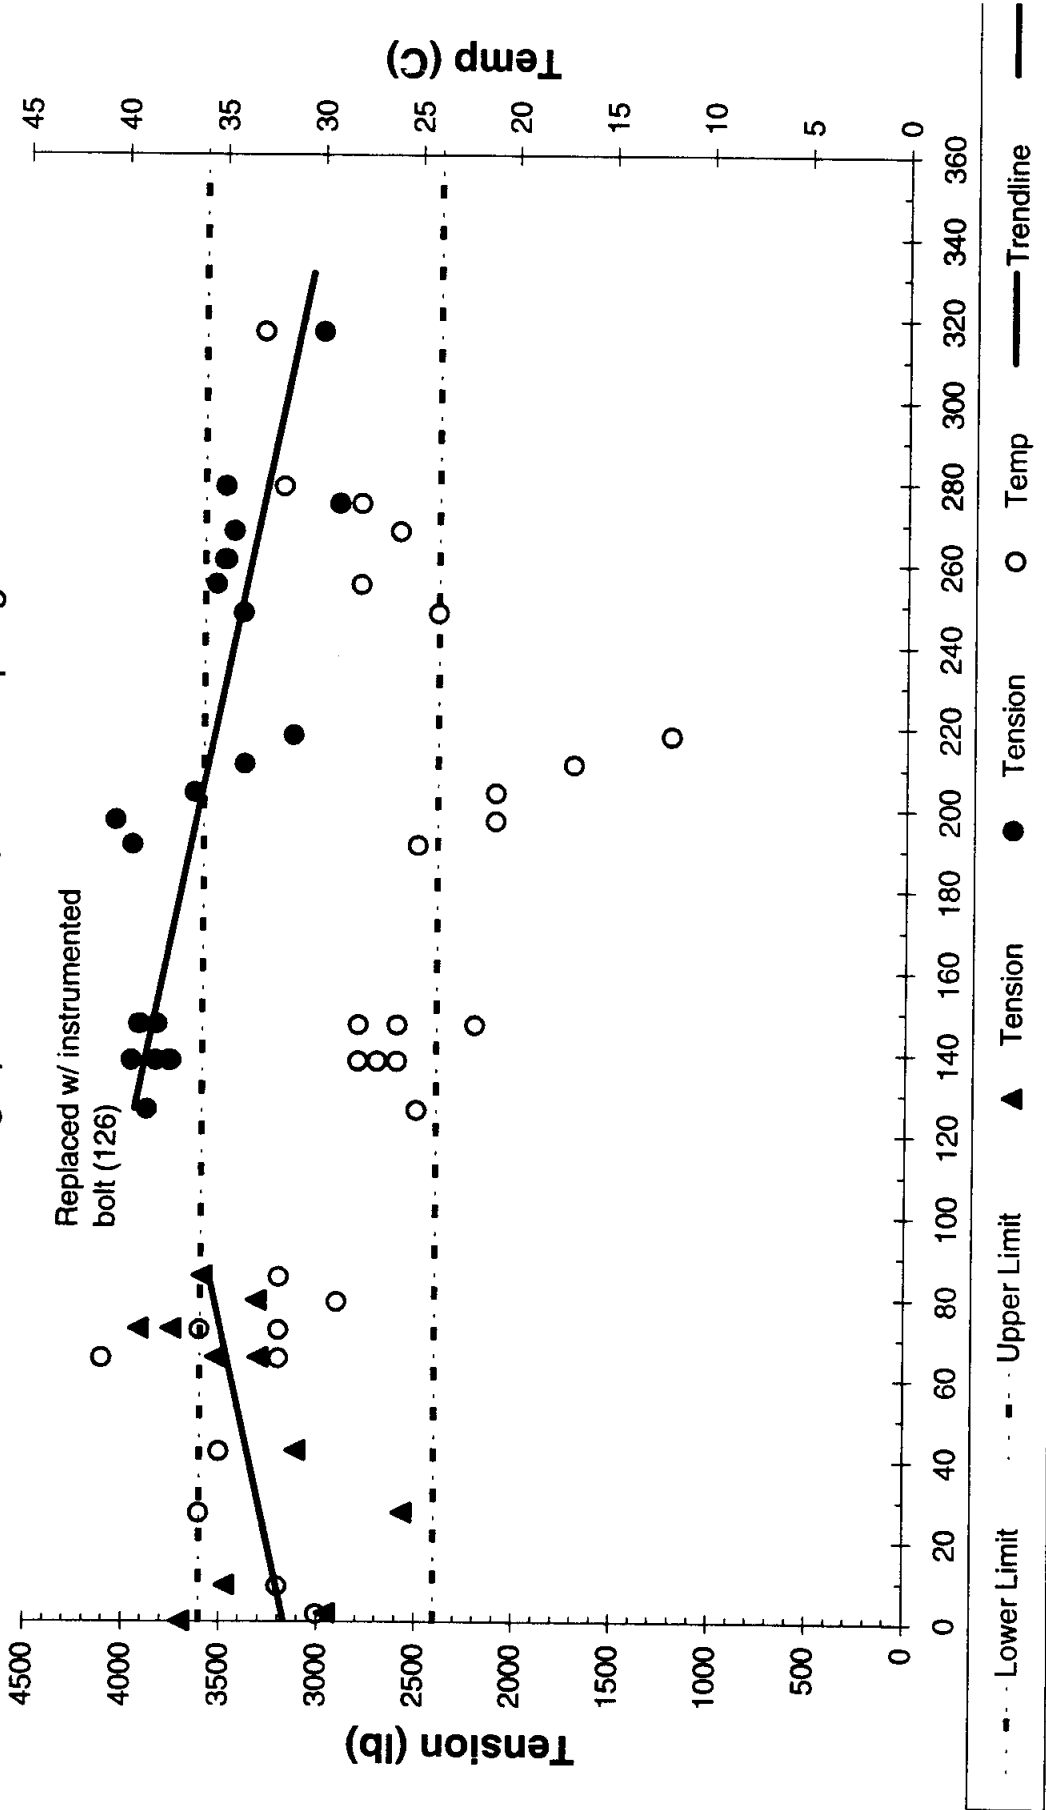
Figure 36 Tension vs Time, Brevard (1) Sign, Bolt with Spring Washers

The bolt with spring washers remained in the acceptable range from July 1998 to November 1998 except for one day: September 26 at 3915 lb. and 3749 lb.

The bolt was replaced on November 4, 1998 because the right strain gage became loose. The newly re-instrumented bolt was re-installed on November 20, 1998 along with a new spring washer stack. After that date, the readings were initially above the upper limit of 3600 lb. until February 15, 1999. From then on, the readings were in the allowable range. On June 15, 1999, the wires were found cut. Therefore the readings were interrupted.

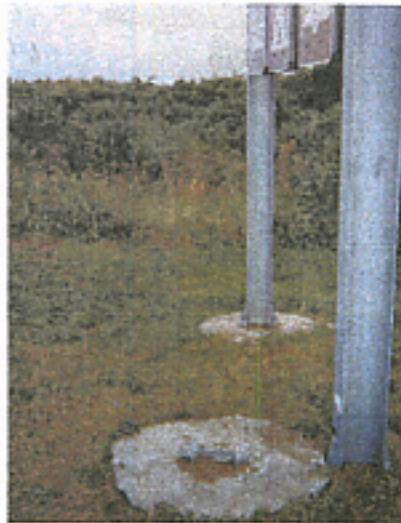
Figure 39 Sebastian Sign after it was hit by a car, 1<sup>st</sup> view

The post with the bolt with spring washers was found dislodged on December 9, 1998. It was hit by a car and the base connection of the post broke away. Neither the bolts nor the spring washers were damaged and they were found scattered on the ground. Figures 39 and 40 show

the sign after it was hit by a car. This event, totally unexpected, provided a clear demonstration of the effectiveness of the spring washers. The post separated neatly from the base and as far as we know, no major damage was reported for the car. The sign was re-installed afterwards and since then, the readings were initially within the acceptable range. However the last readings are not reliable, because the bolt was not galvanized. The bolt deteriorated very quickly, and became completely corroded.

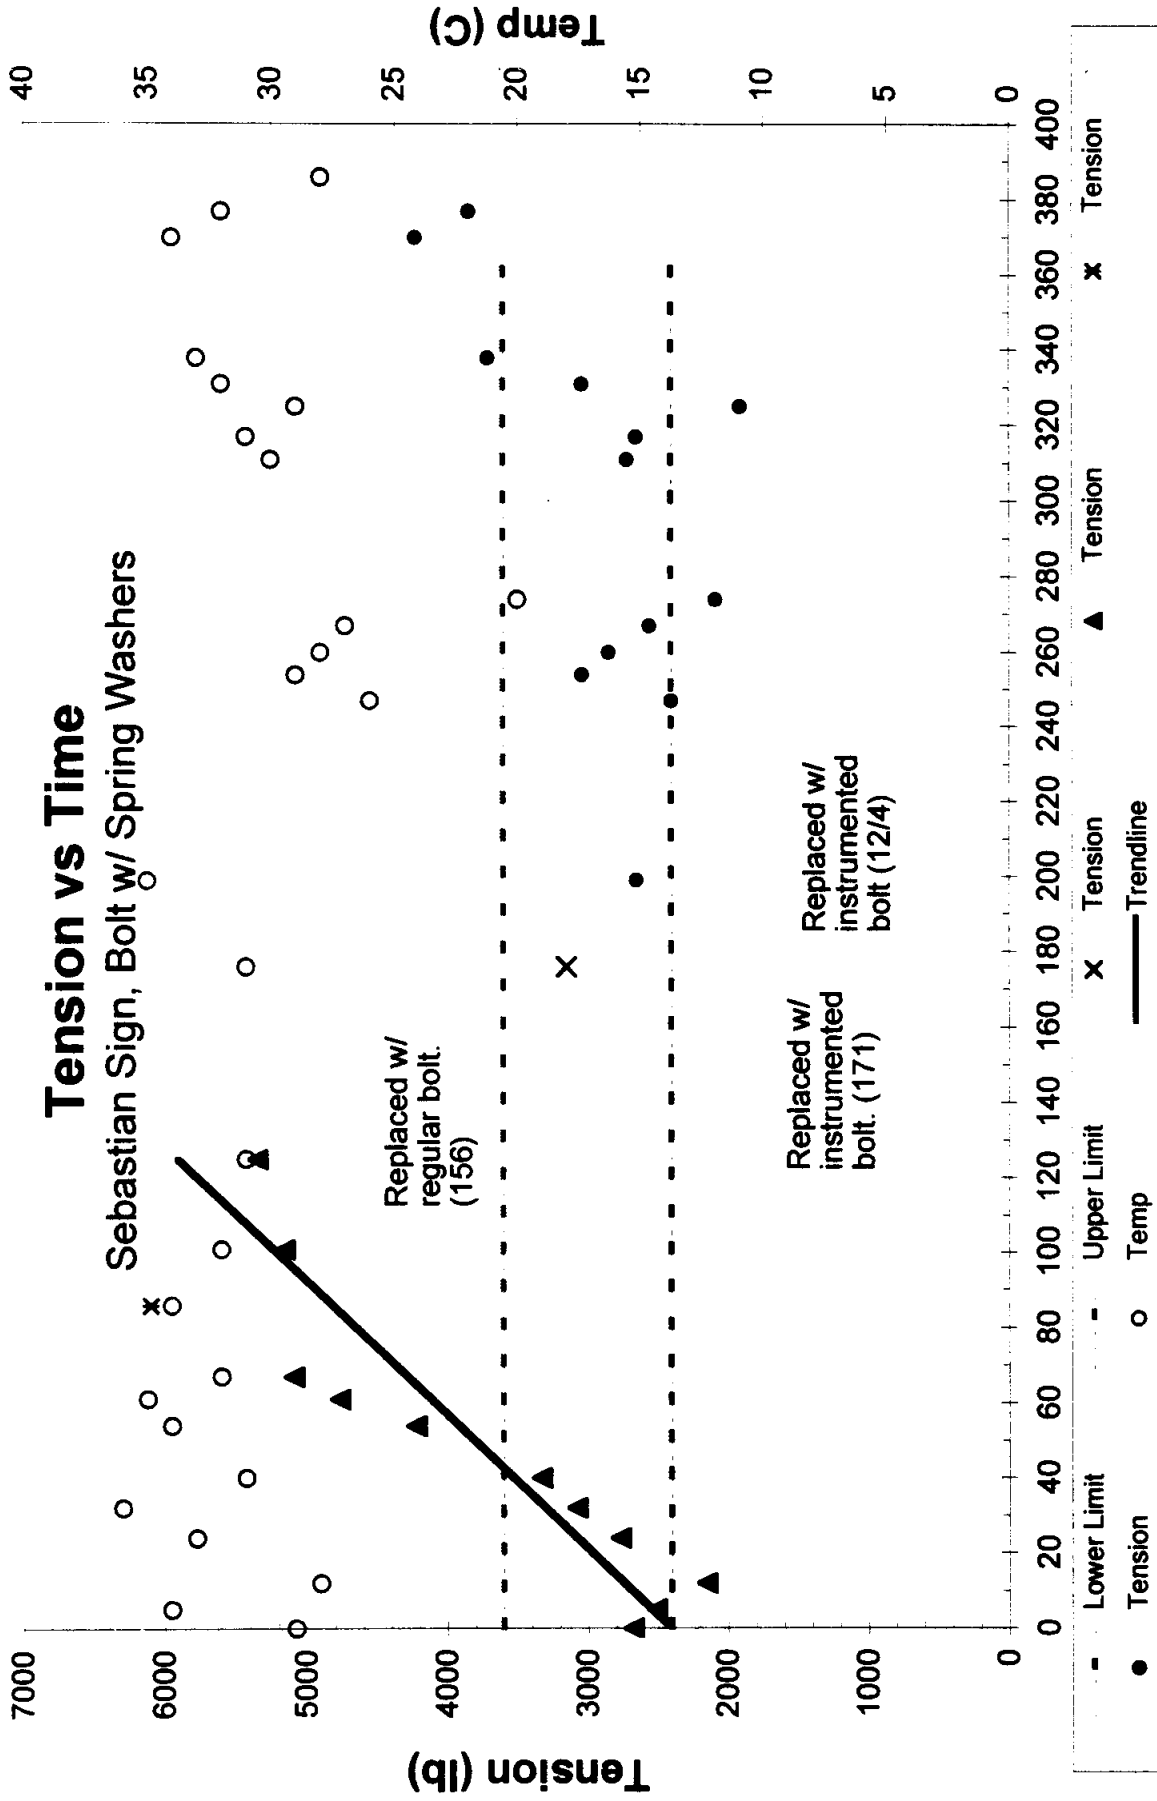
**Days**  
Figure 41 Tension vs Time, Sebastian Inlet Sign, Bolt with Spring Washers

The Sebastian Inlet bolt with spring washers was able to maintain the tension within the acceptable range until June 25 with only one reading dipping below the lower limit; on May 27, 1998 at 2146 lb. After that date the tension readings until September 20 were above the upper limit, peaking at 6098 lb. on August 11, 1998.

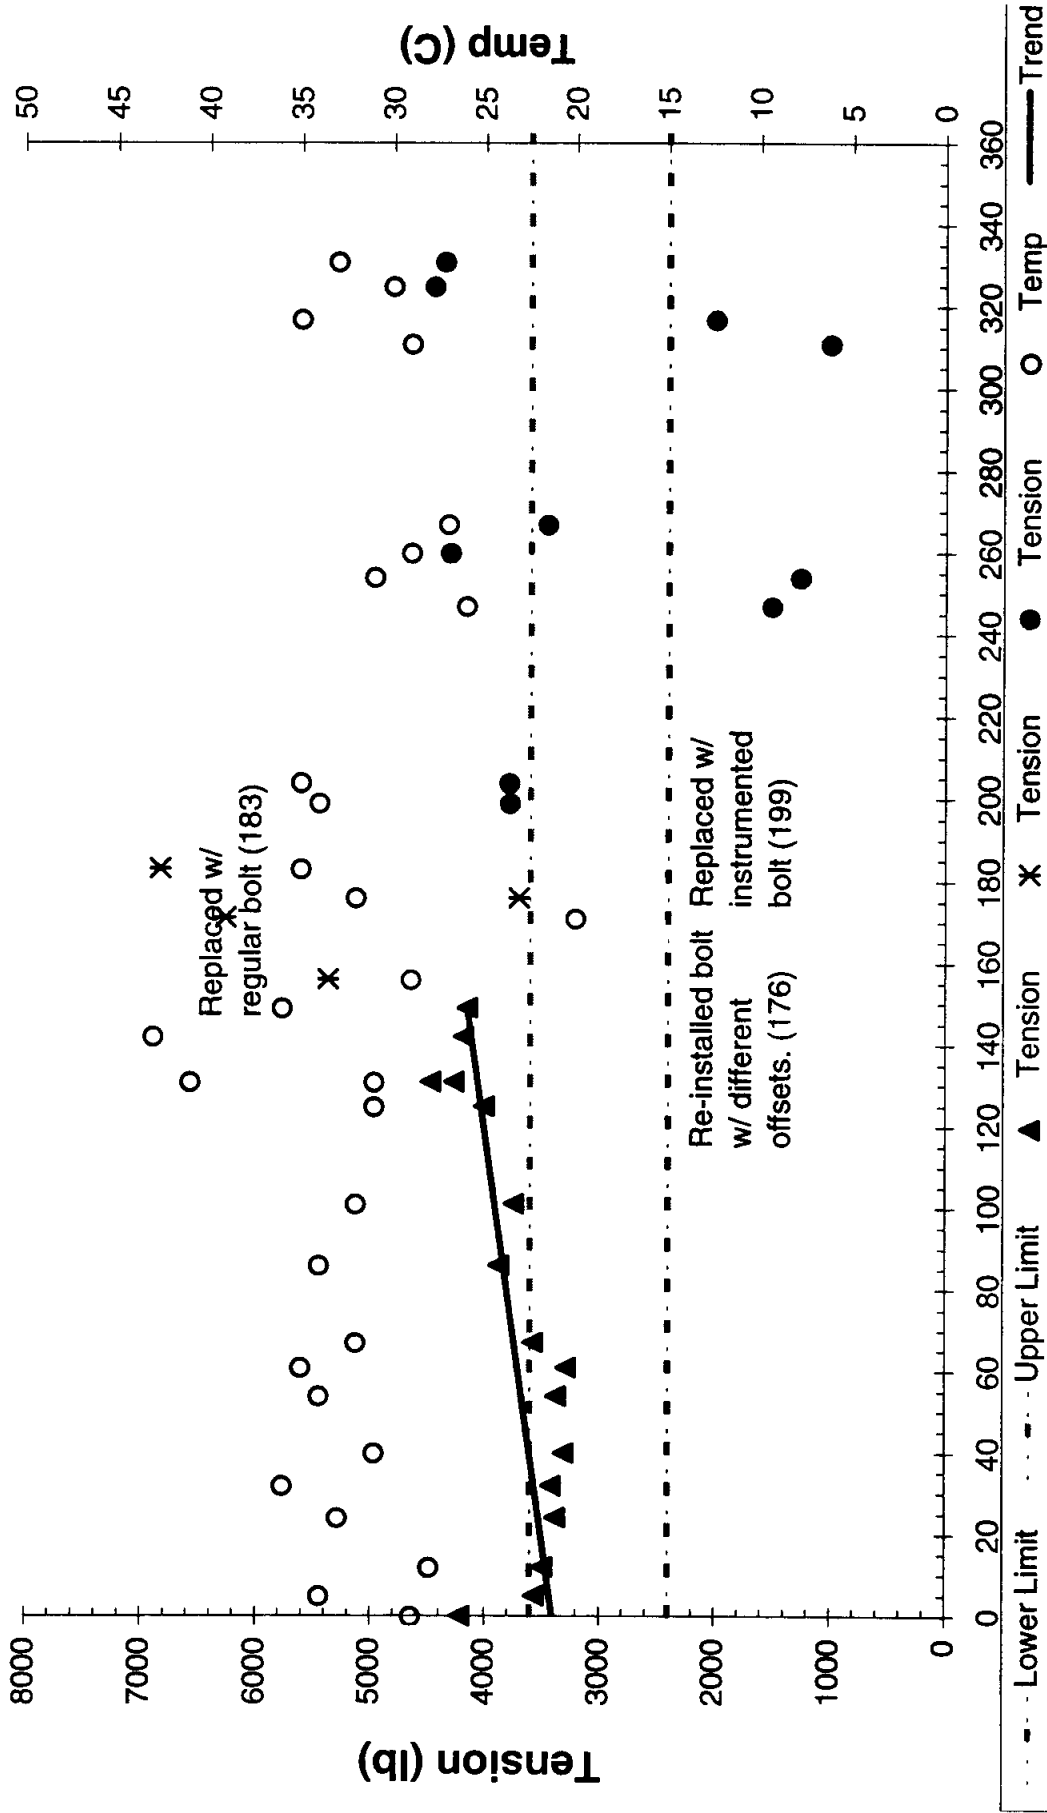
Figure 42 Tension vs Time, Sebastian Inlet Sign, Bolt with Flat Washers

The bolt with flat washers was able to maintain the tension within the acceptable range until July 22. From September 11 to November 6, the readings were above 3600 lb. and the bolt started to
