**FINAL REPORT**

**ON SITE EVALUATION OF  
BRIDGE DECK EXPANSION JOINTS**

**FLORIDA DEPARTMENT OF TRANSPORTATION  
STRUCTURES RESEARCH CENTER  
2007 EAST PAUL DIRAC DRIVE  
TALLAHASSEE, FLORIDA 32310**

**FEBRUARY 1996**

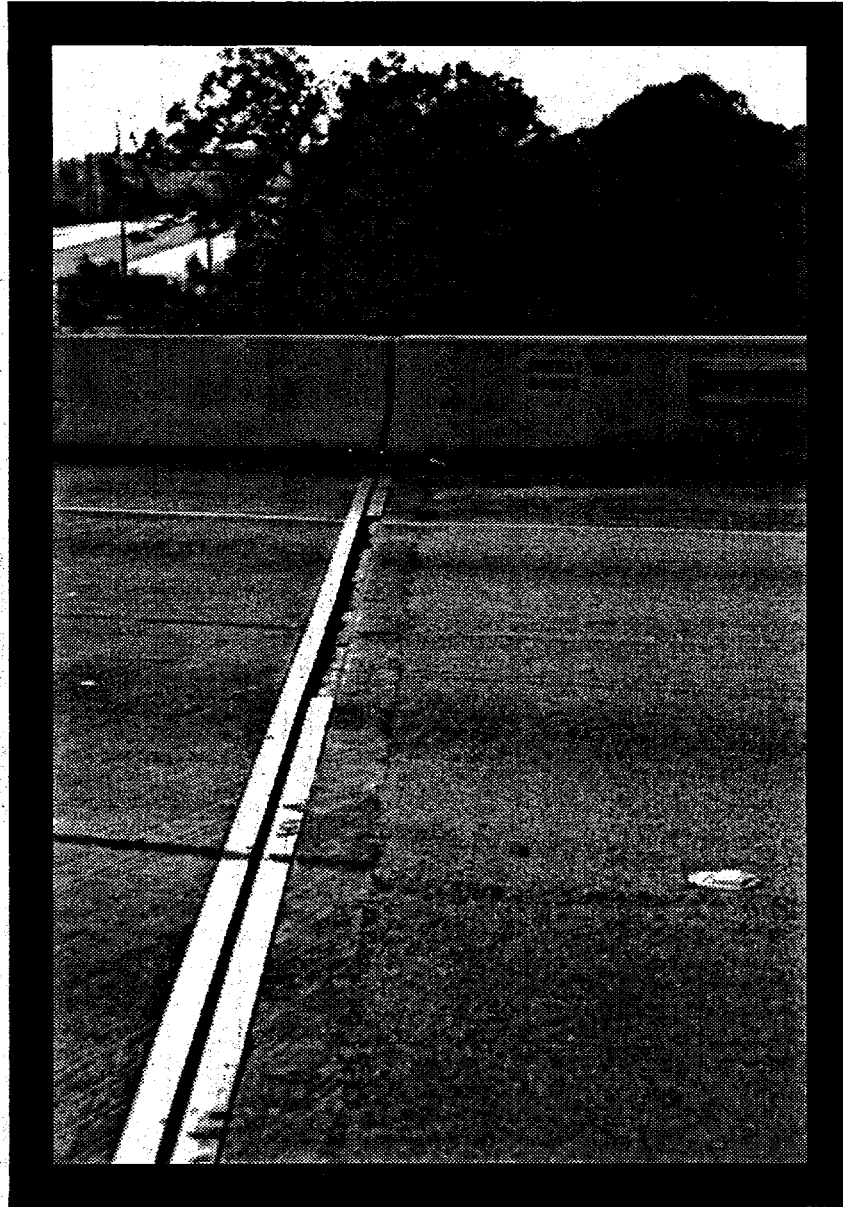
**Figure 1.**

In Florida, steel armored expansion joints with neoprene compression seals have been used frequently on bridges. While these systems function well at times, there are also performance problems associated with these designs. These problems include leaky seals, missing seals, displaced angles, and missing angles. Figure 1 shows an armored joint on I-95 with the steel angle missing and the concrete deck broken at the edge. Failures of this type are potentially very hazardous to a motorist.

**Problem Armored Joint on I-95:  
Missing Angle & Broken Concrete**

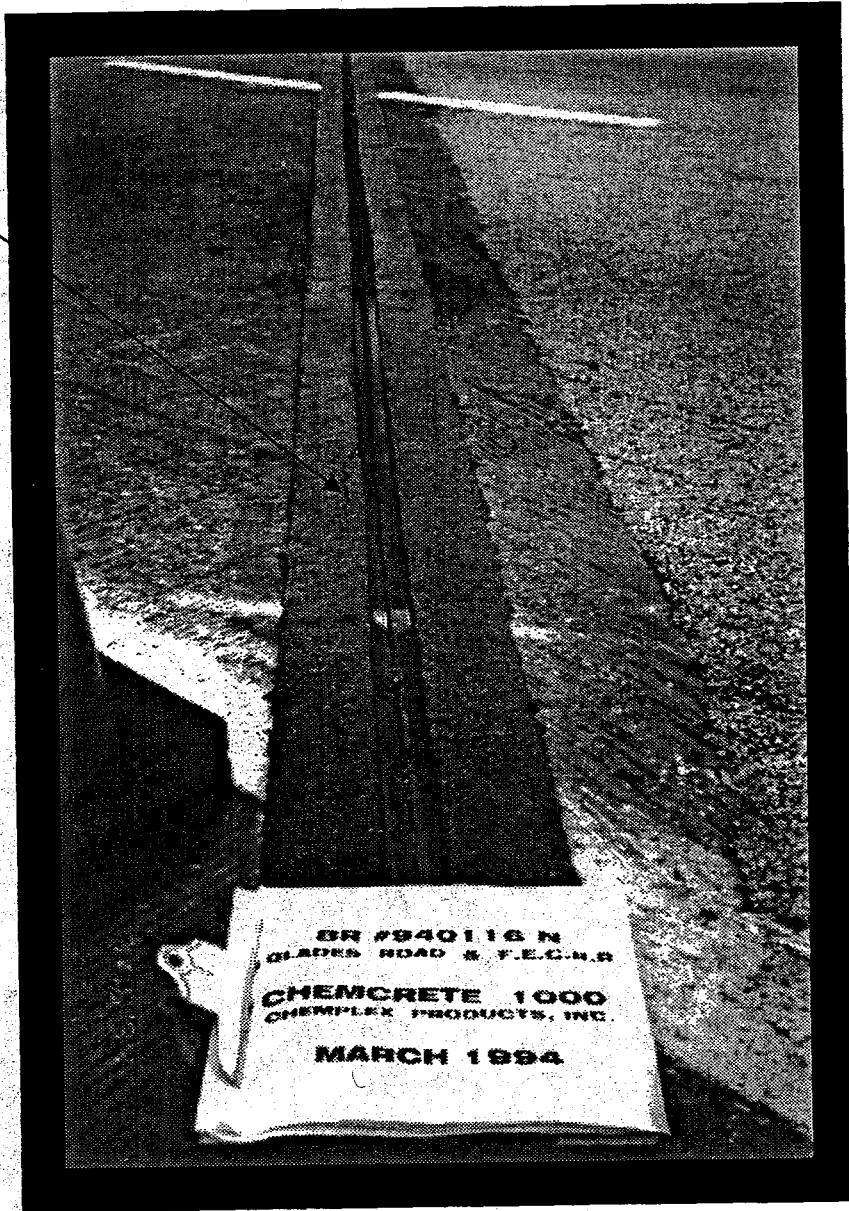
Figure 10

In August 1994, the cracks first noticed in March were longer. One crack was approximately 15" long and 1/16" wide. The other cracks were approximately 24" long and 1/32" wide. See Figure 10. In addition, two more cracks were visible, one in the middle traffic lane and one in the left traffic lane. Near the left wheel path of the center traffic lane, the crack was approximately eight inches long (8"). In the left traffic lane, a crack approximately twelve inches (12") long was in the right wheel path.

Crack

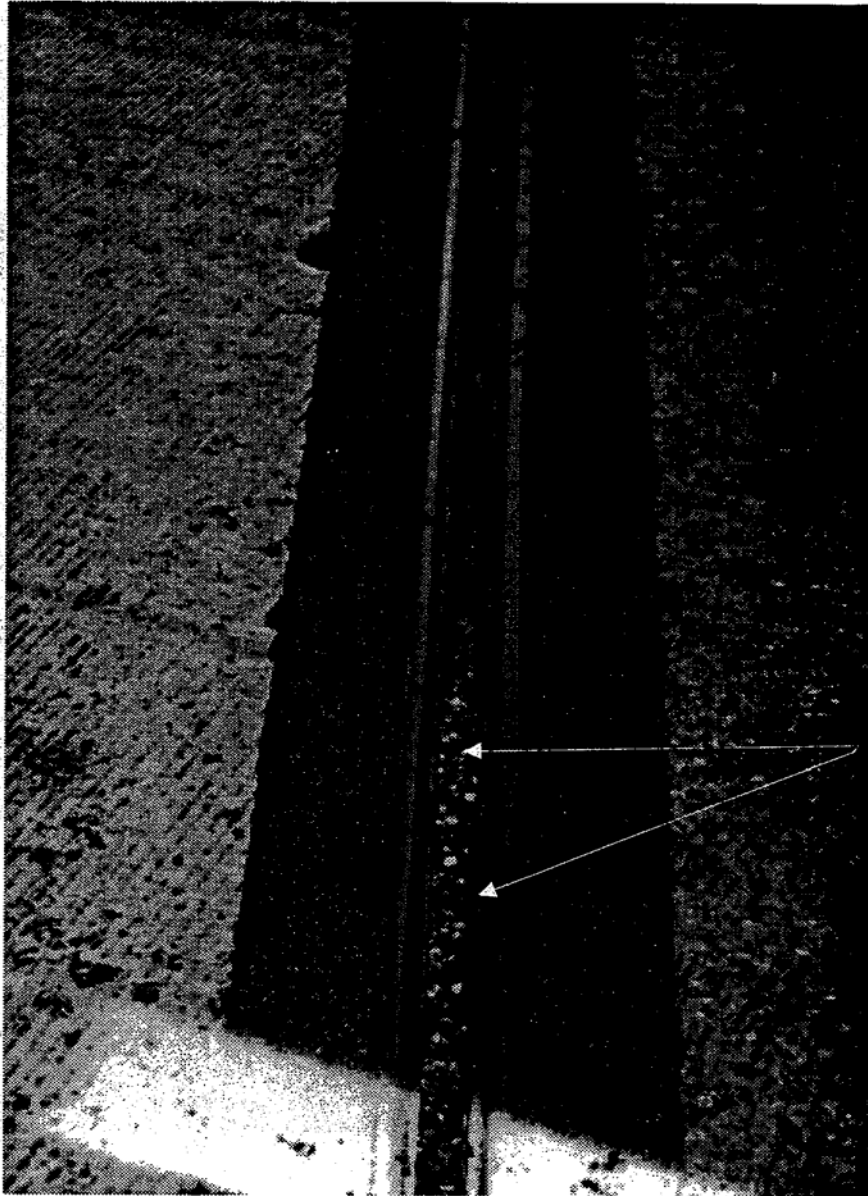
The joint nosing looked very good. However, debris was accumulating in the joint along most of its length. The joint opening was approximately two inches (2") . See Figure 21- 22.

Debris

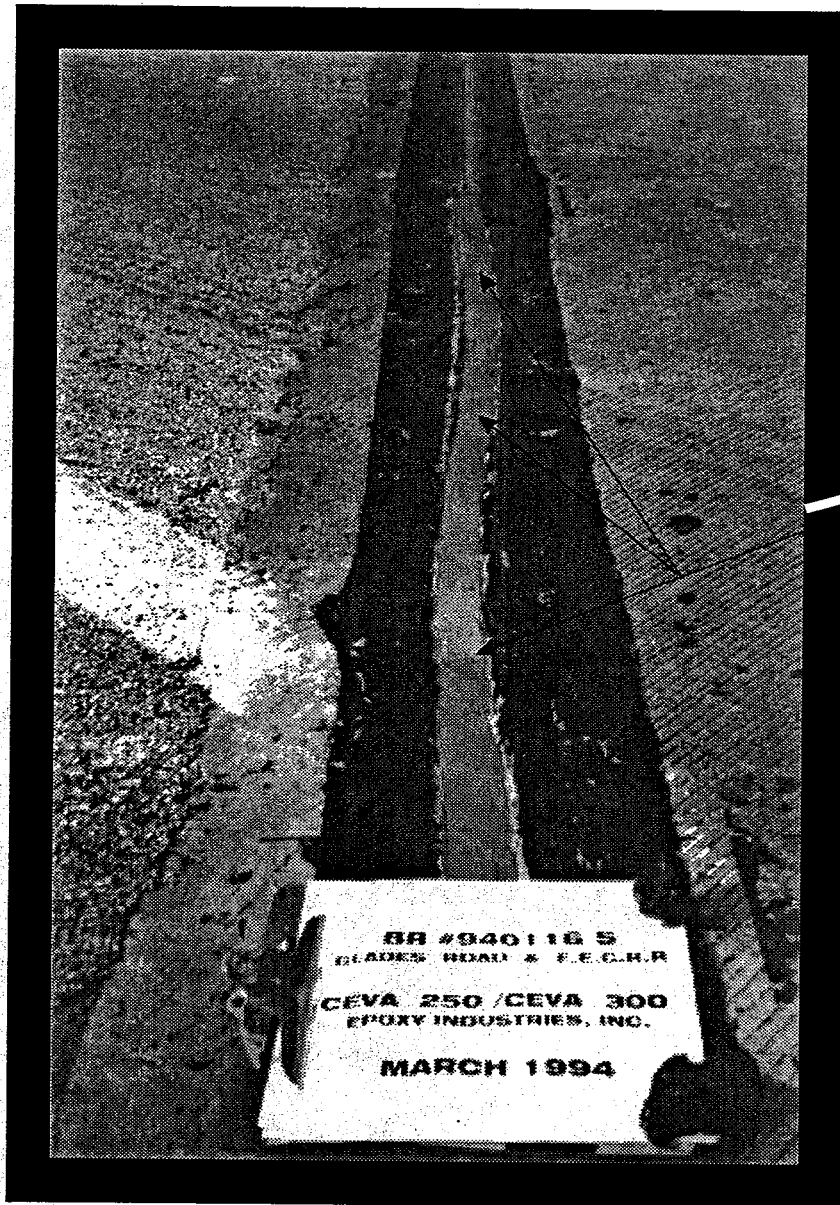
Figure 31

Problem  
Areas

Epoxy Industries: CEVA 250 Joint System  
(Problem Areas)

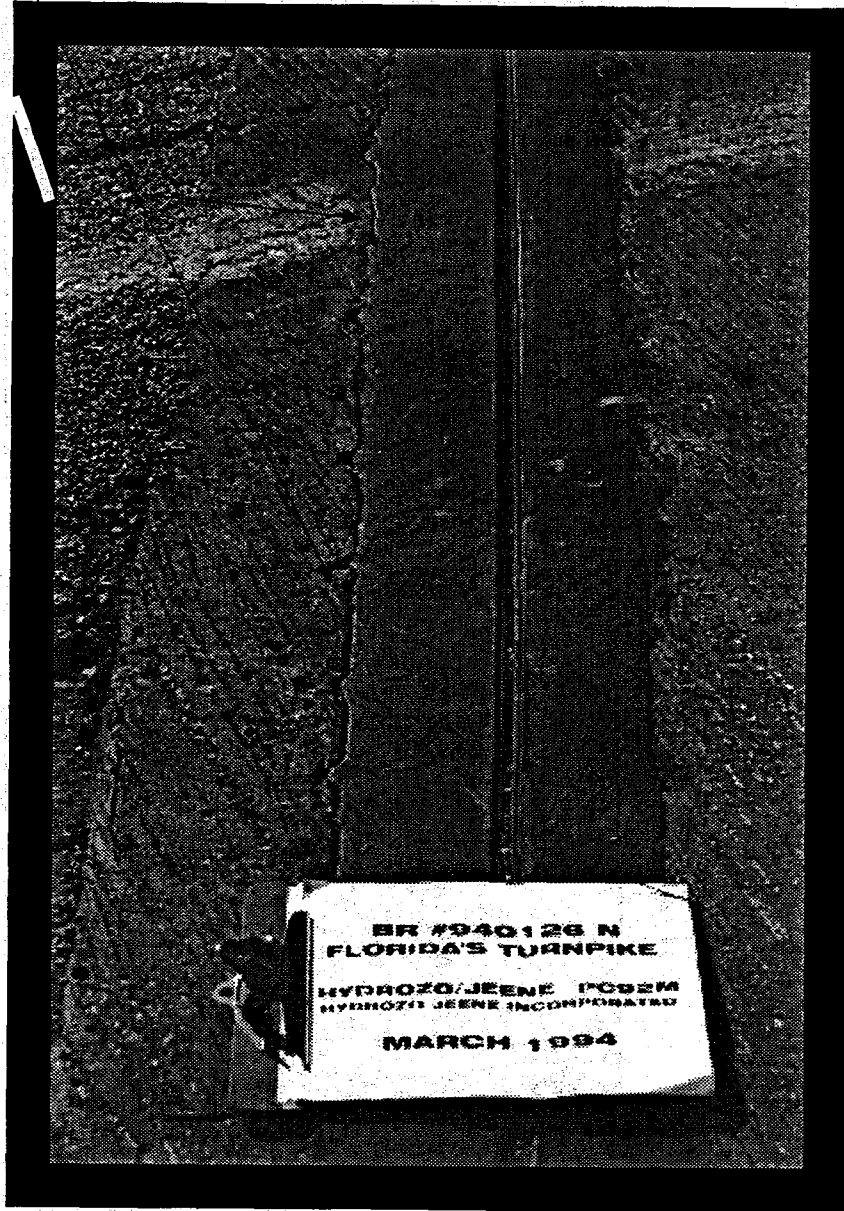
Figure 39

Due to the excessive separation of the nosing from the bridge deck, the joint failed. Since the November 1994 evaluation, bridge deck repair resulted in the removal of a portion the nosing. This was not critical since the joint was scheduled to be replaced. Although the nosing failed, the Jeene structural seal did very well. See Figure 40.

Separation

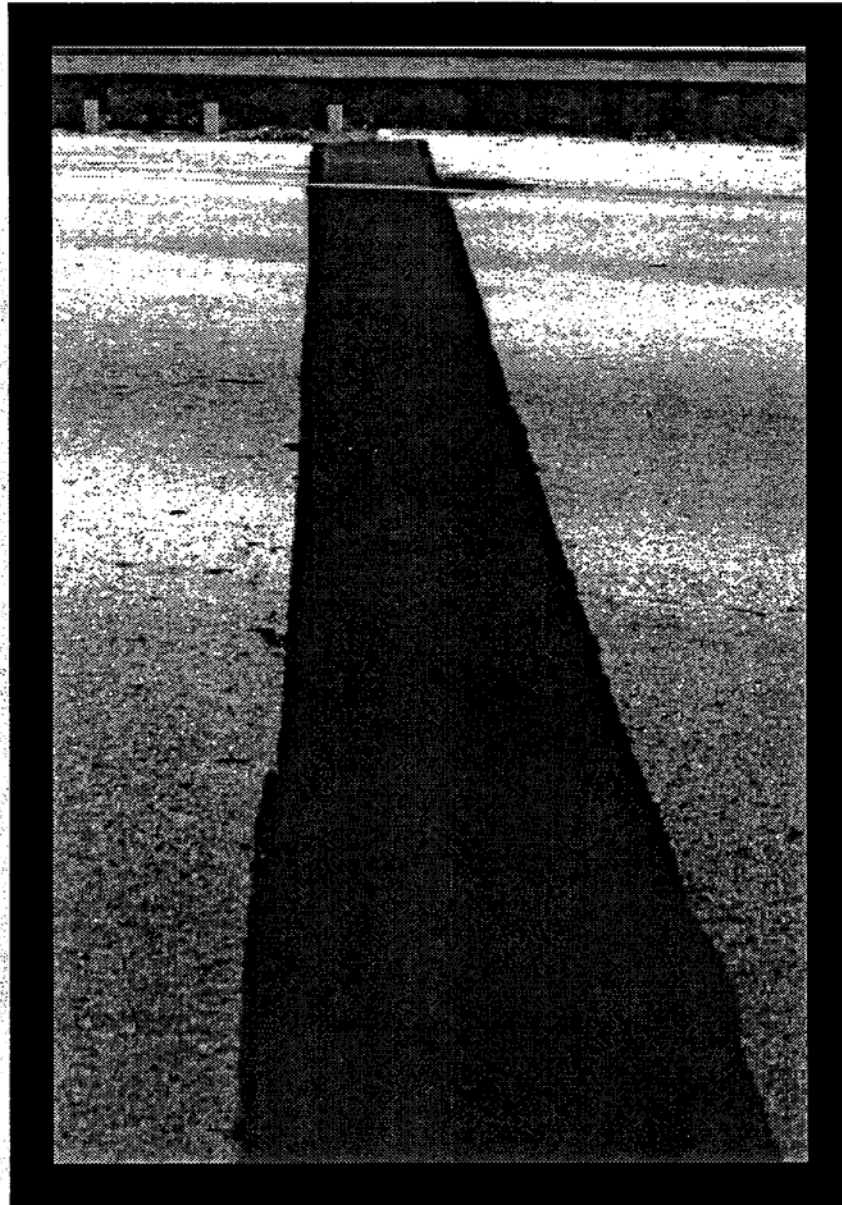
**Figure 44**

This joint system was performing well until it was removed/covered by a roadway resurfacing contractor in March 1995. See Figure 44.

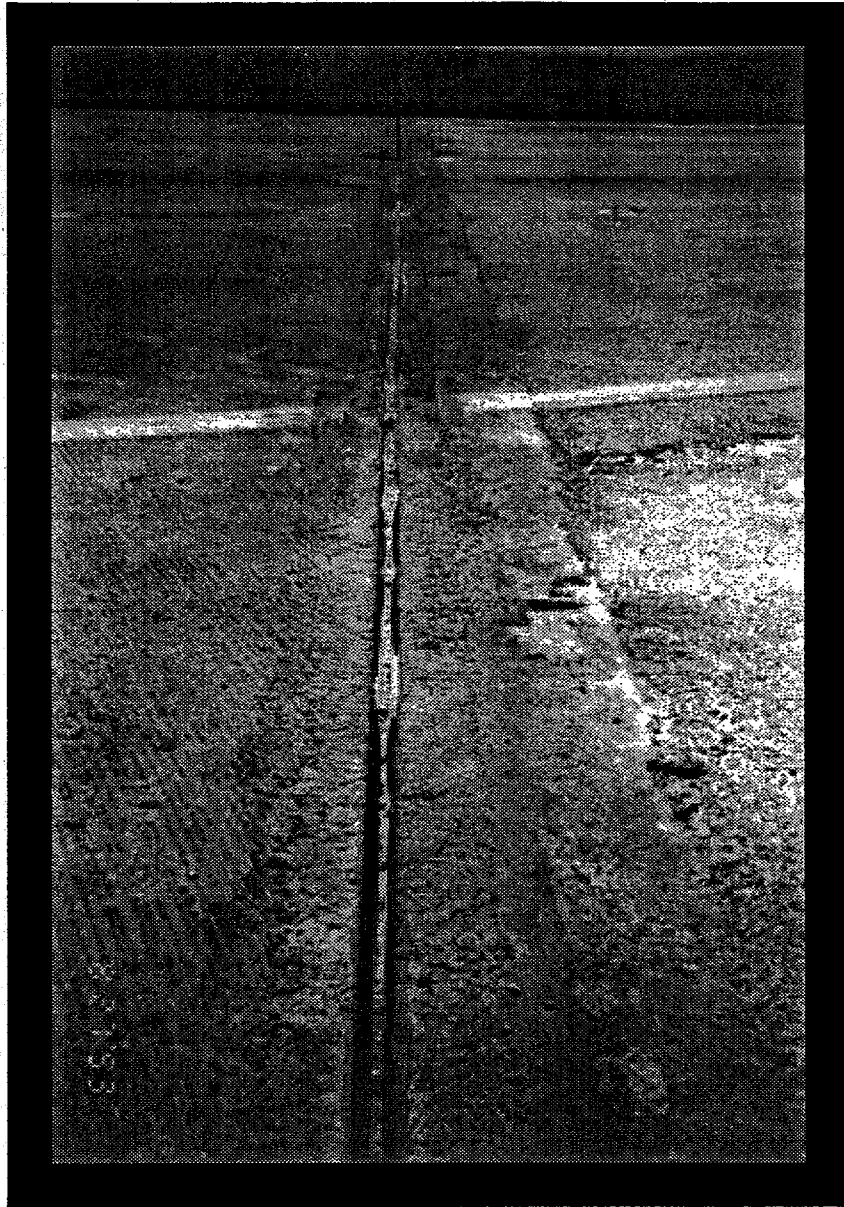
Figure 49

Displaced  
Nosing

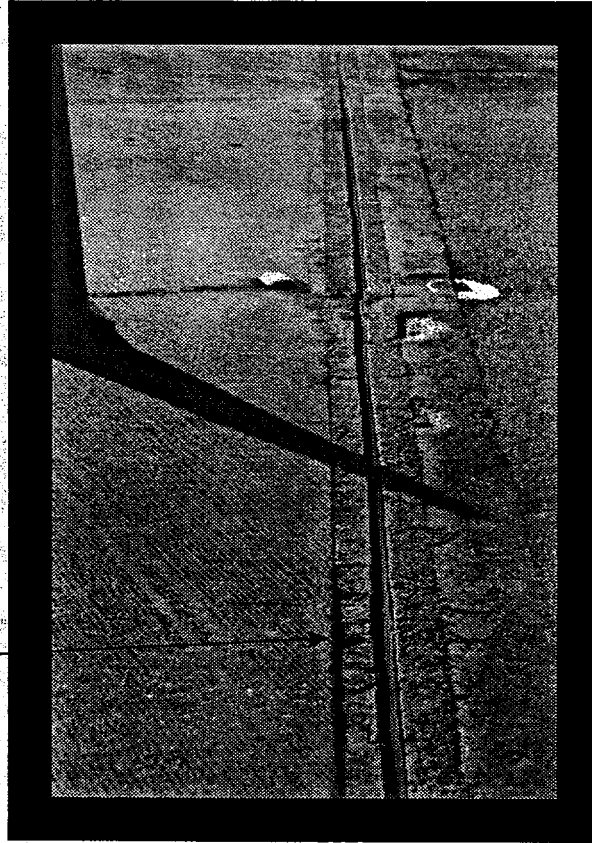
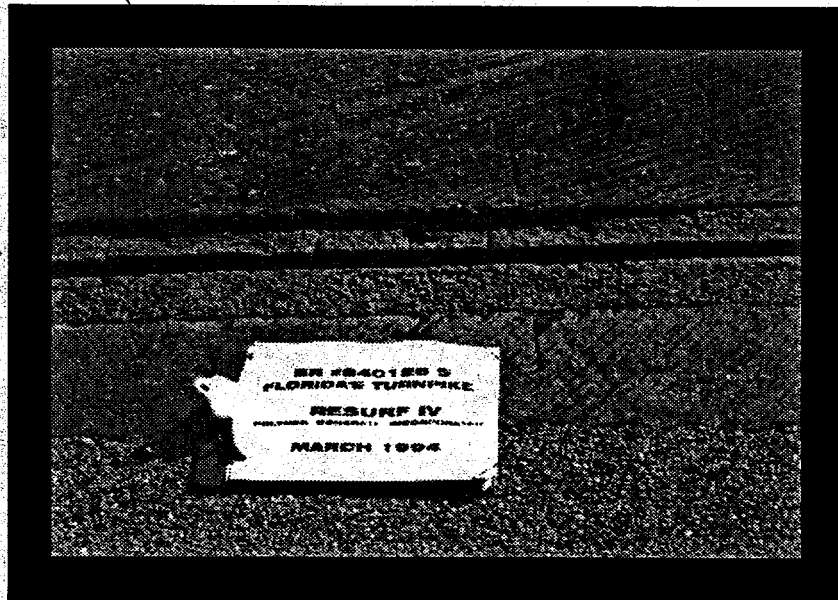
Figure 50

Polymer Concrete Inc.: RESURF IV (Failed Section)

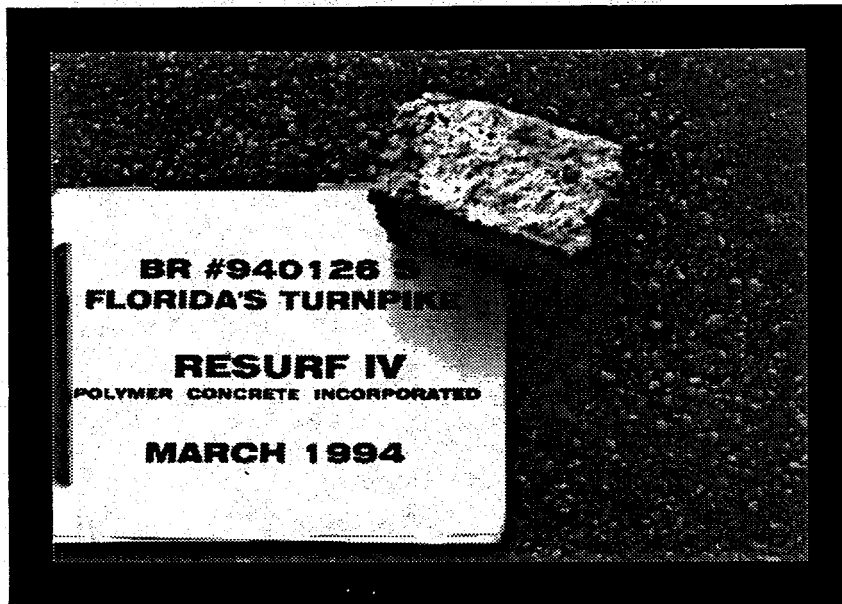
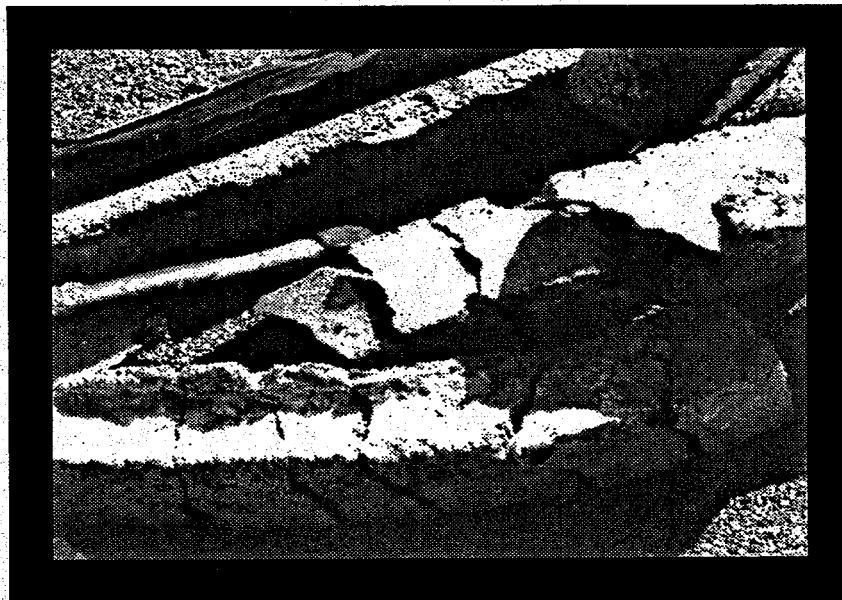
Figure 51

Polymer Concrete Inc.: RESURF IV (Removed Nosing)

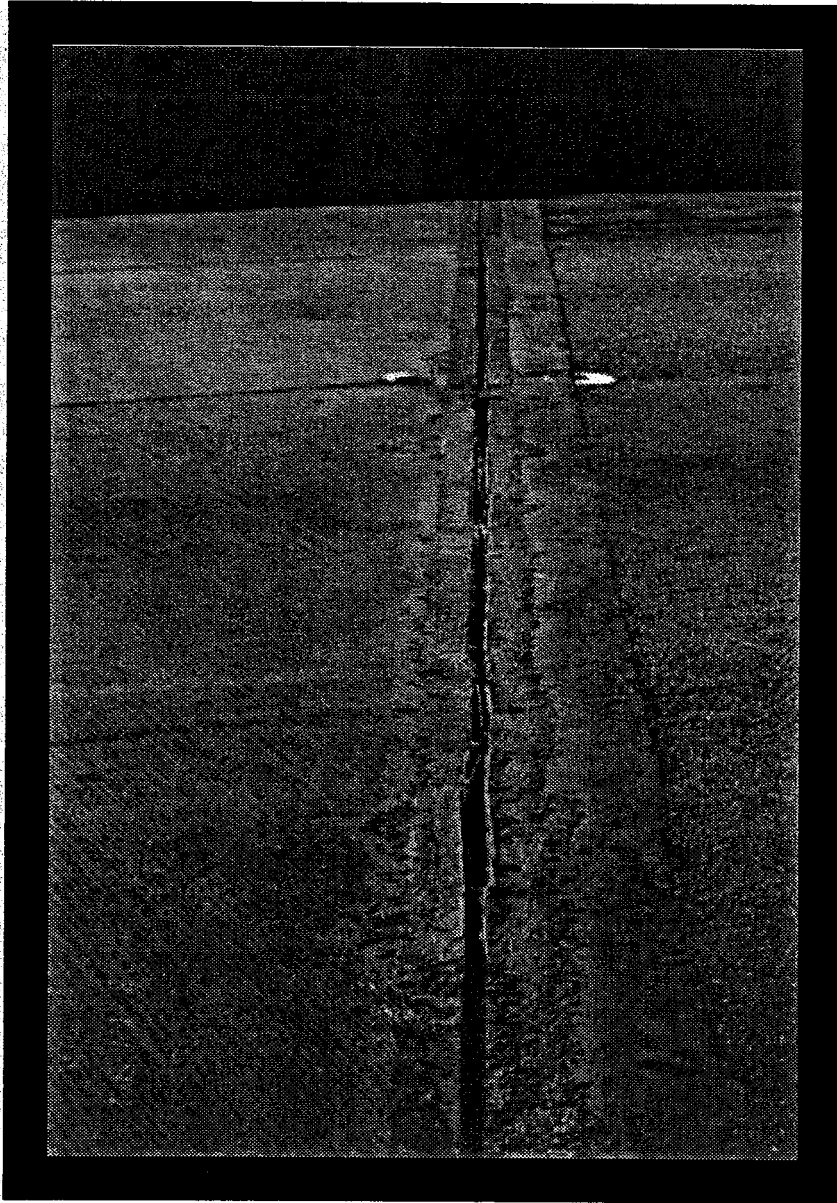
**Figure 52**

**Polymer Concrete Inc.: RESURF IV (Replaced Nosing)**

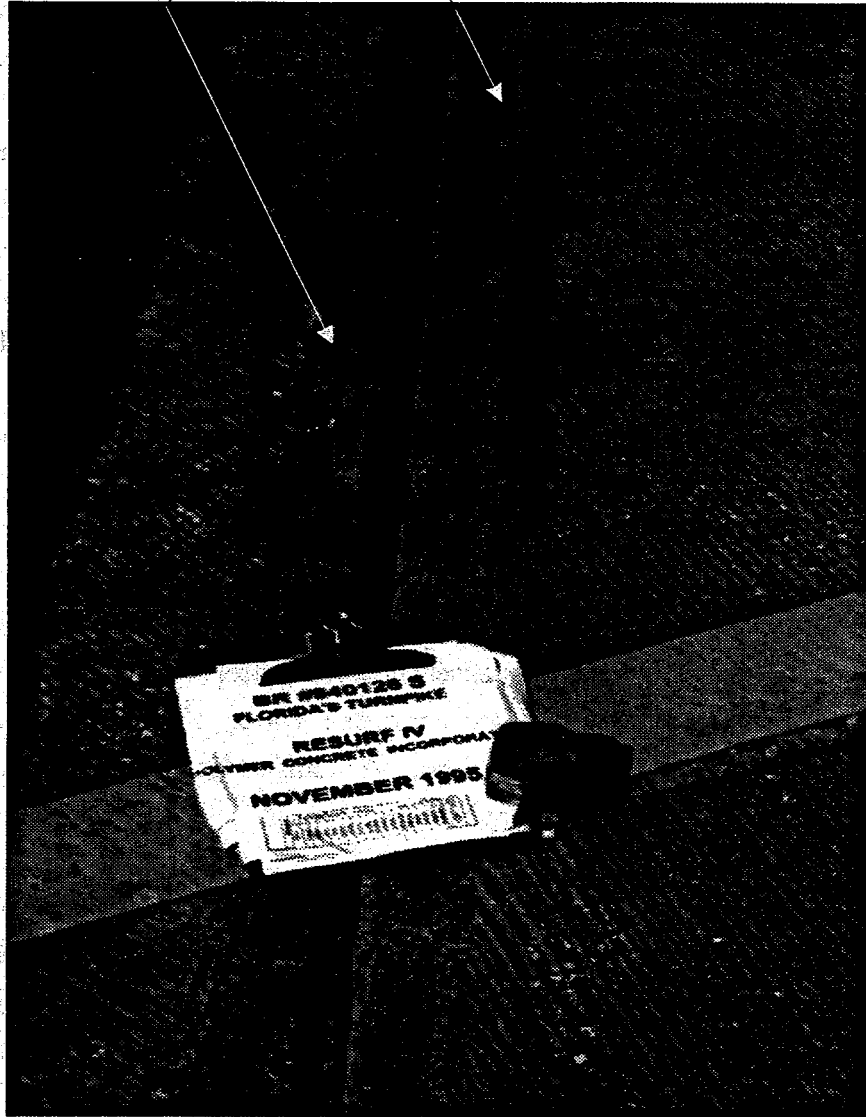
In the sections replaced in March 1994, the condition appears to be the same as in August 1994. At 2-3 foot intervals, there were transverse cracks. In the left lane that consists of nosing material placed in the original installation (August 1993) of RES TRF IV, there was a broken and displaced section of nosing. Also, there were some transverse cracks in the left lane. See Figure 53 - 54.

## Separation and Cracks

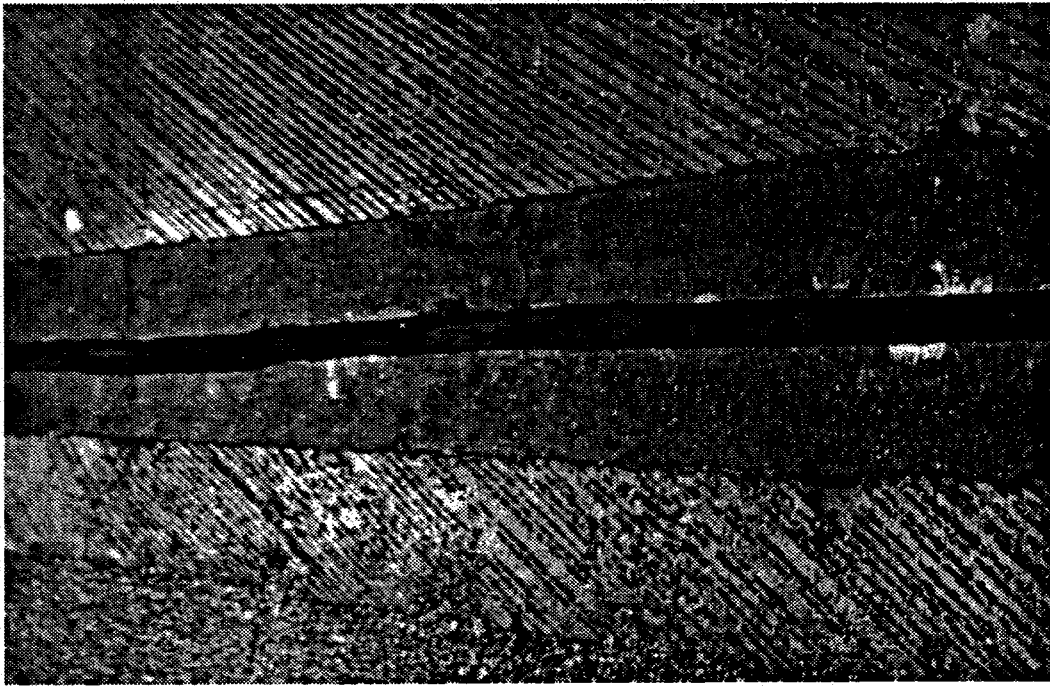
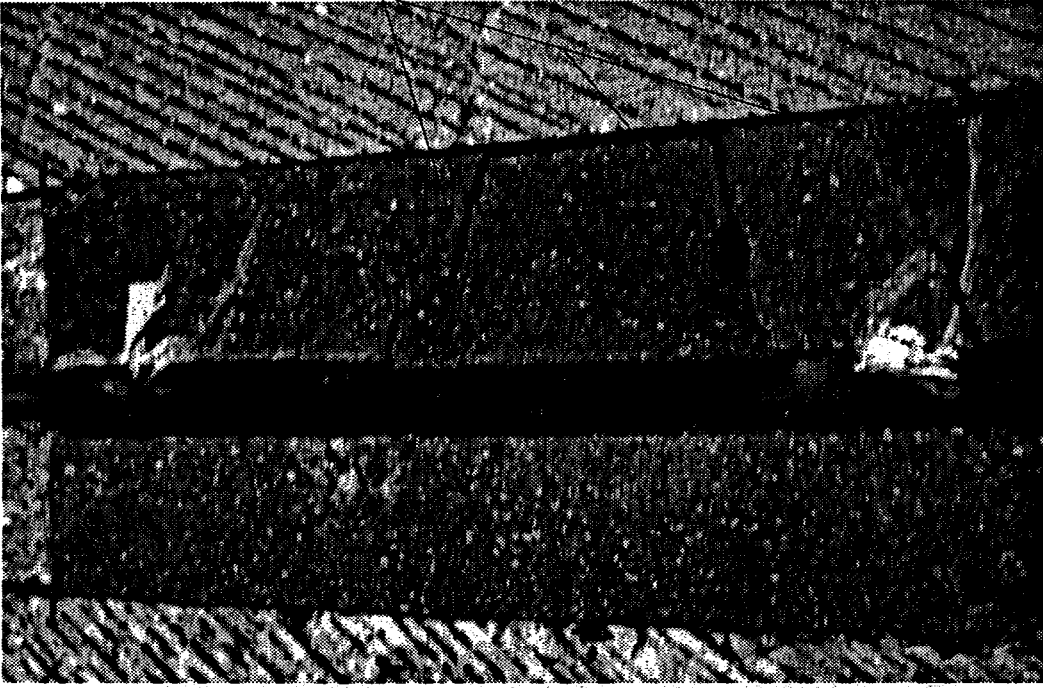
This joint system failed as was noted in August 1994. The joint system was replaced on December 7, 1994 with another company's joint system.

cracks

R.J. Watson: Flexcon 2000 Joint Sealing System (failed Joint) - Second Installation

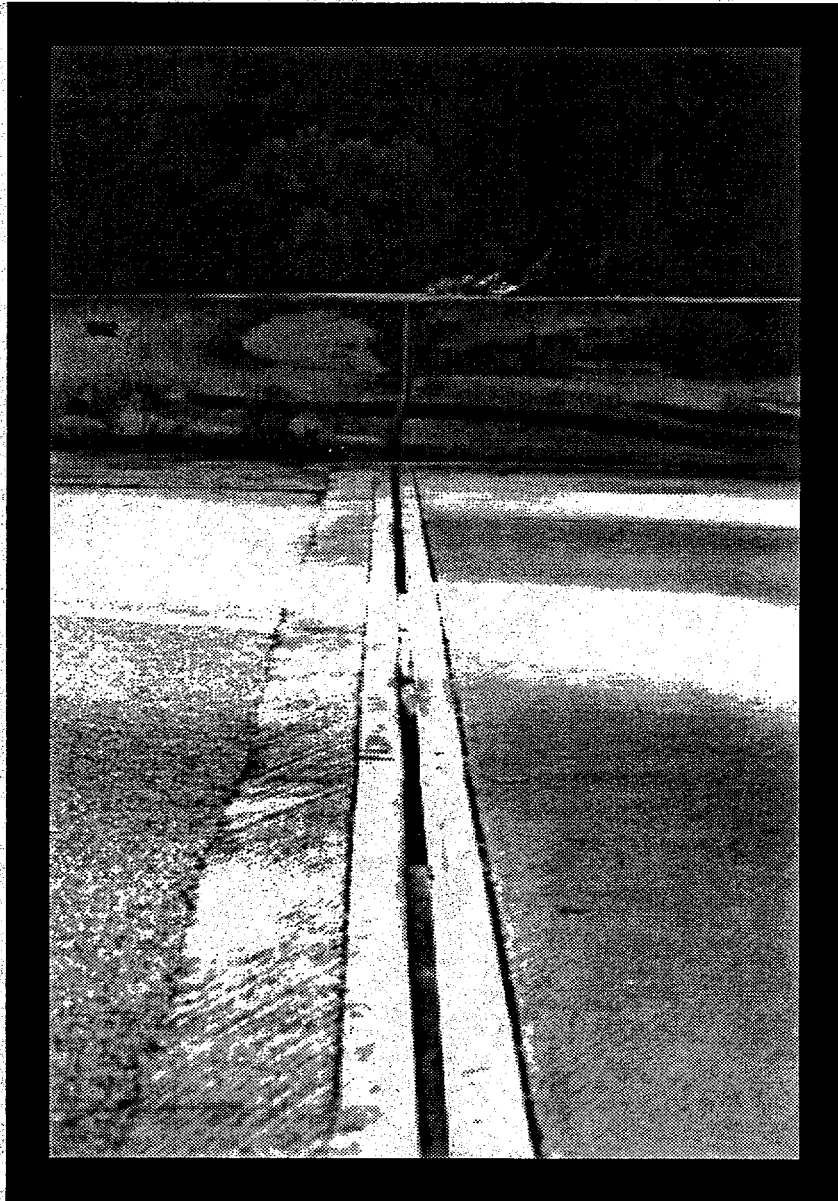
**Figure 59**

This joint failed due to excessive leakage as noted in the August 1994 progress report. In some locations the sealant was separating from the armor angle. In a 2-3 foot section, there were many small holes in the sealant See Figures 59 and 60.

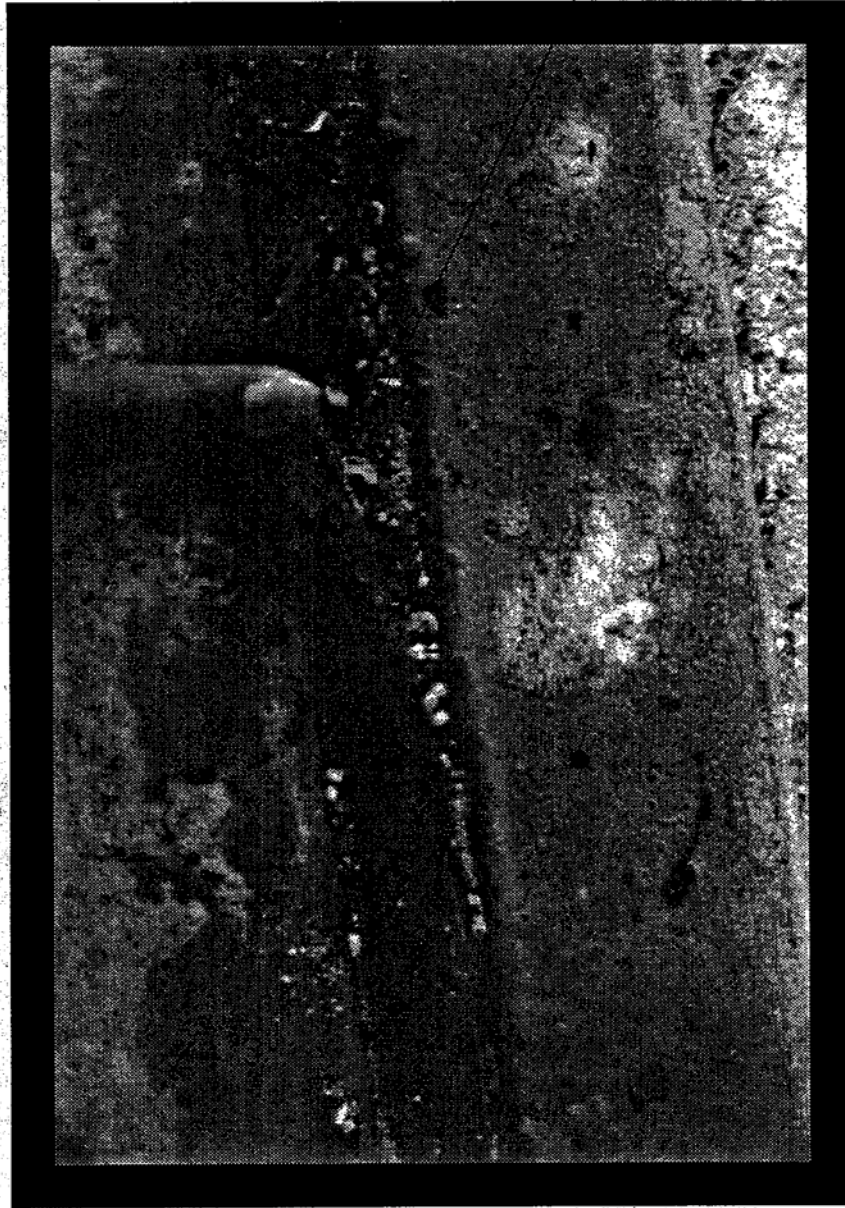
**Figure 60**

Separation

**Sylvax Corporation: Sylcrete 10 Minute Joint Sealant  
(Debonding Shoulder Area)**
