**FLORIDA DEPARTMENT OF TRANSPORTATION
BRIDGE MANAGEMENT SYSTEM
Inspection/CIDR/Bridge Profile Report with PDF attachment(s)
Inspection**

Structure ID: 890151

BY: Transystems Corporation Consultants	STRUCTURE NAME: New Roosevelt
OWNER: 1 State Highway Agency	YEAR BUILT: 1997
MAINTAINED BY: 1 State Highway Agency	SECTION NO.: 89 015 000
STRUCTURE TYPE: 6 P/S Conc Continuous - 21 Segmental Box Girder	MP: 0.118
LOCATION: 1mi S of SR-707 on SR-5	ROUTE: 00001
SERV. TYPE ON: 5 Highway-pedestrian	FACILITY CARRIED: SB US-1/SR-5
SERV. TYPE UNDER: 8 Hwy-waterway-RR	FEATURE INTERSECTED: St. Lucie River/SR-707

TYPE OF INSPECTION: Regular NBI

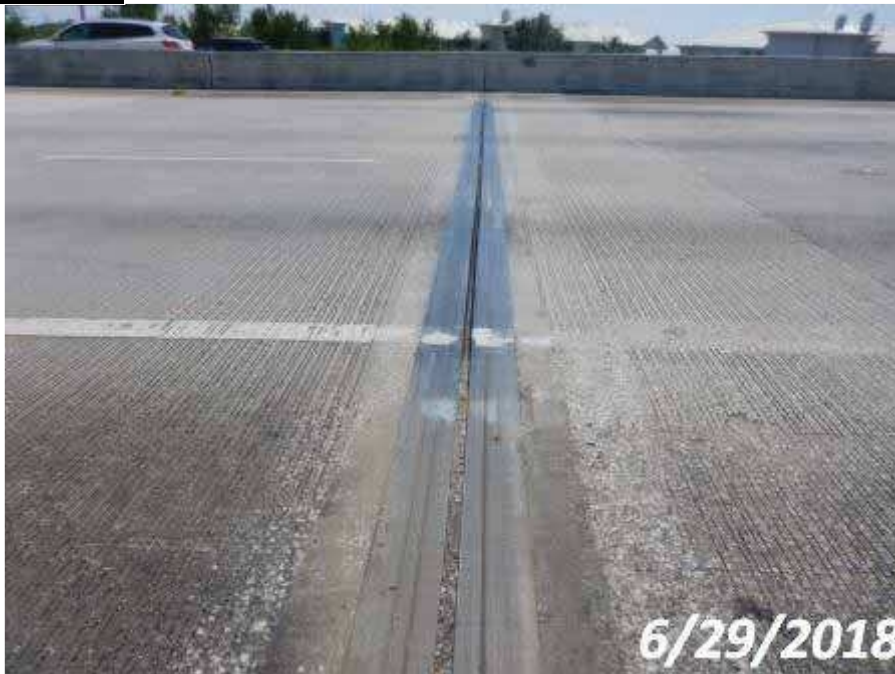
Photo 300-S01 (Unit 0: Strip Seal Exp Joint)

Accumulation of sand in the strip joint at End Bent 22.

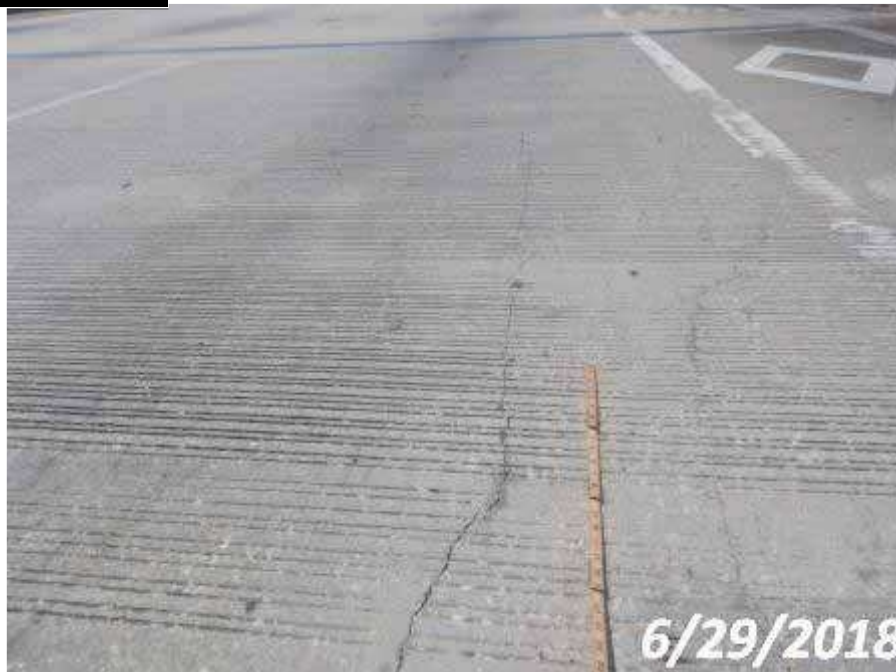
Photo 321-S01 (Unit 0: Re Conc Approach Slab)

321/4 C/S-3
1) There are several longitudinal cracks up to 20ft. L x 1/16in. W in the approach slabs (total 100sf.). NO CHANGE. See Photos 321-S01.

Several longitudinal cracks in the north approach slab.

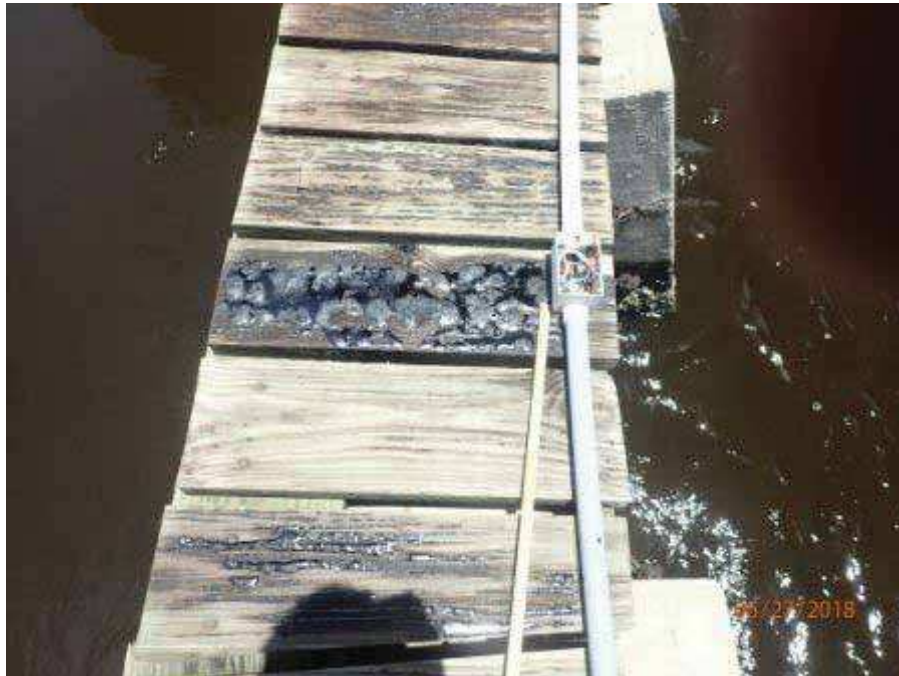
Photo 8387-U01 (Unit 0: PS Fender/Dolphin)

- 5) The cable clamps for the top and bottom wire ropes have heavy corrosion. NO CHANGE
- 6) The pile attachment bolts for the bottom 3 wales typically have heavy corrosion. NO CHANGE
- 7) All cable wraps exhibit moderate to heavy corrosion. NO CHANGE
- 8) The south fender section 3, the J-box has a missing the cover with exposed wires. NEW. See Photo 8387-S01.

Missing J-Box cover at the south fender, Section 3.

Replace missing J-box cover at the south fender, Section 3. (Item 8)

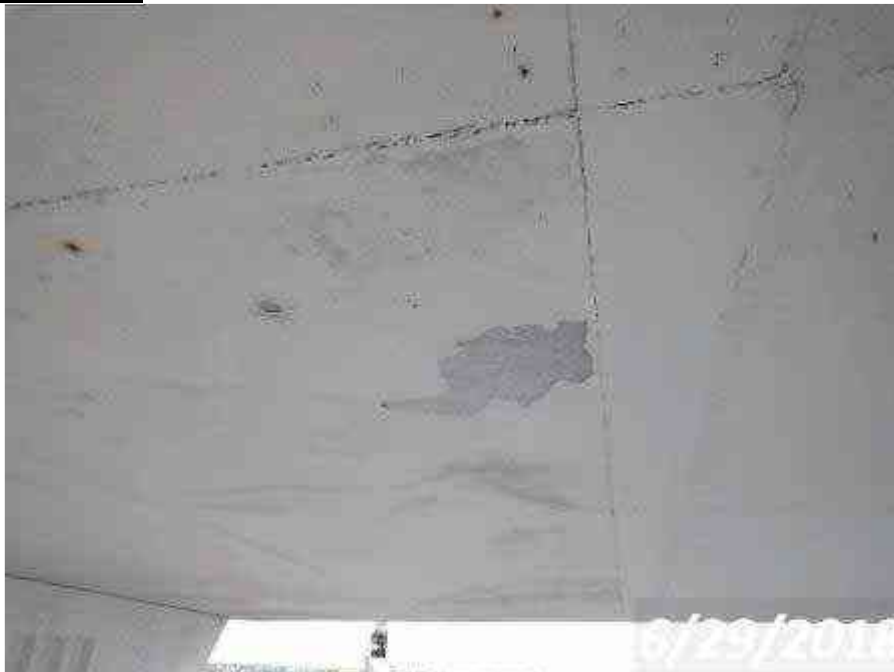
Photo 104-S07 (Unit 0: Pre Clsd Box Girder)

Peeling paint on the underside of Span 10.

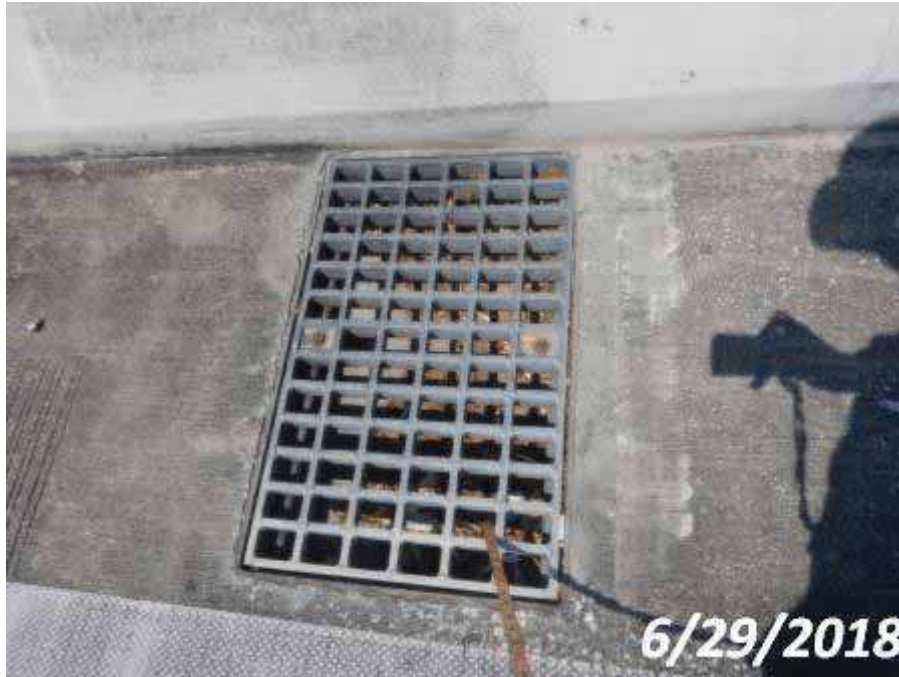
Photo 8398-S01 (Unit 0: Drainage System - Other)

Clogged drainage at Span 18.

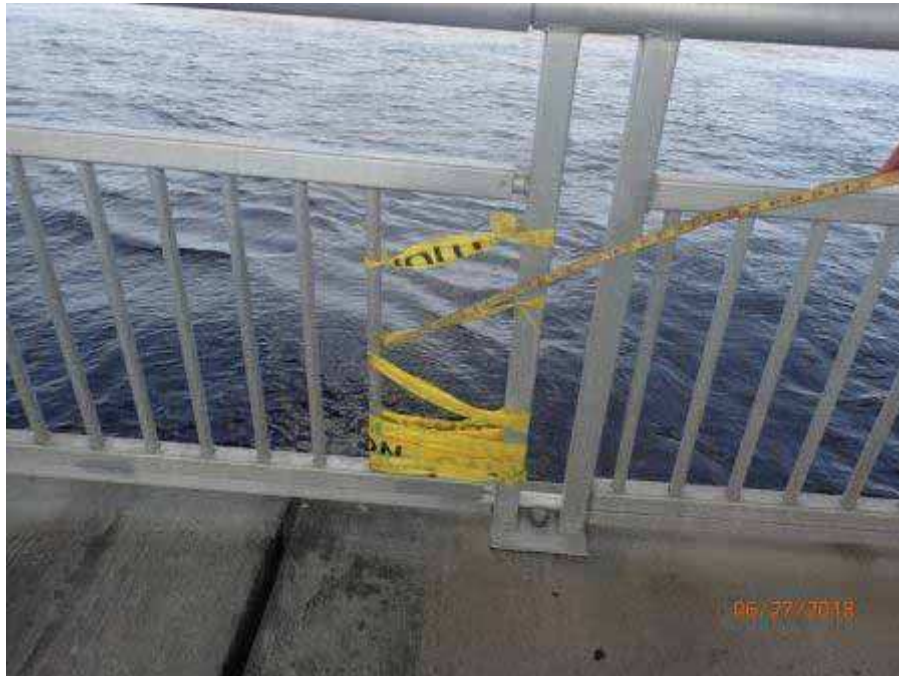
Inspection Notes Photo 1

- 1) The right rail adjacent to joint 4 has (1) missing Pickett. NEW. See Inspection Notes Photo 1.
- 2) The fishing pier joints over the bent caps show signs of adhesion failure and weathering. NEW. See Inspection Notes Photo 2.
- 3) Light Post # 5 left side has a broken / missing cover lens. NEW. See Inspection Notes Photo 3.
- 4) Light Post #13 at Pier 6 is missing the luminaire assembly. NEW. See Inspection Notes Photo 4.

Right rail missing Pickett adjacent to Joint 4.

- 1) Replace missing Pickett at the right rail adjacent to joint 4. (Item 1)
- 2) Replace fishing pier joints over the bent cap due to adhesion failure and weathering. (Item 2)
- 3) Replace missing/broken cover lens at Light Post # 5. (Item 3)
- 4) Replace missing luminaire assembly at Light Post #13 at Pier 6. (Item 4)
- 5) Enclose exposed J-box wires at Bent 2 cap west face of the light post. (Item 5)
- 6) Enclose exposed J-box wires at Span 3 south of Bent 2 cap and Span 4 south of Bent 5 cap light post. (Items 6 and 7)
- 7) Replace broken PVC with exposed wires at the strut of Span 5 south of Pier 6. (Item 8)

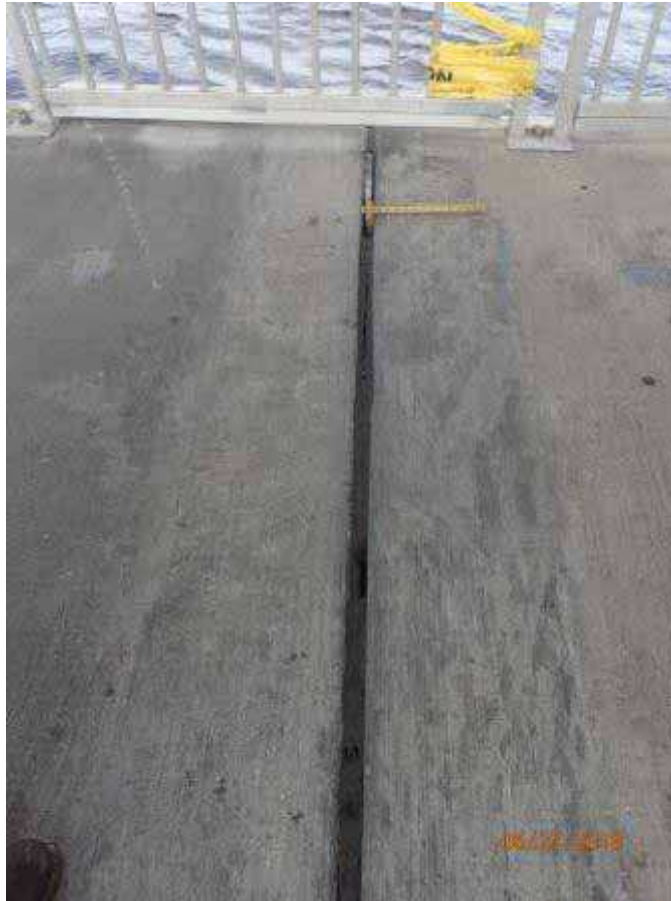
Inspection Notes Photo 2

Typical deteriorated joint condition at fishing piers.

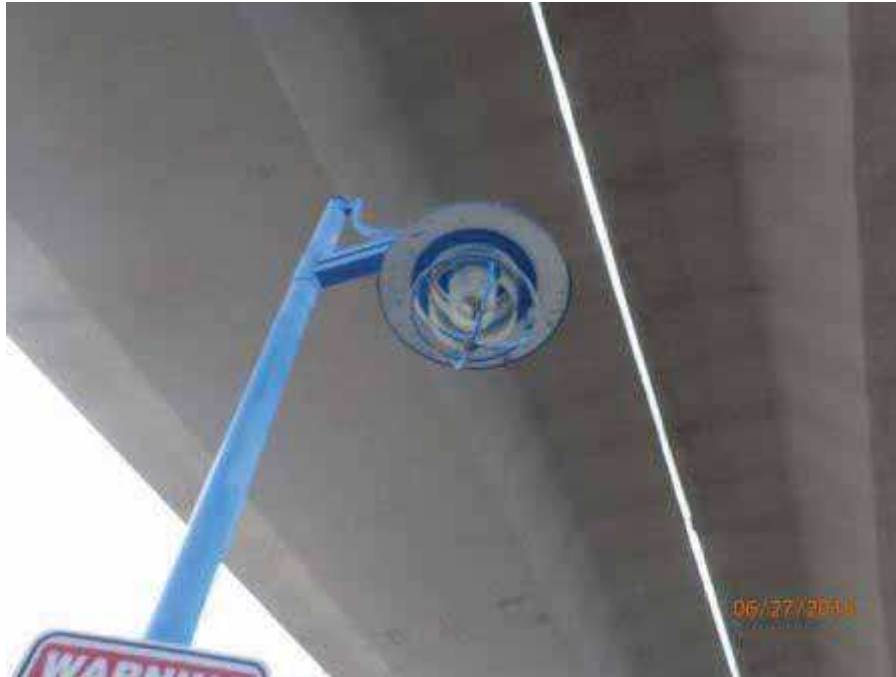
Inspection Notes Photo 3

Broken/missing lens at Light Post 5, left side.

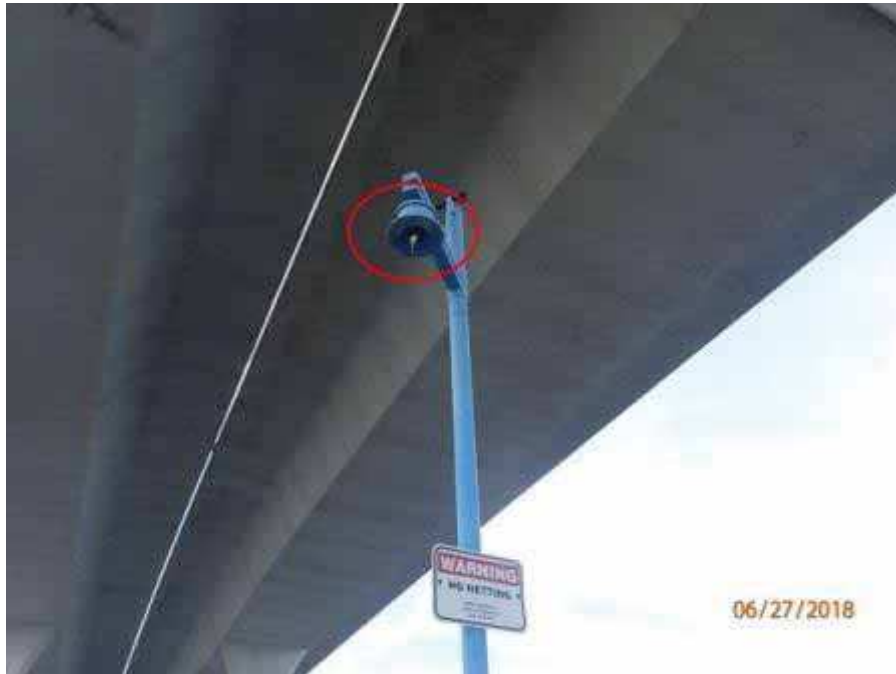
Inspection Notes Photo 4

Missing luminaire assembly at Light Post 13 at Pier 16.

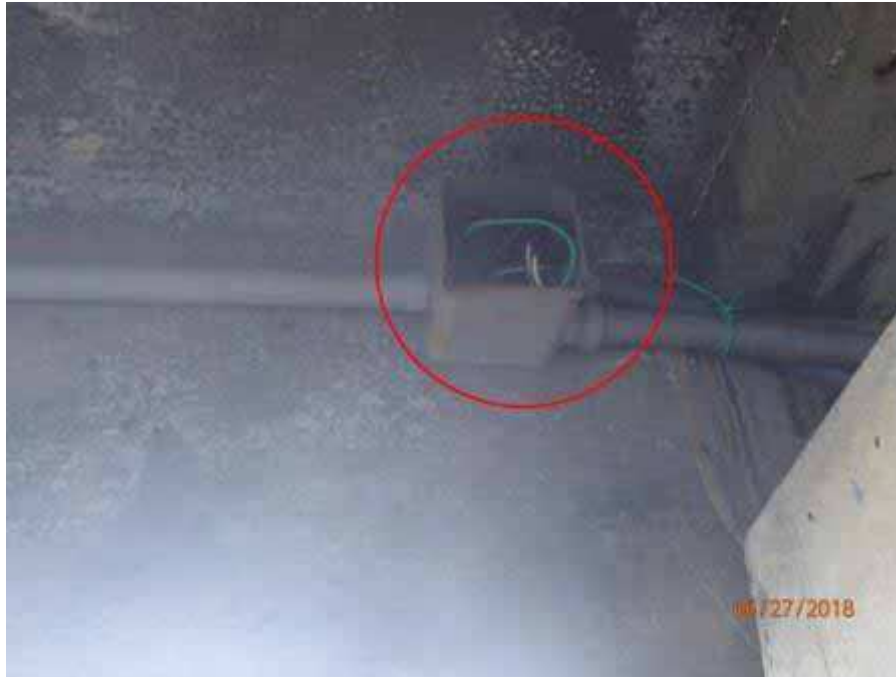
Inspection Notes Photo 5

- 5) At Bent 2 cap west face the light post J-box wires are exposed. NEW.
- 6) Span 3 south of Bent 2 cap the light post J-box wires are exposed. NEW. See Inspection Notes Photo 5.
- 7) Span 4 south of Bent 5 cap the light post J-box wires are exposed. NEW.
- 8) Span 5 south of Pier 6 broken PVC with exposed wires at the strut. NEW.

Exposed wires at J-Box in Span 3 south of Bent 2 cap.

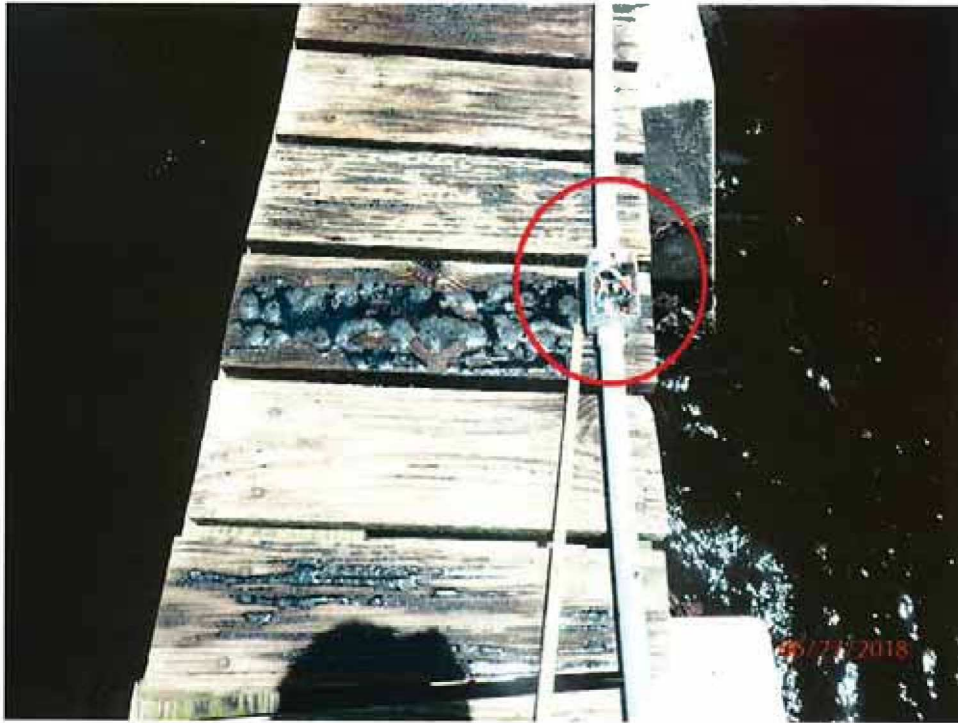
8) The south fender section 3, the J-box has a missing the cover with exposed wires. NEW See photo 1.

Photo 1: Element 8387: Showing south fender section 3 missing J-Box cover.

Recommended Feasible Action:
 Repair Item 8.

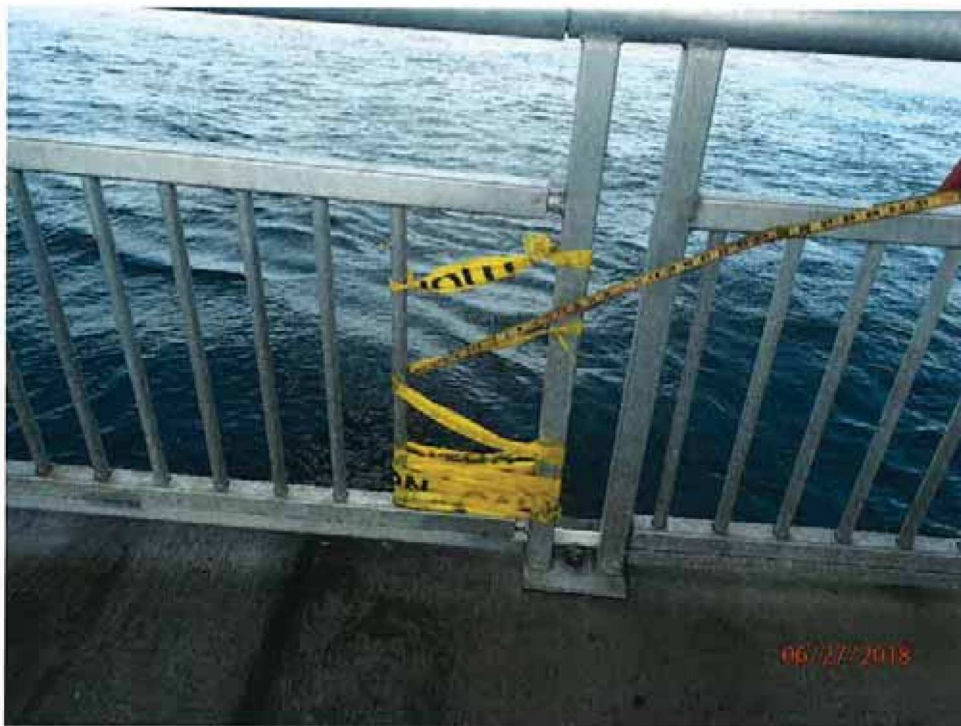
- 1) The right rail adjacent to joint 4 has (1) missing Pickett - NEW. See Photo 2.
- 2) The fishing pier joints over the bent caps show signs of adhesion failure and weathering – NEW. See photo 3.
- 3) Light post # 5 left side has a broken / missing cover lens – NEW. See Photo 4.
- 4) Light post #13 at pier 6 is missing the luminaire assembly – NEW. See Photo 5.

Photo 2: Structure Notes: Showing right rail missing Pickett.

Recommended Feasible Action:
Repair Items 1 thru 8.

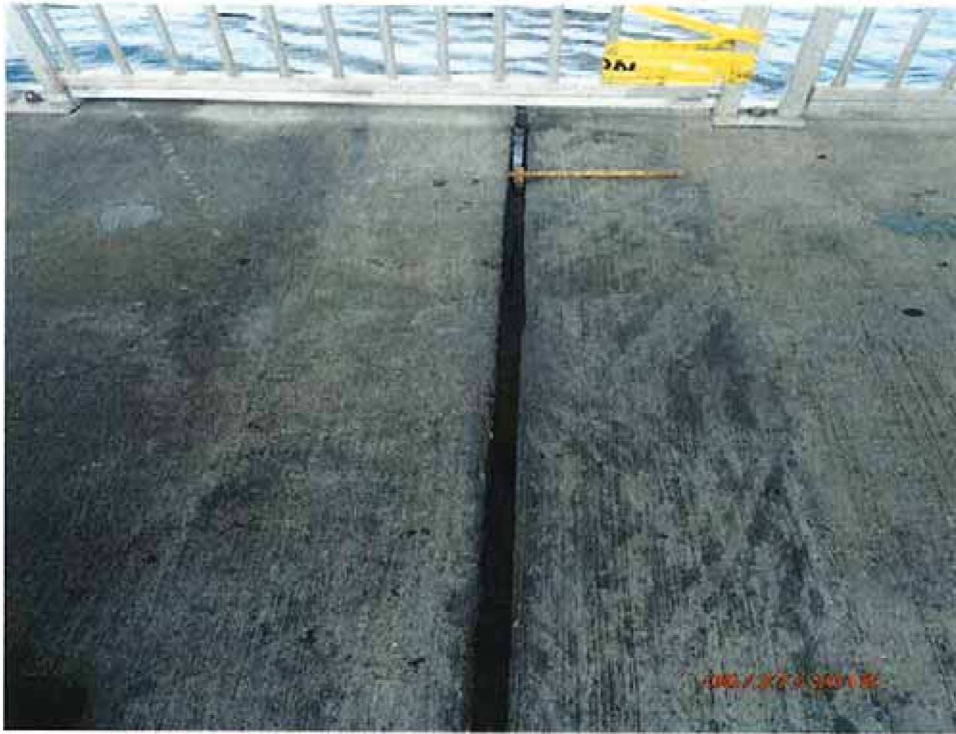
Photo 3: Structure Notes: Showing typical joint condition at fishing piers.

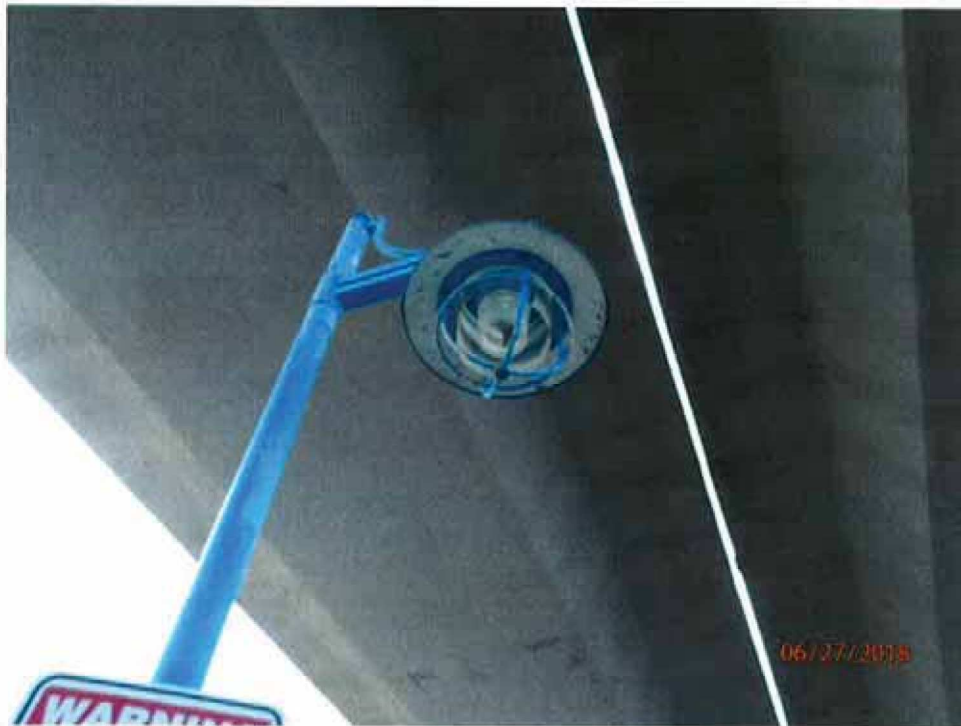
Photo 4: Structure Notes: Showing broken/missing lens at light post 5.

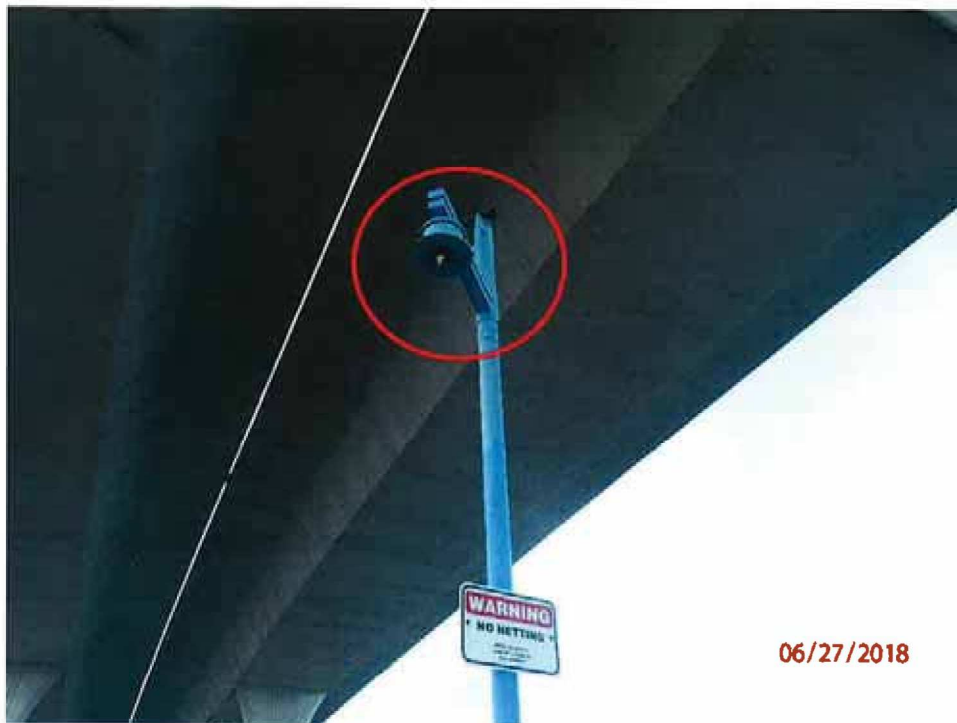
Photo 5: Structural Notes: Showing missing luminaries assembly at post 13.

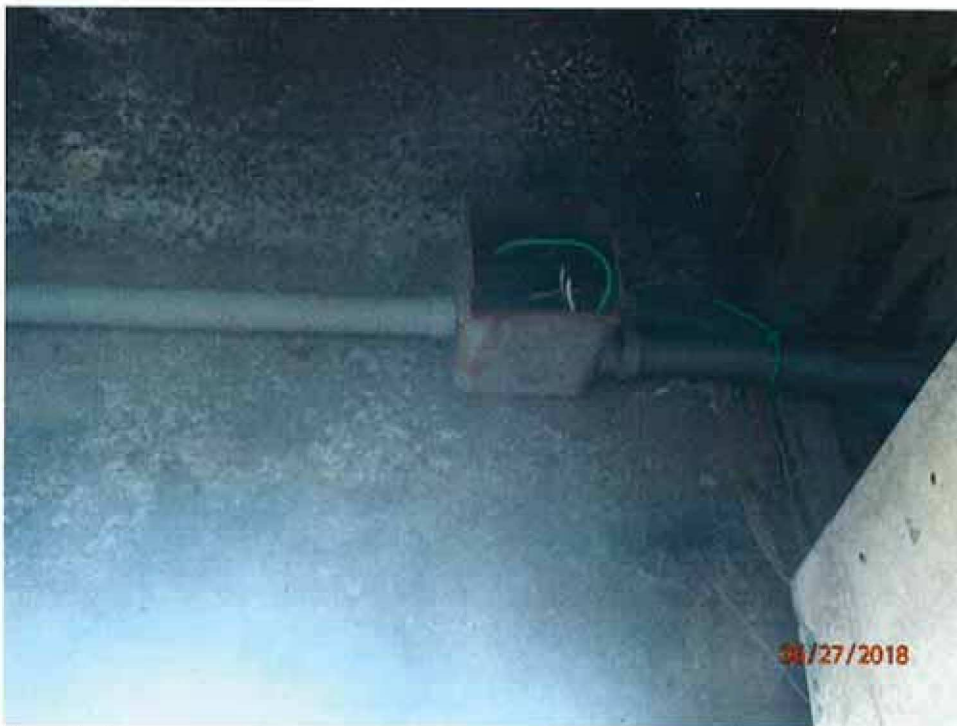
- 5) At Bent Cap 2 west face the light post J-box wires are exposed - NEW
- 6) Span 3 south of Bent Cap 2 the light post J-box wires are exposed – NEW See Photo 6.
- 7) Span 4 south of Bent Cap 5 the light post J-box wires are exposed – NEW
- 8) Span 5 south of pier 6 broken PVC with exposed wires at the strut – NEW

Photo 6: Structural Notes: Showing exposed wires at J-Box covers.
