**FLORIDA DEPARTMENT OF TRANSPORTATION
BRIDGE MANAGEMENT SYSTEM
Inspection/CIDR/Bridge Profile Report with PDF attachment(s)
Inspection**

Structure ID: 890152

BY: Transystems Corporation Consultants	STRUCTURE NAME: New Roosevelt
OWNER: 1 State Highway Agency	YEAR BUILT: 1997
MAINTAINED BY: 1 State Highway Agency	SECTION NO.: 89 015 000
STRUCTURE TYPE: 6 P/S Conc Continuous - 21 Segmental Box Girder	MP: 0.118
LOCATION: 1mi S of SR-707 on SR-5	ROUTE: 00001
SERV. TYPE ON: 5 Highway-pedestrian	FACILITY CARRIED: NB US-1 / SR-5
SERV. TYPE UNDER: 8 Hwy-waterway-RR	FEATURE INTERSECTED: St Lucie River / SR-707

TYPE OF INSPECTION: Regular NBI

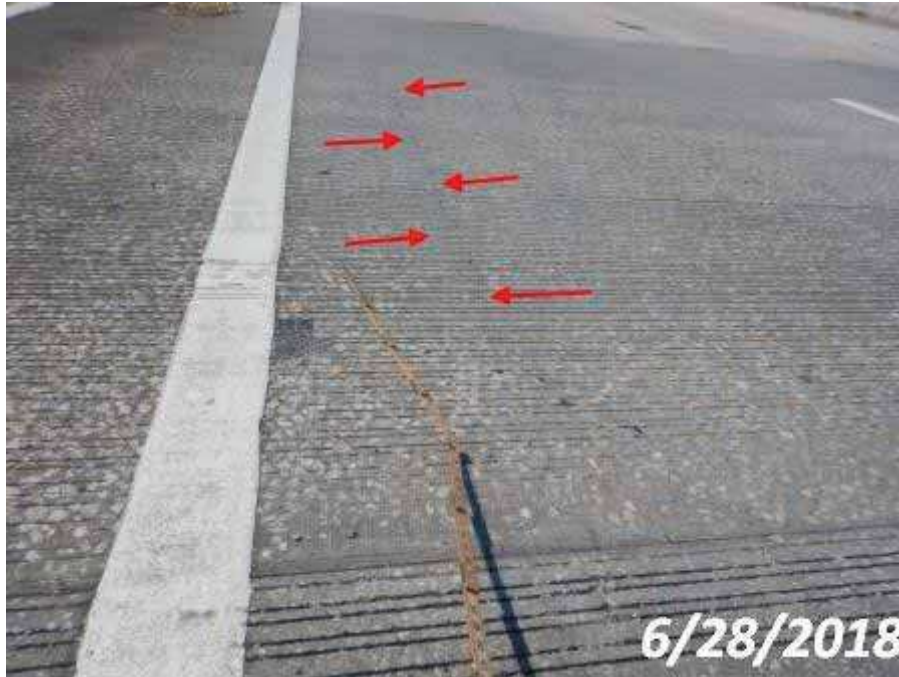
Photo 321-S01 (Unit 0: Re Conc Approach Slab)

Longitudinal crack in the south approach slab.

Str Unit	Elem/Env	Description	Qty1	%1	Qty2	%2	Qty3	%3	Qty4	%4	T Qty
0	321 / 4	Re Conc Approach Slab	2420	99.18	0	.	20	0.82	0	.	2440 sq.ft
0	1130 / 4	Cracking (RC and Other)	0	.	0	.	20	100	0	.	20 sq.ft

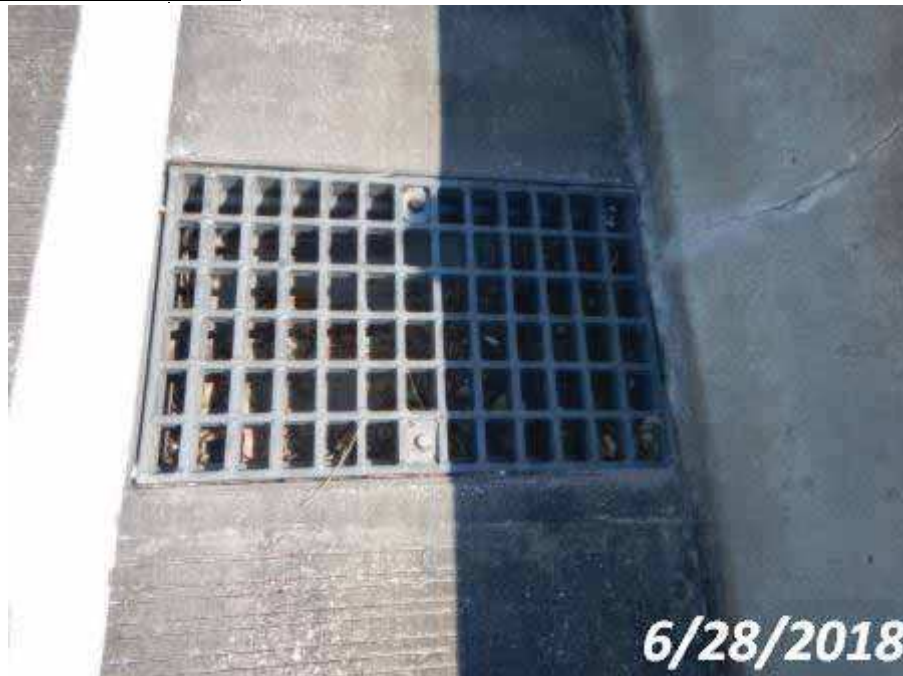
Photo 8398-S01 (Unit 0: Drainage System - Other)

8398/4 CS1:
1) The drainage inlets exhibit debris throughout the length of the bridge. NO CHANGE.
See Photo 8398-S01.

Debris in the drainage inlet at Span 10.

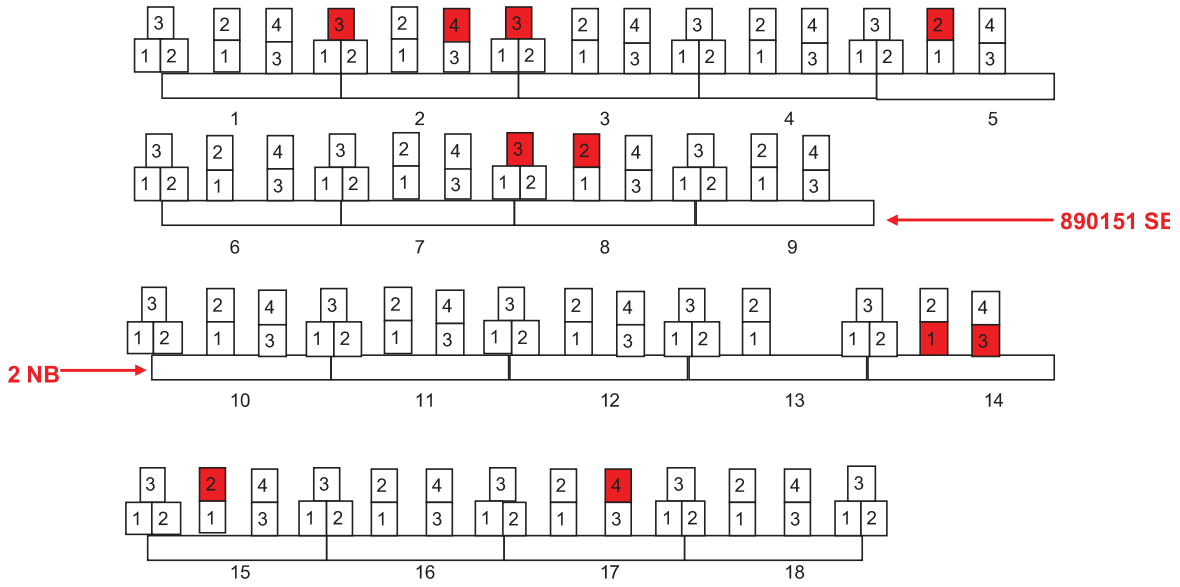
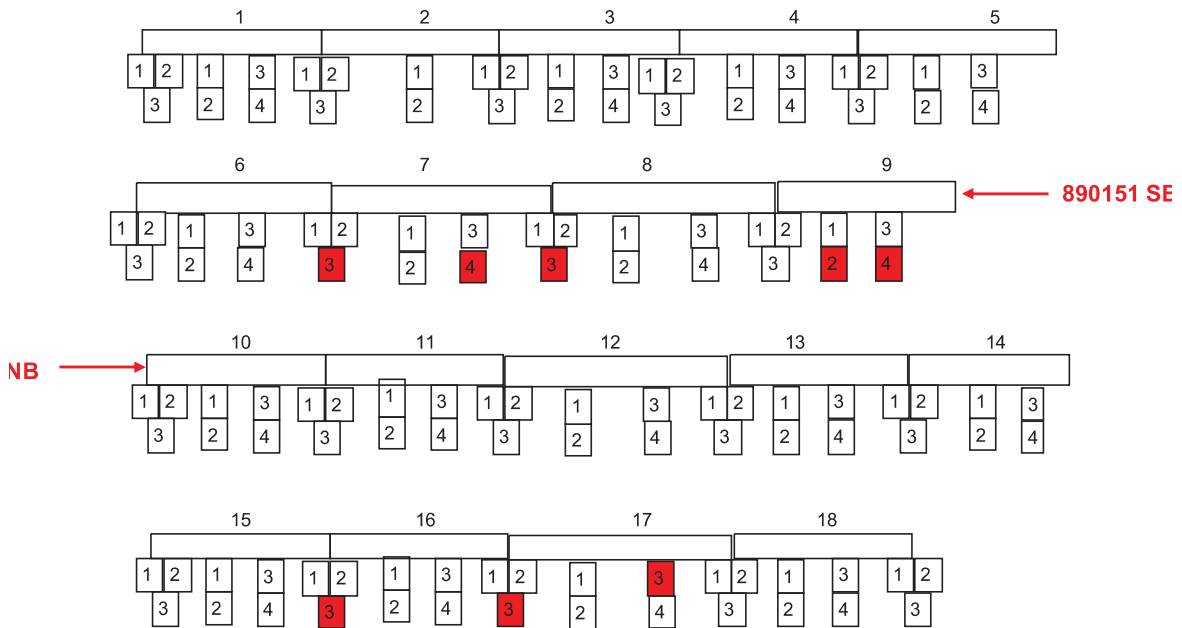
Fender Pile Layout

1) The following piles have spalls up to 14in. H x 6in. W x 3in. D with exposed steel at the top of the pile; however, the exposed steel has been epoxy coated since the previous inspection and only minor corrosion is bleeding thru at S14P1, S14P3, S15P2 and S17P4 (total 4ft.). NO CHANGE.

2) The following piles have spalls up to 14in. H x 6in. W x 3in. D with exposed steel at the top of the pile, however, the exposed steel has been epoxy coated since the previous inspection and only minor corrosion is bleeding thru at C16P3, C17P3, and S17P3 (total 3ft.). NO CHANGE.

3) The cable clamps for the top and bottom wire ropes have heavy corrosion. NO CHANGE.
4) The pile attachment bolts for the bottom 3 wales typically have heavy corrosion. NO CHANGE.
5) All cable wraps exhibit moderate to heavy corrosion. NO CHANGE.

6) The bottom wale in Section 15 has moderate external decay and evidence of minor marine borer attack. NO CHANGE.
7) The ends of the bottom wale in Sections 13, 14 and 16 have light external decay and evidence of minor marine borer attack. NO CHANGE

1) Repair the corroded saddle clamps throughout the structure. (Item 3)
2) Repair the connection bolts for the bottom 3 wales. (Item 4)
3) Repair the corroded cable wraps. (Item 5)

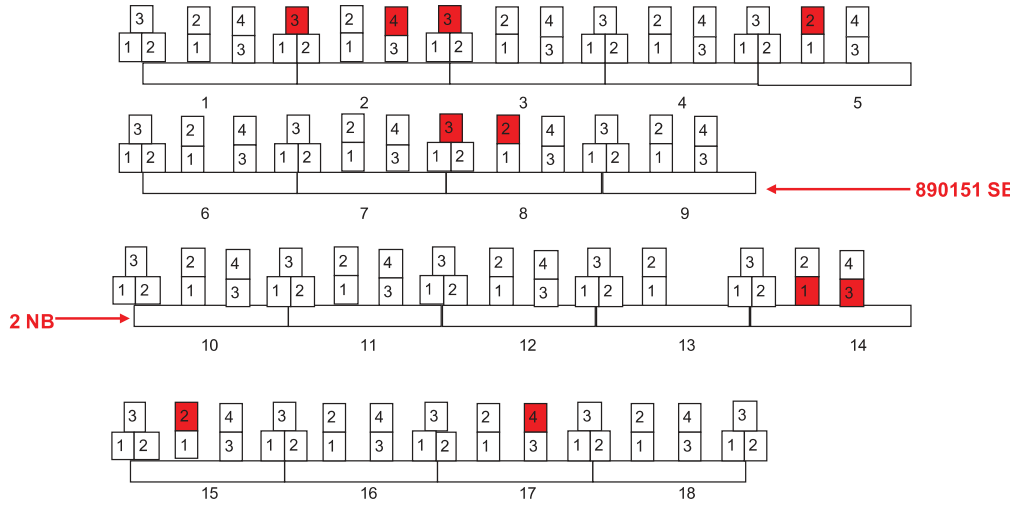
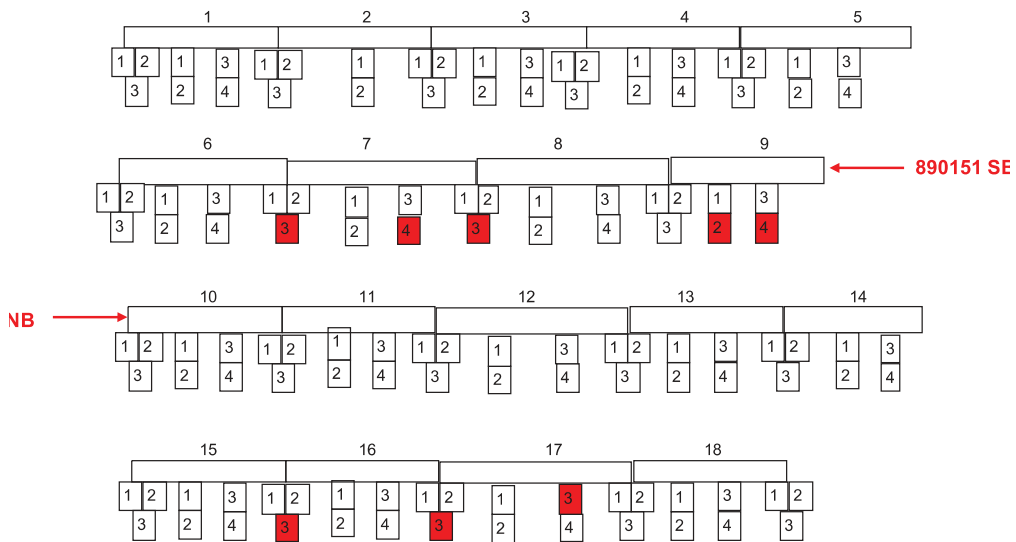
Fender Pile Layout

1) The following piles have spalls up to 14 in. H x 6 in. W x 3 in. D with exposed steel at the top of the pile, however, the exposed steel has been epoxy coated since the previous inspection and only minor corrosion is bleeding thru at S14P1, S14P3, S15P2 and S17P4. NO CHANGE. (1080 / 4 LF)

2) The following piles have spalls up to 14 in. H x 6 in. W x 3 in. D with exposed steel at the top of the pile, however, the exposed steel has been epoxy coated since the previous inspection and only minor corrosion is bleeding thru at C16P3, C17P3, and S17P3. NO CHANGE. (1080 / 3 LF)
