**FLORIDA'S EXPERIENCE WITH CRACK-AND-SEAT
REHABILITATION STRATEGY**

Bouzid Choubane¹, Abdenour Nazef¹, James A. Musselman¹, and Bjorn Birgisson²

Paper submitted for consideration for presentation at the 2002 Association of Asphalt Paving Technologists (AAPT) Annual Meeting and Publication in the AAPT Journal.

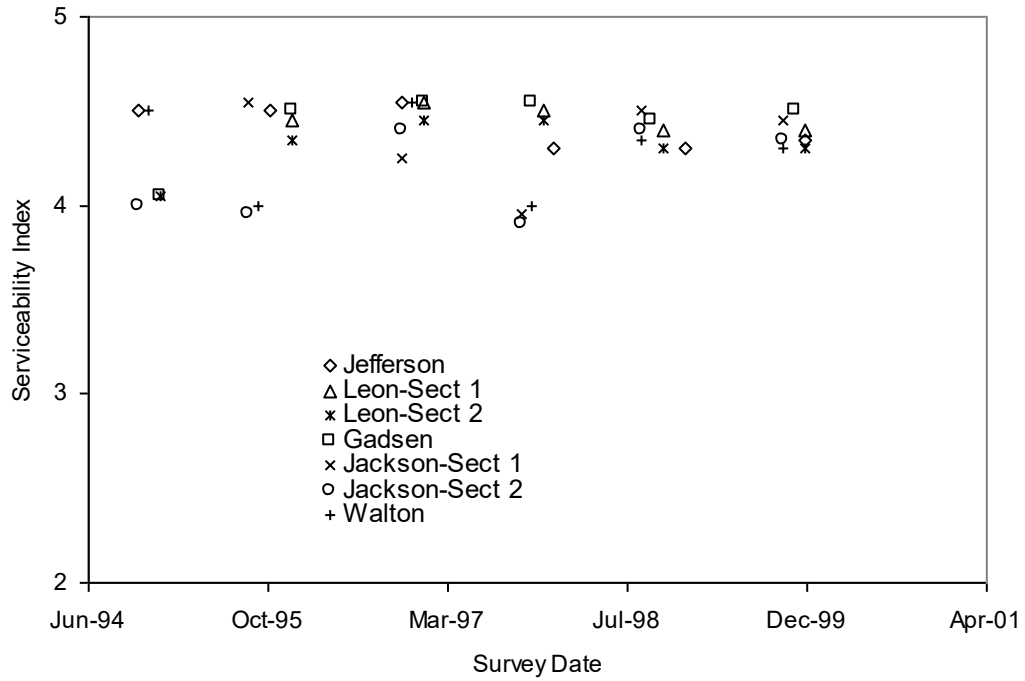
Figure 2 Ride quality vs. time as measured on the eastbound direction

The trends in the performance data collected during this study are illustrated in Figures 2 through 7. The ride quality was rated in terms of the present serviceability. The latter rating was derived from readings taken with an automated profiler that measures deviations in a pavement surface. These deviations provide a measure of the smoothness or roughness of the pavement. The ride quality is rated on a scale of 0 to 5, with 0 being very poor (undriveable) and 5 being very good (new surface). The ride rating data, summarized in Figures 2 and 3, indicate that all the projects still have very good to good ride characteristics after seven years of service.

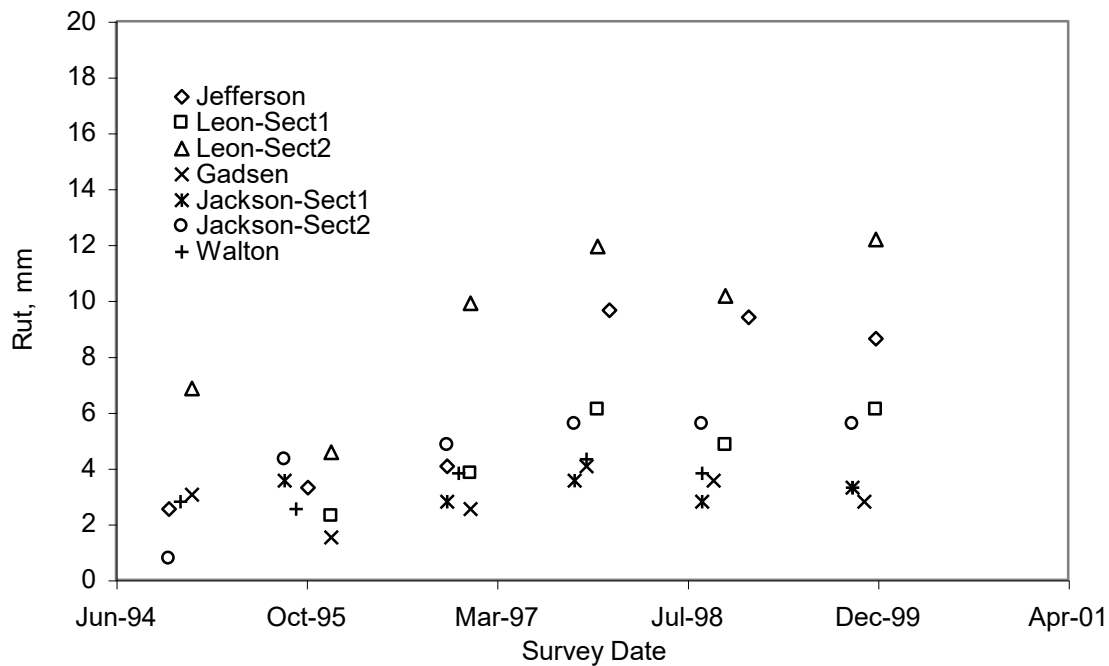
Figure 4 Rut depth vs. time as measured on the eastbound direction

The rut depth measurements as plotted in Figure 4 and 5 show presently at most 6 mm rut on the majority of the sections considered in this evaluation. Typically, asphalt pavements in Florida average approximately 2.8 mm (0.11 in.) of rutting after one year of service (5). This is mainly the result of consolidation of the structural layers. The two projects that seem to exhibit relatively higher levels of deformation are those located in Jefferson and Leon (second project) Counties where rut depths averaging approximately 12 mm (0.5 in) were recently recorded. It is likely that this rutting is due to problems with the asphalt mix since a number of problems were encountered during the mix production, and the same mix was placed on both projects. Critically low in-place air voids (ranging from 0.2 to 1.9 percent) were measured on the Leon County project (6). Although this resulted in the removal and replacement of a substantial amount of pavement on this project before its completion in August of 1993, low in-place air voids ranging from 2.5 to 2.9 percent were still measured during a 1994 forensic investigation. It is also probable that the fine graded, 50-blow Marshall designed mixes were inadequate to withstand current loading conditions. Over the past 10-15 years, a significant number of asphalt pavements on Interstate projects in north Florida have experienced premature failures, primarily due to rutting (7).

- All projects still have very good to good ride characteristics on both east and west directions.
- The majority of the sections considered in this experiment exhibited at most 6-mm (0.25 in.) rutting. However, two projects, located in Jefferson and Leon (second project) Counties, showed relatively higher levels of deformation, averaging approximately 12 mm (0.5 in), although this appears to be asphalt mix related.

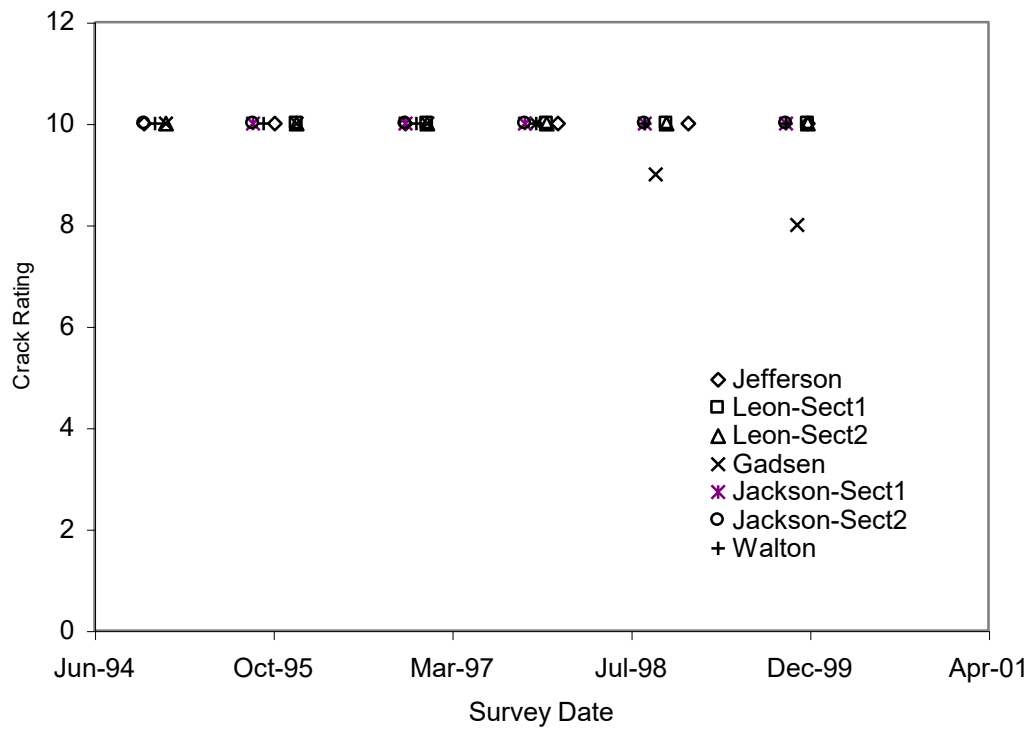
Figure 6 Crack rating vs. time as measured on the eastbound direction

In any case, the major distress associated with the crack-and-seat technique is primarily reflection cracking. Therefore, a more appropriate measure of crack-and-seat field performance should be in terms of cracking. An earlier investigation elsewhere indicated that the cracking-and-seating method reduced reflection cracking during the first few years after construction, but after 4 to 5 years the cracking increased, thus questioning the effectiveness of such a rehabilitation procedure (4). However, as illustrated in Figures 6 and 7, in combination with visual inspections, the overall performance, in terms of cracking and patching, of the Florida crack-and-seat projects is still highly rated. In most cases, this rating is equal or better than one would expect on asphalt overlays after approximately seven years of service. Although it should be noted that, within the last 18 months, an increase in the amount of cracks was observed on the

Gadsen County project (in both directions) and, to a lesser extent, on the second project in Jackson County (westbound side), visual surveys still indicate that the amount of cracking was relatively insignificant in most of the sections.

- Within the last 18 months, an increase in the amount of cracks was observed on the Gadsen County project (in both directions) and, to a lesser extent, on the second project in Jackson County (westbound side). However, the overall performance of the Florida crack-and-seat projects is still highly rated in terms of cracking and patching. Visual surveys indicated that the amount of cracking was still relatively insignificant in most of the sections.
