# SR-222 Micro Surfacing Project Performance

State Materials Office

EXP-SR-222

July 28, 2020

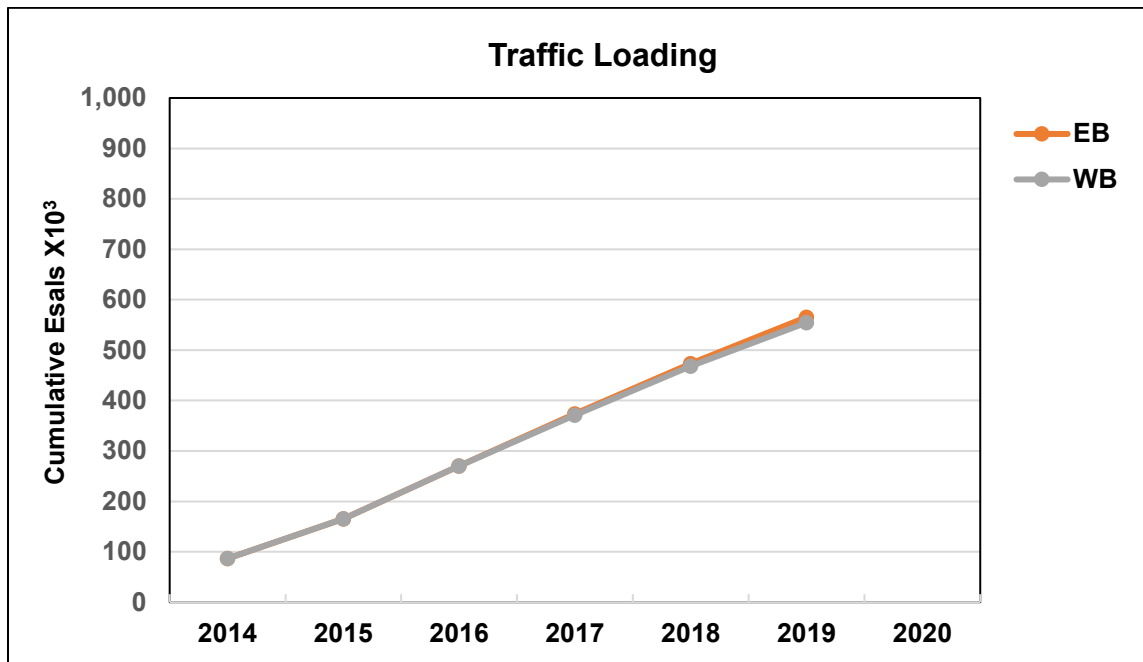
**FIGURE 3 Traffic**

- **Traffic** Average Annual Daily Traffic (AADT) between 2014 and 2019 averaged 15,000 with 2.5% truck traffic in each travel direction. Traffic data for 2020 was not available as of the writing of this report. In 2019, the cumulative traffic loading was nearly 0.6 million Equivalent Single Axle Load (ESAL) in the design lane (Figure 3).

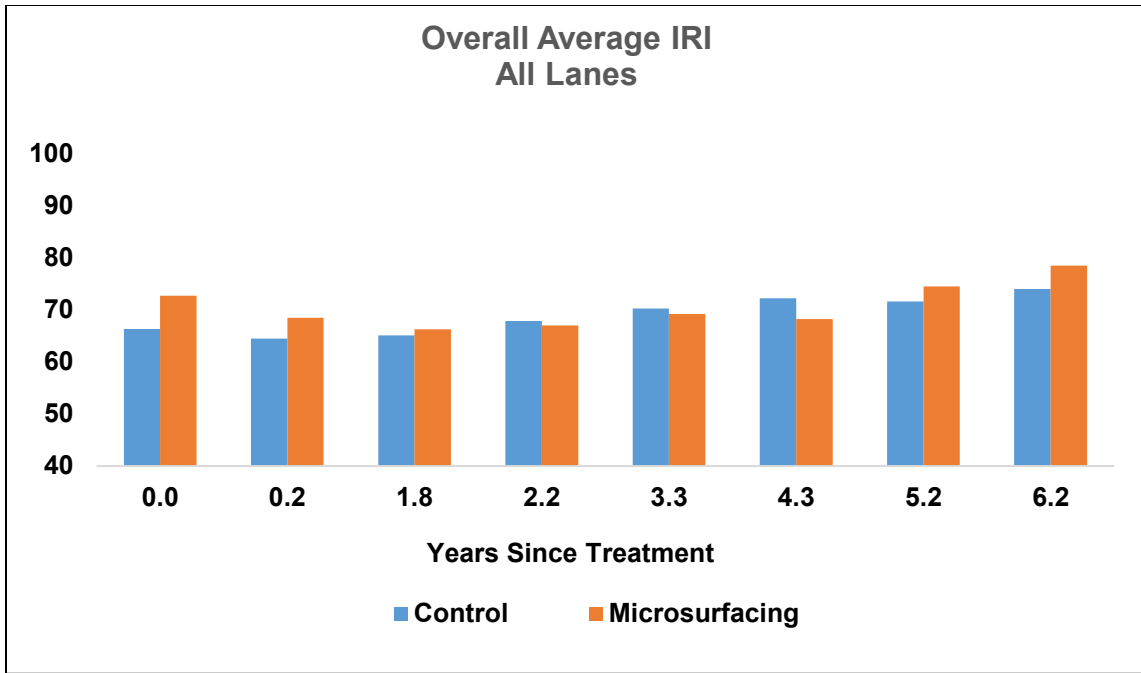
**FIGURE 4 Smoothness**

- **Smoothness** Performance data shows both control and microsurfacing exhibit a relatively smooth ride (Figure 4).

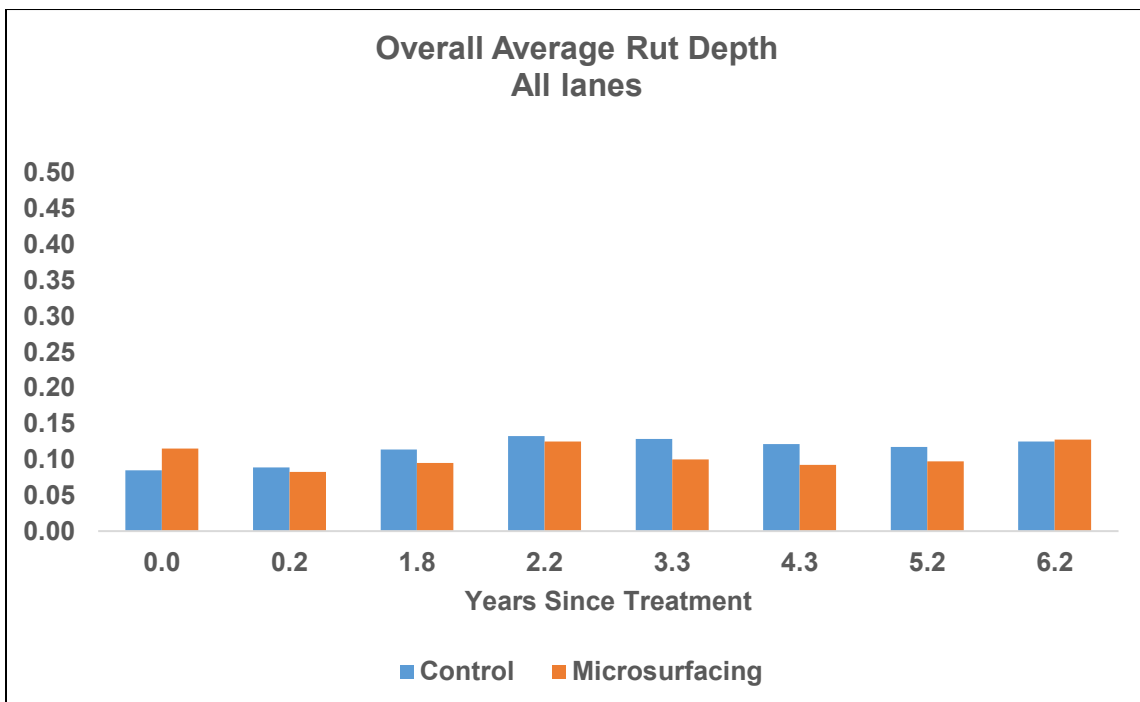
**FIGURE 5 Rutting**

- **Rutting** Rut depth data show no significant difference between micro surfacing and control sections (Figure 5).

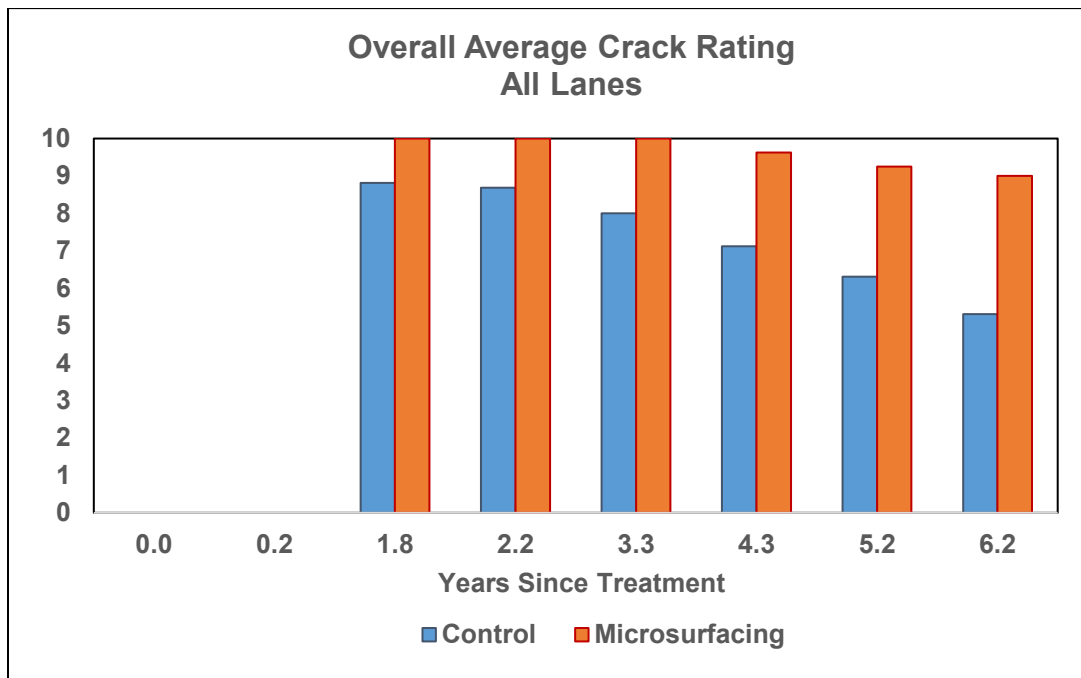
**FIGURE 6 Cracking**

- Cracking** 2019 cracking data shows little visible cracking distress and light patching in the micro surfacing sections. The control sections exhibited Class 2 and Class 3 cracking with light raveling, potholes, and patching, which initiated 1.5 years following construction. Some control sections were in worse condition than the rest particularly in the eastern end of the project (MP 2.075 to 2.970), with a crack rating of 5.5 in R1 and L2; also, the control section in the western end of the project in L2 (MP 0.665 to 1.155) had a crack rating of 4.5. The overall average crack rating in 2019 across sections was 9.3 for micro surfacing and 6.3 for control sections (Figure 6).

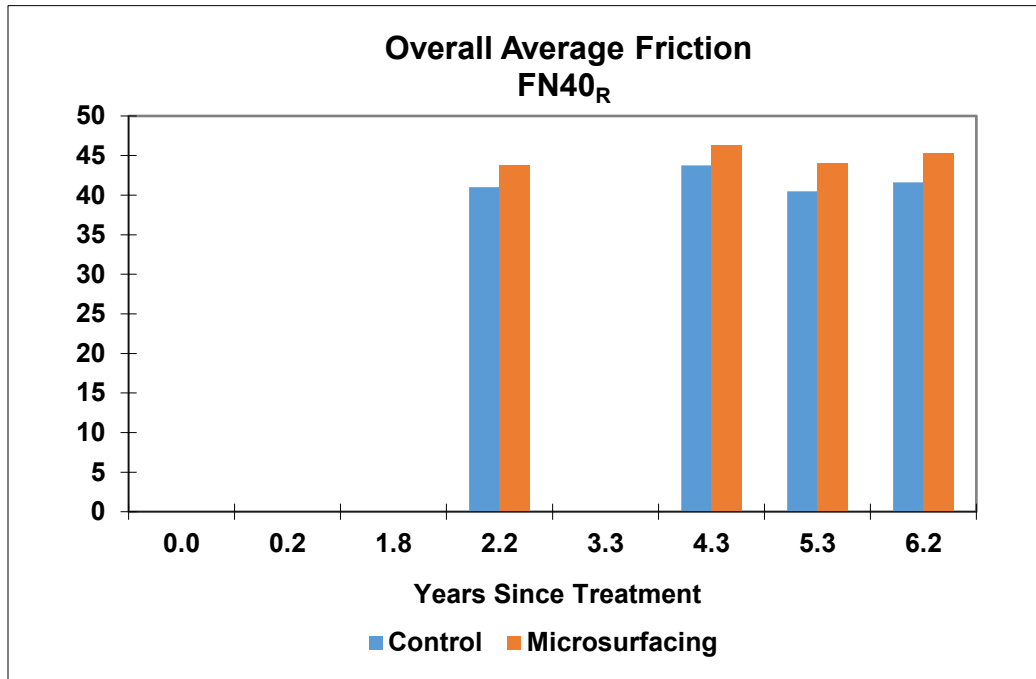
**FIGURE 7 Friction**

- Friction** Performance data was not collected in 2014 (pre and post construction), 2015, 2017, and 2020. Friction data show relatively higher overall FN for micro surfacing sections compared to control sections (Figure 7). In 2019,

after 5 years of service, FN value per test section ranged from 43 to 45 for micro surfacing, and 37 to 42 for control sections, with overall average FN of 44 and 41, respectively. The FN for all sections was above the minimum required threshold of 35.
