**State of Florida Department of Transportation  
PAVEMENT EVALUATION AND CONDITION DATA SHEET**

<b>Project No.:</b> 434417-1	<b>Cored By:</b> Elipsis Engineering and Consulting	<b>Date:</b> 10/22, 10/23, 10/24/14	<b>Page No.:</b> 1 of 3
<b>County:</b> Brevard	<b>Highway Sect. No.:</b> 70080	<b>From:</b> S. of George King Blvd	<b>To:</b> Section # 70070
<b>Road No.:</b> SR A1A	<b>Begin MP:</b> 3.149	<b>End MP:</b> 4.114	<b>Length:</b> 0.965 mile(s)

# Supplemental Data to PECD

FIN: 434417-1 Section 70080

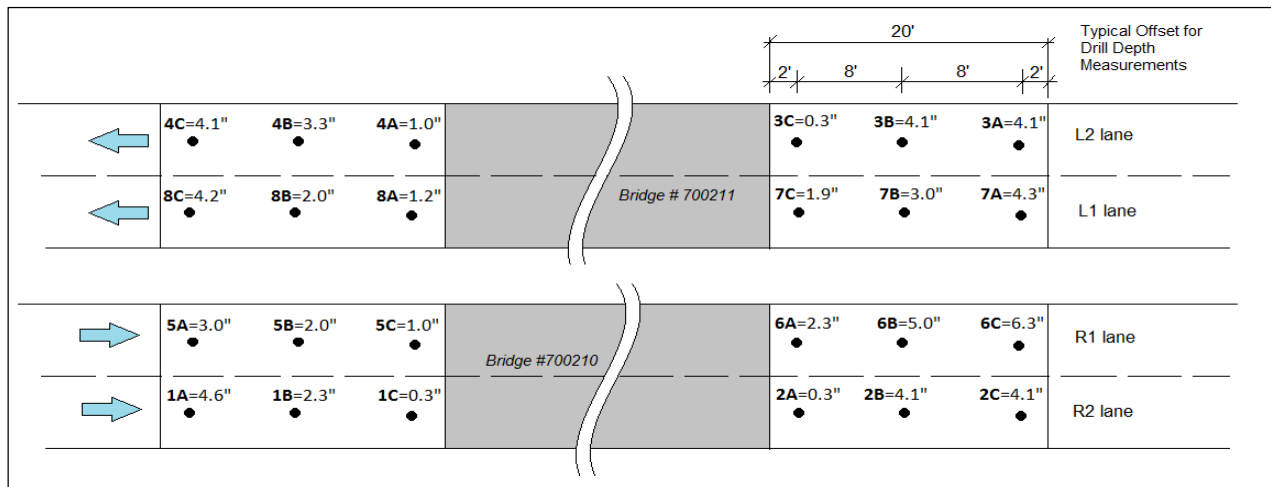
### Conceptual Layout of Drill Locations for Asphalt Thickness.

<u>L2 Lane</u>		<u>L1 Lane</u>	
Drill #	Asphalt Thickness	Drill #	Asphalt Thickness
3A	4.1"	7A	4.3"
3B	4.1"	7B	3.0"
3C	0.3"	7C	1.9"
Bridge # 700211			
4A	1.0"	8A	1.2"
4B	3.3"	8B	2.0"
4C	4.1"	8C	4.2"

<u>R1 Lane</u>		<u>R2 Lane</u>	
Drill #	Asphalt Thickness	Drill #	Asphalt Thickness
6C	6.3"	2C	4.1"
6B	5.0"	2B	4.1"
6A	2.3"	2A	0.3"
Bridge # 700210			
5C	1.0"	1C	0.3"
5B	2.0"	1B	2.3"
5A	3.0"	1A	4.6"

This pavement segments represents the maintenance repair work (with FC-12.5 asphalt) on both ends of the George King Boulevard Bridge. It is currently in good to fair condition. The approach slabs are overlaid in 2013 with new asphalt in the roadway lanes only. The shoulder areas of the approaches are bare concrete. This was due to settlement issues on both ends of the bridge. From the bridge inspection reports, it is noted that the approach slabs appear to have settled approximately 3 to 4 inches adjacent to the roadway transition. The settlement has caused the approach slabs to rotate leaving them up to 3/4" higher than the deck top at the end bent expansion joints. This has caused live load impacting of the bridge deck and approach slabs and it is most prevalent in the inside lanes (L1/R1) at both ends of the bridge. The maintenance repair work extended beyond the approach slabs by approximately 95 feet to ensure smooth ride while approaching/leaving the bridge deck.

In addition to the coring work, the crew obtained multiple drill depth measurements on the approach slabs. This work was done with a power drill and masonry drill bit. At the designated distance offset, the drilling was advanced down until it encountered the underlying Portland Cement Concrete. The drill bit was then marked at pavement surface level and pulled out. The depth of drill penetration was measured and noted in the core data sheets. As seen in the schematic diagram above, the asphalt thickness varies significantly. The thicker values at the far ends of the approach slabs is indicative of prior approach slab settlement and overlay repairs.
