**Florida Department of Transportation**  
**23 CFR Part 667**

Periodic Evaluation of Facilities Repeatedly  
Requiring Repair and Reconstruction Due to Emergency Events

**March 1, 2024**

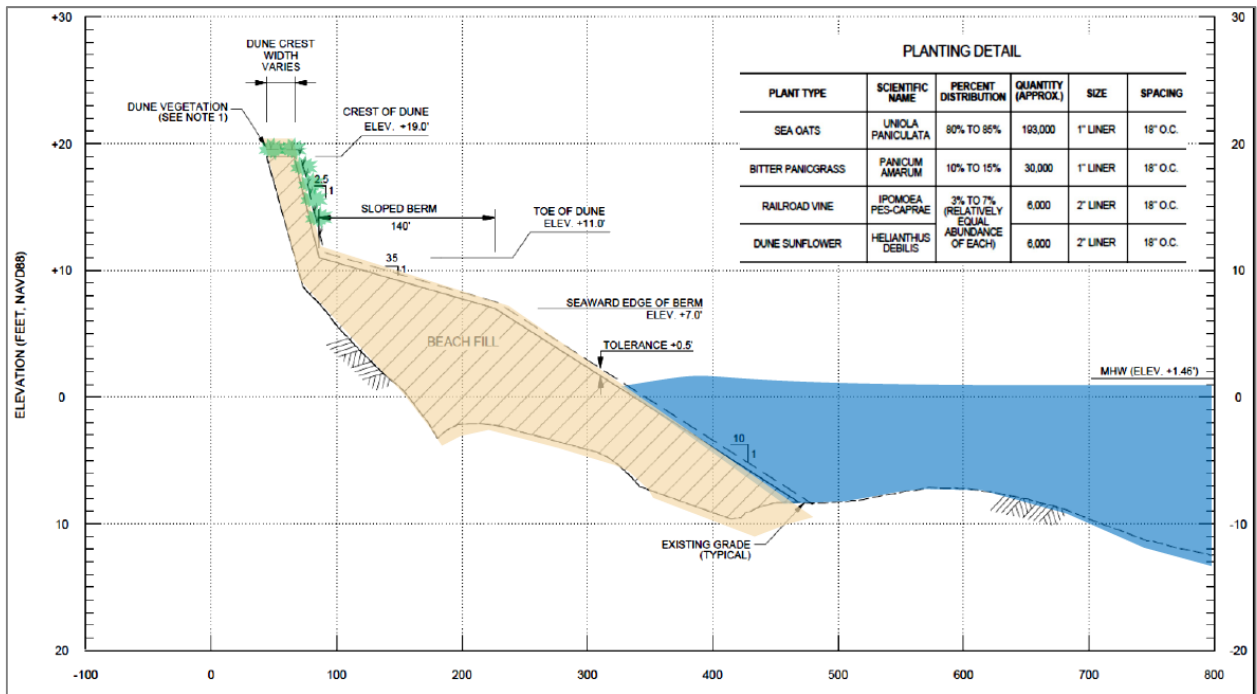
Figure 2: Beach Fill Typical Profile

This portion of the roadway is now part of the Flagler County Coastal Storm Risk Management Project/USACOE. The anticipated cost for this Army Core project is \$17,494,000 with a duration of 365 days and has a 50-year design life. This project will require 4 periodic renourishments within locations 3 & 4. Funding has yet to be determined.

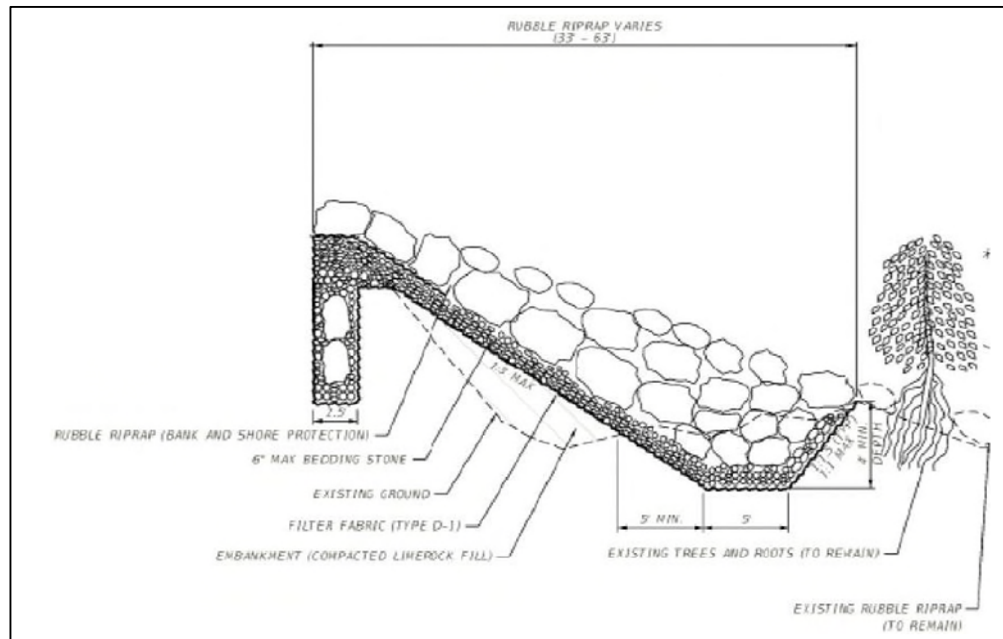
Figure 3: Rubble Riprap Restoration Repair Detail

The majority of the damage caused by recent hurricane storms consists of roadside slope/embankment erosion/washout that primarily affected the roadside. However, in specific situations it also impacted the shoulder and/or mainline. With the exception of the Sea Oats Beach limits located within the Village of Islamorada (MM 74.2 to MM 75.2), geotechnical studies recommended for the reconstruction of these impacted locations to include rubble riprap trench anchors (vertical trenches at the bottom and top of the slope) that provide extra protection against undermining from future storms. The recommended rubble riprap design (Figure 2) would have an estimated construction cost of approximately \$1.8M/mile.

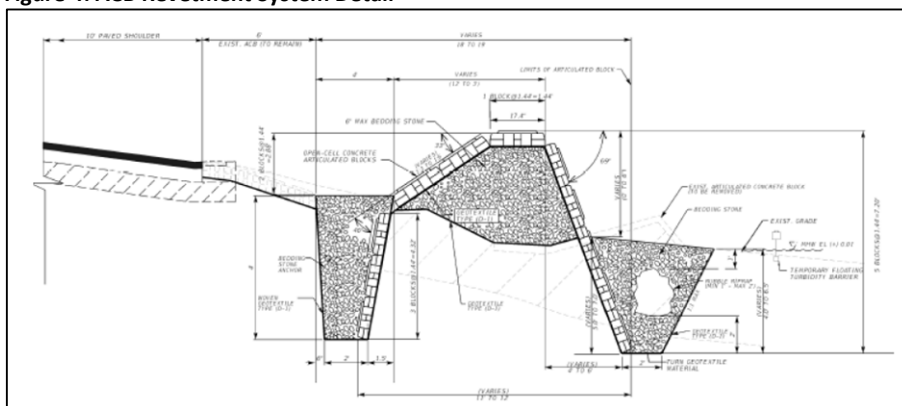
Figure 4: ACB Revetment System Detail

The Sea Oats Beach limits repairs will include an Articulating Concrete Block (ACB) revetment system (Figure 3). The system was requested by the Village of Isla Morada for this specific site conditions that includes but is not limited to environmental consideration for sea turtles.

The ACB revetment system is not adequate for other corridor locations that entail embankment erosion/washout repairs. The recommended ACB design would have an estimated construction cost of approximately \$1.3M/mile.
