Florida Department of Transportation

23 CFR Part 667

Periodic Evaluation of Facilities Repeatedly
Requiring Repair and Reconstruction Due to Emergency Events

March 17, 2025

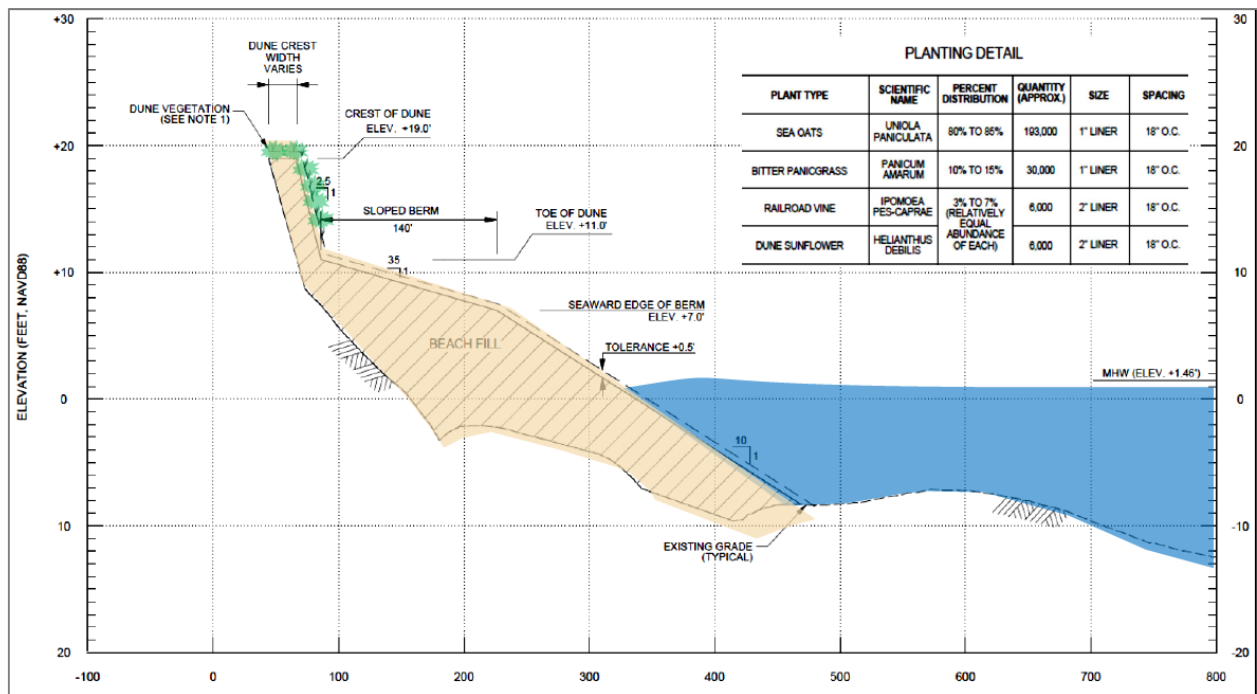
Figure 2: Beach Fill Typical Profile

This portion of the roadway is now part of the Flagler County Coastal Storm Risk Management Project/USACOE. The anticipated cost for this Army Core project is \$17,494,000 with a duration of 365 days and has a 50-year design life. This project will require 4 periodic renourishments within locations 3 & 4. Funding has yet to be determined.

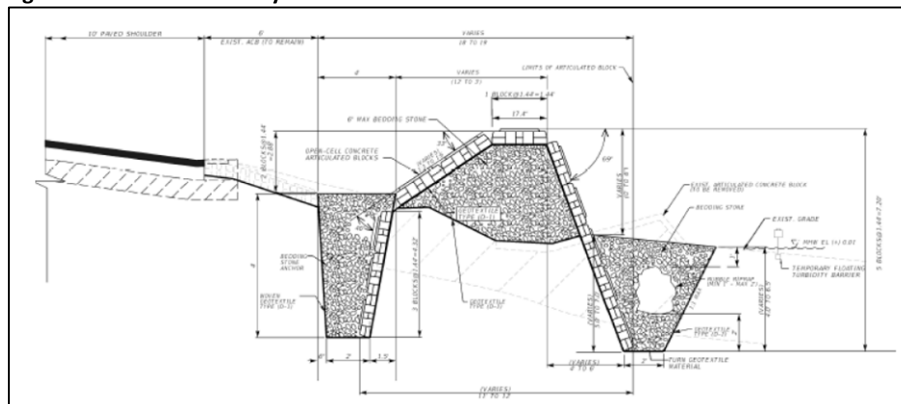
Figure 4: ACB Revetment System Detail

The ACB revetment system is not adequate for other corridor locations that entail embankment erosion/washout repairs. The recommended ACB design would have an estimated construction cost of approximately \$1.3M/mile.
