Florida Department of Transportation

23 CFR Part 667

Periodic Evaluation of Facilities Repeatedly
Requiring Repair and Reconstruction Due to Emergency Events

April 01, 2026

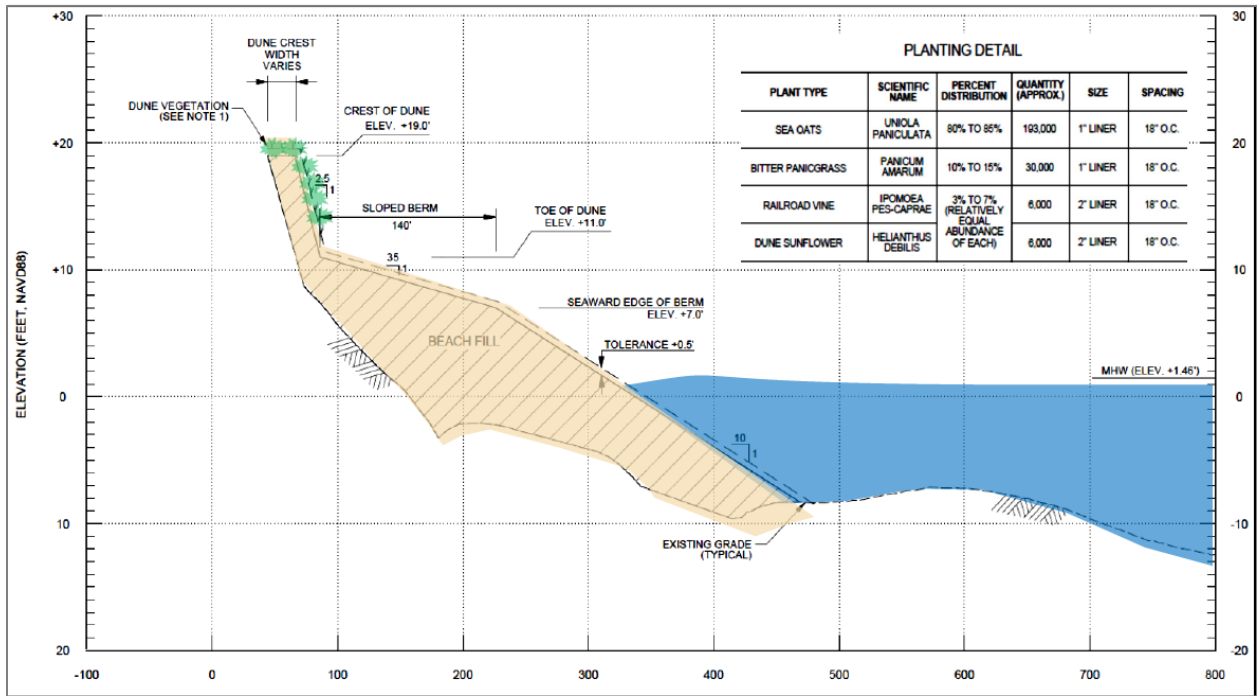
Figure 2: Beach Fill Typical Profile

This portion of the roadway is now part of the Flagler County Coastal Storm Risk Management Project/USACOE. The anticipated cost for this Army Core project is \$17,494,000 with a duration of 365

days and has a 50-year design life. This project will require 4 periodic renourishments within locations 3 & 4. Funding has yet to be determined.

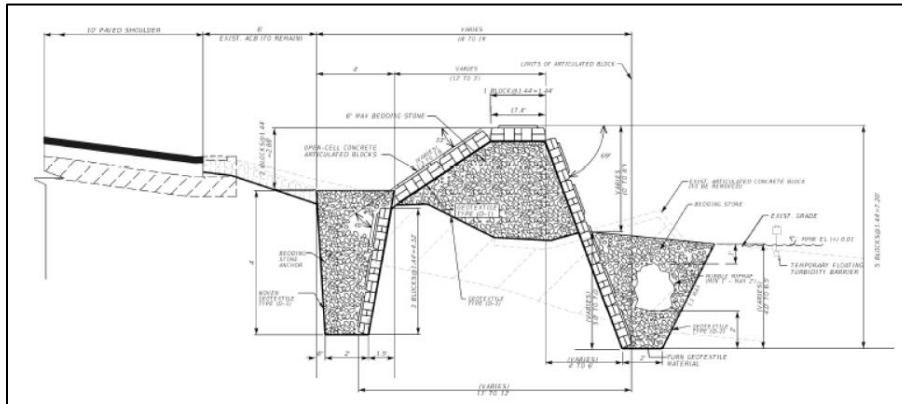
Figure 4: ACB Revetment System Detail

The ACB revetment system is not adequate for other corridor locations that entail embankment erosion/washout repairs. The recommended ACB design would have an estimated construction cost of approximately \$1.3M/mile.
