DRAINAGE COMPLAINT

S.R. 29 From North of S.R. 78 to Chaparral Slough (M.P. 4.709 – 6.877)

Reference No. 05090-1

January 2010

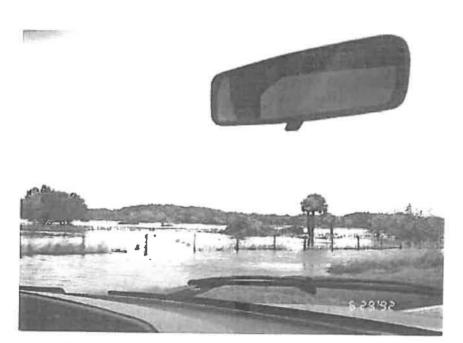
SR 29 - Between Bridge 050033 and SR 78 on June 29, 1992 - wet season.

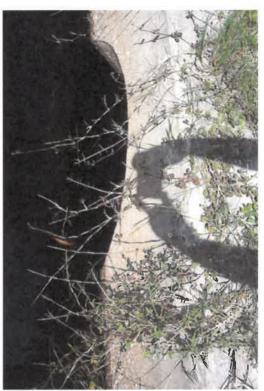
Staining on headwall on east side of cross drain.

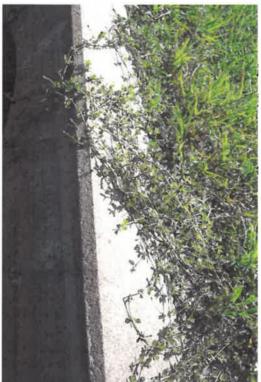
Headwall on west side of cross drain.

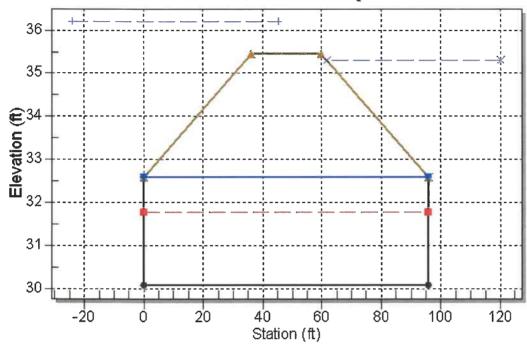
Water Surface Profile Plot for Culvert: Culvert 1

The existing triple 30" cross drain is clearly undersized. It overtops the roadway well before the 25 year design flood of 94.35 cfs. The existing triple 36" pipe has enough capacity to handle flow rates higher than the 50 year design flood.

Crossing - Triple 30" Cross Drain, Design Discharge - 104.1 cfs Culvert - Culvert 1, Culvert Discharge - 74.7 cfs

Therefore, the recommended temporary improvements to this area includes de-silting of the existing pipes and ditches, replacing the existing triple 30" pipes with quadruple 48" pipes at the first cross drain and replacement of the existing triple 36" pipes to the north due to failing joints.

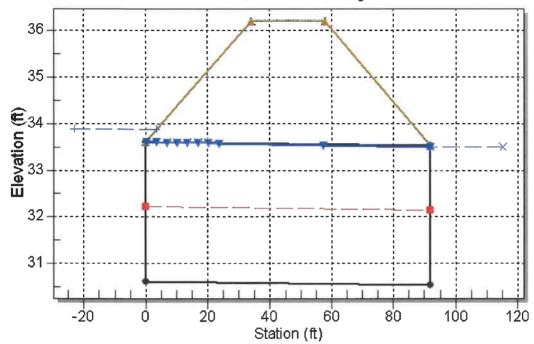
Water Surface Profile Plot for Culvert: Culvert 1

Crossing - Triple 36" Cross Drain, Design Discharge - 73.9 cfs Culvert - Culvert 1, Culvert Discharge - 73.9 cfs

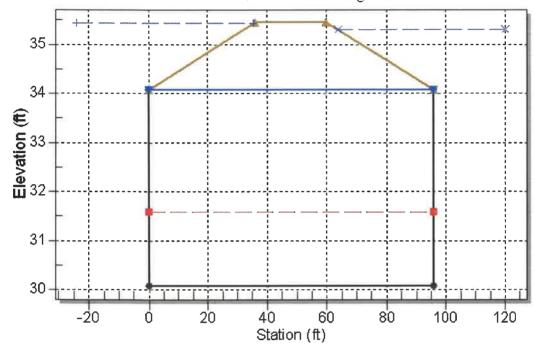
Water Surface Profile Plot for Culvert: Culvert 1

Crossing - Quadruple 48" Cross Drain, Design Discharge - 104.1 cfs Culvert - Culvert 1, Culvert Discharge - 104.1 cfs

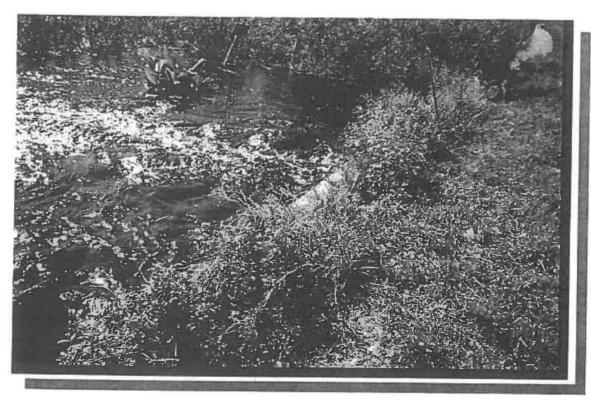
LOOKING SOUTH ALONG S.R. 29 AT (3) 30" RCP APPROXIMATELY STA. 354+00

- The location of the (3)-30" pipes offers a more efficient path for removal of flood waters than either Lone Pine Creek or Chaparral Slough. This is apparent from the photographs of flooding. It is obvious that the tailwater stages at this site are 2' to 3' below upstream stages. Low velocities at the bridge, observed during flood events, indicate losses through the bridges are low. If the headwaters are near 35.5, as shown in the photograph, then the tailwaters at the bridges are much closer to the 35.5 than at the pipes. An examination of the USGS Quadrangle map adds further support to the hypothesis that tailwater stages are lower at the pipes than at the two bridges. Based on these facts, the original design may not have been the most hydraulically effective. Clearly, the most certain remedy for the flood condition is a significant enlargement of the (3)-30" pipes, however such alteration can have far reaching impacts. The increased discharge rate downstream would require concurrence of property owners and the Water Management District.

Step two is to be implemented if the side drain enlargement does not reduce flooding to an acceptable level. It requires replacement of the (3)-30" cross drain pipes with a box culvert. This modification will involve design, permitting, and possible acquisition of flood rights from downstream property owners.
