DRAINAGE COMPLAINT

S.R. 29

**From North of S.R. 78 to Chaparral Slough
(M.P. 4.709 – 6.877)**

Reference No. 05090-1

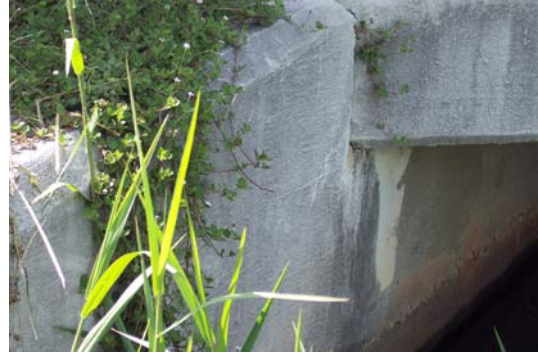
Ditch on northwest side of bridge.

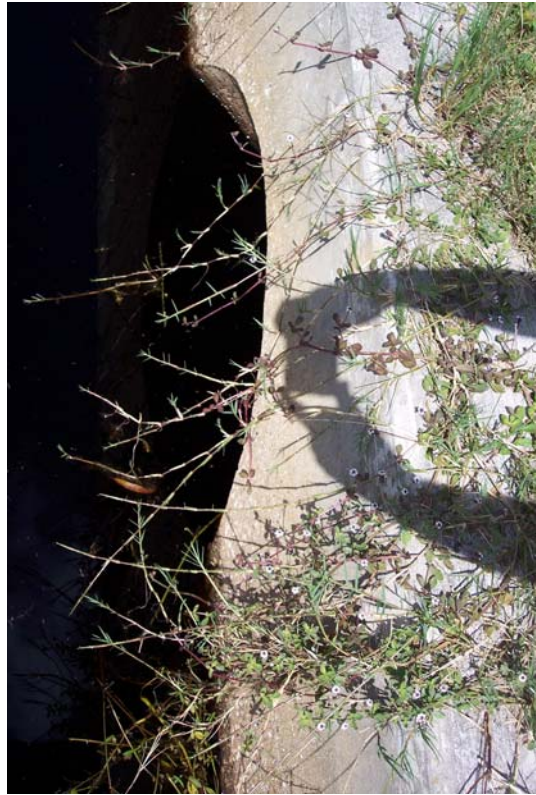
Erosion at headwall on east side of cross drain.

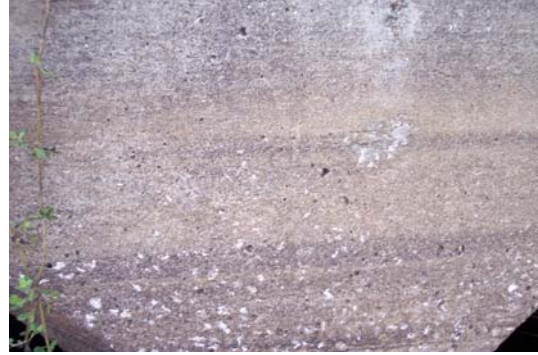
Headwall on west side of cross drain.

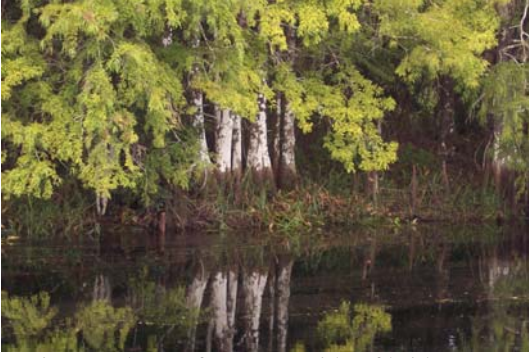
Facing west from west side of bridge.

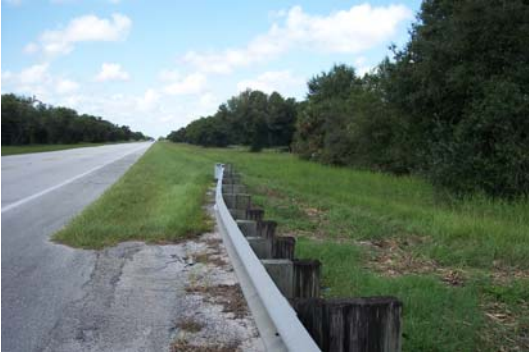
Facing southwest from west side of bridge. Trees appear to have water stains pretty high.

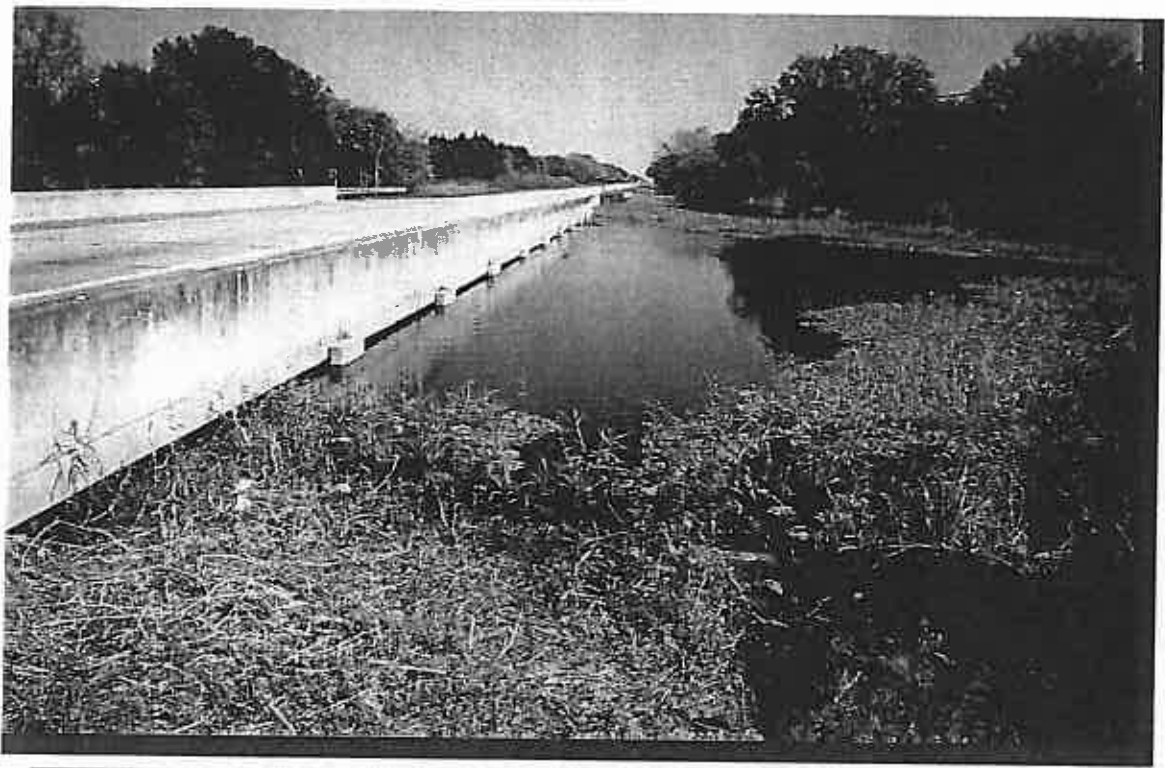
LOOKING NORTHEAST ALONG S.R. 29 AT CHAPARRAL SLOUGH BRIDGE

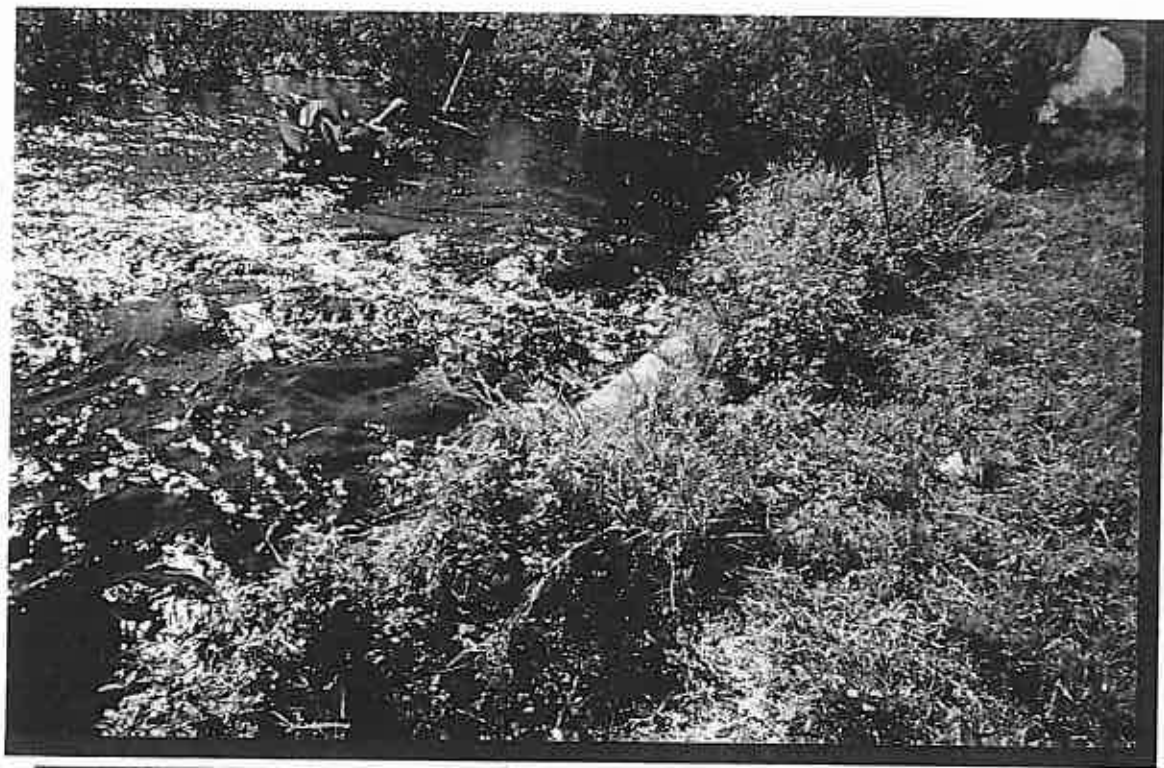
LOOKING SOUTH ALONG S.R. 29 AT (3) 30" RCP APPROXIMATELY STA. 354+00

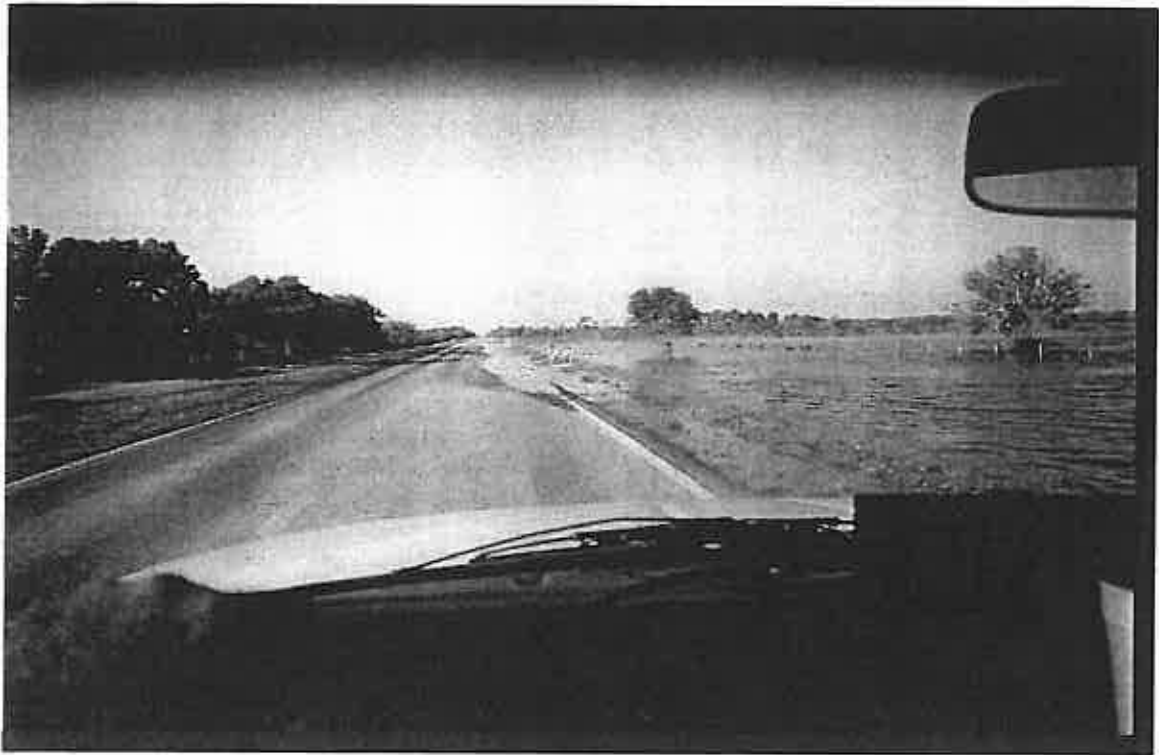
**LOOKING SOUTHWEST ALONG S.R. 29 BETWEEN LONE PINE CREEK AND
CHAPARRAL SLOUGH**

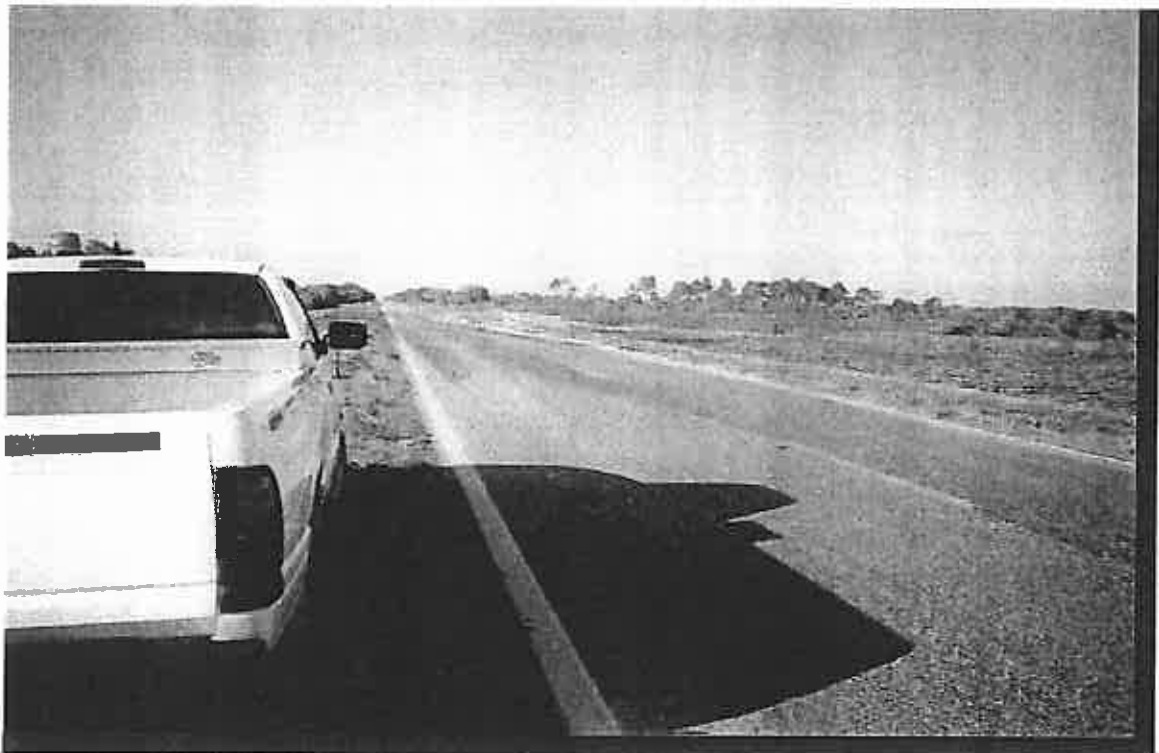
**LOOKING SOUTHWEST ALONG S.R. 29 BETWEEN LONE PINE CREEK AND
CHAPARRAL SLOUGH**

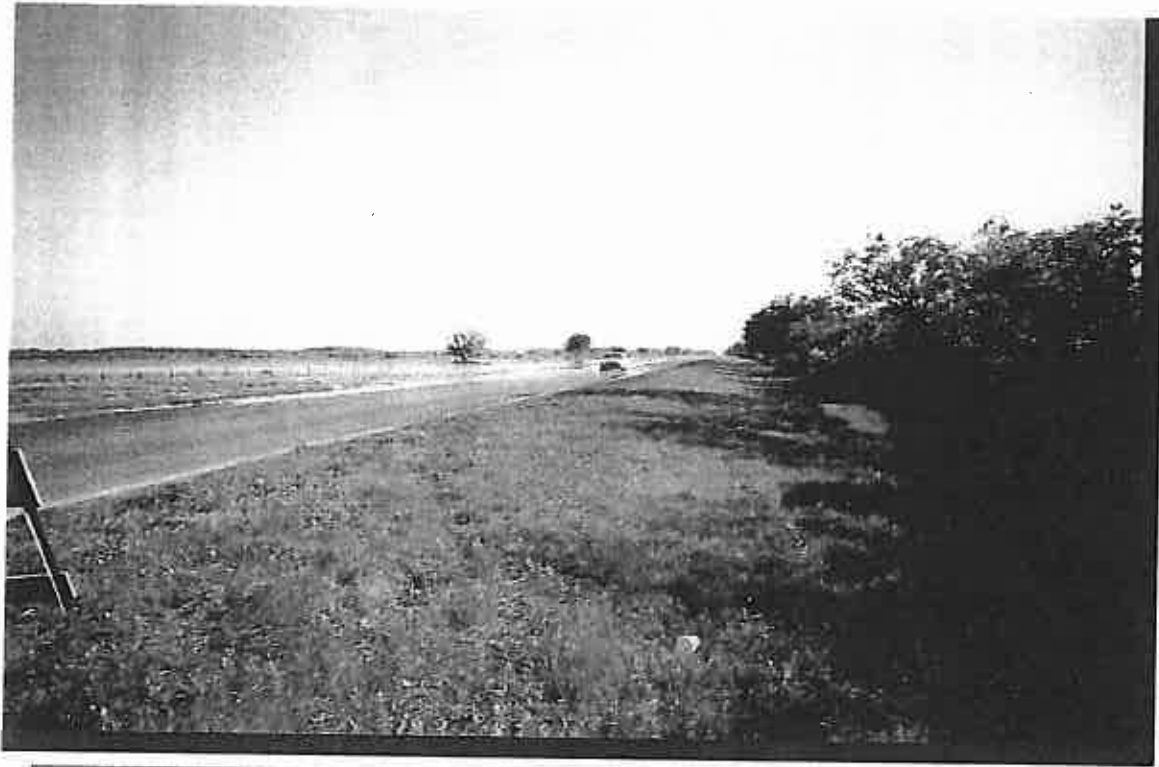
**LOOKING NORTHEAST ALONG S.R. 29 BETWEEN LONE PINE CREEK AND
CHAPARRAL SLOUGH**

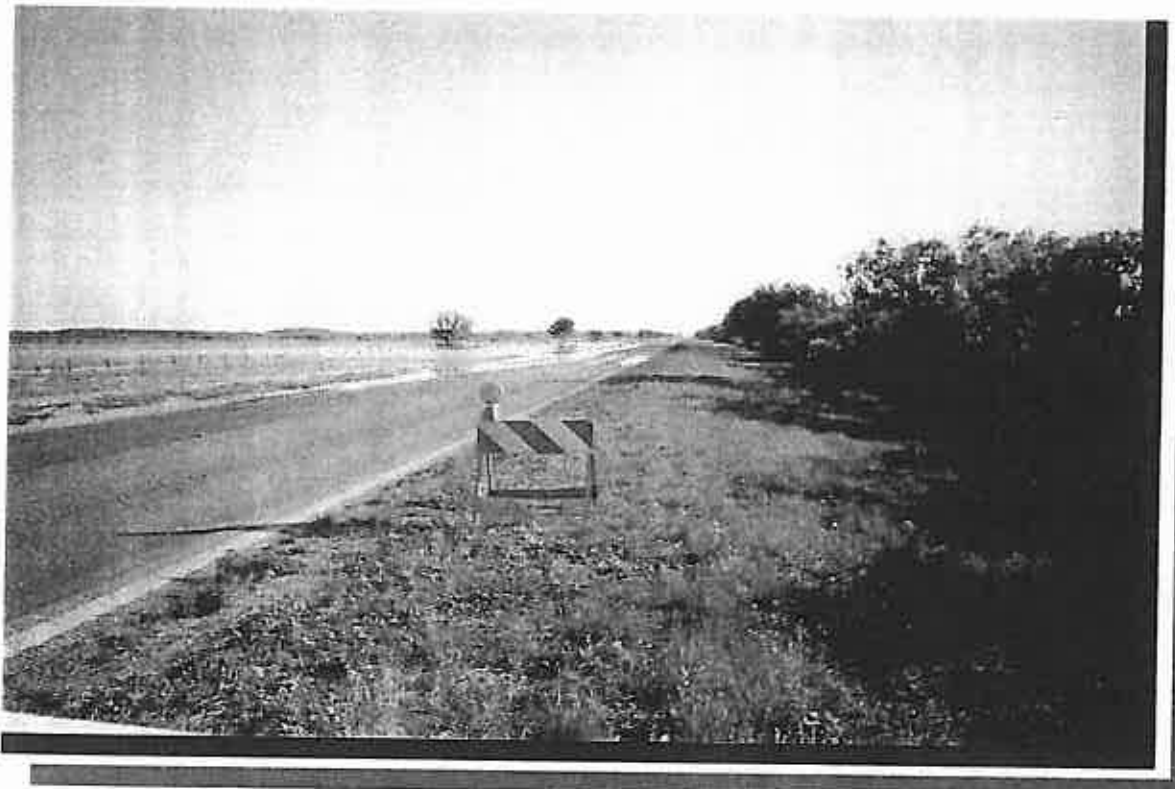
**LOOKING NORTHEAST ALONG S.R. 29 BETWEEN LONE PINE CREEK AND
CHAPARRAL SLOUGH**
