# SCOPING REPORT

SR 5 / US 1 / BISCAYNE BOULEVARD  
FROM SOUTH OF NE 38<sup>TH</sup> STREET TO NE 61<sup>ST</sup> STREET  
(87030000 MP 13.588-15.048)  
MIAMI-DADE COUNTY, FLORIDA

FPID 250759-3-22-04

May 2023

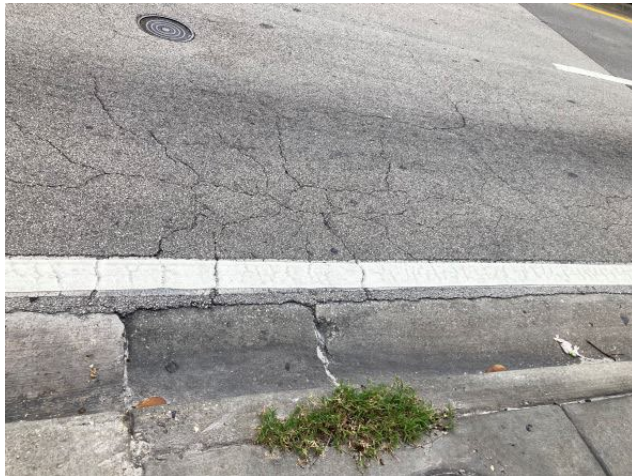
After conducting a field review on the pavement condition (PC), surface deteriorations were encountered, such as cracking, and utility cuts. The pavement condition was reviewed in the Pavement Condition Survey (PCS) Ratings by State Materials Office (SMO) 2022. According to the PCS, the survey along the corridor resulted in a ride evaluation of 6.3 (northbound) and 6.5 (southbound) with a projection that this value will reduce to 6.2 and 6.0 in 2027, respectively. The cracking evaluation shows a 9.0 (northbound) and 8.5 (southbound) with a projection of 8.3 and 7.7 in 2027, respectively. Refer to Appendix D-1. The following images illustrate samples of the different type of surface deterioration encountered during the field review.

**1. CRACKS ON ASPHALT**

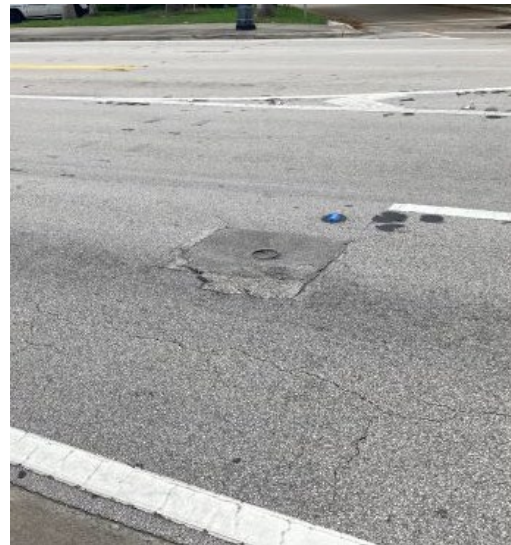
**2. UTILITY PATCH ON ASPHALT**

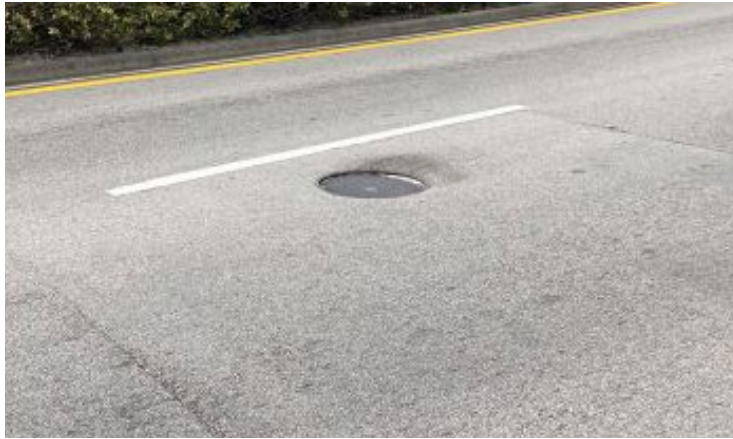
**3. SUNK MANHOLE**

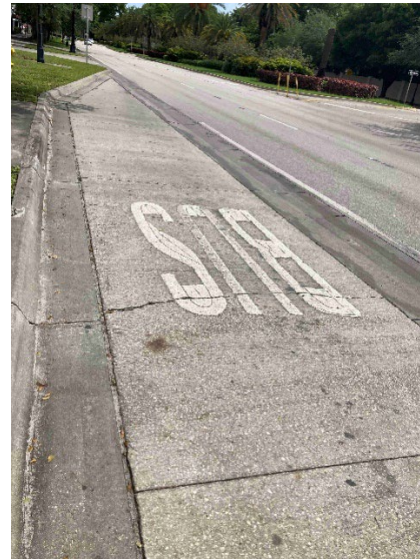
**4. CRACKS ON PCC**

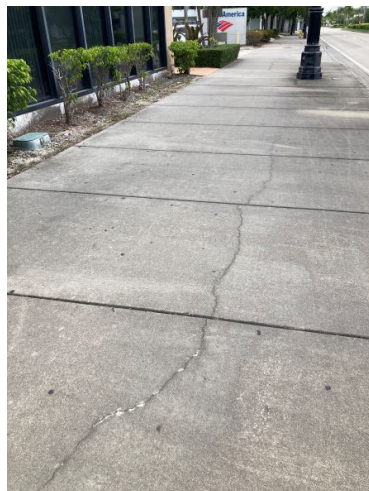
Cracks on sidewalk. Sta 143+00 LT

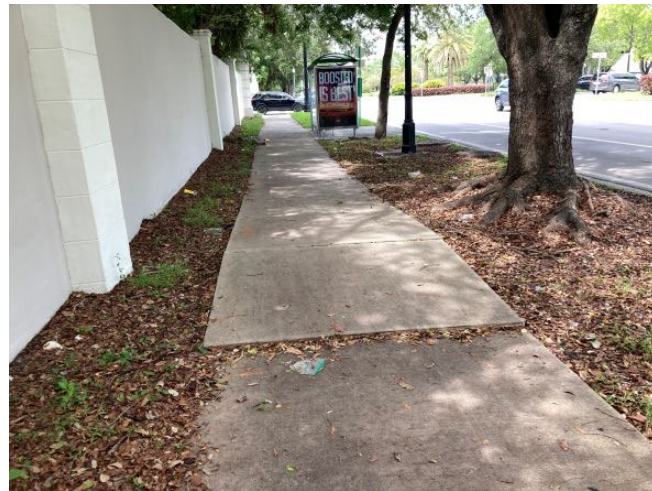
Uneven sidewalk. Sta 125+39 RT

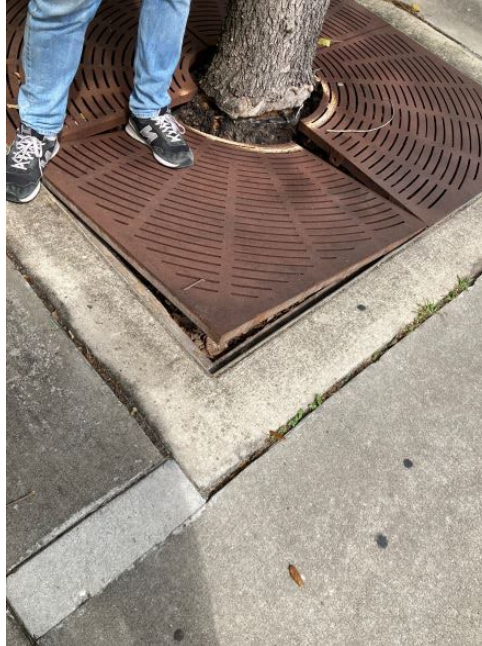
Tripping hazard. Typ.
