FEBRUARY 2022

# SEVEN MILE BRIDGE 900101 REPLACEMENT REPORT

FDOT DISTRICT SIX STRUCTURES MAINTENANCE OFFICE

PREPARED BY BARBARA KING-RUSSEL, P.E.  
REVIEWED BY PABLO OROZCO, P.E. & GEIDY COELLO, P.E

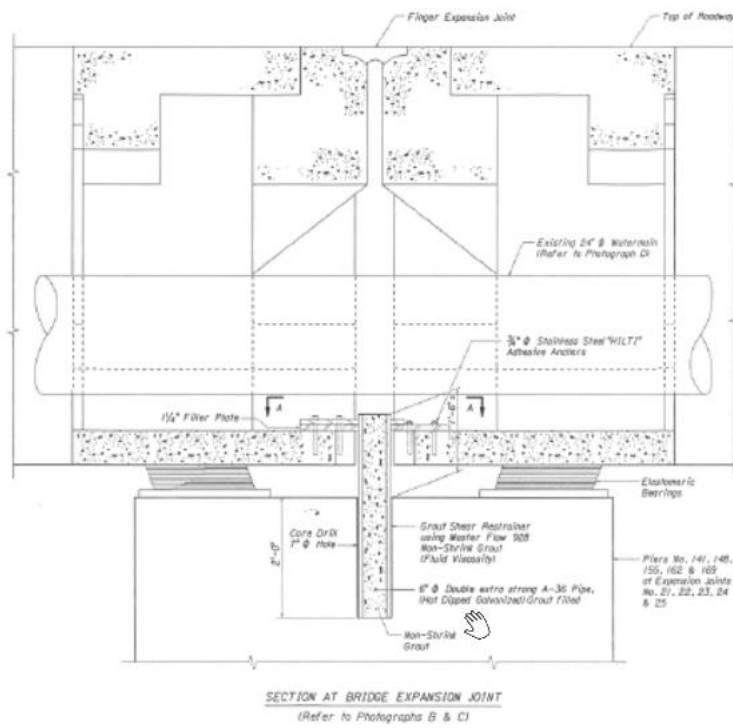
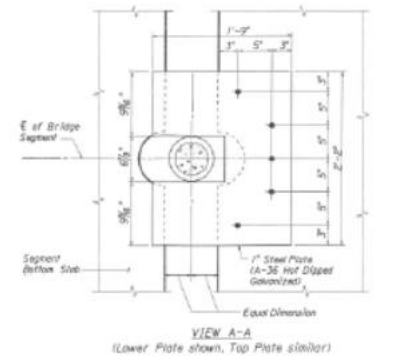
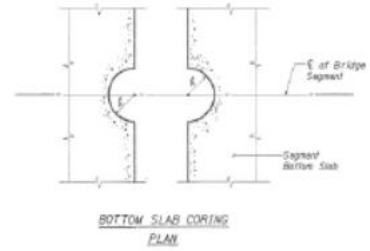
Figure 3.1

- Superstructure movements caused by high wind events necessitated bearing replacements (jacking required), as well as expansion joint replacements. Shear restrainers were also added to minimize further transverse movement of the superstructure. In addition, lateral movements caused the original concrete restrainers to impact the top of columns, initiating spalling and cracking at the tops of columns.

1999: Shear Restrainers (Figure 3.1) were added to address the superstructure lateral movement, as shown below. Additionally, expansion joint (finger joints) hardware was replaced and reset due to superstructure movement during hurricane winds.
