US 29 from W. Burgess Road to Old Chemstrand Road

PRELIMINARY FREIGHT CORRIDOR SCREENING US 29 (W. Burgess Road to CR 297 (Old Chemstrand Road))

N. Palafox Street (SR 95) from W. Leonard Street to Brent Lane

US 90 from Avalon Boulevard to SR 87 South

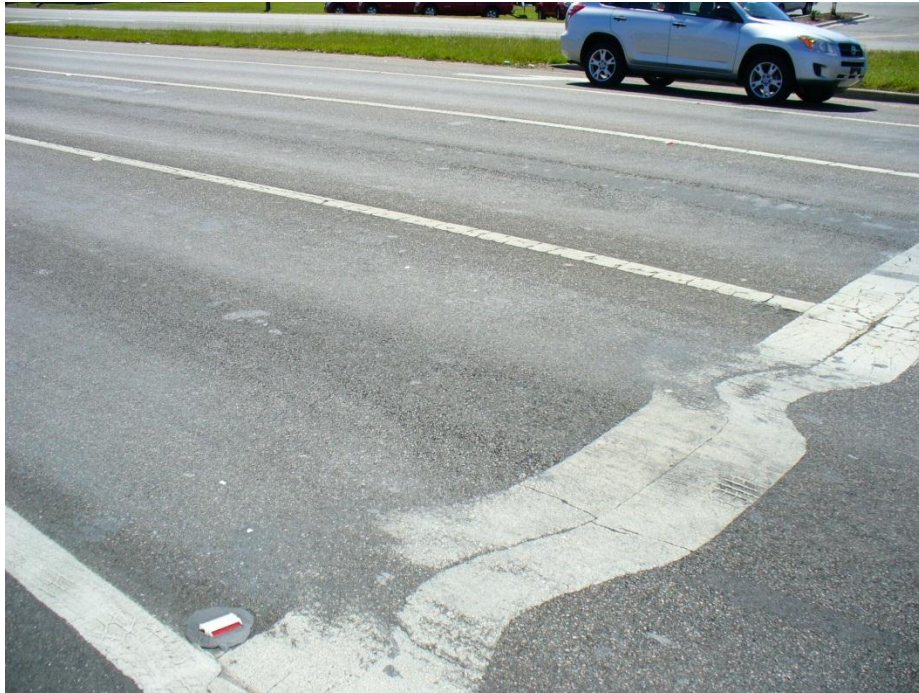
There is major and minor rutting at the northbound and southbound approaches to W. Burgess Road that continue through the intersection (see Photo 1 in Appendix 3). There is also major rutting in the southbound to westbound right-turn lane. To a lesser extent, similar rutting conditions were noted at Broad Street, W. 10 Mile Road, E. Kingsfield Road, and at Old Chemstrand Road.

Major and minor rutting at the northbound and southbound approaches to W. Burgess Road

- Perform maintenance to remove and resurface rutted sections of the roadway at the approaches of all signalized intersections. (FA1)
- Off-tracking by trucks has resulted in damage to the pavement edges and soft shoulders at various intersections identified in the discussion above. Consider repairing and extending corner shoulder pavement to provide a solid road surface for right turning trucks and other vehicles. Priority should be given to the southeast corner of W. Hood Drive, which has been patched several times. As noted in Photo 1 in Appendix 3, water pooling is also an issue at this corner which leads to the Wal-Mart unloading docks. (FA2)

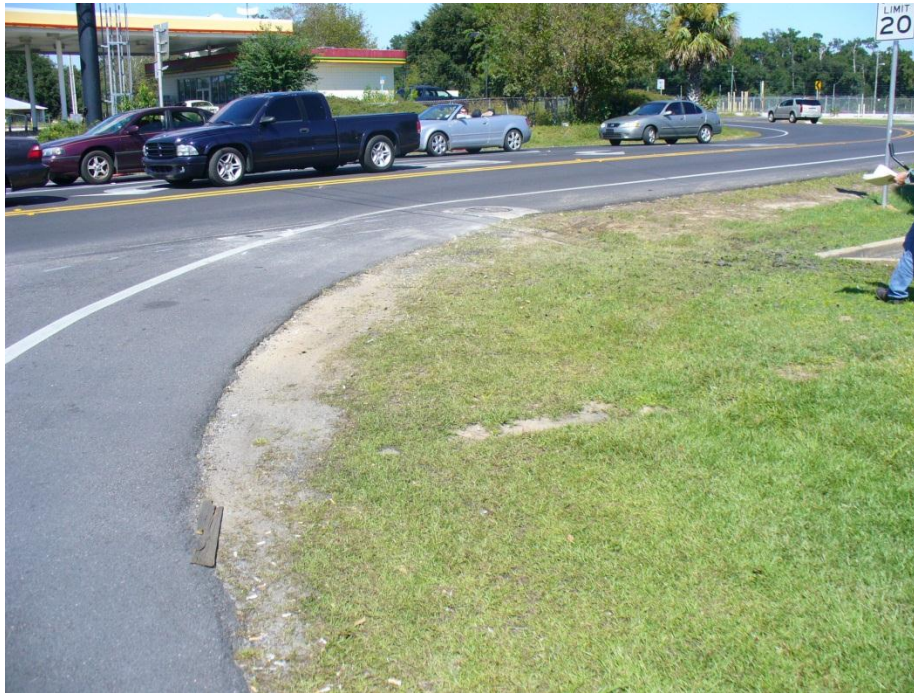
Traffic signals at W. Burgess Road are mounted on mast arms (see Photo 2 in Appendix 3). At Diamond Dairy Road, the signals are strain pole mounted. The curb at the southbound inside left-turn lane has been damaged by off-tracking at W. Burgess Road. There is similar off-tracking damage at the southeast quadrant (see Photo 3 in Appendix 3).

The curb at the southeast quadrant has been damaged by off-tracking at W. Burgess Road

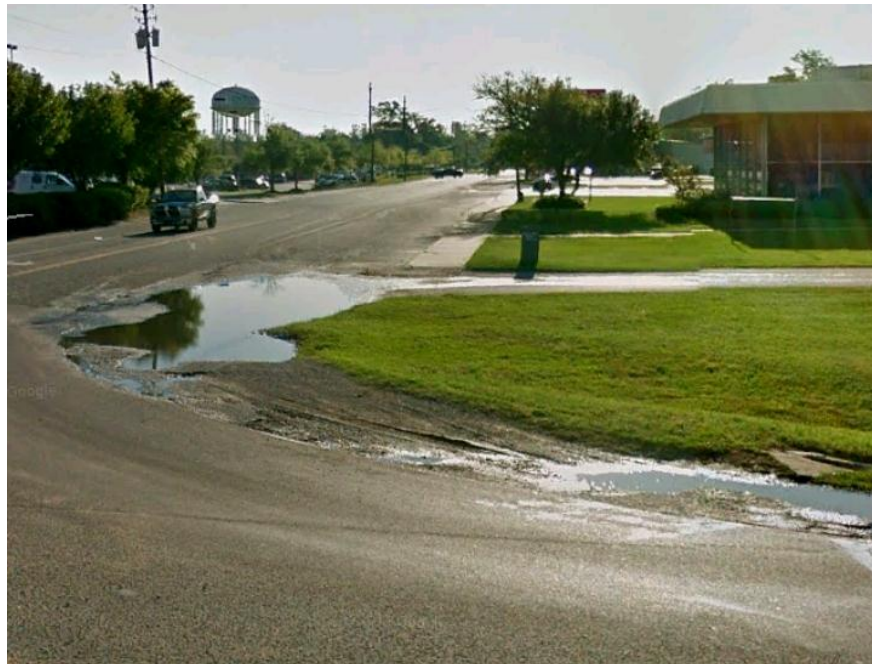
Photo 4

The EOP at the southeast quadrant of W. Hood Drive is severely deteriorated and retains pooling water

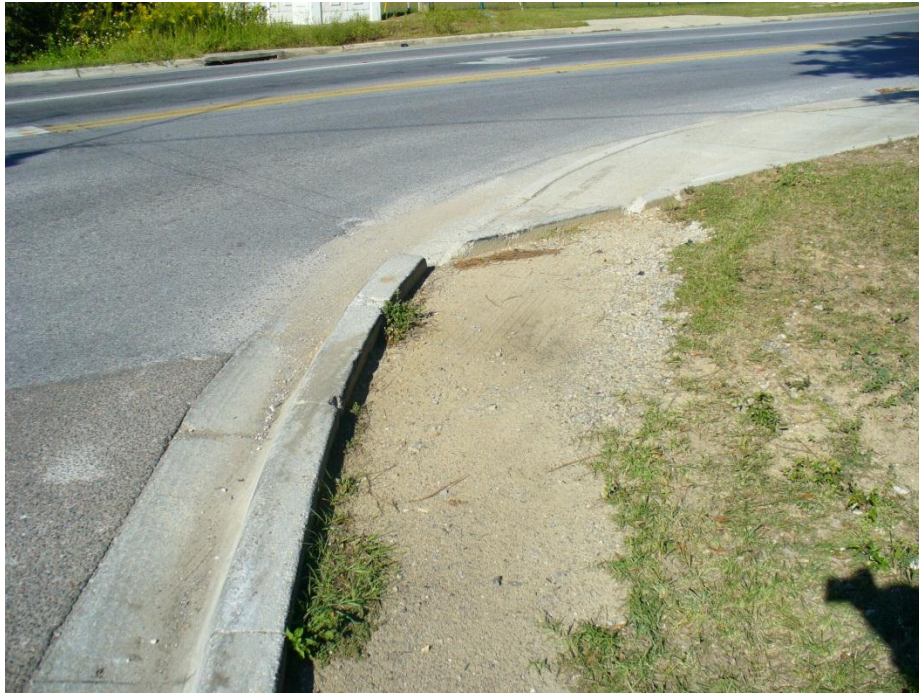
- At W. 10 Mile Road, corner shoulder damage was noted at all quadrants, the sidewalk was crushed/severely cracked, and the utility pole was damaged at the southeast quadrant due to off-tracking.

Traffic signals at W. 10 Mile Road are strain pole mounted. The southeast quadrant at W. 10 Mile Road has concrete curbing around the corner and a sidewalk located east of the intersection. Both the curbing and the sidewalk are damaged due to off-tracking vehicles (see Photo 5 in Appendix 3). There is also a damaged traffic signal strain pole (see Photo 6 in Appendix 3). The northwest and southwest quadrants have paved shoulders with the EOP severely damaged. Medians are grass drainage swales with no curbing.

The southeast quadrant at W. 10 Mile Road has curbing and sidewalk damage due to off-tracking vehicles

- While off-tracking was noted at all corners of W. 10 Mile Road, the southeast corner is especially bad with crushed curbing and sidewalks and a slightly damaged utility pole. If possible, adjust the corner radius and replace the damaged infrastructure including the possible relocation of the utility pole. (FA3)

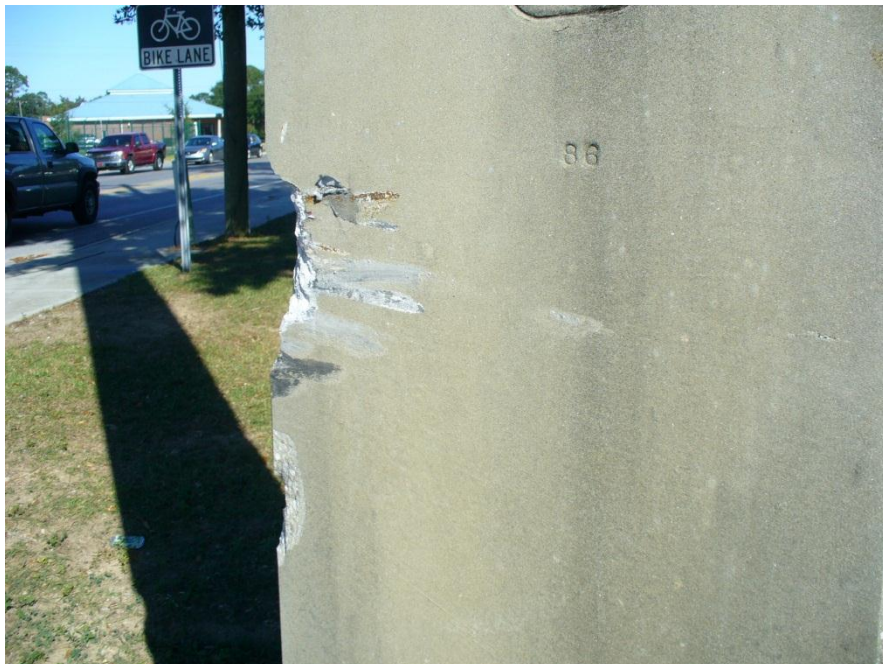
Photo 6

The southeast quadrant at W. 10 Mile Road has a damaged traffic signal strain pole

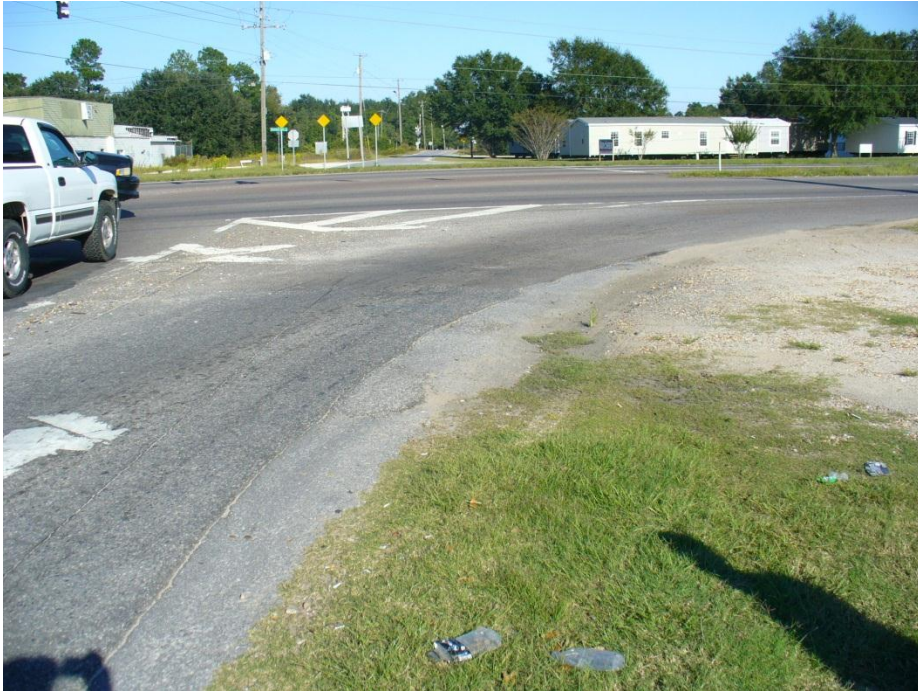
Traffic signals at W. Roberts Road are mounted from concrete strain poles that are set back more than 10 feet from the highway. Corners lack curbing or sidewalks and the EOP is damaged due to off-tracking (see Photo 7 in Appendix 3).

Corners at W. Roberts Road lack curbing. Sidewalks are damaged due to off-tracking.

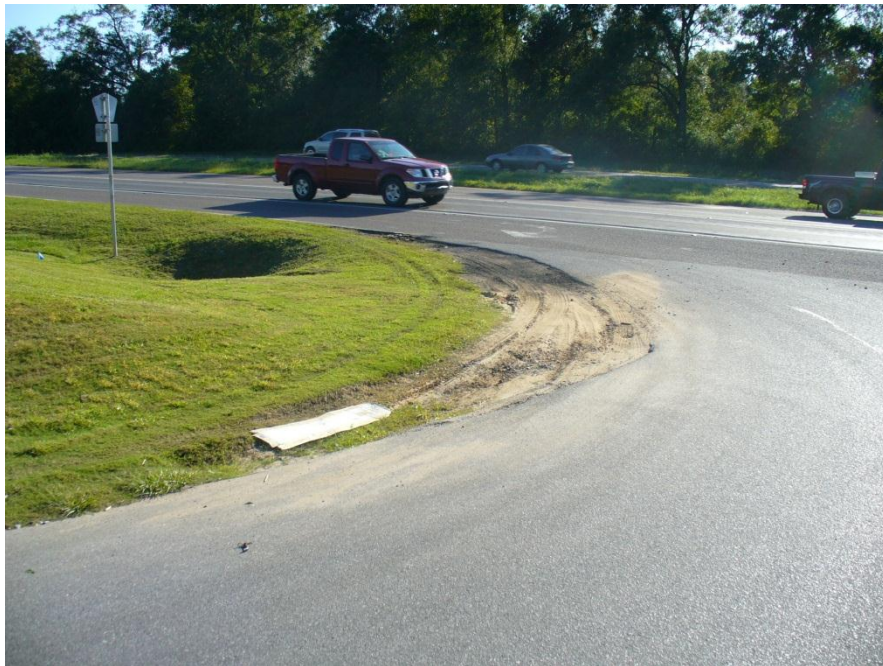
Photo 8

The traffic signals at E. Kingsfield Road and at Tate School Road are mounted on concrete strain poles. The signals at Old Chemstrand Road are mounted on mast arms. The paved corner shoulders at all four quadrants of E. Kingsfield Road are damaged (see Photos 8 and 9 in Appendix 3). Off-tracking at the northeast and southeast quadrants at Old Chemstrand Road has resulted in deep rutting of the soft shoulder and has damaged the concrete drain openings (see Photo 10 in Appendix 3). The railroad crossing located immediately east of N. Palafox Road causes occasional queues to back up to US 29.

The paved corner shoulders at all four quadrants of E. Kingsfield Road are damaged

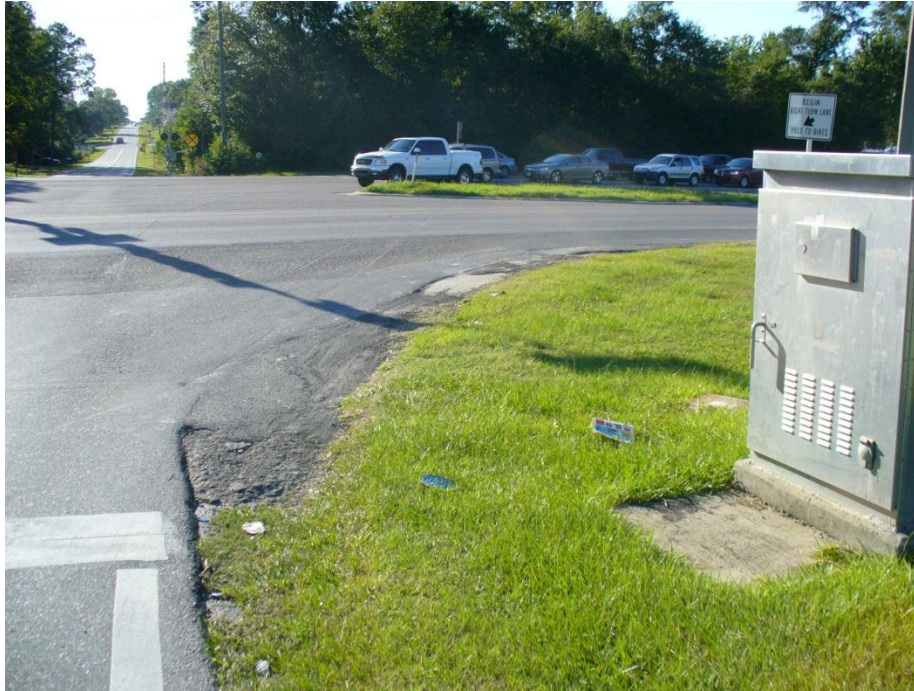
Photo 9

The paved corner shoulders at all four quadrants of E. Kingsfield Road are damaged

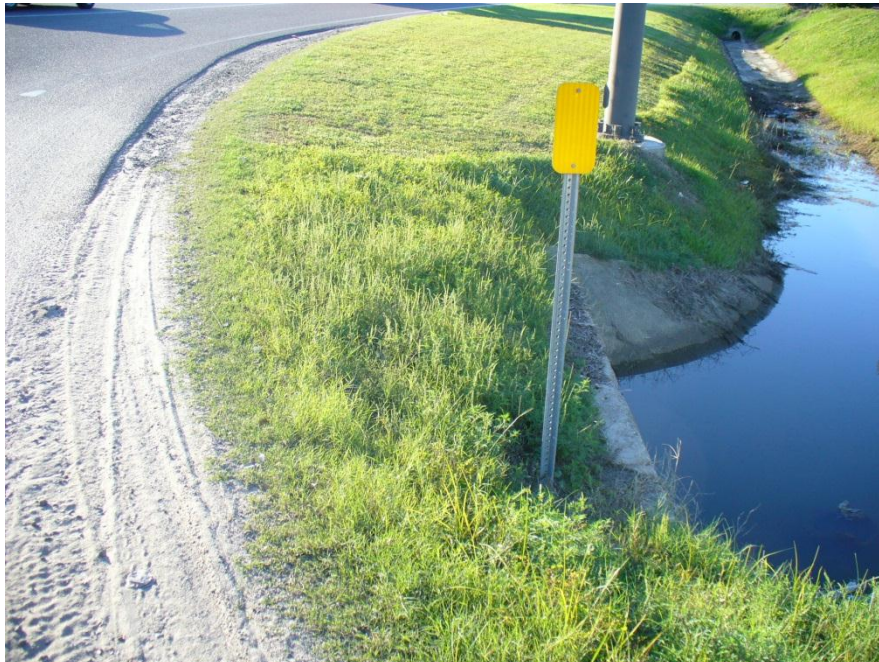
Photo 10

The northeast and southeast quadrants at Old Chemstrand Road has deep rutting of the soft shoulder and has damaged the concrete drain openings caused by off-tracking

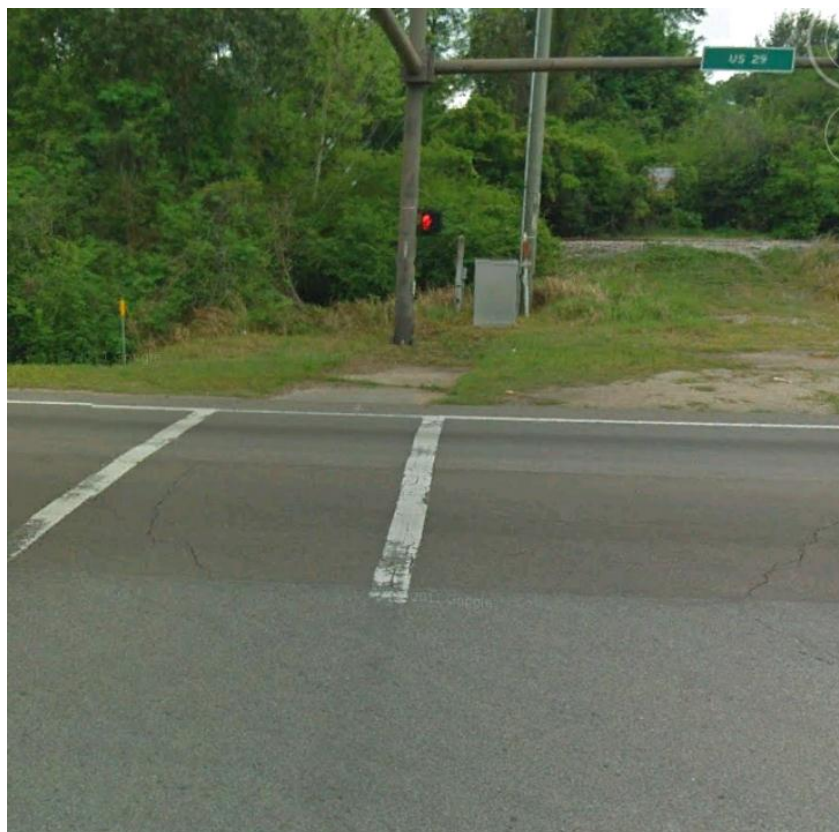
Photo 12
The crosswalk across US 29 does not connect to land use that would justify signal activation features

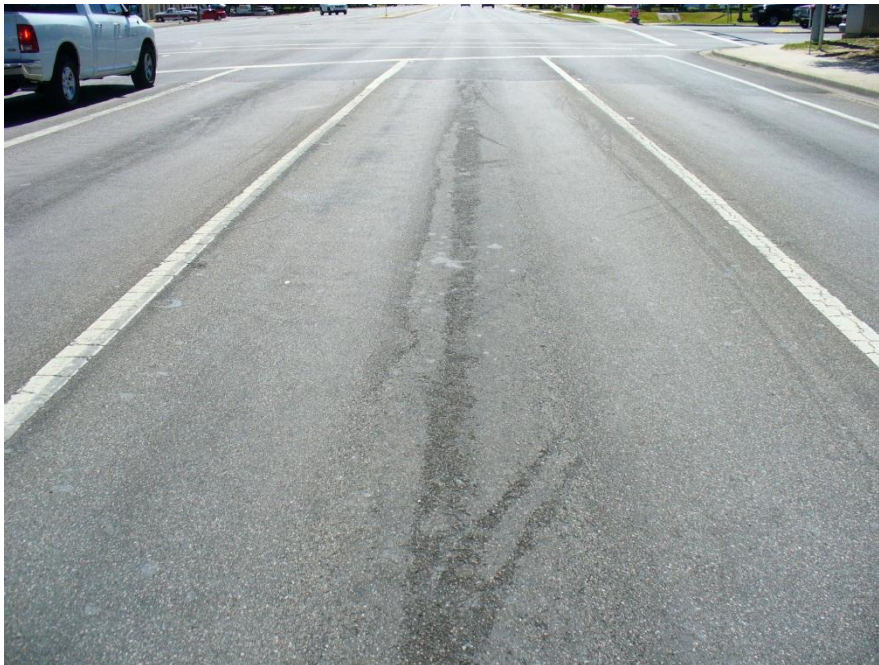
Major rutting was noted on the southbound approaches to E. Brent Lane (see Photo 2 in Appendix 3) and minor rutting on the northbound approaches. Deep rutting is a problem for both trucks and other vehicles particularly during rainy conditions when water accumulated in the cracks. This can result in hydroplaning and increased stopping distance. The center of the intersection has been recently repaved and is in good condition.

Photo 2
Rutting on southbound approaches to E. Brent Lane

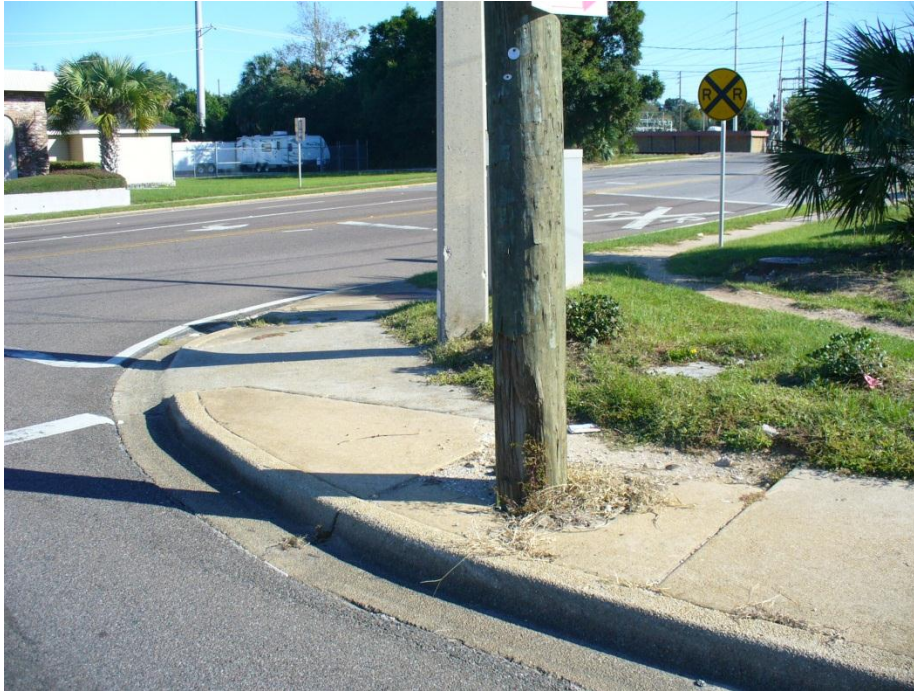
The strain pole located at the southeast corner at W. Leonard Street has been damaged by turning trucks (see Photo 3 in Appendix 3). There is also a damaged power pole at the northwest quadrant of N. Palafox Street immediately preceding the intersection with W. Texar Drive. This pole is located within the sidewalk, approximately 2 feet from the curb (see Photo 4 in Appendix 3). The location of the pole is also a detriment to wheelchairs, which do not have enough room to maneuver around the pole due to an adjacent parking lot. If possible, this pole should be relocated to the east side of the sidewalk. There is curb damage at both the northeast and southeast quadrants of W. Texar Drive.

Photo 3
Damaged pole at the southeast corner of W. Leonard Street

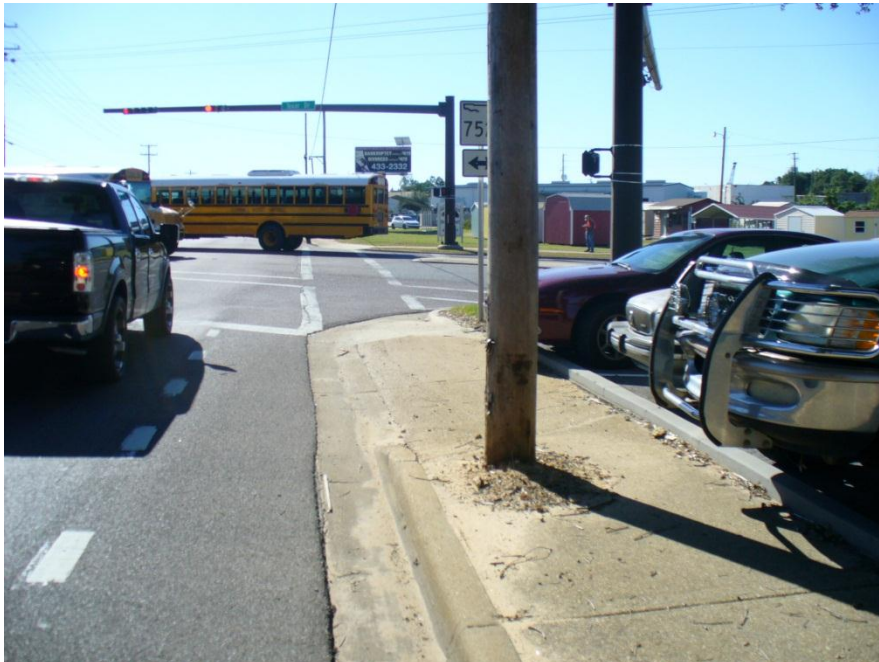
Photo 4
Poorly located utility pole is too close to the roadway. Location may also pose a safety issue for wheelchair-bound persons.

- Perform preventive maintenance to seal the cracking at the approaches at W. Leonard Street. (FA11)
- If possible, relocate the position of the concrete traffic signal strain pole at the southeast corner of W. Texar Drive away from the center of the sidewalk and the corner to prevent damage from turning trucks. This pole also presents an operational issue for persons using wheelchairs. (FA12)

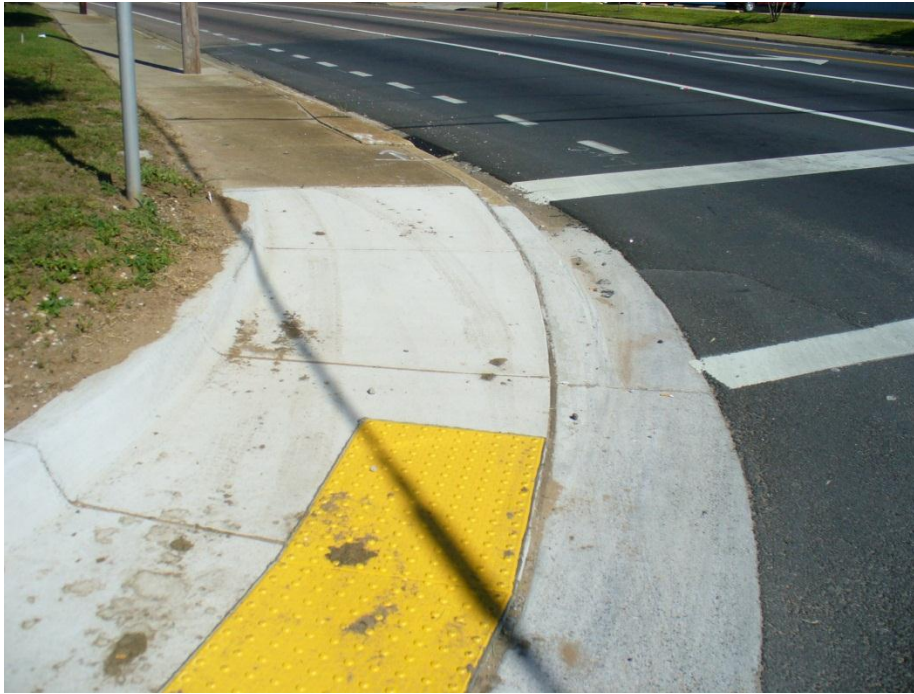
Tire tracks were noted on the corner sidewalks at all quadrants of W. Fairfield Drive (see Photo 5 in Appendix 3). While the intersection was recently repaved, the infrastructure was not modified to accommodate trucks including the relocation of power poles adjacent to the roadway and intersection corners. Due to the high truck use not only on the main corridor, but also on all of the cross streets and side streets in this industrial area, future improvements should be designed to accommodate large truck turns that will minimize damage to the non-road infrastructure such as sidewalks, drainage curbs, and utility structures.

Photo 5
Tire tracks on recently modified pedestrian ramp on W. Fairfield Drive, similar conditions were noted at all quadrants

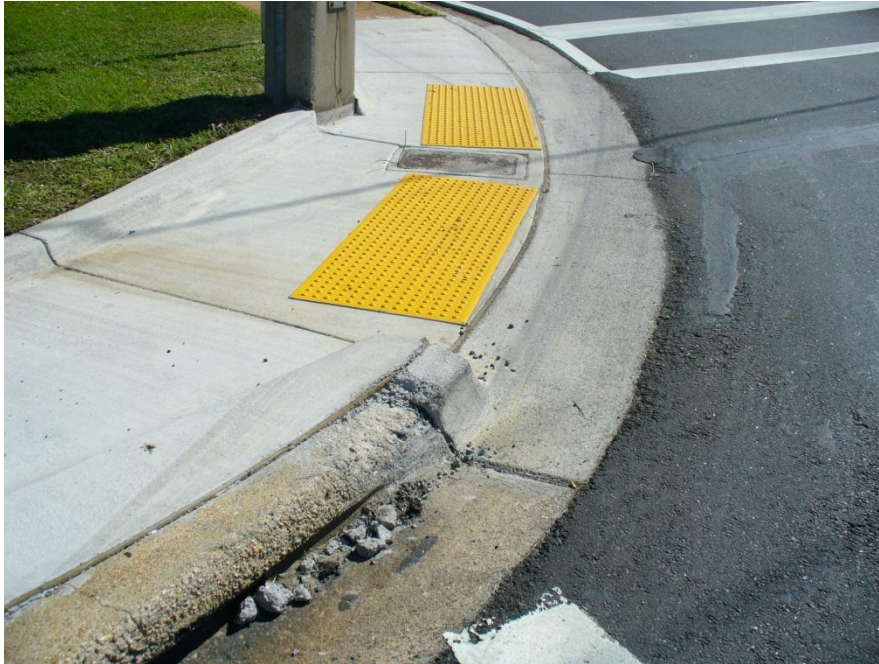
Trucks making wide right turns were noted from southbound N. Palafox Street to westbound W. Texar Drive. This is probably due to the slightly acute angle for this turning movement. Similar wide right turns were noted at N. Palafox Street and W. Fairfield Drive. In all cases, the receiving corridor contained two lanes, which mitigated these movements somewhat. However, damage was noted at all corners at W. Fairfield Drive indicating that there is still an issue and during congested conditions this additional lane may not be available to the trucks which accounts for the curb damage (see Photo 11 in Appendix 3).

Photo 11
Damaged curb at W. Fairfield Drive due to over tracking

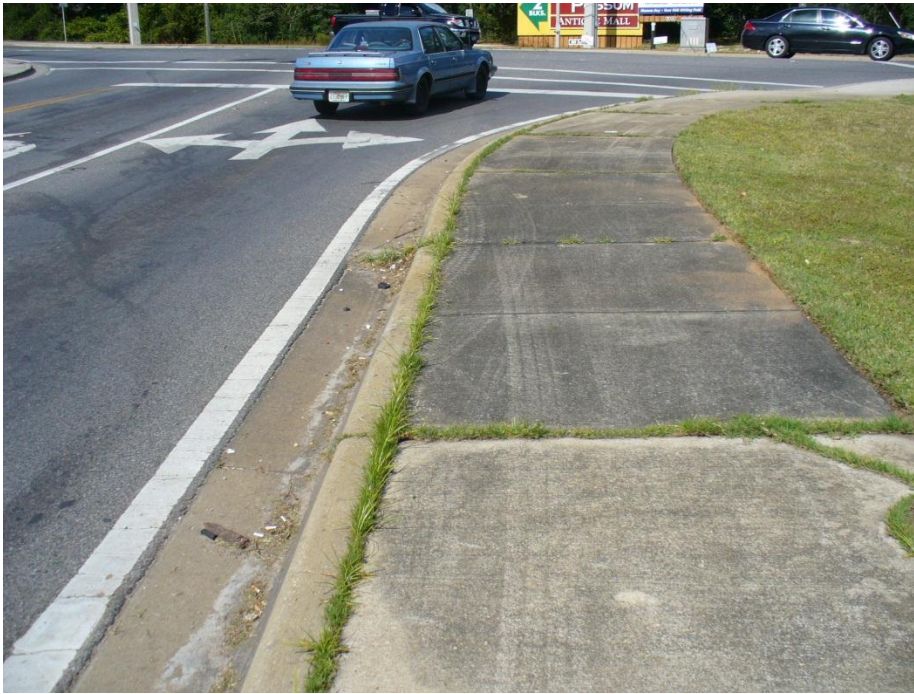
At the intersection of Ward Basin Road, the southeast and southwest corners show signs of off-tracking by trucks. The northbound to eastbound right turn is acute, causing trucks to off-track in order to make the right turn due to the single receiving lane (see Photo 10 in Appendix 3). At the southeast corner, damage may be caused by gasoline and delivery trucks turning into the gas station driveway immediately south of the corner (see Photo 11 in Appendix 3).

Photo 11
Northbound to eastbound right turn at Ward Basin Road showing tire marks from truck off-tracking

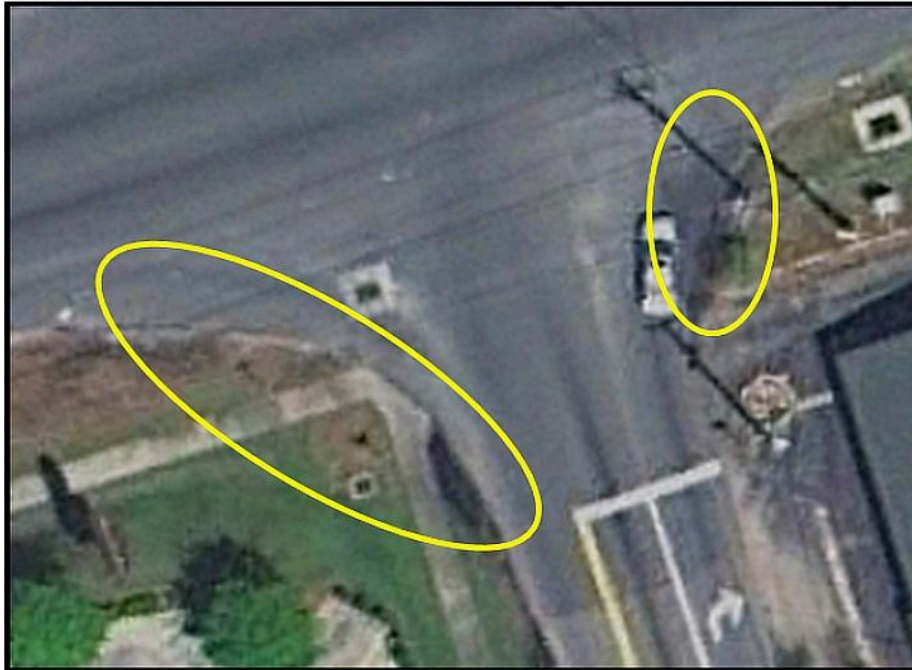
Photo 13

Aerial view of Parkmore Plaza Drive showing damaged soft shoulders. Parkmore Plaza Drive becomes Galt Road and leads to a large mining and landfill area to the south.
