SR 85 from John King Road to Airport Road

PRELIMINARY FREIGHT CORRIDOR SCREENING SR 85 (John King Road to Airport Road)

PRELIMINARY FREIGHT CORRIDOR SCREENING US 98 (Destin Bridge to Walton County Line)

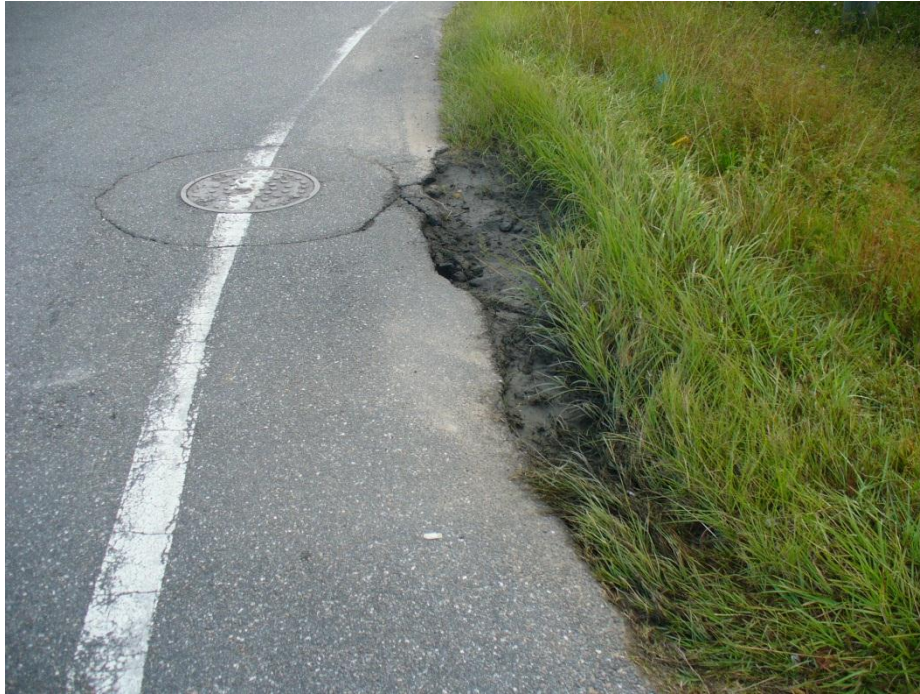
Photo 1
Soft shoulder damage at southeast corner of John King Road

There is some minor soft shoulder rutting at the southeast and northeast quadrants of John King Road (see Photo 1 in Appendix 3) that can be mitigated by extending the pavement 4 to 5 feet around the corner of the shoulder. Truck turning movements at this intersection are minimal, mostly servicing restaurants and a gas station. Traffic signals are strain pole mounted and the concrete strain poles are located away from the corners. There are power poles and various utility boxes and underground cable and pipe markers also located on the corners.

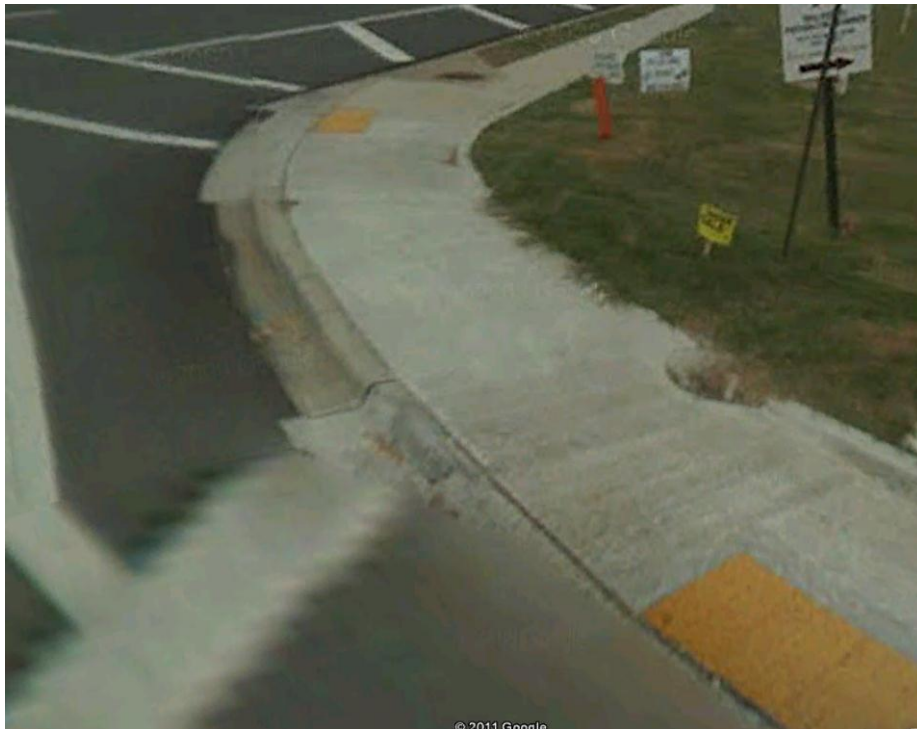
The infrastructure at Mirage Avenue was recently upgraded (the aerial does not show these improvements) to include new curbing and a sidewalk along the east side of the roadway; however, the sidewalk does not extend along the cross streets. There are pedestrian crossings at all four quadrants with ADA prescribed wheelchair ramps (see Photo 2 in Appendix 3). Note that the ramps that lead to the crosswalks at the northeast quadrant are separated by a raised curb. This curb is showing signs of off-tracking and since there is no drainage opening, consideration should be given to removing this small section of curb.

Photo 2
Pedestrian ramps at northeast corner of Mirage Avenue. Raised curb between ramps is not truck-friendly.

- Remove the curbs between the pedestrian ramps at the corners of Mirage Avenue and W. Redstone Avenue/Redstone Drive. Trucks off-tracking on these curbs result in unnecessary structural damage to the curb and sidewalks, as well as mechanical and tire damage to trucks. (OW6)

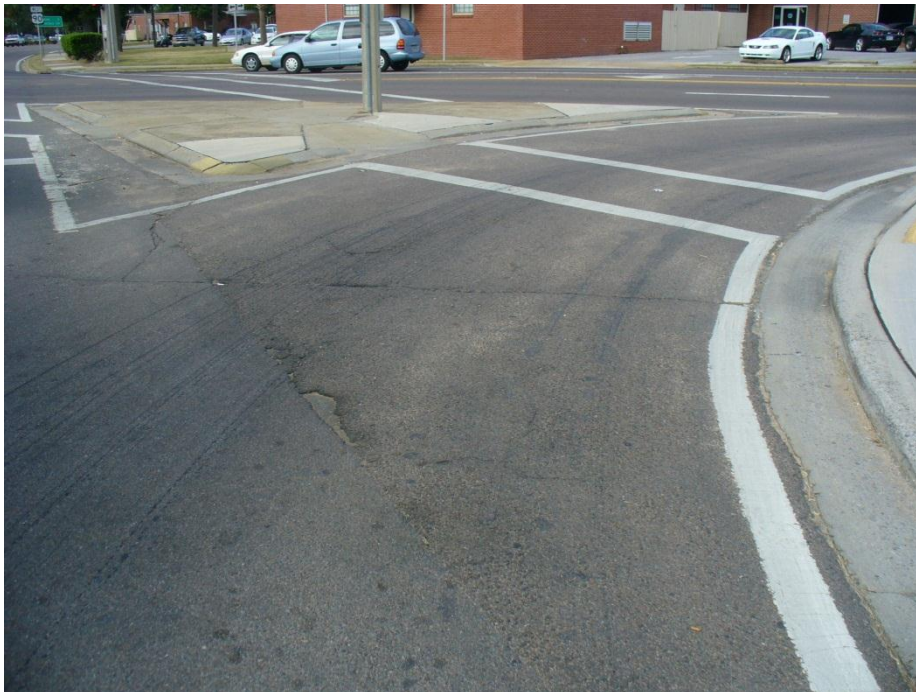
Photo 4
Channelized right-turn lane at northeast corner of US 90 and SR 85, note the raised concrete pedestrian island and cracked pavement

- Evaluate the construction of a short dedicated right-turn lane at the northeast quadrant of US 90 and SR 85. (OW1)
- Evaluate improving the turning radii at the northeast and southeast quadrants of Stillwell Boulevard to facilitate trucks turning movements and reduce the damage to the corner infrastructure. (OW2)

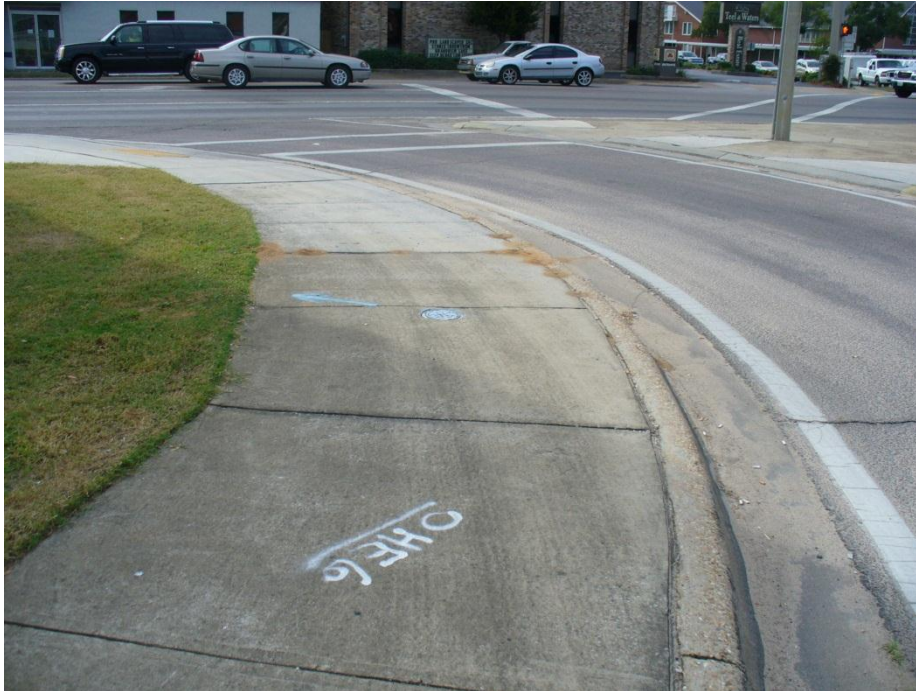
Photo 5
Tire marks from off-tracking trucks at northeast corner of US 90 and SR 85

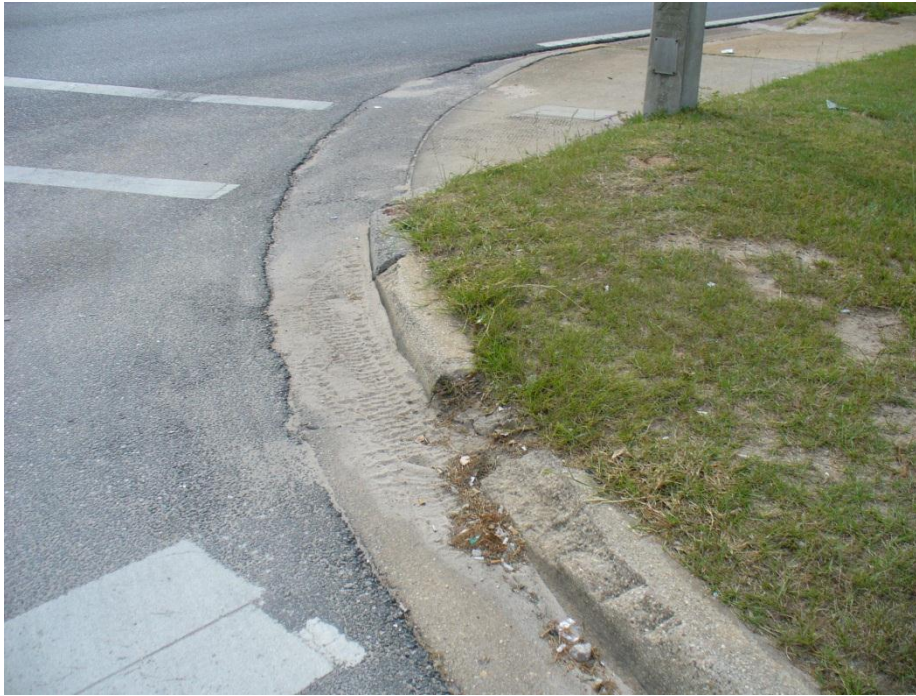
Photo 7

The primary truck movements at Stillwell Boulevard are through traffic, however, this facility provides access to the Crestview Ready Mix Concrete plant. As a result, there are numerous turning movements by dump trucks and concrete mix trucks at this intersection. The signal timing is such that the through traffic receives 65 seconds of green in the signal progression; however, only 10 seconds are allotted for left turns. This may not be sufficient for a loaded truck to clear the intersection. The position of the stop bars on SR 85 are set back sufficiently to allow for turning trucks without encroaching on the northbound and southbound left-turn lanes. However, the stop bar on Stillwell Boulevard should be moved back to facilitate both left and right turning trucks from SR 85. In addition, a small modification to the turning radii at the northeast and southeast corners would improve truck operations and reduce the damage to the curbs and sidewalks at these corners.

Damaged curbing and cracked sidewalk at the southeast corner of Stillwell Boulevard due to off-tracking trucks

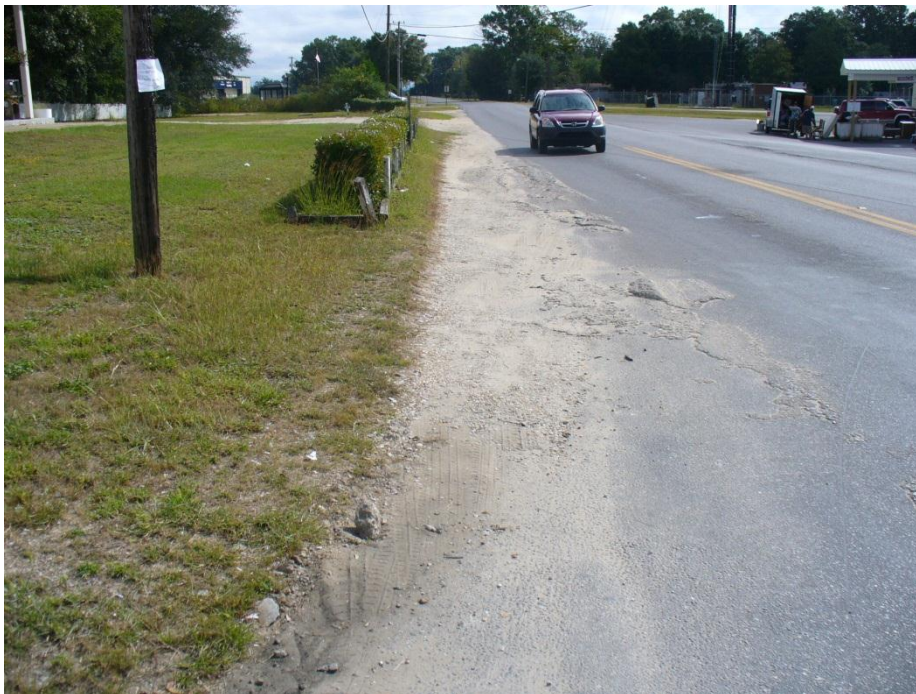
Photo 8

Shoulder damage due to off-tracking trucks at the northeast corner of Stillwell Boulevard

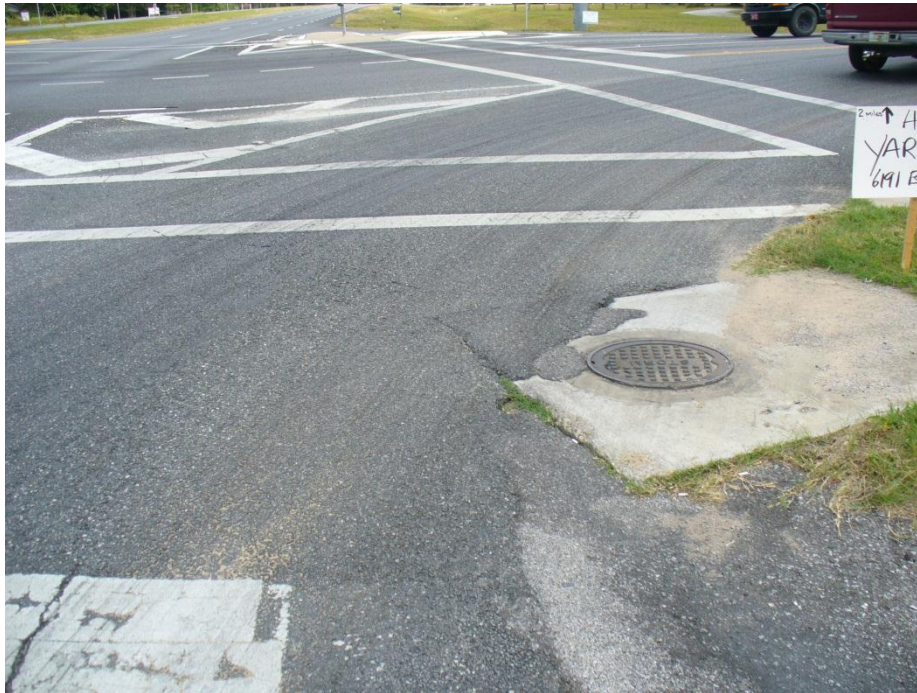
Photo 11
Damaged storm drain at the southeast corner of Airport Road

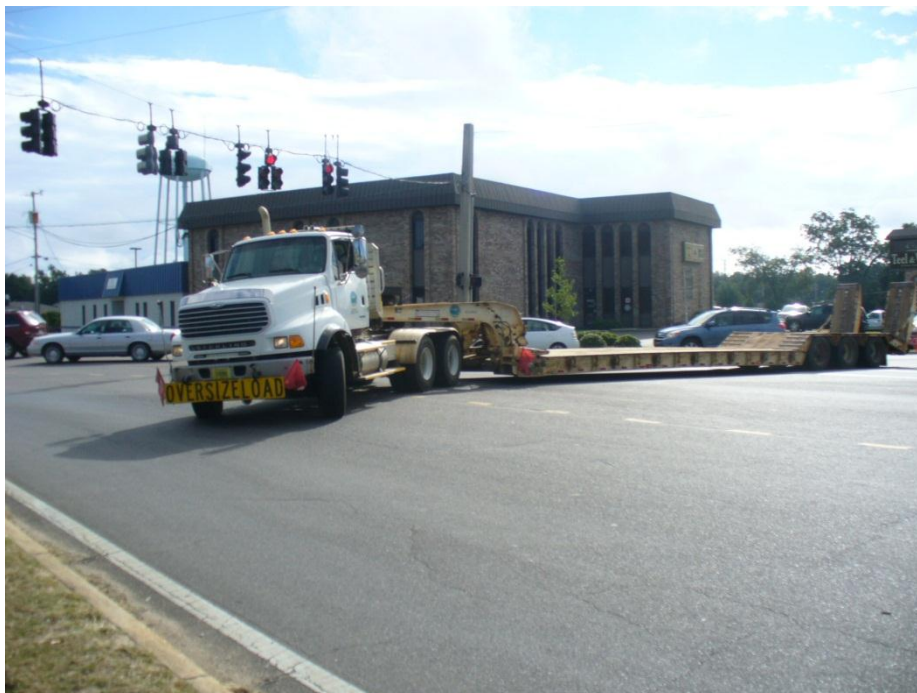
The intersection at US 90 results in the most large truck turning movements (see Photo 12 in Appendix 3) within the corridor but the exact impact is hard to determine due to the lack of turning movement counts; however, based on the traffic counts north and south, as well as east and west of the intersection, it is estimated that there are 150-200 truck turning movements in each direction at this intersection with 600-800 north-south through movements. Although congested, the intersection is operating a Level of Service (LOS) of "C." Signal timing appears to be adequate with 45 seconds allotted for through traffic and 25 seconds for left turns on SR 85. Courthouse Terrace forms a fifth leg at this intersection and is located within the acute right-turn movement to southbound SR 85. However, this is an inbound only street and helps to widen the corner turning radius for the eastbound to southbound right-turn movement for trucks. Although there is a channelized right turn at the northeast quadrant, there is no associated dedicated right-turn lane. As a result, it only takes a minimum of two to three vehicles stopped for the signal in the westbound direction to block this turning movement resulting in unnecessary delay. The addition of a short right-turn lane should be evaluated to improve the performance at this intersection. The stop bars in the eastbound direction of US 90 are placed far enough back from the intersection to allow for turns by trucks without encroaching on the eastbound left-turn lane. The same is true for the westbound stop bars.

Photo 12
Truck making wide left turn at US 90

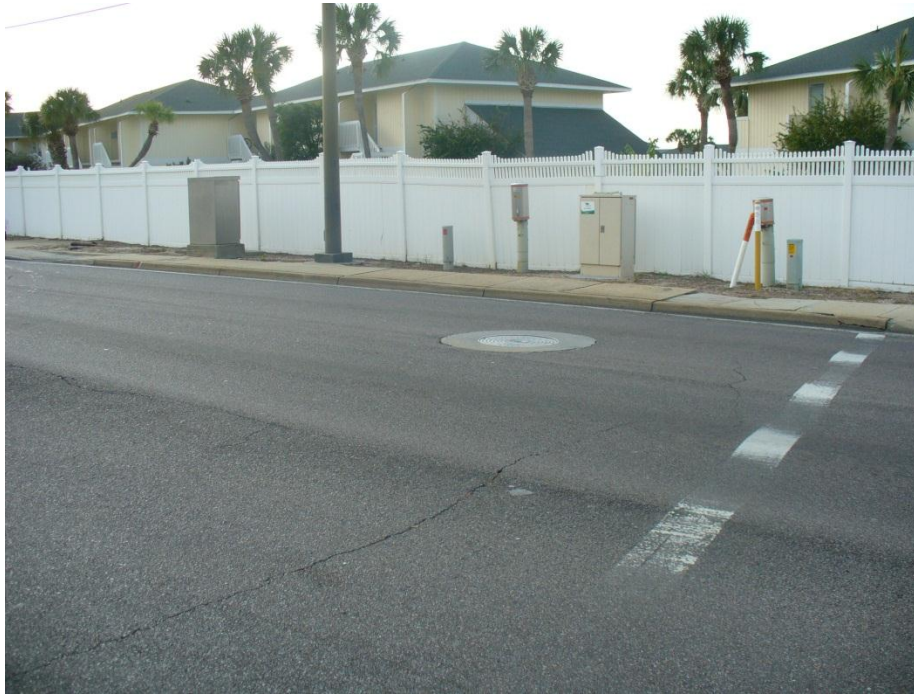
The pavement is in generally good condition with rutting noted at Main Street (see Photo 1 in Appendix 3) and Beach Drive (Segment 1), minor rutting on Gulf Shore Drive and Airport Road (Segment 2), minor rutting in the through lanes, as well as shoulder damage in the outside westbound lanes of Segment 3. The pavement in Segment 4 is in good condition.

Photo 1
Through lane rutting was noted at intersections in Segments 1-3 of the corridor.
This photo shows rutting at Main Street.

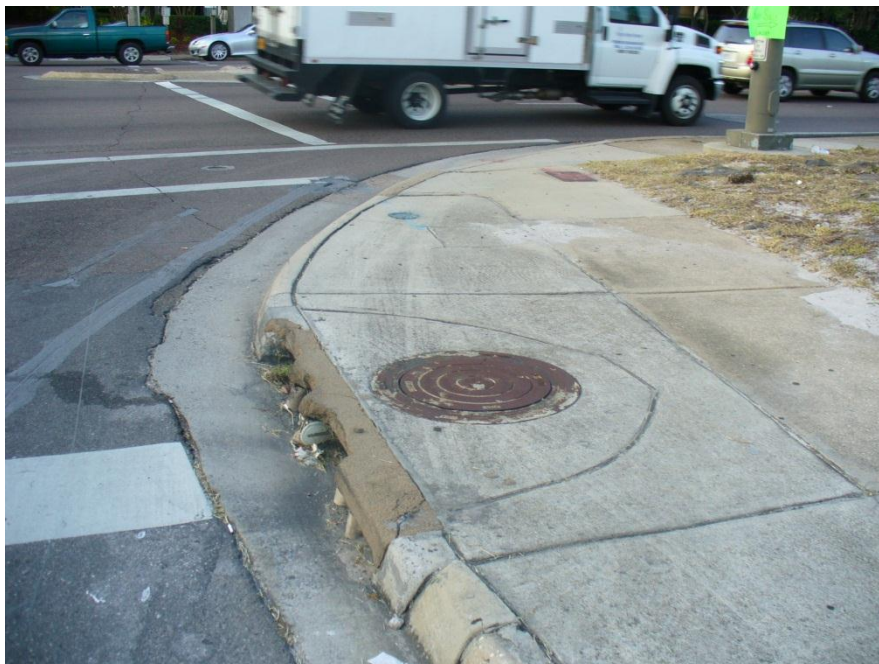
There were indications of curb and sidewalk damage caused by off-tracking trucks at Beach Drive (see Photo 2 in Appendix 3) and Main Street (see Photos 3 in Appendix 3).

Photo 2
Off-tracking indicated by the damaged storm drain and tire tracks on the sidewalk at Beach Drive

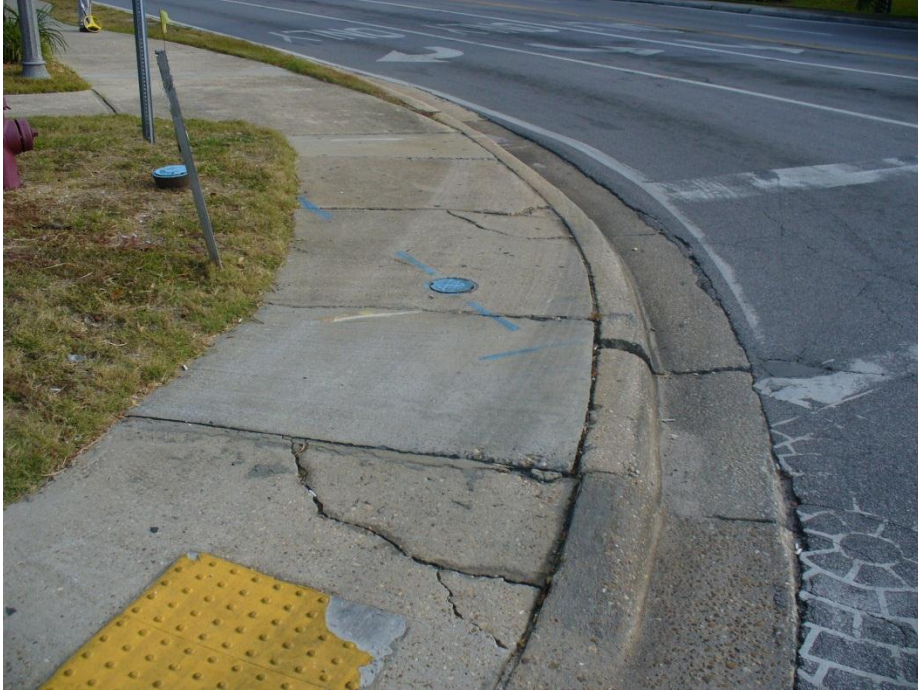
Photo 3
Cracked sidewalk caused by off-tracking trucks at Main Street

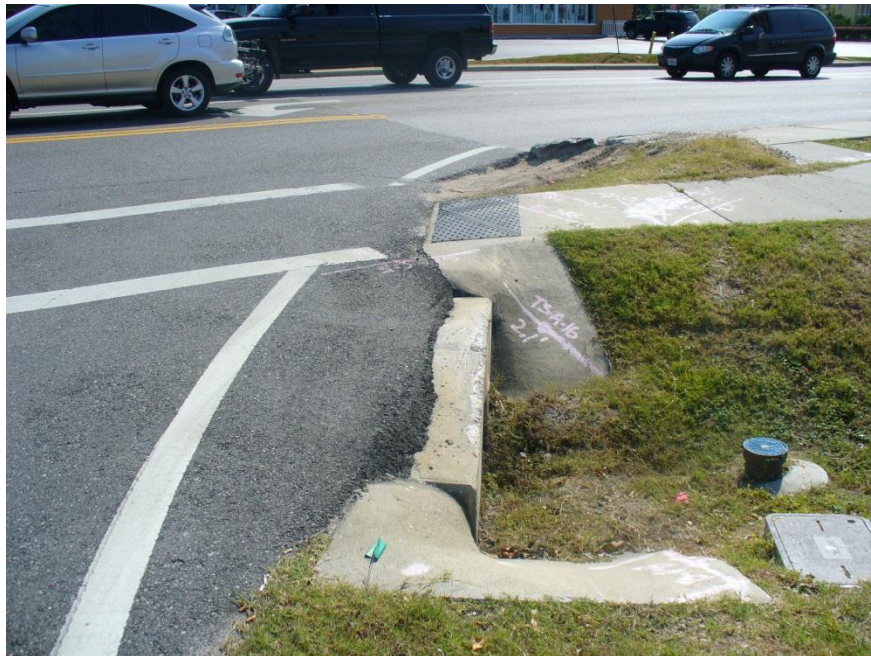
Photo 4
Matthew Boulevard safety issues. The culvert should be extended further away from the EOP or a guardrail installed to prevent trucks leaving the road and over-turning.

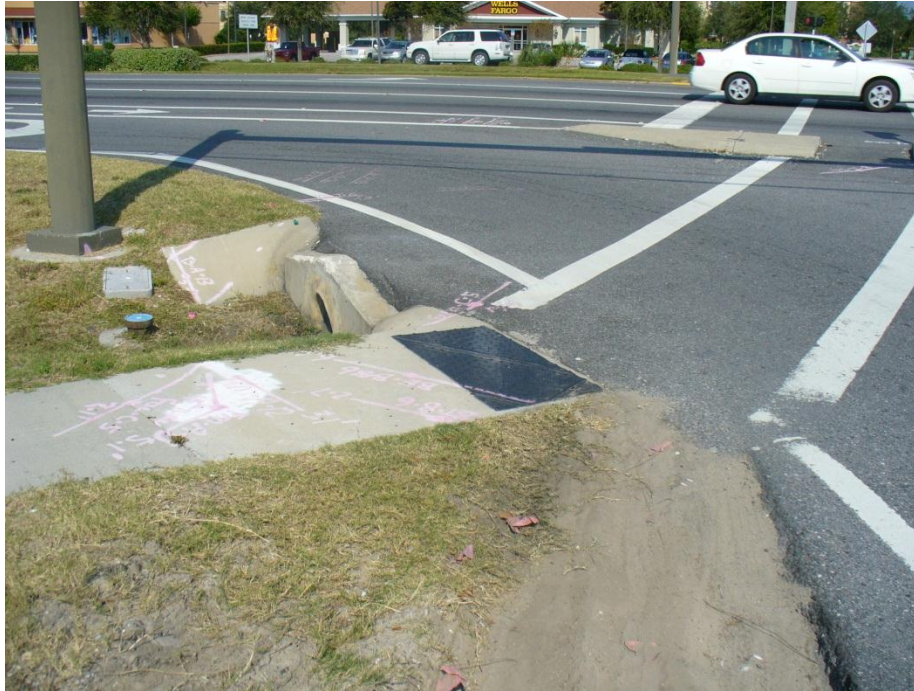
Photo 5
Southwest corner of Matthew Boulevard showing unsafe concrete culvert and sidewalk

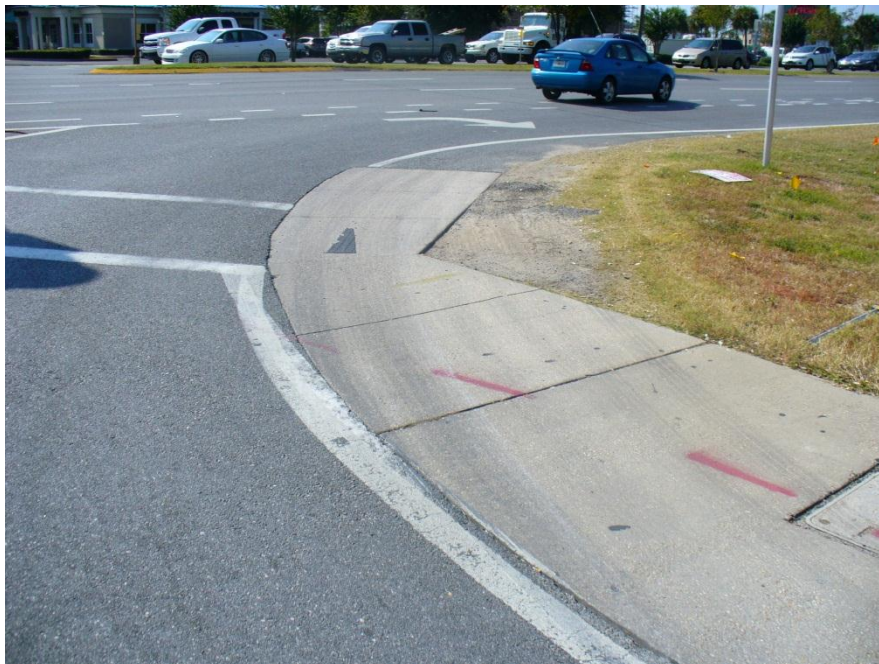
The northeast and northwest quadrants of Danny Wuerffel Way (SR 293) also show signs of truck off-tracking. Tire marks are clearly shown in Photos 6 through 8 in Appendix 3, as well as rutting beyond the sidewalk areas. Complicating the truck turns is the raised concrete pedestrian island that channels the right turn movement at both quadrants and a steel mast arm signal pole (see Photos 9 and 10 in Appendix 3) located on the island at the northwest quadrant. During non-congested conditions this is probably not a big issue because trucks can make wide turns into the westbound outside through lane; however, during congested conditions this may be impossible. Since this intersection leads north to the Mid-Point Bridge and experiences numerous truck turning movements, improvements to the turning radii should be evaluated and implemented.

Photo 6
Danny Wuerffel Way showing off-tracking. The sidewalk is truck mountable but should be extended to include the rutted area.

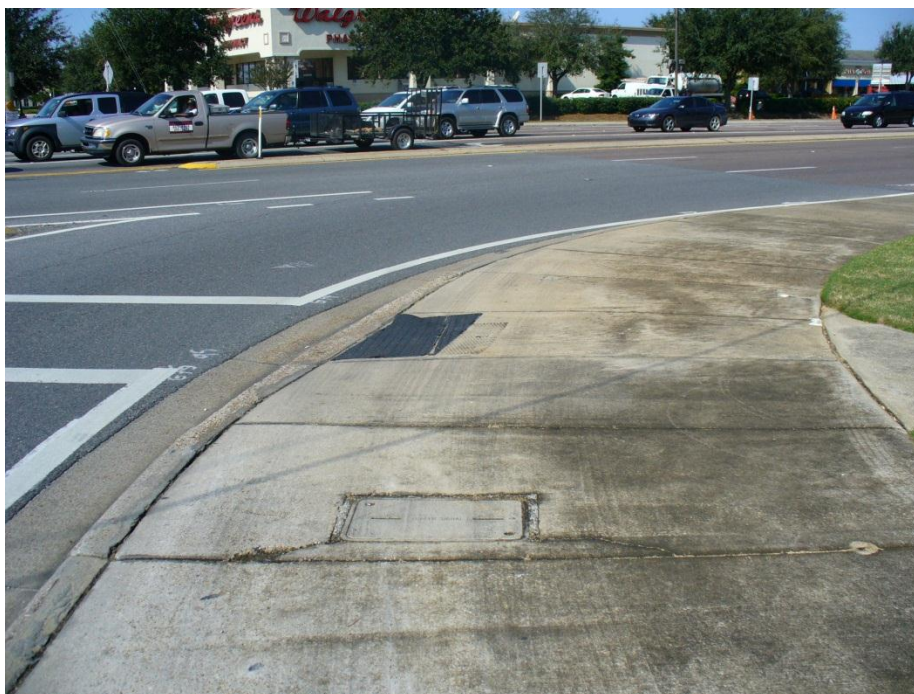
Photo 7

Danny Wuerffel Way. Tire tracks are for beyond the EOP and the curbing is not mountable.

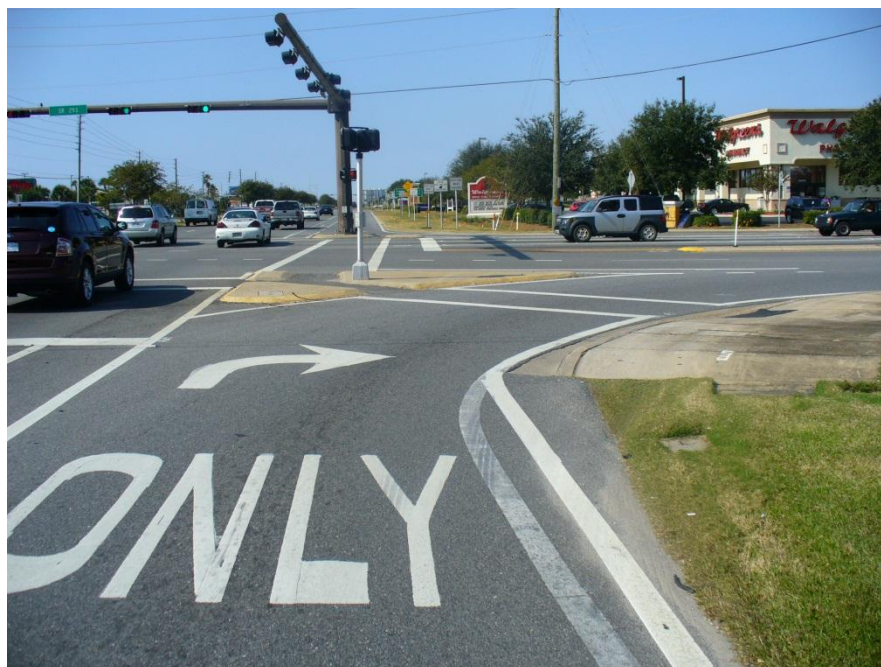
Photo 8

Danny Wuerffel Way. Raised concrete island and pedestrian signal pole forces trucks to off-track as can be seen by the rutting of the soft areas beyond the shoulder.

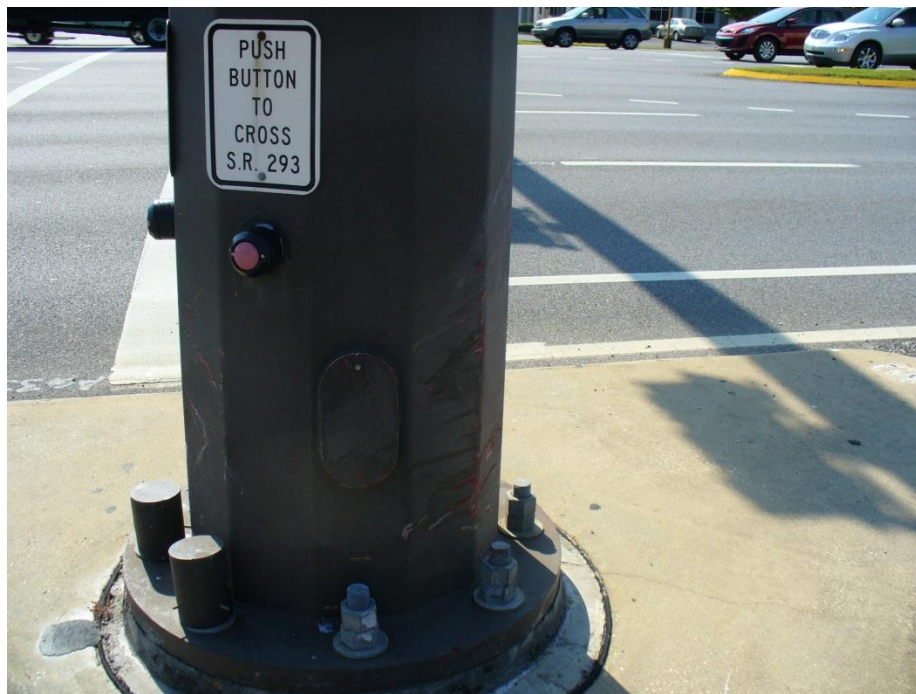
Photo 9

The mast arm pole at the northwest corner of Danny Wuerffel Way is centered on the right-turn lane that is channeled to the right by the concrete island.

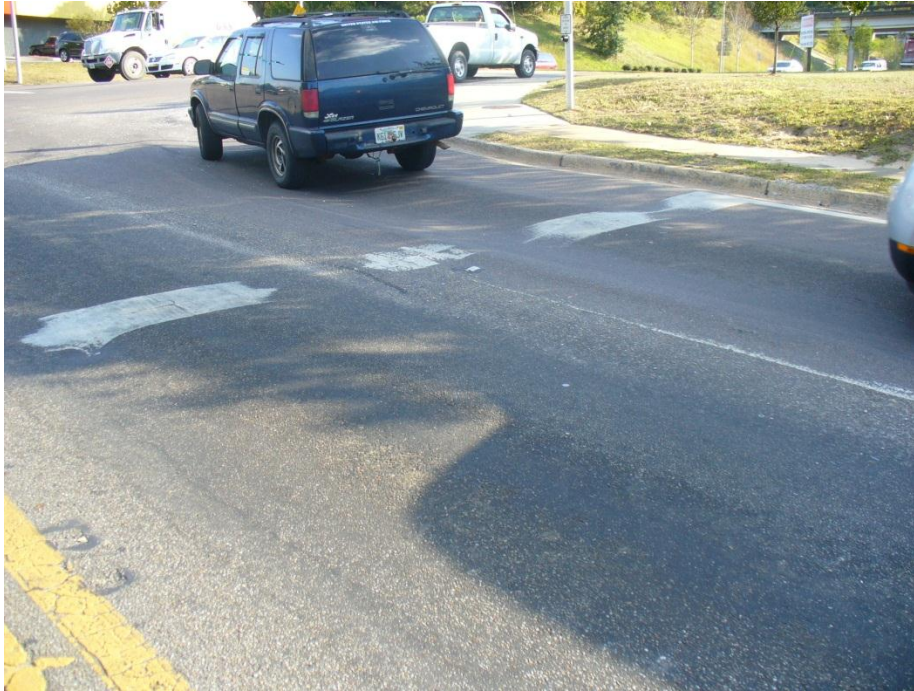
Photo 3
Deep rutting in the eastbound lanes of US 90 at US 331 South

- The intersection of US 90 and US 331 South should be milled and resurfaced to remove the deep rutting on the through lanes and the worn out pavement markings. (OW14)

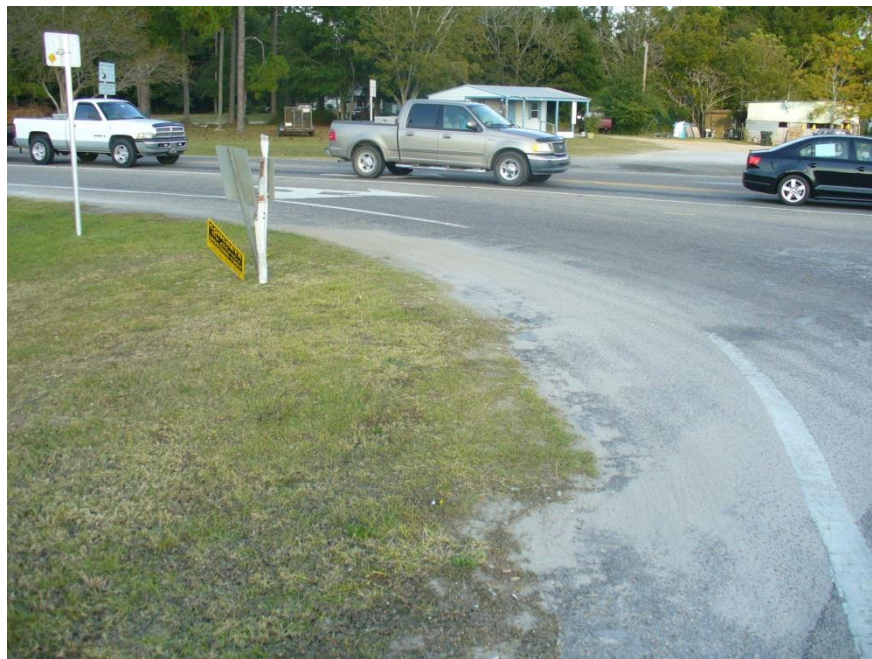
Photo 4
Shoulder deterioration due to off-tracking at the northwest corner of US 331 and US 90

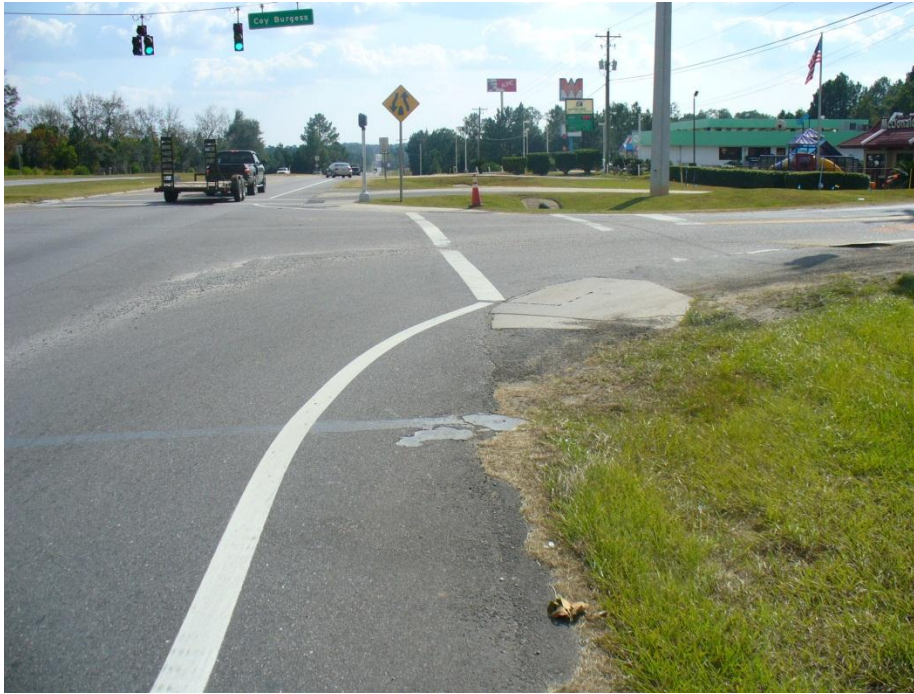
Photo 5
New traffic signals and pedestrian features at Coy Burgess Road (also note off-tracking damage at the northbound corner)

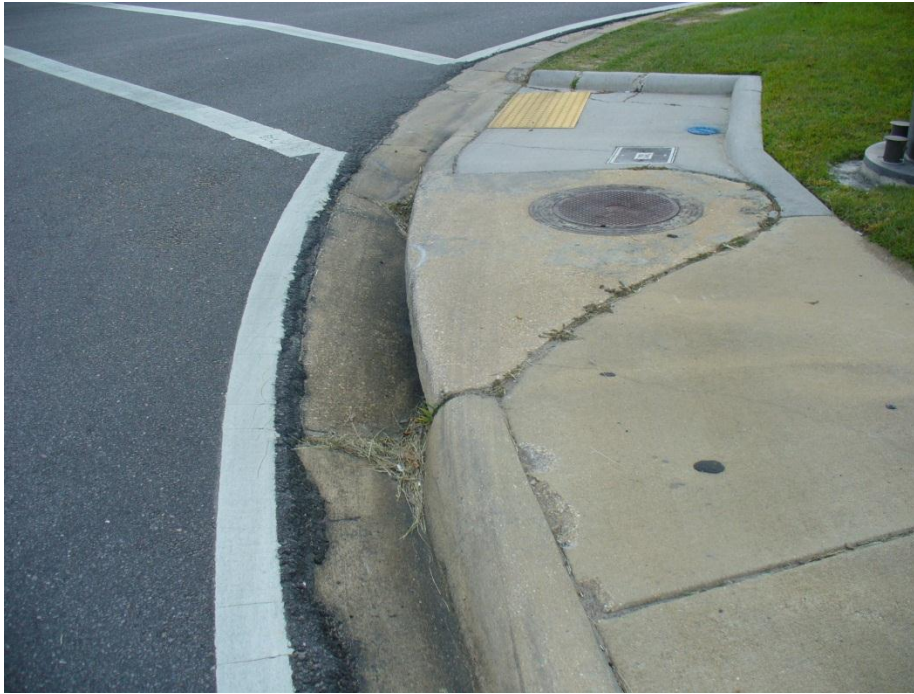
Traffic signals at Bob Sykes Road are mast arm mounted. The southwest and northwest corners of Bob Sykes Road show signs of off-tracking. The northwest corner includes a drain opening and a pedestrian ramp with a raised curb along the back and one side (see Photo 7 in Appendix 3). Off-tracking trucks will eventually crush the top of the drain opening and the curbing on the pedestrian ramp at the Winn Dixie Plaza the signals are strain pole mounted. Curb damage is minor and probably not caused by trucks which access Winn Dixie from a driveway off Bob Sykes Road. New mast arm mounted signals (see Photo 8 in Appendix 3) have been installed at the intersection of Bruce Road (previously un-signalized). The northeast corner was improved as part of the installation and is in good condition. Bruce Road leads back to a residential area and a school and is an unlikely road for truck use. Minor damage at the southeast corner is probably due to turning school busses.

Pedestrian ramps and storm drain opening at Bob Sikes Road. Trucks off-track onto the sidewalk as noted by tire marks and cracked curb of the pedestrian ramp.
