**SR 22 (Wewa Highway) from Star Avenue to US 98 Business**

# PRELIMINARY FREIGHT CORRIDOR SCREENING SR 22 (Wewa Highway) from Star Avenue to US 98 Business

# PRELIMINARY FREIGHT CORRIDOR SCREENING SR 368 (23<sup>rd</sup> Street) and SR 390 (St. Andrews Boulevard/Beck Avenue)

# **PRELIMINARY FREIGHT CORRIDOR SCREENING US 98 (15th Street) and Jenks Avenue, US 98 and Harrison Avenue, and US 231 and Harrison Avenue**

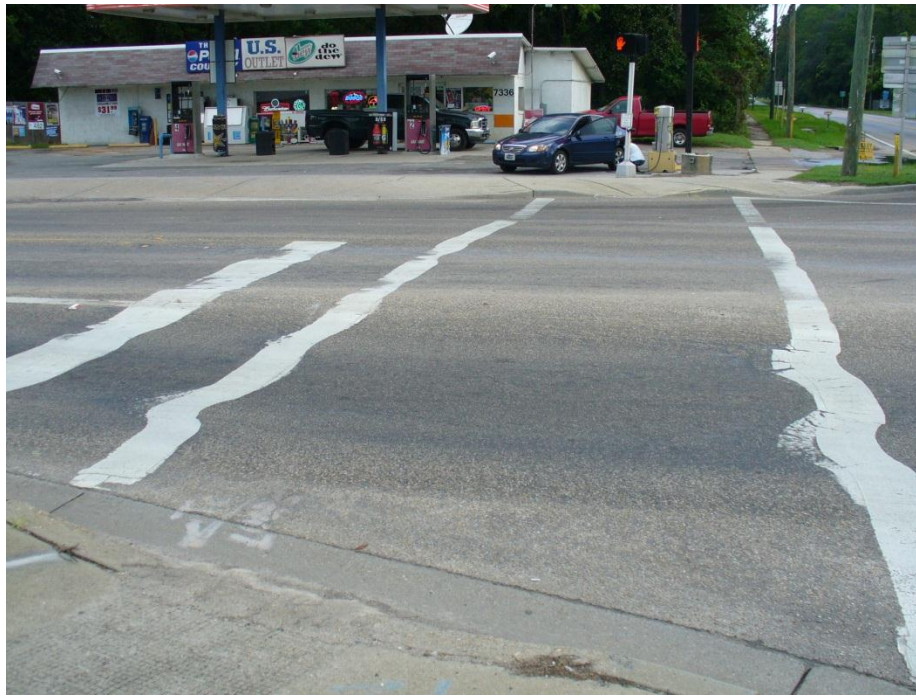
**Photo 3**

The pavement along the entire corridor is in fair condition that is free of pot holes. However, rutting, deep in some locations, is evident throughout the corridor especially at the signalized intersections. Rutting is a particular problem as the ruts tend to keep all vehicles running over the same footprint of the pavement, resulting in even deeper ruts over time. In the case of this corridor, the rutting is primarily caused by heavy log trucks that carry logs from the forest to the paper mill located south of SR 22 on US 98 Business. Rutting also causes water to pool during heavy rains resulting in dangerous hydroplaning. The shoulder pavement is in generally good condition except at some intersection corners and at locations, where there are long continuous driveways.

**Deep rutting across all lanes at Star Avenue indicated by the uneven pavement markings. This is typical of the conditions at all intersections on the corridor.**

- Rehabilitate the pavement along the entire corridor to eliminate the deep rutting, especially at signalized intersections. The flexible surface pavement is too soft to support the weight of heavy trucks and should be replaced with a more rigid composition. (BA1)

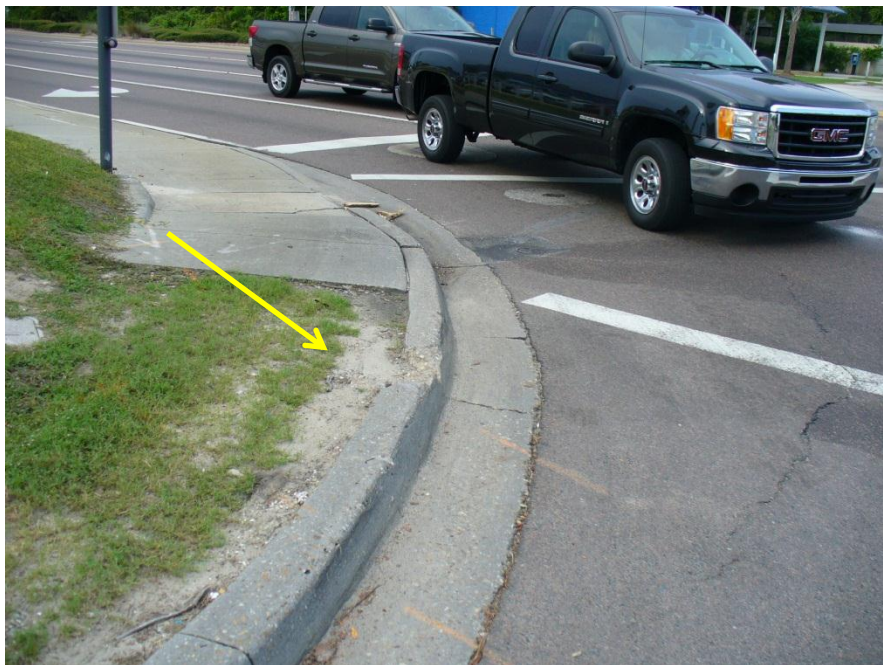
**Photo 4**

There are curbs and gutters present along all approaches to the intersection at Tyndall Parkway. Some damage to the curbing at Tyndall Parkway due to over-tracking by large trucks was noted. The northeast corner shows rutting beyond the curb where the sidewalk ends. If the corner radius cannot be improved, consider changing the curbs to a mountable version. Corner curbs with storm sewer drains are included at the corners of US 98, but none extend beyond a few feet in either direction. This infrastructure is showing signs of damage from truck off-tracking (see Photo 6 in Appendix 3) with one drain opening having been recently replaced.

**Curb damage at the northeast corner of SR 22 and Tyndall Parkway caused by truck off-tracking. Note the ruts beyond the curb and the black tire rubs on the curb.**

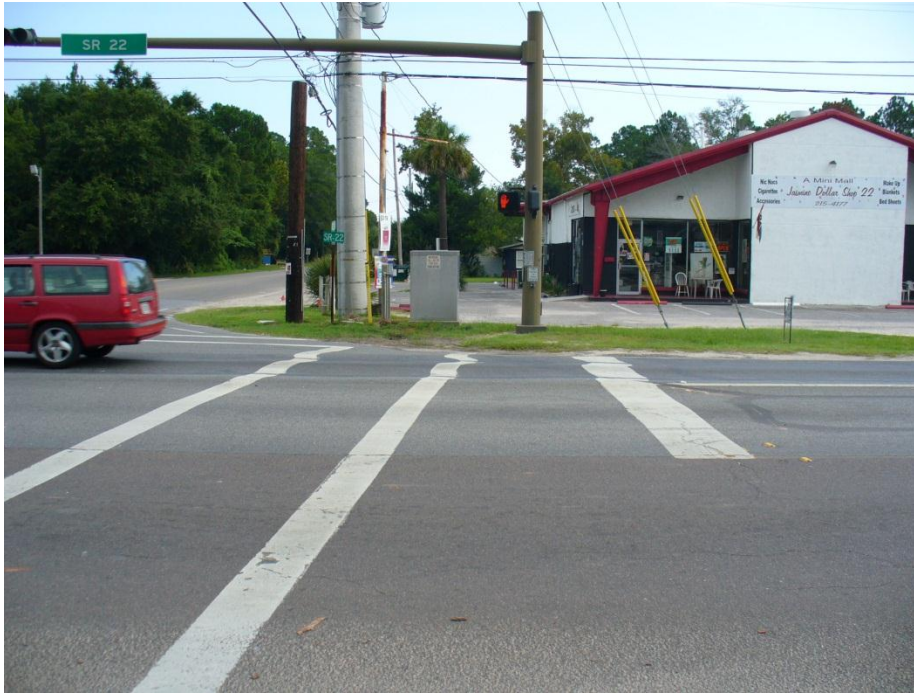
**Photo 5**

**Infrastructure located at the northeast corner of Bob Little Road, including power poles, telephone poles, signal mast arm, and signal control box. Note the rutting in the eastbound approach lanes.**

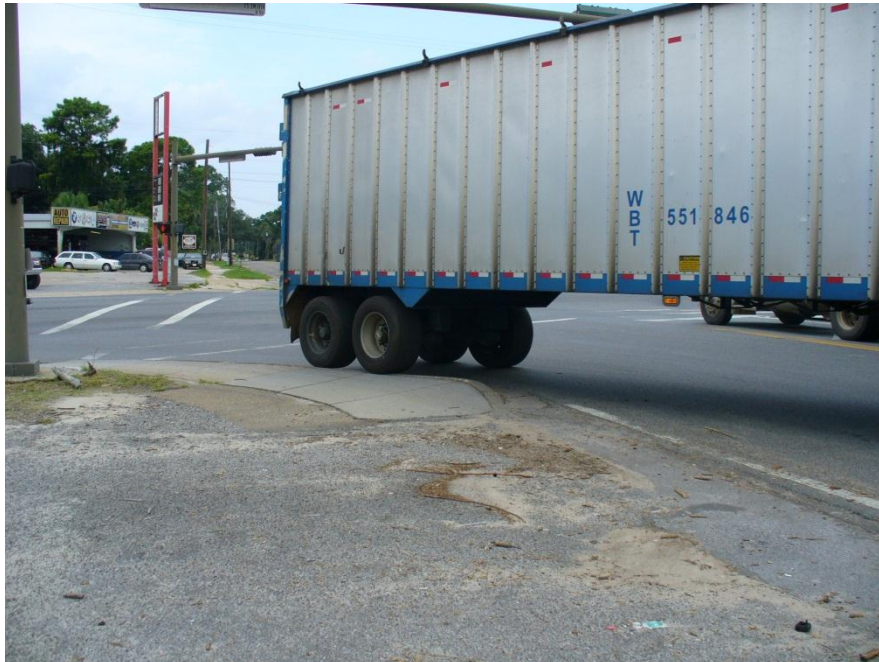
**Photo 6**

**Truck off-tracking over storm sewer drain and sidewalk at southeast corner of US 98 Business.**

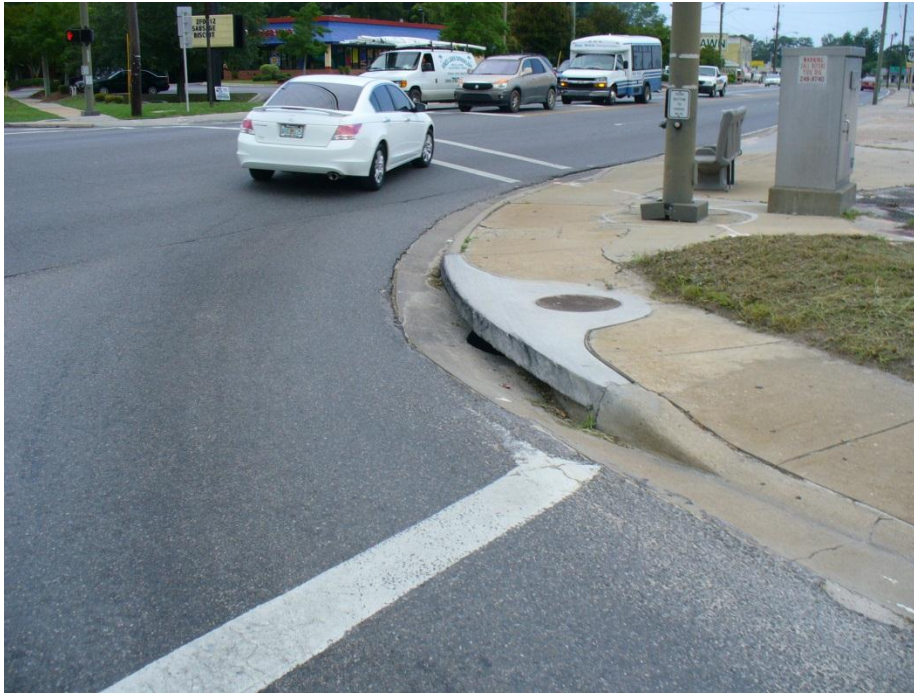
**Photo 7**

**Recently replaced storm sewer opening at the northeast corner of US 98 Business. Note new tire rubs on the face of the opening.**

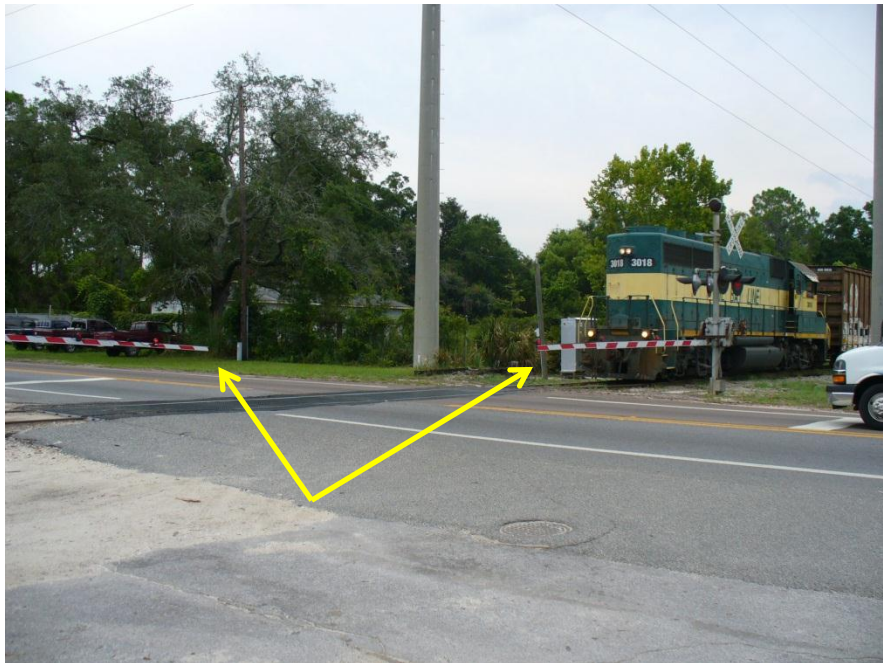
**Photo 8**

**Safety issue at the railroad crossing. The gates are too short to prevent vehicles from circumventing them immediately prior to train arrival.**

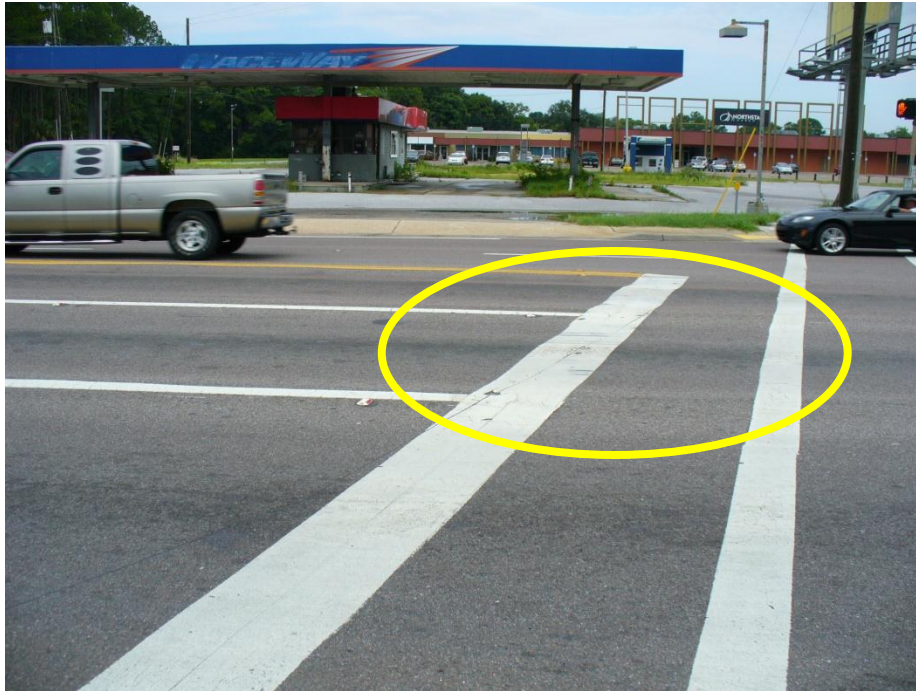
Minor rutting exists in the left turn lane on the eastbound approaches of SR 368 (23<sup>rd</sup> Street) (see Photo 1 of Appendix 2). There is also minor rutting, but to a lesser extent on the eastbound and westbound through lanes. Rutting is a problem in that it causes a railroad track effect on the travel lanes and results in water retention during rainy periods that could result in hydroplaning. Trucks crossing heavily rutted intersections encounter load shift issues that could result in damaged goods. There are no potholes or major cracking. No shoulder or curb damage exists because of the long turning radii, which allows all vehicles to make the turns without encroaching on the corners.

**Photo 1**  
**Minor rutting on the SR 368 (23<sup>rd</sup> Street) eastbound approach**

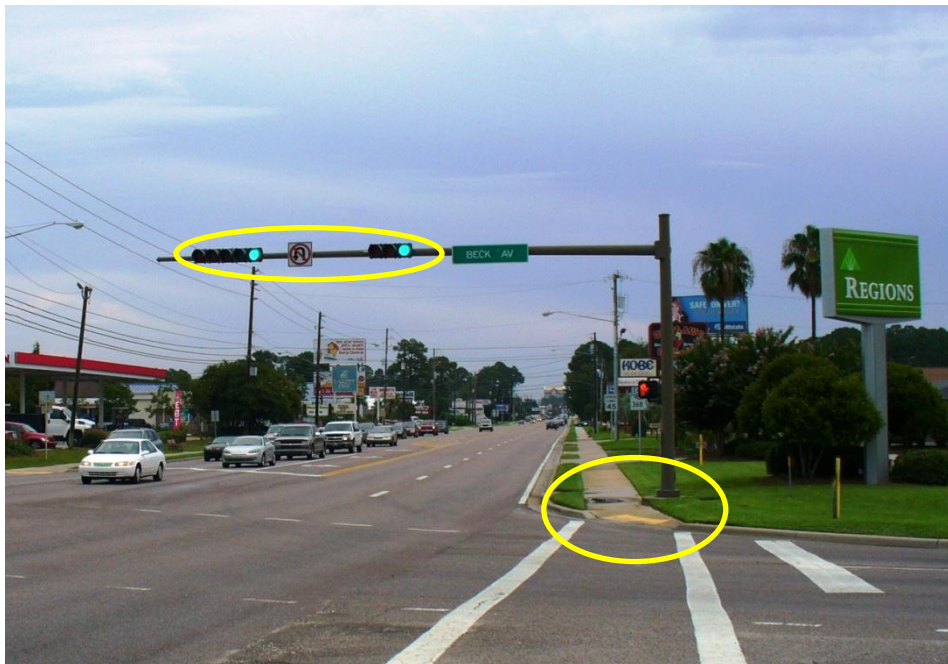
Traffic signals are mounted on mast arms located on all four corners. The signal lights in the eastbound and westbound directions do not include back plates (see Photo 2 of Appendix 2). As a result, they are difficult to see during low sun angles. The mast arms and telephone poles are located outside of the sidewalks, which decreases the chances of damage from turning trucks. The crosswalk from the northeast to the northwest corner is approximately 166 feet in length without a pedestrian refuge due to the lack of a raised median or raised island at the northeast corner (see Figure 2).

**Photo 2**  
**Eastbound traffic signals with no back plates.**  
**Infrastructure outside sidewalks away from road and corners.**

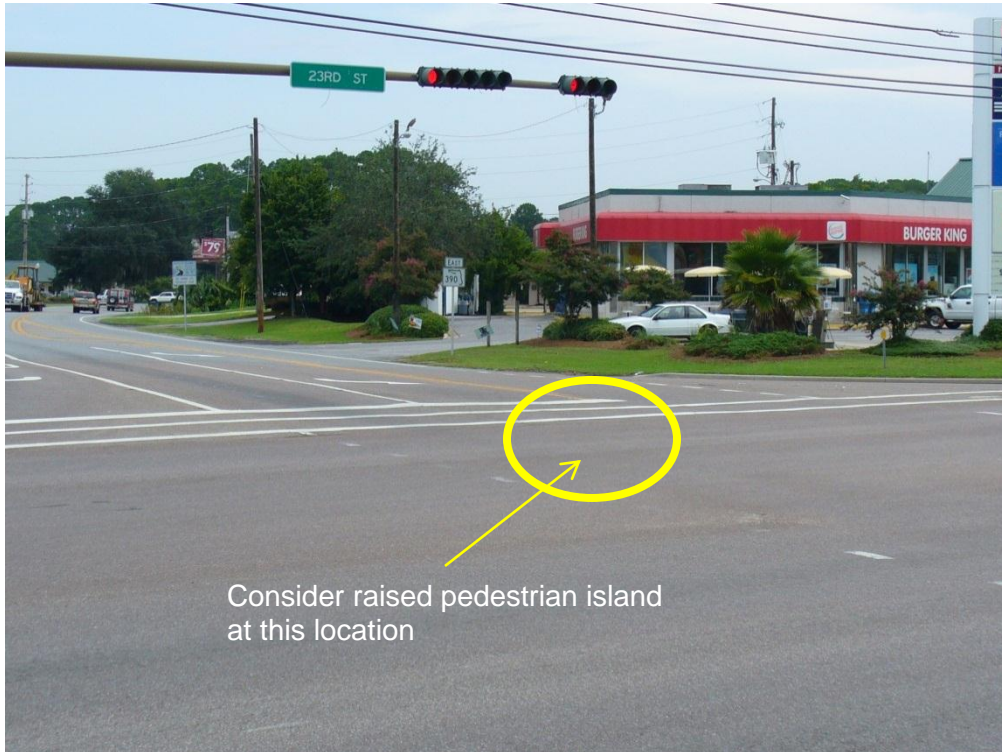
**Photo 3**  
**Long pedestrian crossing**

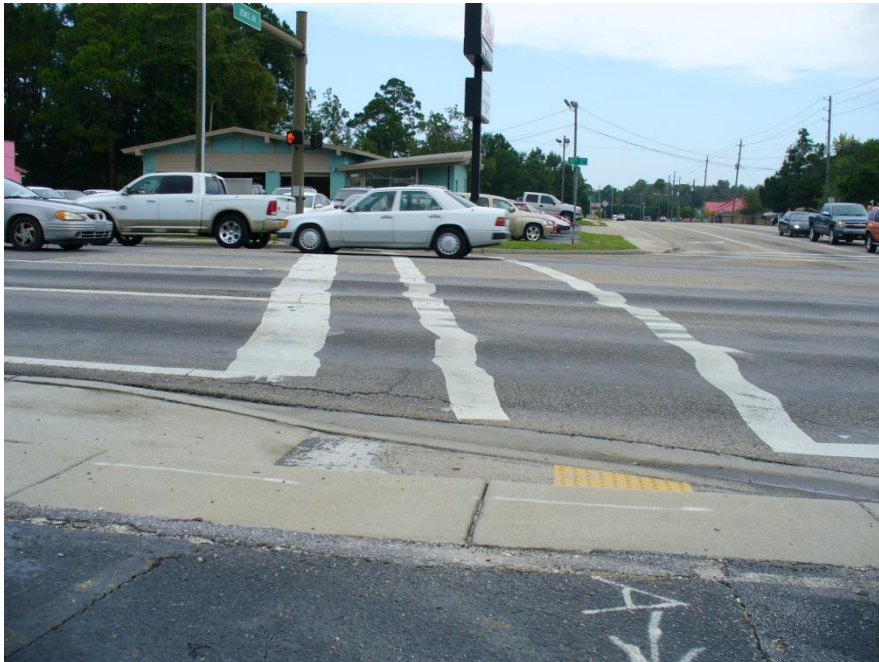
Deep rutting was noted on all approaches to the US 98/Jenks Avenue intersection (see Photos 1, 2, and 3 in Appendix 2). The rutting resulted in a checkerboard pattern inside the intersection resulting in a rough, almost railroad track-like crossing. The rutting continues east of the intersection to Harrison Avenue and the dedicated left-turn lane to US 231. South of the US 98 intersection, Harrison Avenue was recently repaved and is in good condition.

**Photo 1**  
**Deep rutting and some minor cracking in all eastbound lanes on US 98 at Jenks Avenue.**

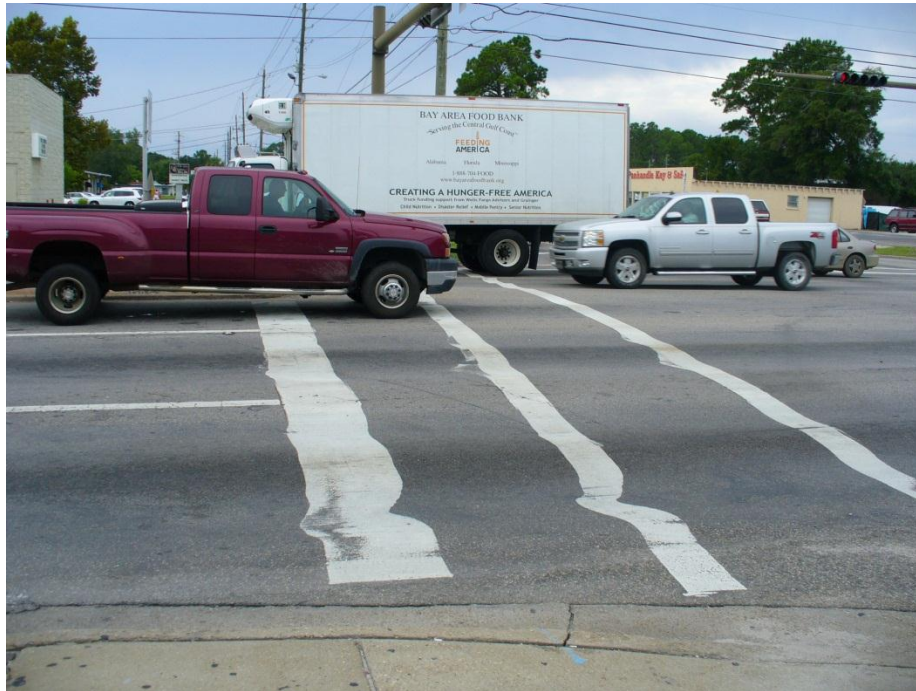
**Photo 2**  
**Deep rutting in westbound lanes of US 98 at Jenks Avenue**

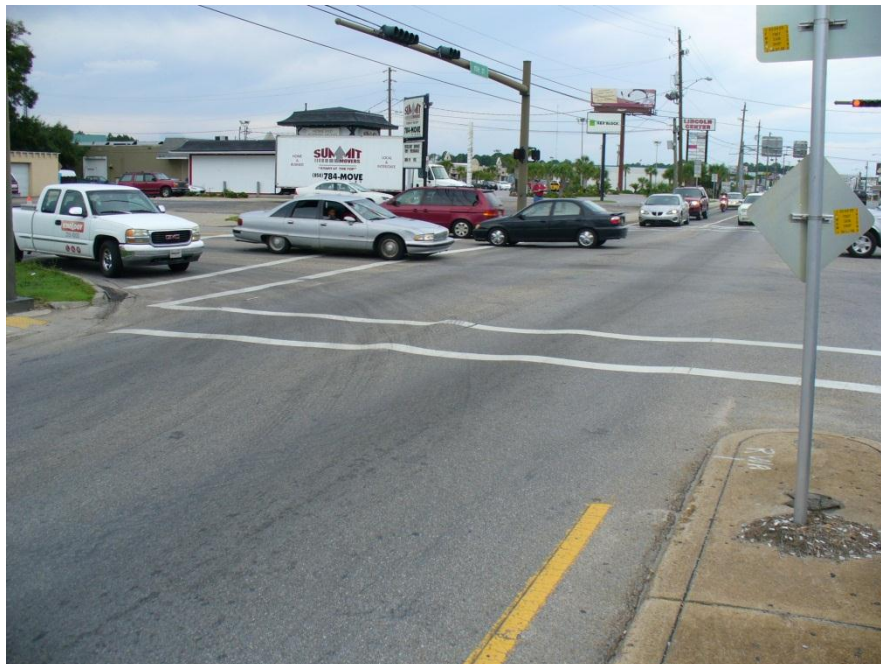
**Photo 3**  
**Rutting throughout the US 98/Jenks Avenue intersection forms a checker pattern, creating a rough intersection for travel in all directions.**

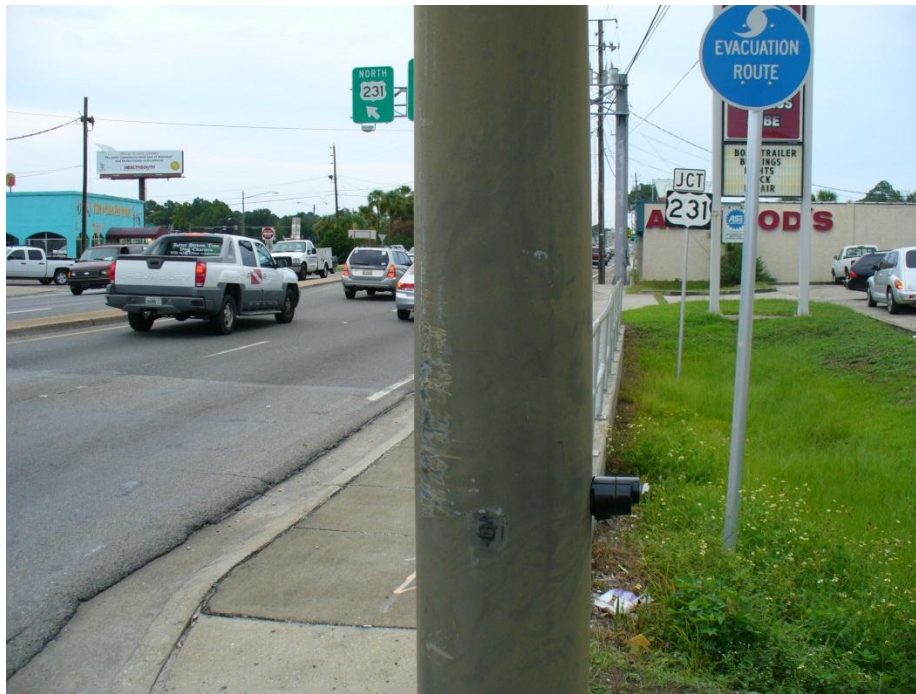
There are mast arms located at all four corners at Jenks Avenue and US 98. The mast arm located at the southeast corner is damaged, as is the curbing and sidewalk (see Photo 4 in Appendix 2). This indicates a turning radius issue for trucks resulting from the traffic on US 98 that forces trucks to complete their turns within the outside lane, and the tracking of the rear trailer wheels over the curb.

**Photo 4**  
**Mast arm damage caused by turning truck at the southeast corner of US 98/Jenks Avenue intersection.**

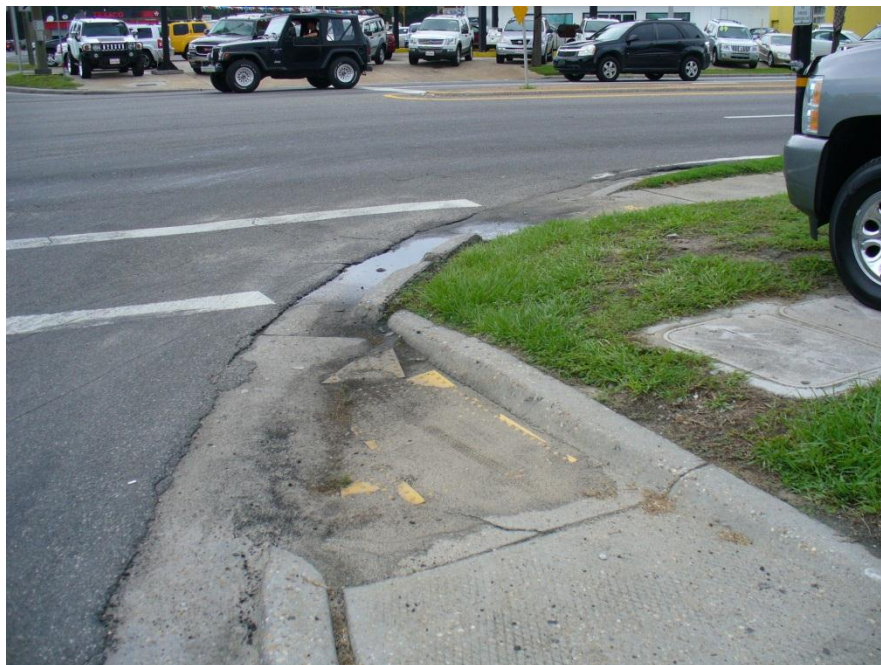
At Harrison Avenue, the curb and gutter at the southeast corner are severely cracked for the same reasons stated previously (see Photos 5 and 6 in Appendix 2). Additionally, the curbing located at the front of the median on US 98 is damaged from vehicles turning left from Harrison Avenue (see Photo 7 in Appendix 2). There are mast arms with pedestrian features located at all four corners; however, the only crosswalk is located along the south side of US 98 southwest and southeast corners with Harrison Avenue. The mast arm located at the southwest corner has also been hit and is slightly damaged. The driveway entrance to the Tally Ho restaurant located at the southwest corner of US 98 has been blocked by delineators (see Photo 8 in Appendix 2). This was most likely to prevent right turn cut-throughs to Harrison Avenue.

**Photo 5**  
**Curb damage caused by off-tracking trucks at the southeast corner of US 98 and Harrison Avenue.**

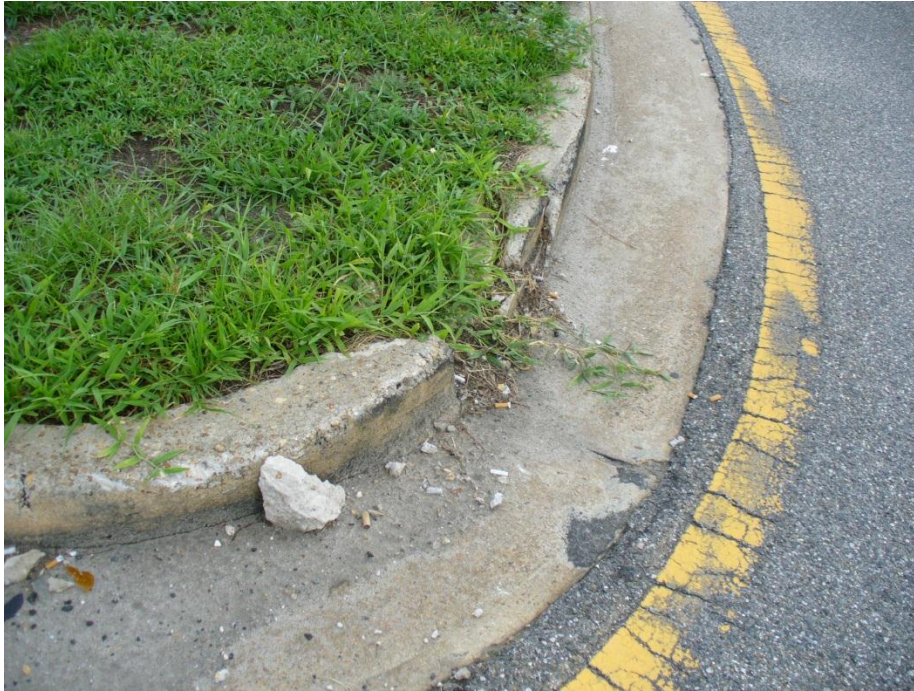
**Photo 6**  
**Curb damage caused by off-tracking trucks.**

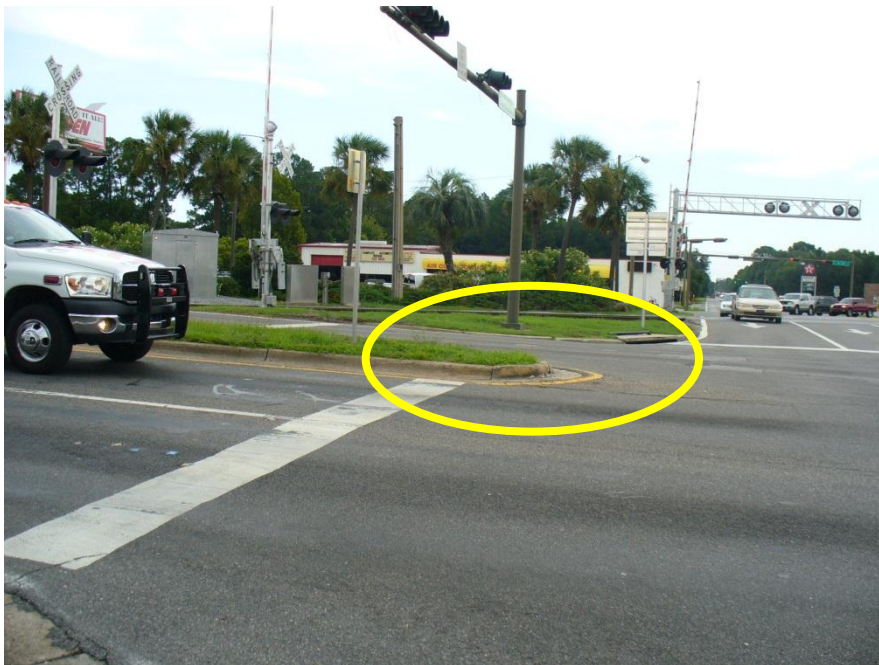
**Photo 7**  
**Bull nose damage on US 98 at Harrison Avenue**

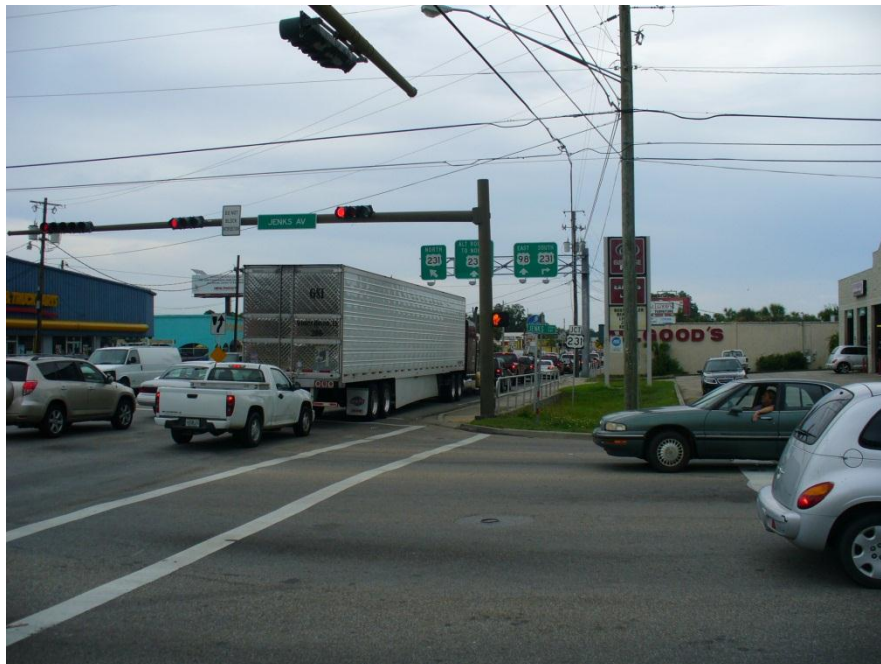
- **Congested conditions often back traffic from Harrison past Jenks Avenue (see Photo 9 in Appendix 2).**  
This multi-intersection area has a long and complicated signal progression that exceeds 3 minutes in length. This combined with the short distance (625 feet) between Harrison Avenue and Jenks Avenue results in queue lengths that back beyond the Jenks Avenue

**Photo 9**  
Traffic congestion at railroad crossing on US 98, looking east. Vehicles block the Jenks Avenue intersection, adding to the congestion.

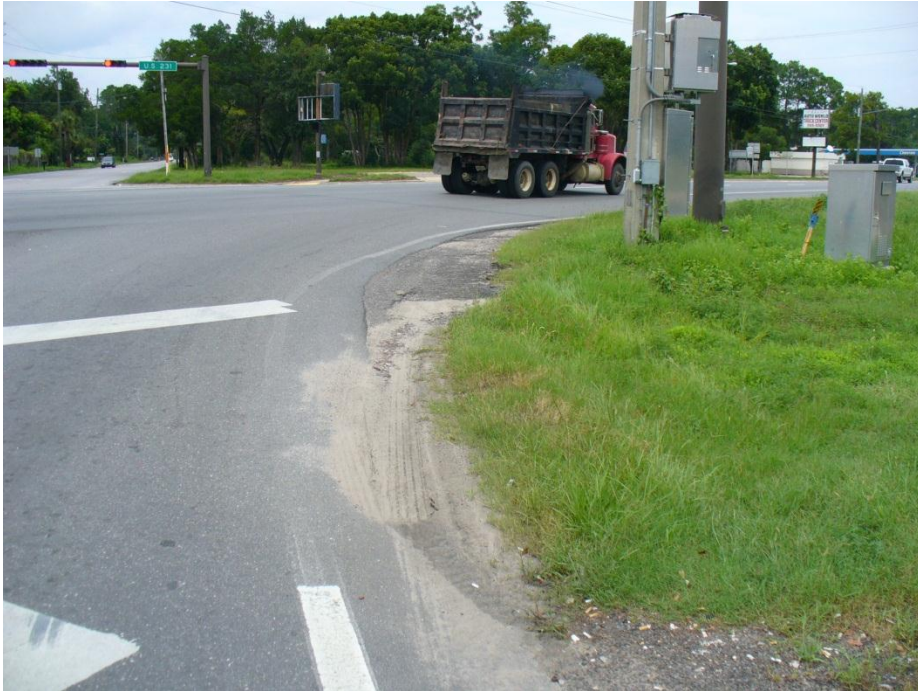
- The northeast corner at the intersection of Lafayette Road and N. East Avenue is heavily rutted due to off-tracking, specifically from fire vehicles (see Photo 1 in Appendix 2).
- Baldwin Road intersects US 231 approximately 800 feet north of N. East Avenue at a non-signalized intersection. Baldwin Road is used by trucks to connect between US 231 and SR 390 on the west side of Panama City (see Figure 3 in Recommendations).
- The Bay Line Railroad main line crosses N. East Avenue 75 feet south of US 231 resulting in less than required storage length for semi-trailers (74 feet minimum) between the railroad gates and the US 231 northbound lanes (see Photo 2 in Appendix 2).

**Photo 1**  
Northeast corner is heavily rutted and the shoulder pavement is deteriorating.

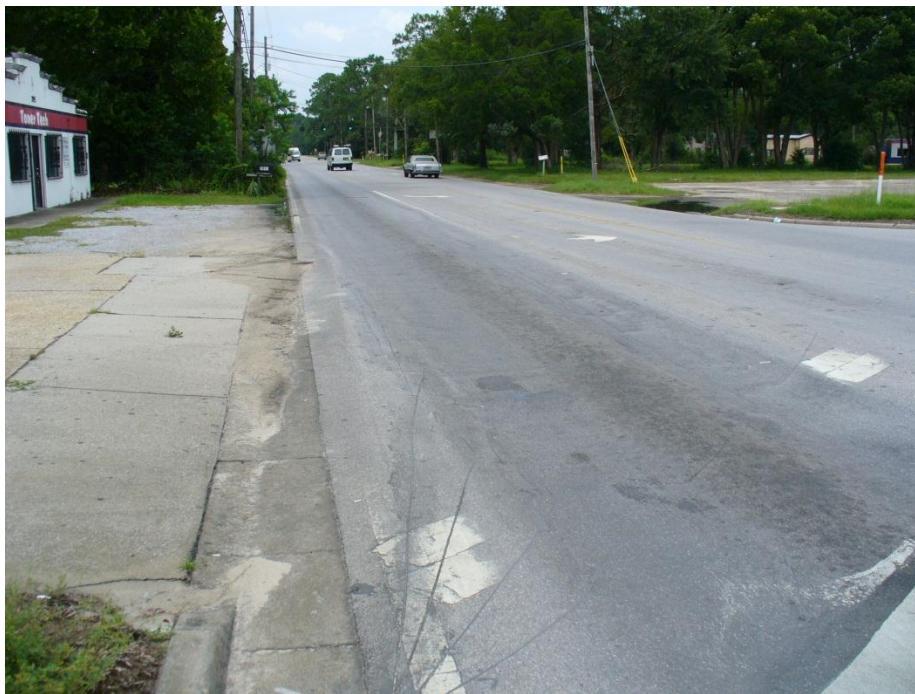
The pavement condition on US 231 is in average condition with little sign of damage from rutting or cracking. The southbound approach on N. East Avenue is rutted and the pavement markings are worn off (see Photo 4 in Appendix 2). There is also some shoulder rutting at the northwest corner due to off-tracking. Shoulder rutting is also at the northeast corner of N. East Avenue and Lafayette Road, immediately south of the railroad crossing (see Photo 5 in Appendix 2). Shoulder pavement should be added to both of these corners to mitigate rutting caused by off-tracking.

**Rutting on the southbound approach of N. East Avenue resulted in badly worn pavement markings.**

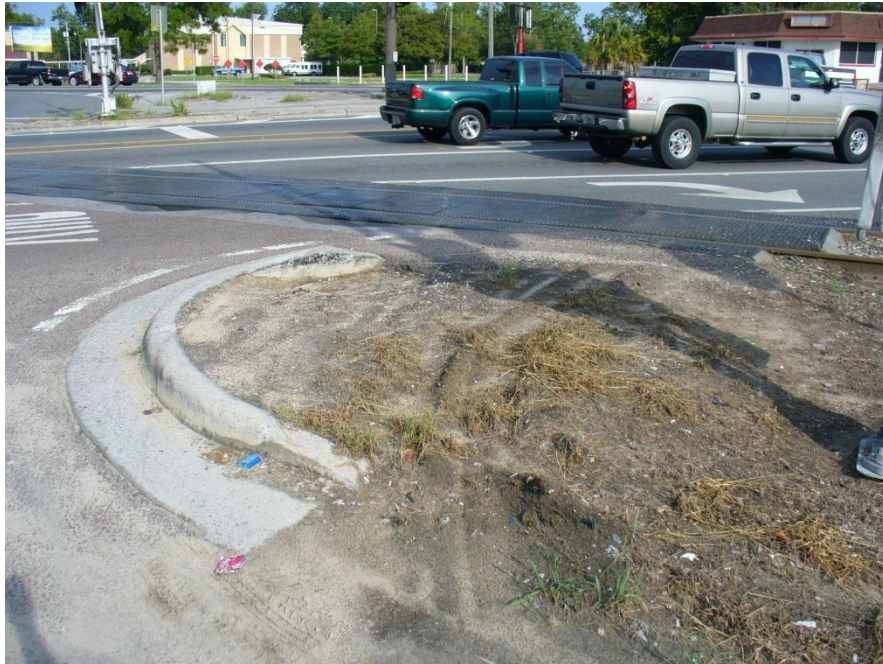
**Photo 5**  
**Shoulder rutting at Lafayette Road. Curb appears to serve no useful purpose.**

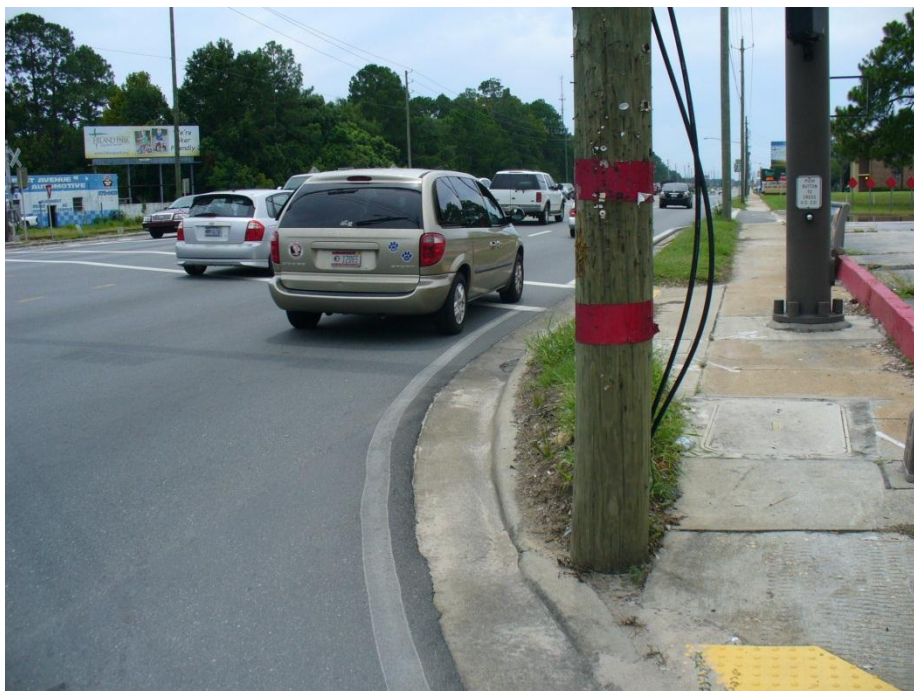
**Photo 6**  
**Pole at the northwest corner is too close to roadway.**

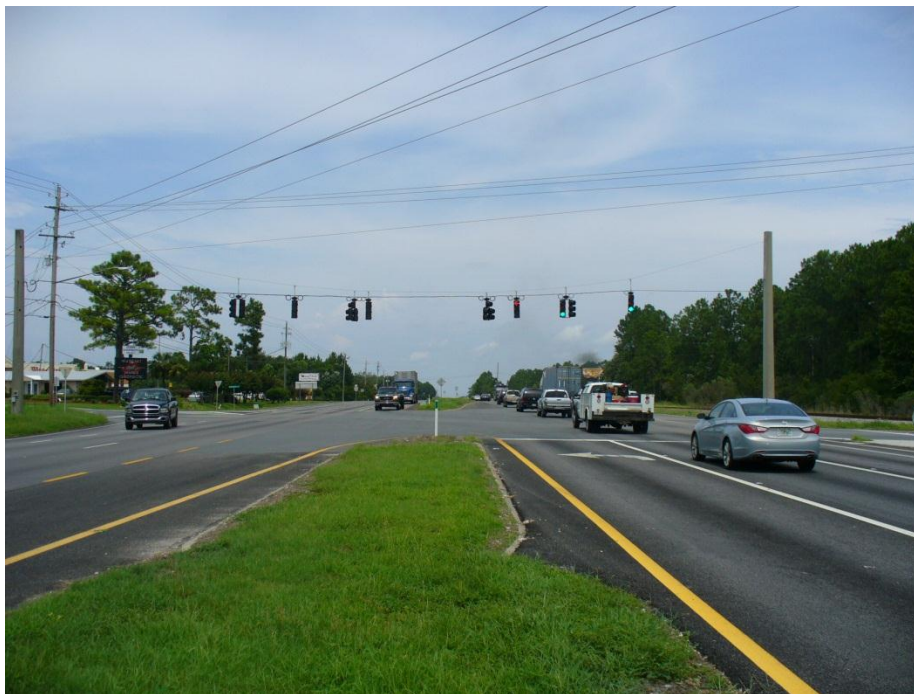
**Photo 5**

**Strain pole mounted traffic signals should be replaced with mast arm mounted signals due to potential for hurricane wind damage.**

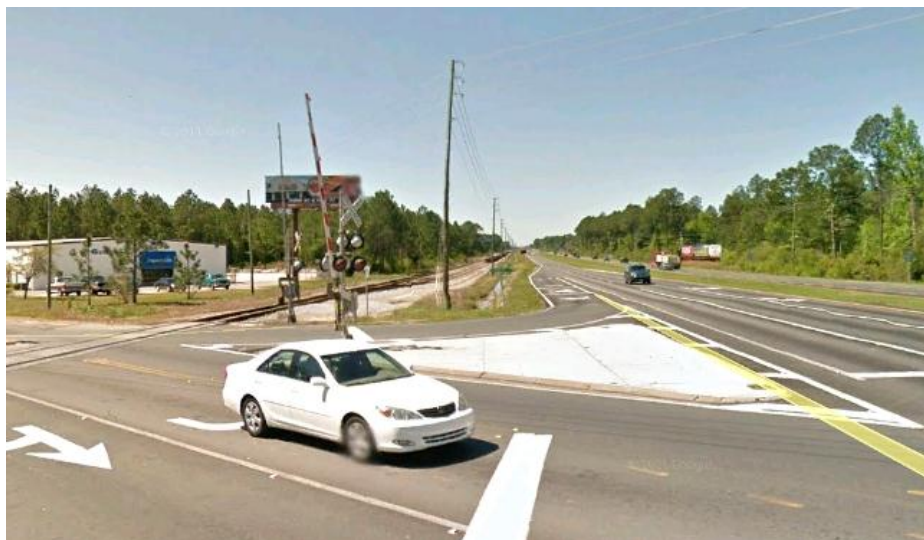
**Photo 6**

**East side of US 231 at Transmitter Road showing raised island and crossing gates for the southbound traffic and the dedicated right-turn lane. The distance from the stop bar shown to the railroad tracks is too short for trucks.**
