**Final Report**

**Corrosion Evaluation of Post-Tensioned Tendons  
on the Mid Bay Bridge in  
Destin, Florida**

**April 15, 2002**

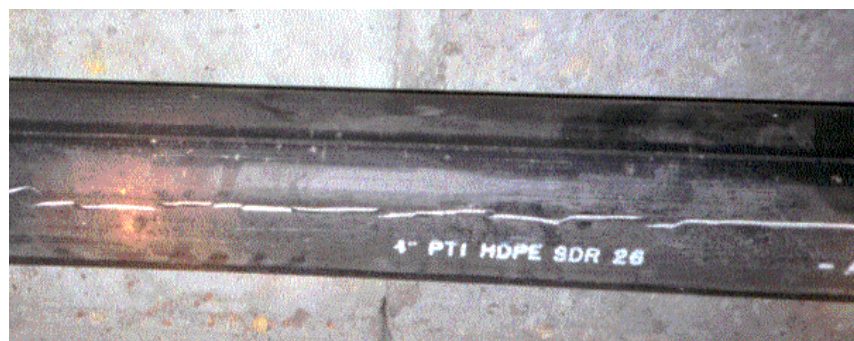
Polyethylene Duct. The PE ducts exhibited cracks at multiple locations along many of the tendons. An example of this is shown in Figure 4. Most of the cracks were along the inclined length between the anchorages and deviation blocks as opposed to the horizontal sections. Also, the cracks were concentrated in the top half of the duct circumference, particularly between 2 and 10 o'clock (12 o'clock was designated as the top of the duct). A general correspondence was found between occurrence of duct cracks and presence of an underlying grout void(s), meaning that the latter was also concentrated in the upper portion of the duct. These voids often extended along the tendon length and, in such cases, are termed void channels. The cause and significance of these elongated voids are discussed subsequently. The duct cracking is thought to have resulted from a combination of 1) the duct not meeting the construction specifications (2) and 2) circumferential tensile stresses that developed subsequent to setting of the grout during times of low temperature

Figure 4. Typical cracking of the PE duct.

when the duct contracted about the grout combined with bending stresses that resulted from the presence of the grout voids. Appendix A provides a detailed proposed mechanism that explains the observed grout void-duct cracking correlation. At the same time, FDOT personnel have reported that HDPE cracks on the Mid Bay Bridge do not necessarily correlate with grout voids. On this basis, voids are not necessarily a requisite for duct cracking.

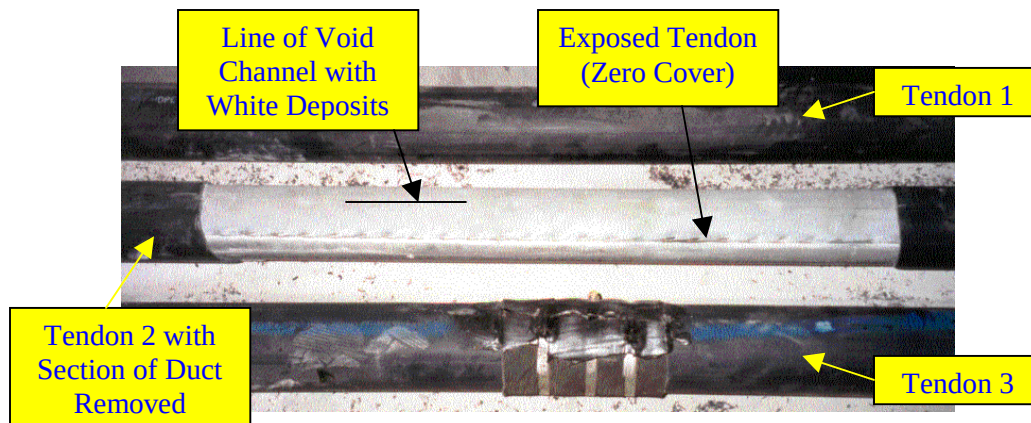
The grout was dry, and no moisture trace was apparent at any locations where the polyethylene duct was removed. A white powdery deposit was observed all along a void channel on the portion of Tendon 2, Span 40-A that had been opened. Figure 5 shows a photograph of this.

Figure 5. Void channel with exposed tendon as seen after removing the PE duct.

The quantity of white powdery deposit was directly proportional to the size (cross section) of the void channel. These channels and the corresponding white powdery deposit were mostly observed in the top half of the tendon but were also found in some cases to extend along the underside of individual cables or several closely grouped cables. The grout in the lower half of the tendon was typically dark gray, well consolidated, and showed no signs of segregation. The one observed exception was an eight foot long section of Tendon 2, span 40-A near the south end where the grout around the entire tendon was white chalky material. Figure 3 showed an example of this white grout as viewed on the anchorage end where light colored material is seen at the bottom

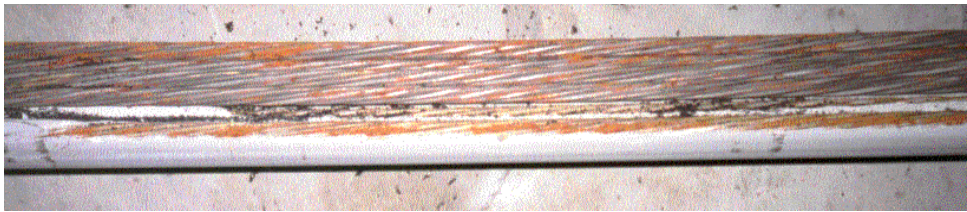
Tendons. Tendon sections for which portions of the duct had been removed, either previously in conjunction with the FDOT investigation or during this inspection, were examined for corrosion related damage. In this regard, Figure 6 shows a general photograph of corrosion along Tendon 4, Span 37-C. Likewise, Figure 7 provides a close-up view of Tendon 2, 40-A where wire pitting corrosion over a relatively broad length and one broken wire on each of three different strands were apparent. Two of the fractured wires exhibited corrosion damage but the third did not. The wire with no corrosion exhibited a well-defined cross section reduction (necking) as is indicative of ductile fracture. Corrosion deposits with small pits were observed on adjacent strands in localized areas. Failure of individual wires was primarily due to corrosion and a subsequent elevated tensile stress that resulted from the reduced cross section.

Figure 6. Typical corrosion observed on tendon 4 in Span 37-C.

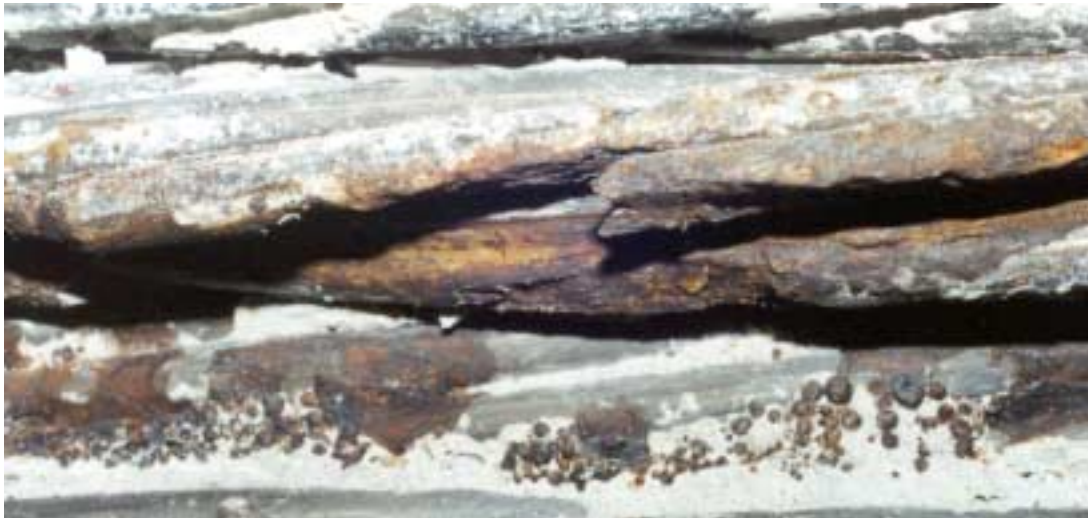
Figure 7. Broken wire in one of the strands of Tendon #2 of Span 40-A.

2. At locations of cavities and grout voids, cables and wires thereof commonly exhibit corrosion, the magnitude of which varies from minimal to severe. Three instances of wire fracture were noted in the case of Tendon 2 of Span 40-A. Half-cell potential data indicated no ongoing active corrosion of grout embedded steel

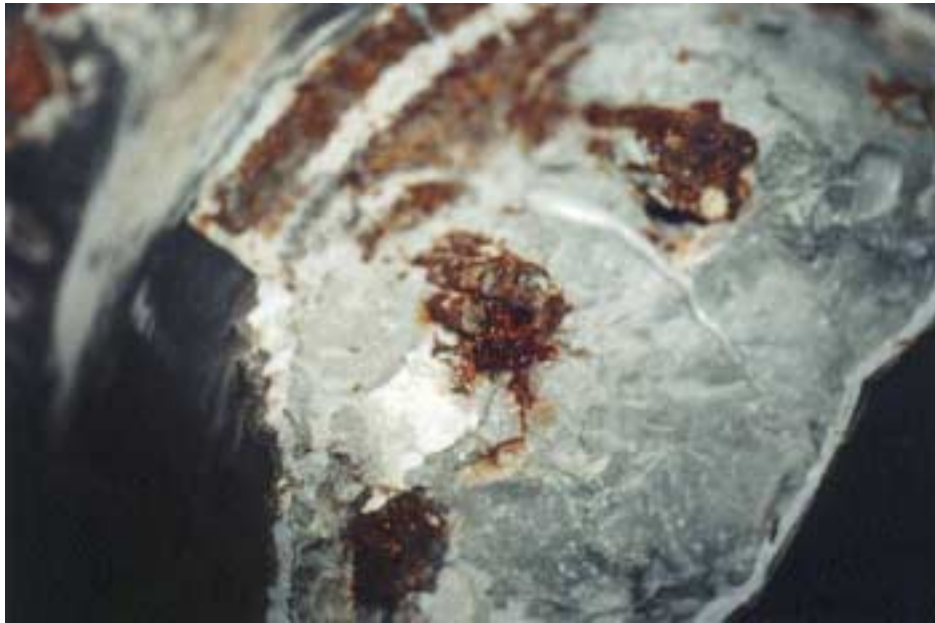
was represented that most of this corrosion had developed subsequent to these being exposed. Figure 8 shows a photograph of three tendon ends with corrosion products emanating from the wire interstices. Note for the center tendon end, which is the only one in focus, that the cut end of the three upper wires is clean, but the ends of the lower wires are covered with corrosion products. The liquid nature of these corrosion products is an indicator that they are acidic, as determined by extensive past observations and experience of the investigators in similar and related situations. Dried corrosion products of this same type are apparent also as spherical rust particles along the base of the bottom cable wire in Figure 7. The possible significance of these observations is discussed subsequently.

Figure 8. Photograph of the exposed end of a tendon anchorage.

While active corrosion was ongoing upon the outer anchorage faces and upon contiguous strand ends that had been exposed several months earlier (see Figure 8), such corrosion was not active at the time of this inspection upon strands, even previously corroded ones, that were exposed by removal of the duct and, in some cases, grout. This difference is attributed to a greater concentration of hygroscopic material within the cable interstices than upon the exterior wire surfaces. It must be expected that corrosion of the strands per se within grout voids or where grout has carbonated will reinitiate during periods of high humidity and, particularly, during times of moisture condensation.

4. End anchorages that were exposed by others by removal of the mastic and packing grout in October, 2000 exhibited pronounced ongoing corrosion as indicated by the presence of rust-colored hygroscopic acidic corrosion products. In numerous instances, these products were emanating from the strand interstices. Similar dried corrosion products were found within the tendons at locations where corrosion had occurred. This suggests that the bleed water residuals are hygroscopic and acidification of condensed moisture, both on the exterior surface of cable wires and within the interstices. Exposure of the cables by removal of duct sections and, in some cases, underlying grout has not, however, significantly affected their corrosion state.

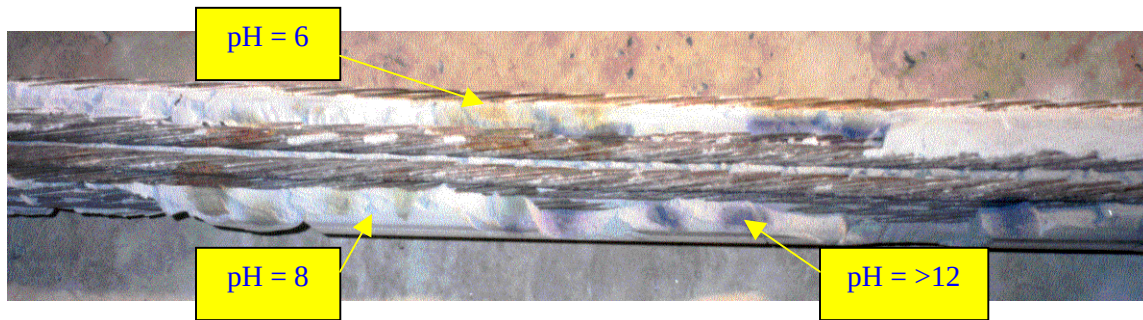
The pH measurements upon the grout of Tendons 1 and 3 of Span 40-A indicated no loss of alkalinity except within a thin surface layer about 1/64" deep. The pH of the white powdery material at the top of Tendon #2, Area 1 was in the range of  $8\pm 1$  prior to cleaning with a wire brush and was  $12\pm 1$  after cleaning. In the corresponding bottom region, the grout was carbonated with a pH of  $8\pm 1$  to a depth of about 1/4". It is within this latter region that the cable wires were broken. The pH was  $12\pm 1$  once the grout transitioned to the dark gray region. Figure 9 shows a photograph of this.

Figure 9. Variation of pH of the grout along Tendon #2 of Span 40-A as revealed by application of a visual indicator.

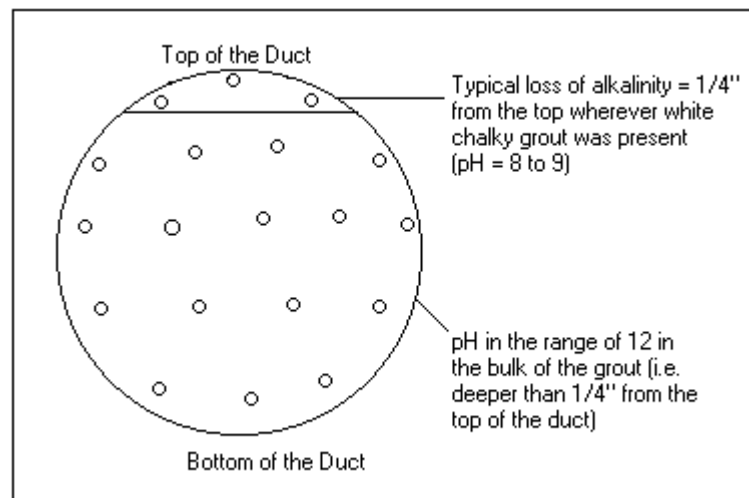
For Span 37-C, the pH measurements upon the grout of Tendons 5 and 6 indicate no loss of alkalinity except for a relatively thin layer about 1/64" deep at the upper surface. However, the grout around Tendon 4 was carbonated to a depth of about 1/4". Figure 10 schematically illustrates the general overall alkalinity profile.

Figure 10: General distribution of grout pH as measured in the field. (Note: Cable end positions are not exact.)

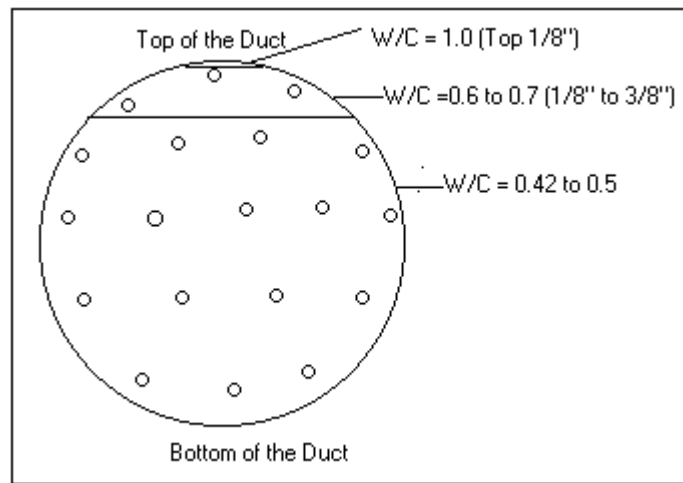
1. The color difference between the white and dark gray grout material was a consequence of a) variations in the w/c of the grout and b) the degree of hydration of the Portland cement. The associated stratification of the cement paste phase resulted from bleeding which was promoted by high w/c, prolonged initial set, and single-end injection resulting in long pumping lengths.
2. The w/c of the hardened grout (away from the duct surface) was in the range 0.42-0.50. The highest w/c was within a 1/8 inch layer at the outer grout surface and was estimated as 1.0 or greater. This material is highly porous, very soft, and weak (it should exhibit a low compressive strength, if this could be measured, due to relatively high porosity). Within 1/8” to 3/8” from the duct, the w/c was estimated as being between 0.6 and 0.7. Figure 11 summarized this schematically.

Figure 11: Schematic illustration of the w/c distribution based on petrographic analysis. (Note: Cable end positions are not exact.)

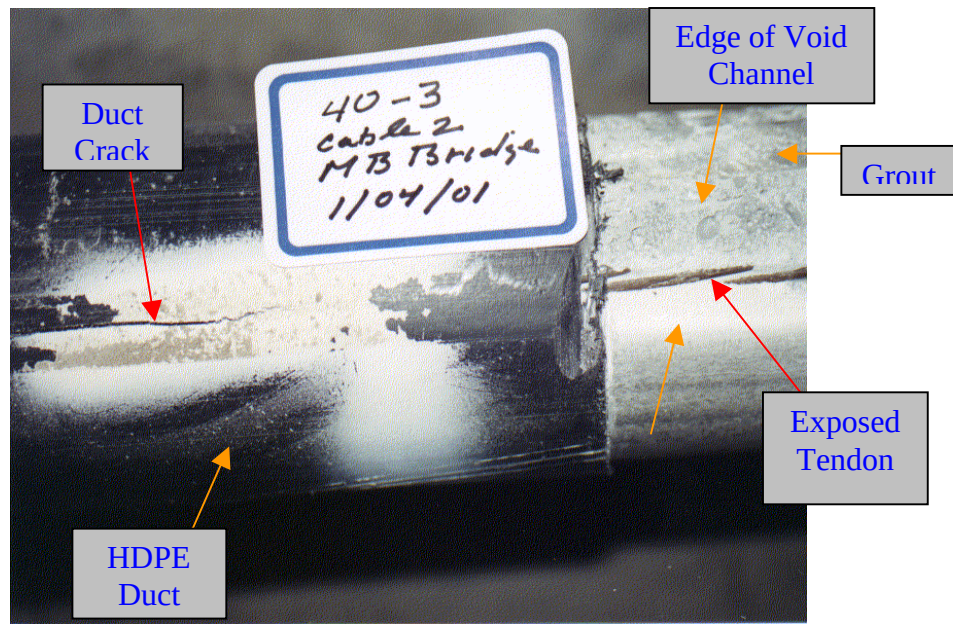
Duct cracking has occurred predominantly between the 10 and 2 o'clock orientations, considering that 12 o'clock is the vertical. Also, the cracks are mostly confined to the inclined cable sections as opposed to the horizontal runs. Lastly, the cracks predominantly occur at the location of an elongated grout void or channel in the underlying mortar. As an example of this, Figure A1 shows a photograph that was taken looking down upon cable 2 of section 40-A from above. Here, the HDPE duct has been cut away on the right side of the cable, thereby revealing the grout and a void channel at the 12 o'clock orientation (the void is difficult to discern in the photograph but its side edges are indicated). Also apparent is that the top of a tendon is exposed near the base of the void. A duct crack that is aligned with the void is seen at the left of the photograph.

Figure A1: Photograph of duct crack and exposed grout with void channel.

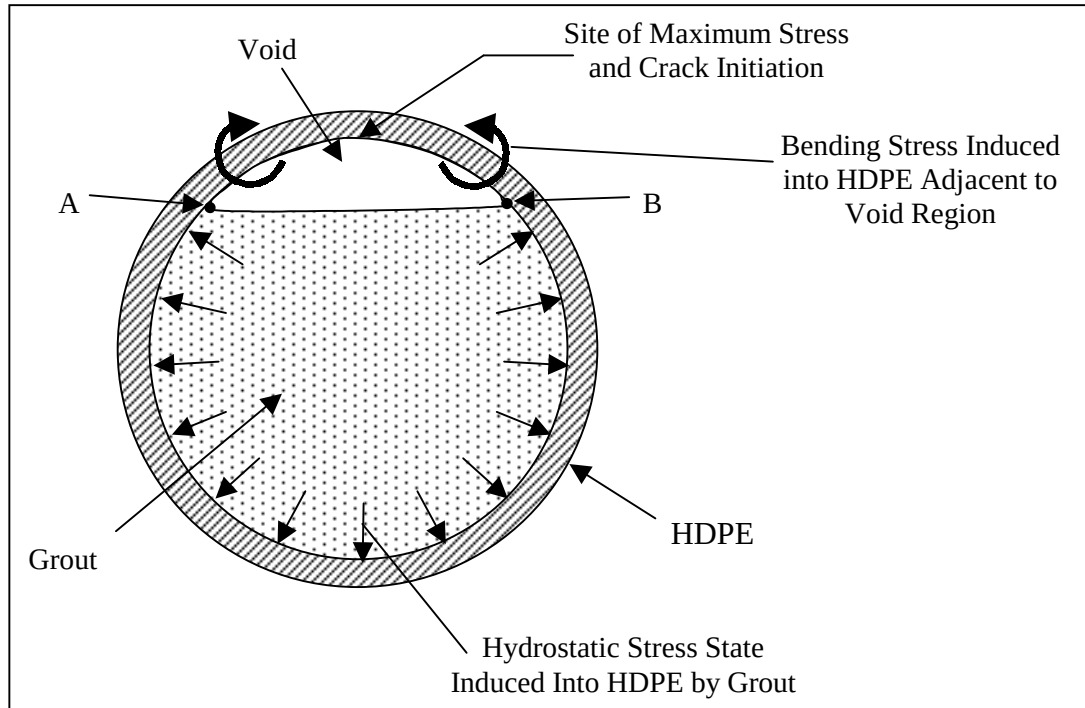
Because the coefficient of thermal expansion for HDPE exceeds that of grout, contraction of the former about the latter during periods of a temperature drop should be resisted by the latter such that a tensile hydrostatic stress state results in the duct. Presence of a void channel is expected to complicate the otherwise simplistic hydrostatic stress state and to introduce both transverse tensile and bending stresses within the portion of the duct adjacent to the void channel. Figure A2 illustrates this situation schematically. Thus, as a consequence of the hydrostatic stress, Points A and B become displaced radially outward and away from one another. This results in the bending stresses as schematically shown with maximum stress occurring on the

Figure A2: Schematic illustration of the proposed HDPE duct cracking mechanism.

interior surface midway between Points A and B. If this stress is sufficiently elevated, as is relatively easy to achieve in bending, then a crack initiates on the interior surface and propagates outward.

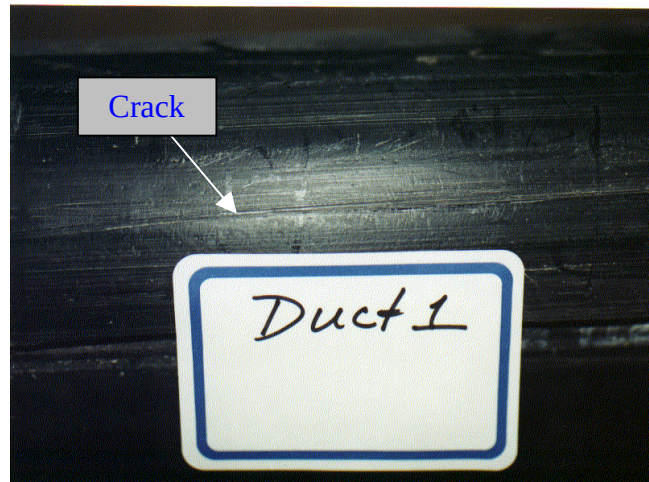
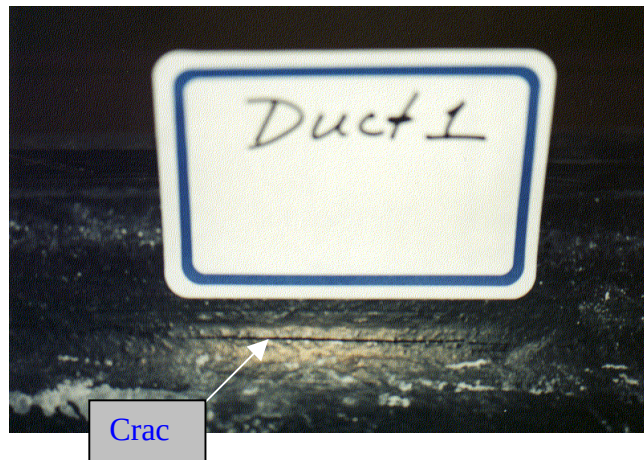
Two rectangular sections of HDPE duct, each of which contain a crack several inches long, were cut from cable 40-2-C. These measured approximately 2x7 inches and were located several feet apart. The cracks were in the 12 o'clock orientation, and a grout void channel extended along the cable directly beneath the cracks. In both cases, the crack opening was greater on the interior surface than the exterior. Figure A3 shows this for one of the two samples. Also, the crack was longer on the interior surface. These findings (greater crack width and length on the interior surface) are consistent with the crack having initiated on the inside of the HDPE and, as such, support the proposed cracking mechanism. This does not preclude the possibility that the duct may have been out of specification or have been improperly specified.

Figure A3: Photograph of crack on duct sample 1 acquired from cable 2 of section 40-C:  
(a) external surface and (b) internal surface.
