**CORROSION PERFORMANCE OF
CONCRETE CYLINDER PILES
Contract No. BC353 RPWO#10
Final Report to Florida Department of Transportation**

**A. A. Sagüés
Principal Investigator
Department of Civil and Environmental Engineering**

University of South Florida
Tampa, FL, 33620
February 28, 2005

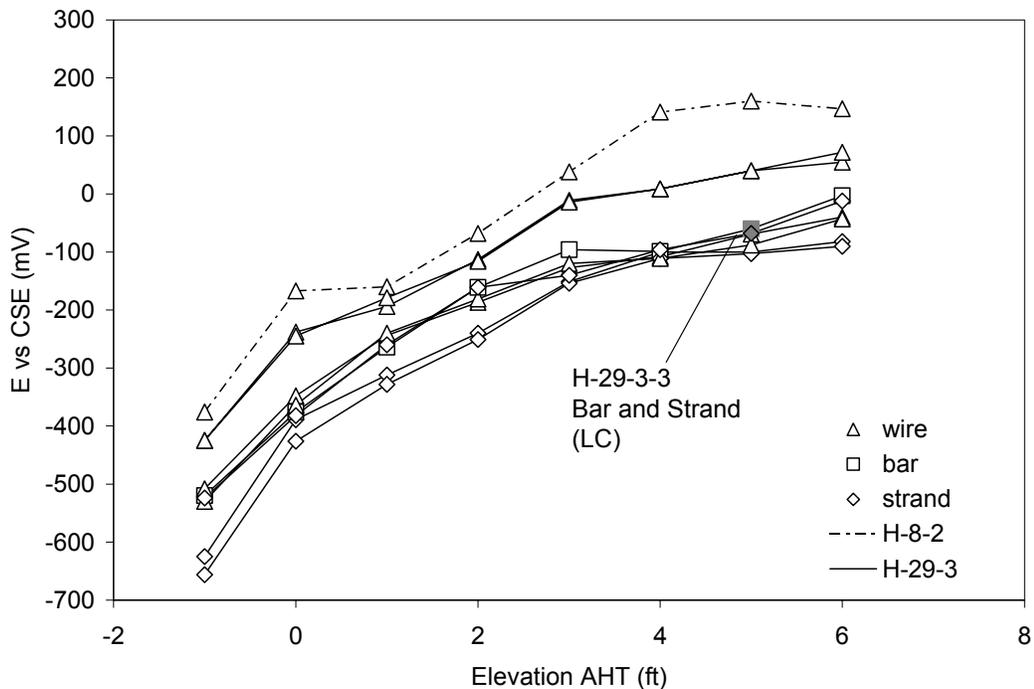
Half-cell potentials as function of elevation are listed in Appendix III Table A5 and a summary is shown in Figure 3.1. Potential levels of -200 mV and -350 mV CSE are traditionally associated with indications of unlikely to likely ongoing corrosion, respectively, in atmospherically exposed concrete [26]. While the potential readings more negative than -350 mV CSE in Figure 3.1 are not a reliable indicator of corrosion in progress in wet concrete [27], values more positive than -200 mV CSE as seen at elevations above 1 to 3 ft (0.3 to 0.9 m) strongly suggest that the steel above those elevations was in the passive condition at the time of the measurements. The potential of the spacing rebar with surface rated as LC in the core drilled on a crack 5 feet (~ 1.52 m) AHT in H-29-3 was -96 mV vs. CSE at that elevation, suggesting that active corrosion was not in progress there when tested.

Figure 3.1 Hathaway Bridge half-cell potential measurements. ■ near steel under LC rating.

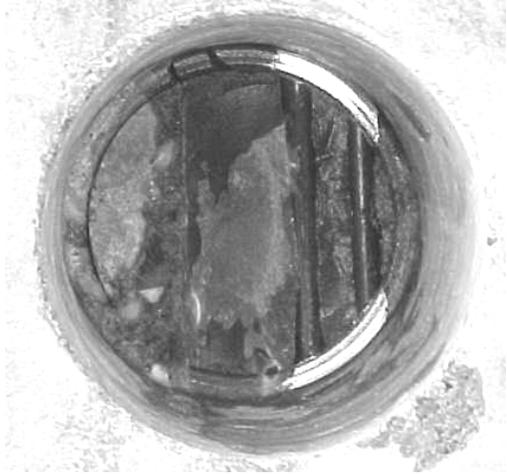
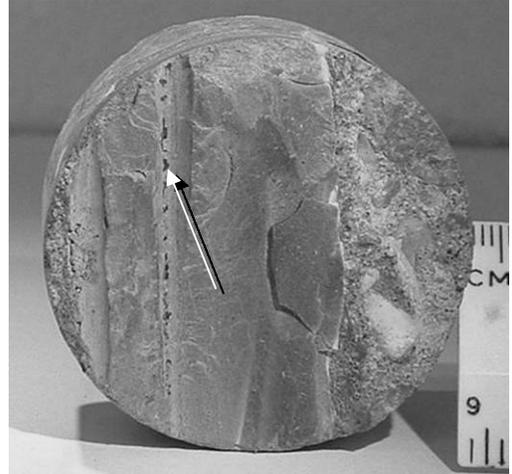
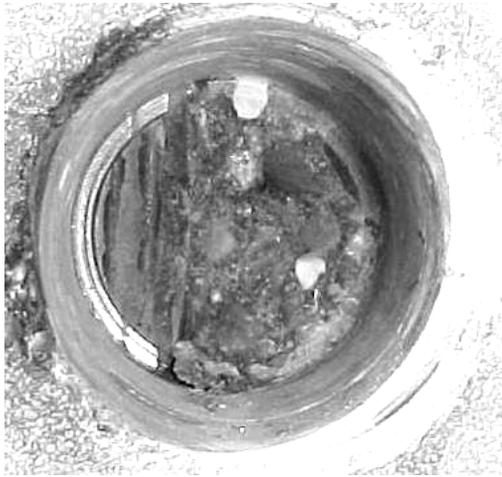
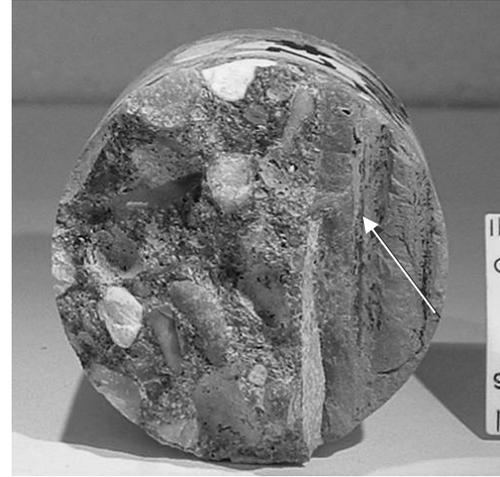
Figure 3.3 Observation of surface rusting on strand, Pensacola Bay Bridge. Faint rust on strand. Traces of rust on grout imprint, indicated by the arrows, shown in the right of the figure. a) P4-1-4. b) P-110-2-2.

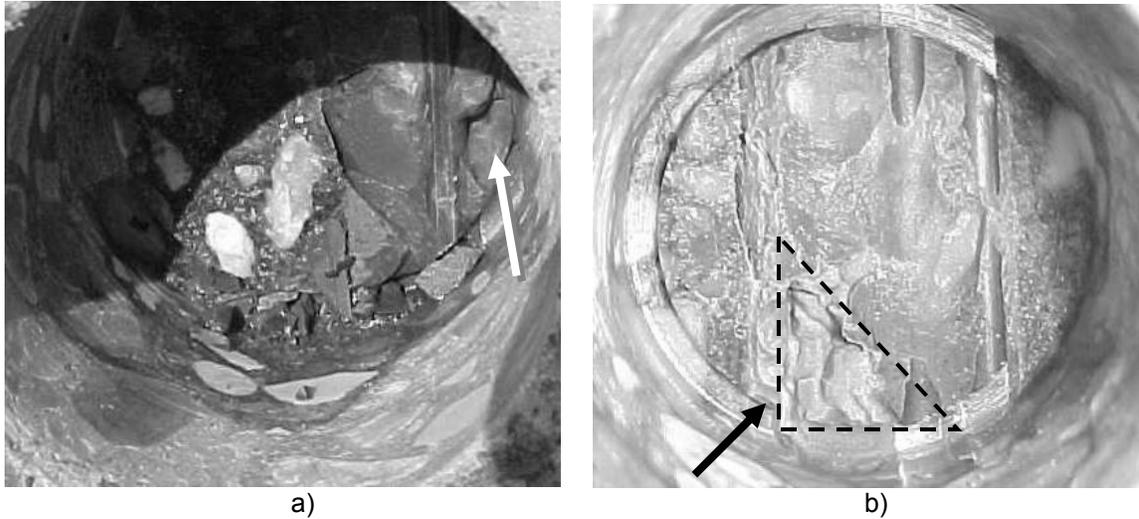
Figure 3.4 Pressurized grout consolidation, Pensacola Bay Bridge. Voids indicated by the arrows. a) P237-1-2. b) P252-1-1 (triangular region).

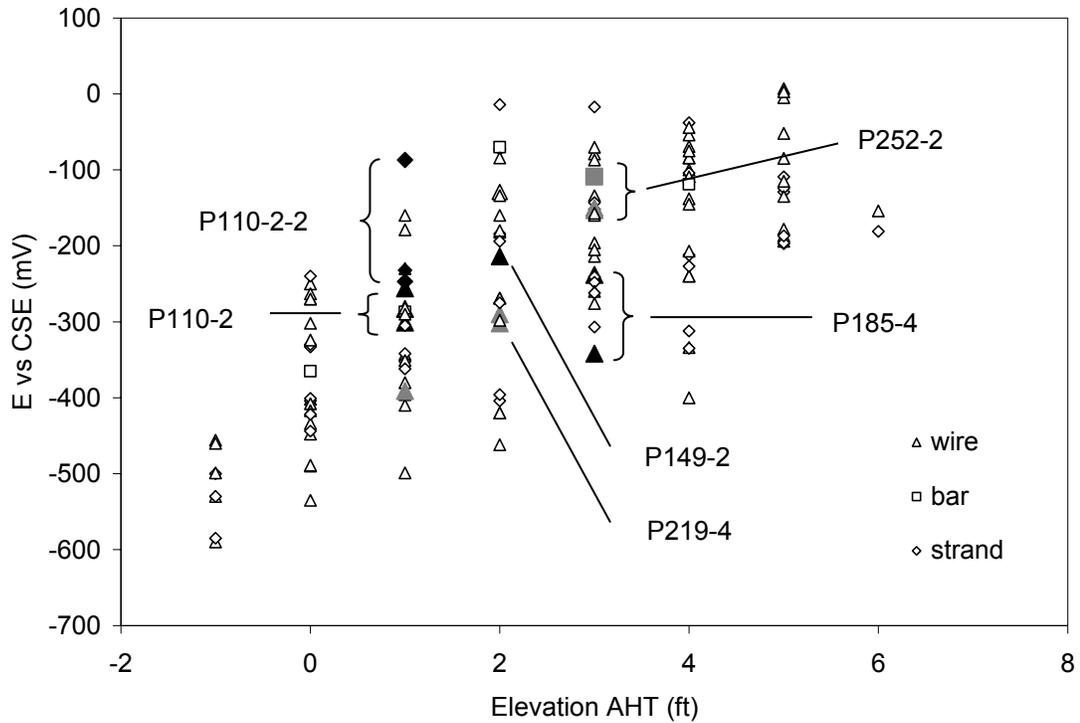
Half-cell potential measurements were made for exposed steel reinforcement in eight of the piles. Results are shown in Figure 3.5 and are listed in Table A5. Four locations having LC and SC ratings are indicated by black symbols in the figure below: P110-2, P110-2-2, P149-2, and P185-4. Duplicate measurements are shown where available. Notably, those corrosion locations had potentials more negative than -200 mV. While most reinforcement in delaminated or previously spalled concrete showed highly negative potentials suggestive of ongoing active corrosion risk, half-cell potential in the delaminated/spalled concrete of P252-1 located ~ 3 feet (~ 1 m) AHT, was only ~ -150 mV vs CSE. This may indicate that the spall/delamination there was not caused by corrosion of the spiral wire/bar or that the spiral wire/bar located 3 feet (1 m) AHT is not continuous with the reinforcements located 1 foot (0.3 m) AHT. However as mentioned above, limited electrical continuity checks from other piles showed that spiral wires severed by coring were electrically continuous to one another.

Figure 3.5 Pensacola Bay Bridge half cell potential measurements. ■ near corroded reinforcement. ■ near rust stained/delaminated concrete.

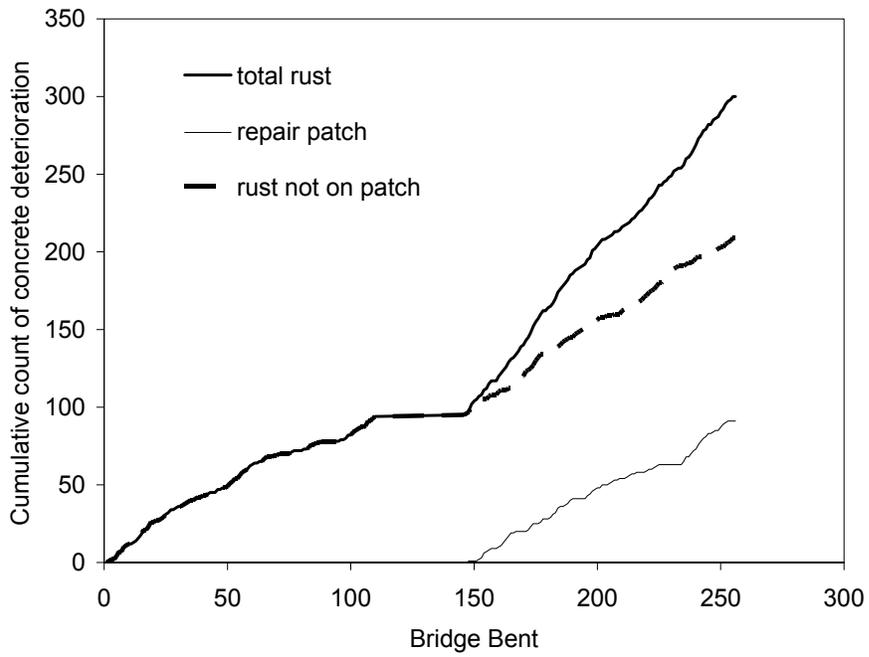
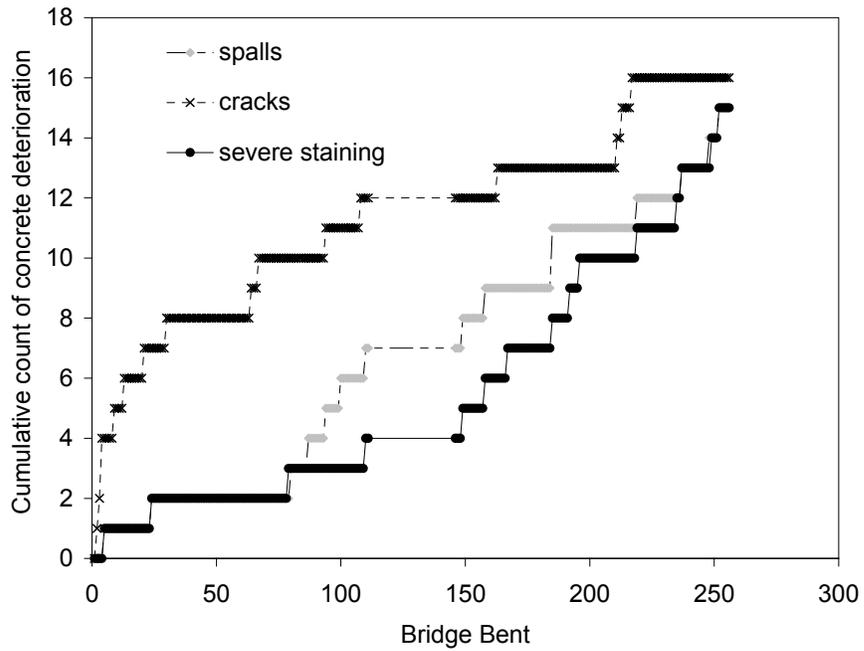
Figure A3 Pensacola Bay Bridge cumulative count of concrete deterioration features. a) rust stain cumulative count. b) spalls, cracks, and severe staining cumulative count.
