# CFRP REPAIR OF IMPACT-DAMAGED BRIDGE GIRDERS

## VOLUME I: STRUCTURAL EVALUATION OF IMPACT DAMAGED PRESTRESSED CONCRETE I GIRDERS REPAIRED WITH FRP MATERIALS

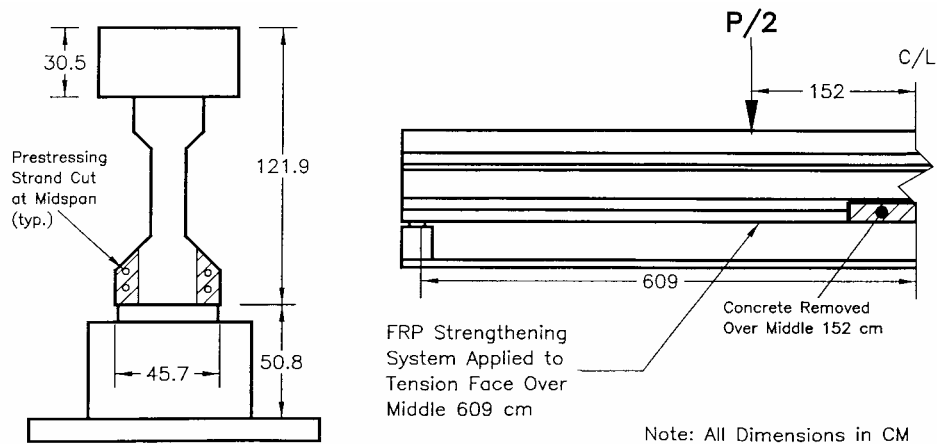
Figure 1: Test-setup and specimen dimensions

Six full-scale AASHTO girders were repaired and loaded to failure at the FDOT structures research facility in Tallahassee. Two of the girders served as control specimens (one with no damage and one with simulated impact damage at the girder's midspan). Simulated impact damage was imposed on the remaining four girders, which were then strengthened in flexure with different FRP systems and tested as shown in Figure 1.
