CFRP REPAIR OF IMPACT-DAMAGED BRIDGE GIRDERS

VOLUME II – INSPECTION OF FRP COMPOSITE REPAIRS USING INFRARED THERMOGRAPHY

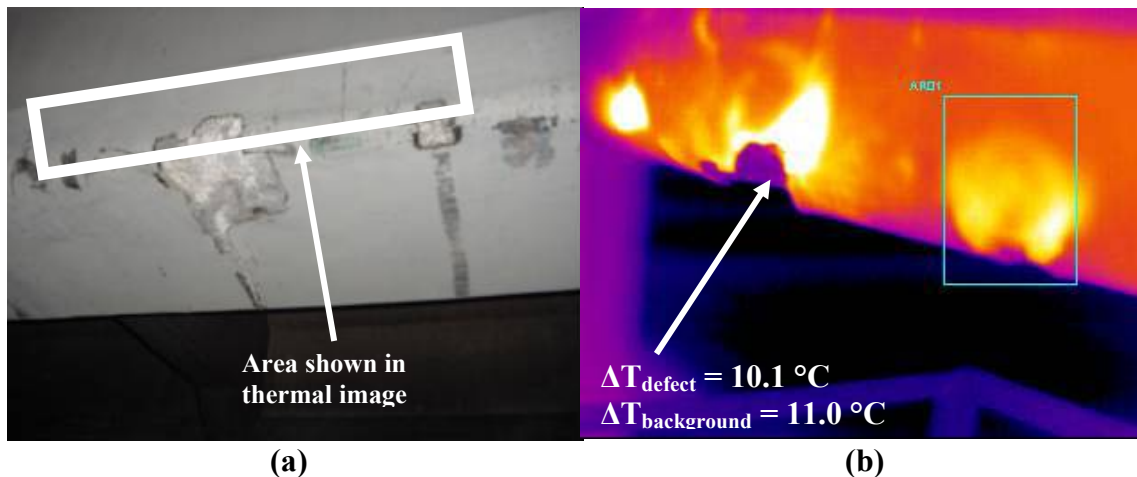
The IRT inspections performed on the in-service bridge identified several installation defects (figure 2). Researchers also inspected a portion of one girder with additional impact damage to the FRP system. Thermography results indicated that the detected damage was limited to the vicinity of the impact. Further research is needed to (1) improve data collection efficiency and (2) develop a standardized inspection procedure that can be used for a wide variety of FRP system types.

Figure 2: Field inspection of Chaffee Rd. Bridge (a) visible impact damage to FRP system (b) thermal image
