# **CFRP REPAIR OF IMPACT-DAMAGED BRIDGE GIRDERS**

## **VOLUME II – INSPECTION OF FRP COMPOSITE REPAIRS USING INFRARED THERMOGRAPHY**

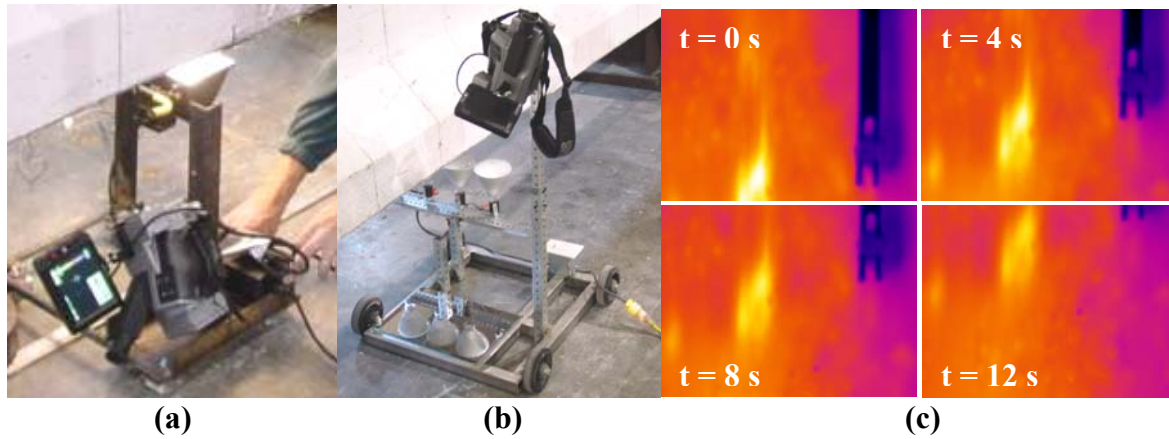
Laboratory results indicated that IRT is a potentially powerful tool for identifying unbonded areas in FRP systems (figure 1). However, as the thickness of the FRP system increases, detection of unbonded areas at the FRP/concrete interface becomes increasingly difficult. IRT was not successful in detecting defects at the FRP/concrete interface in the systems applied to girder 3, 4, or 5. Near surface defects, however, were detected in all of these systems. IRT was capable of detecting defects throughout the thickness of the composite applied to girder 6.

Figure 1: Data collection in laboratory (a) and (b) scanning cart configurations and (c) typical thermal images
