Final Report

June 2006

UF Project No. 00051711  
Contract No. BD545, RPWO #27

## ST. GEORGE ISLAND BRIDGE PILE TESTING

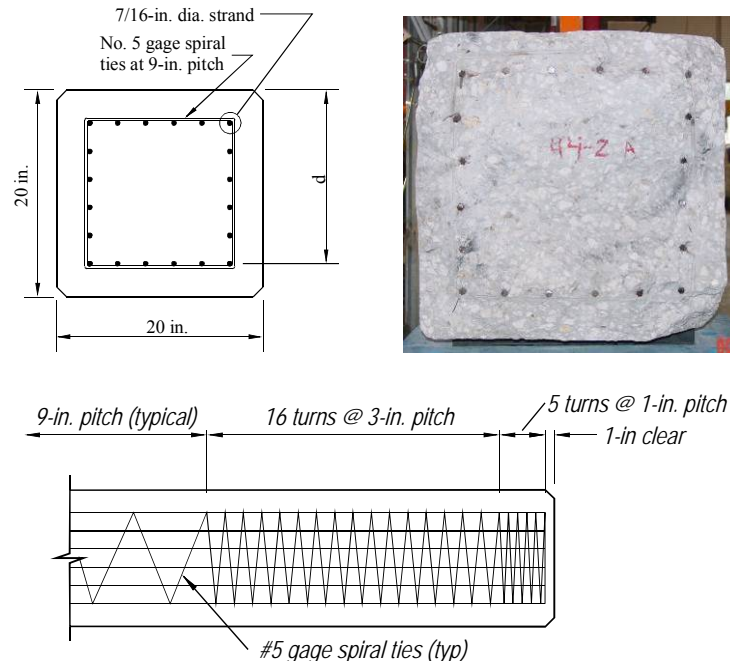
Figure 2 – Pile cross section and spiral details

Construction records indicated that the prestressed piles had a 20-in square cross-section and were prestressed with twenty 7/16-in. diameter stress-relieved prestressing strands (Figure 2). The records further indicated that each strand was prestressed to 18.9 kips and that the pile ends were reinforced with No. 5 gage spiral ties. Design clear cover over the prestressing strand was 3-in. Measurements of effective depth  $d$  were made at each end of the piles after extraction and are given in Section 7.

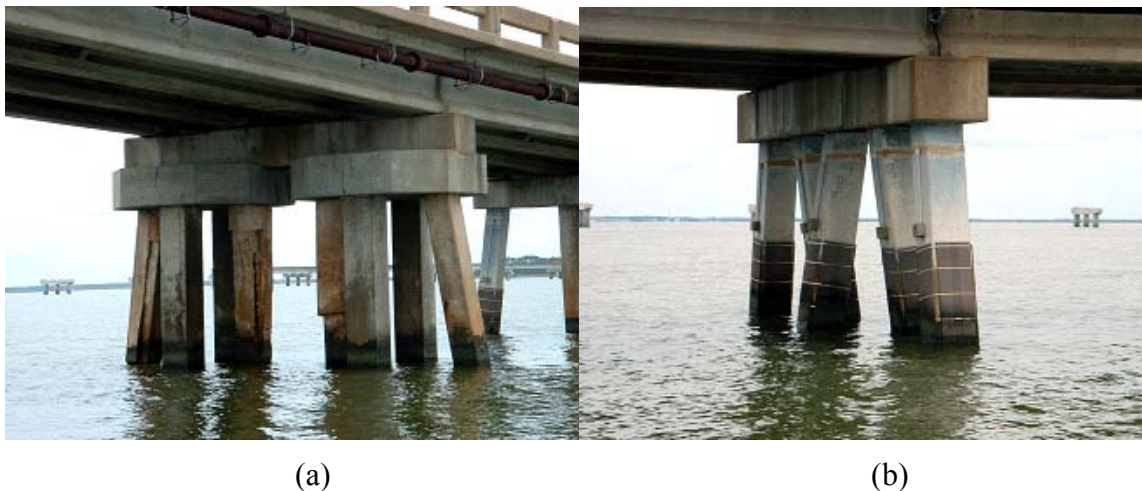
Figure 3 – Prestressed pile bents before bridge demolition. (a) “crutch bents” installed to relieve piles damaged by corrosion (b) cathodic protection system on existing piles

In 1994 extensive repairs were made to the prestressed piles including patching, installation of concrete jackets, and a galvanic cathodic protection system. In addition, a number of piles were so severely deteriorated that additional piles (termed “crutch” bents) were installed to share the bent loads. Figure 3a shows one such installation in which holes were cut in the deck to allow installation of the supplementary piles. Supporting cap beams were then cast under the existing cap beam to transfer load to the new piles. A three tiered galvanic cathodic protection was also installed as part of the repair process. Figure 3b shows the cathodic protection system in which the submerged portion of the pile was protected by a bulk zinc anode, the splash zone by a zinc mesh, and above the splash zone a sprayed zinc anode coating.

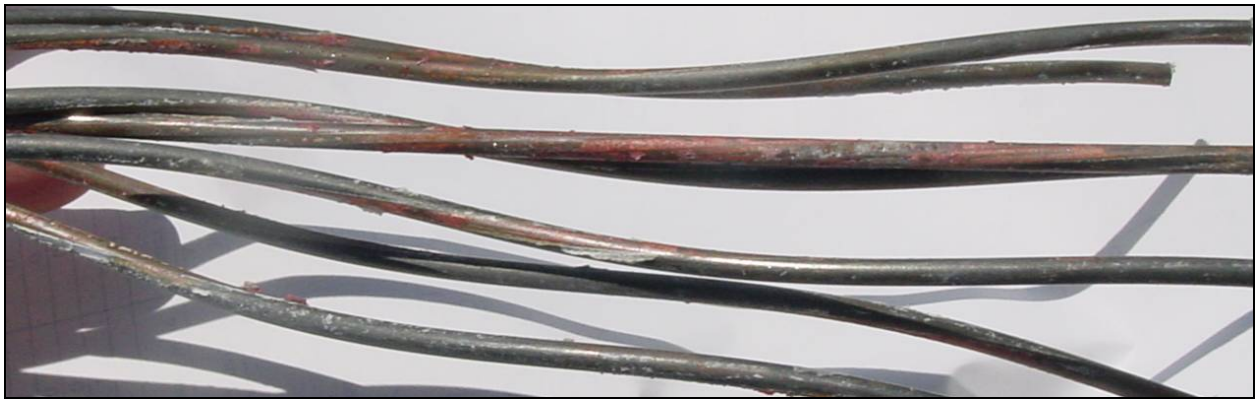
Strand samples taken from both piles generally exhibited light to moderate surface corrosion with spotty mild pitting (Figure 13a). The strand samples from Pile 21-4 showed corrosion primarily in the interstitial space between the outside and center wires. This pattern was consistent at all sample locations. In general, the cathodic protection system appeared to have done a reasonable job of protecting the reinforcement. Some of the strand samples pulled from pile 44-2 (Figure 13b) had surface corrosion on the outer wires. The strand shown in the figure exhibits some bleeding of corrosion product into the concrete as well as black corrosion product indicating a low oxygen environment. Note that the corrosion has the appearance of emanating from the tie wire.

Figure 13 – Corrosion on strand pulled from (a) pile 21-4 (b) pile 44-2.

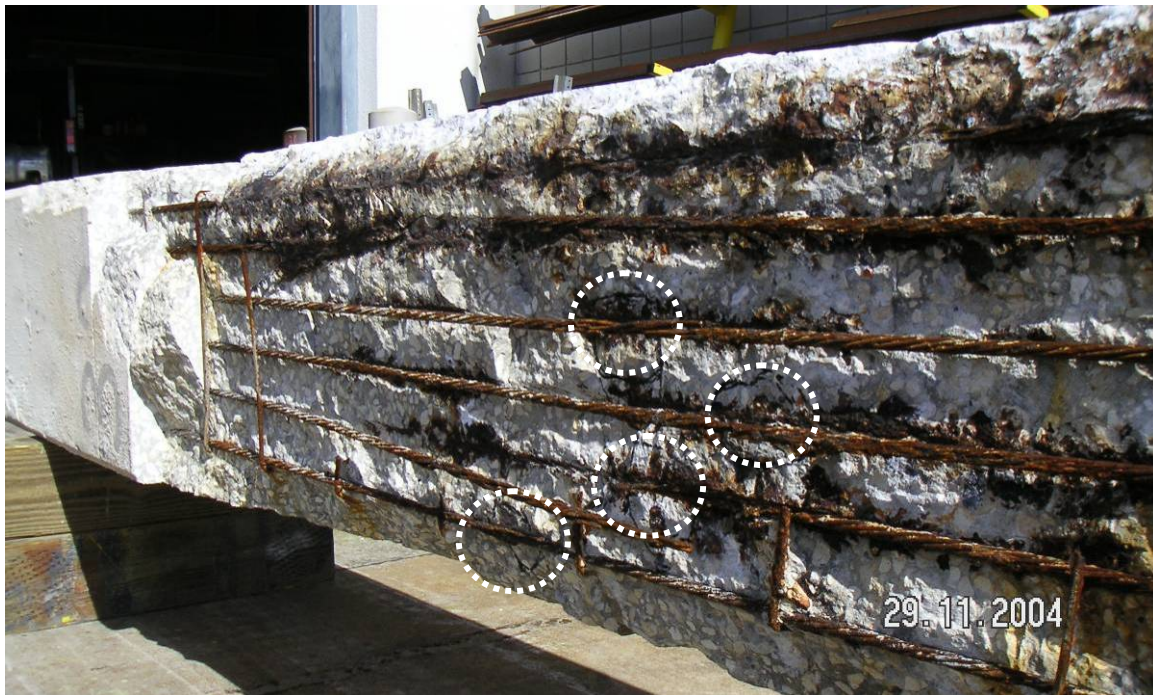
Severe corrosion was also noted in strand that appears to have been used for pick up points during pile construction and handling. Pick up points were noted in both 32-3J and 44-2. Figure 29 shows an example in which the pick-up point strand and pile strand have been nearly completely consumed by corrosion. The pick-up point strand, however, was in bright condition away from the pile strand and farther into the pile. Corrosion at these locations likely was initiated by chloride intrusion along the pick-up point strands where they exited the pile. The fact that the pick-up point was located in the splash zone accelerated this behavior.

Figure 28 – Pile 32-3J after excavation. Wire breaks are circled.

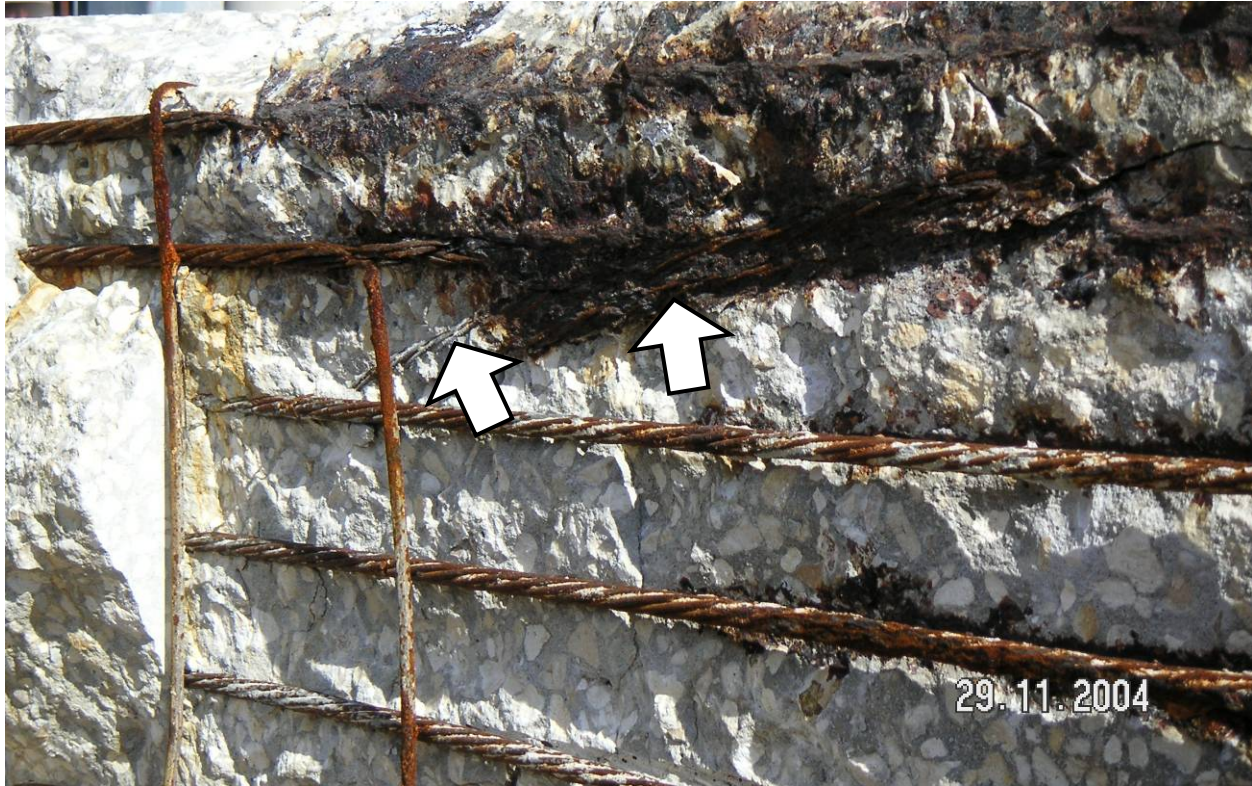
Figure 29 – Severely corroded strand from pick up point on Pile 32-3J. Prestressing strand in this area has been completely consumed by corrosion. Moderate to severe corrosion on the remaining strands as they enter the splash zone.

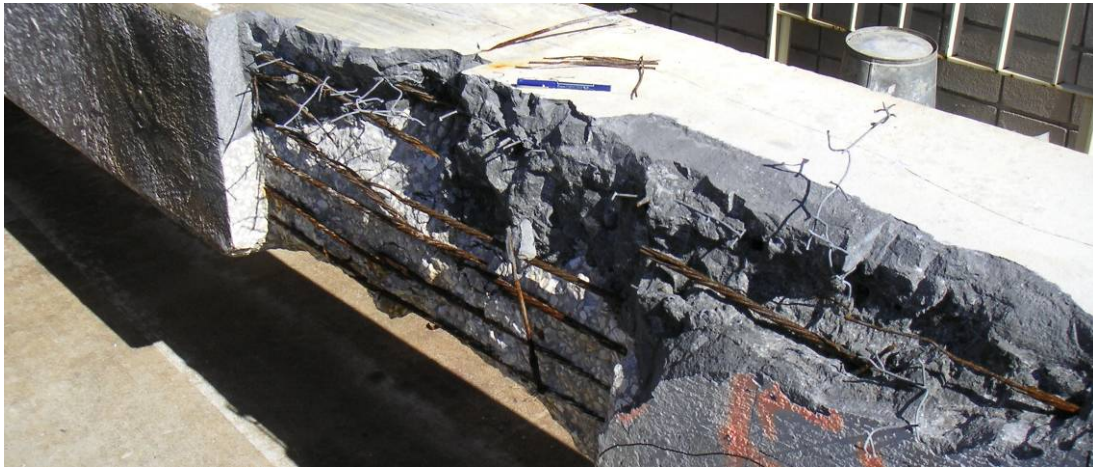
Figure 30 shows pile 44-3CP after excavation. The repair material used to replace the original concrete that spalled due to corrosion appears darker and devoid of coarse aggregate. The patch was reinforced with a galvanized steel welded wire fabric, which did not have significant corrosion (Figure 31). Closer inspection of the prestressing strand showed that there was significant loss of cross-section at the time of the repair. Figure 31 shows the severe elongated pitting associated with corrosion of prestressing strand. The pits are filled with grout indicating that the corrosion products were likely mechanically removed before patching. Corrosion product was present on the remainder of the prestressing strands to varying degrees. Figure 32 shows four of the strands from the bottom strand layer of pile 44-3CP highlighting the variation in corrosion severity across the width. The top strand has light to moderate surface corrosion. The strand below it has moderate to significant corrosion with some significant pitting. The bottom two strands have severe corrosion with significant loss of cross-section and have rupture where they intersect a flexural crack in the concrete.

Figure 30 – Pile 44-3CP after excavation. Darker concrete is patch material placed during the 1994 repairs.

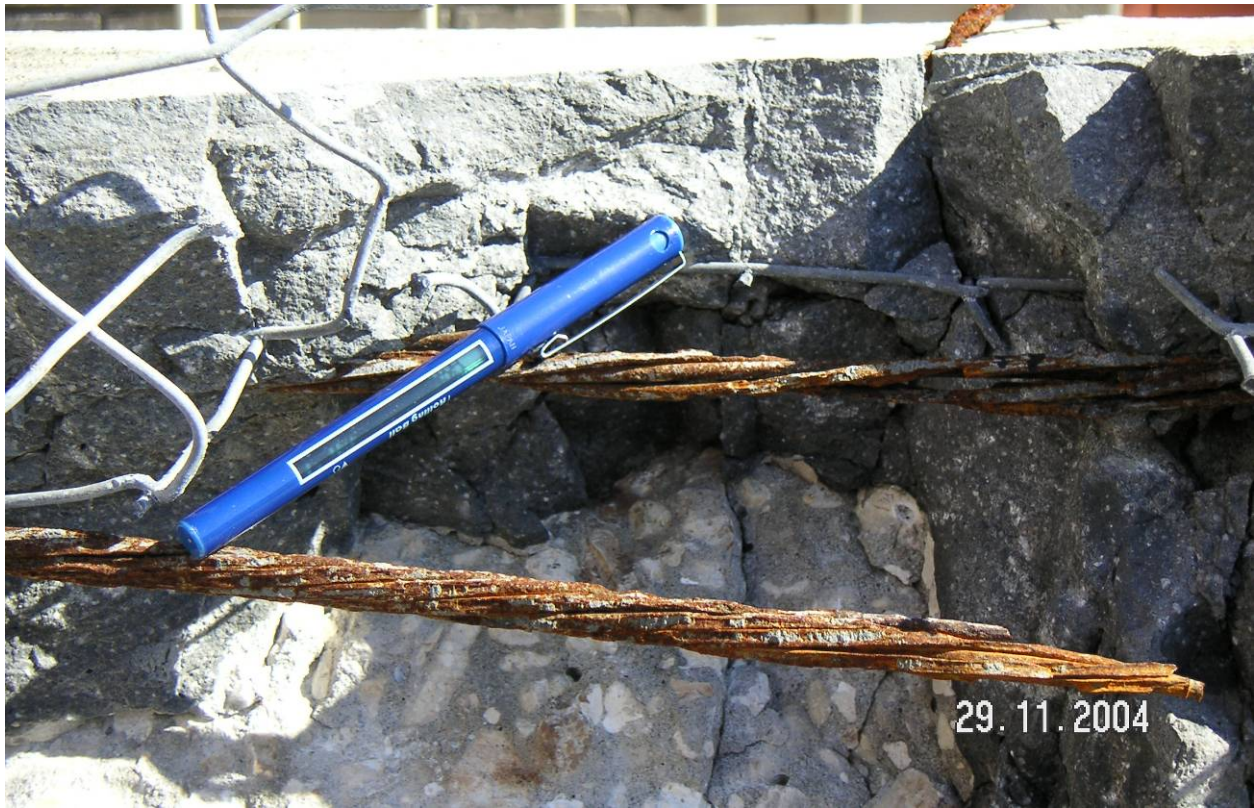
Figure 31 – Interface between existing pile concrete and patch material. Galvanized steel mesh was used in patch. Prestressing strand in foreground appears to have had significant section loss before repair.

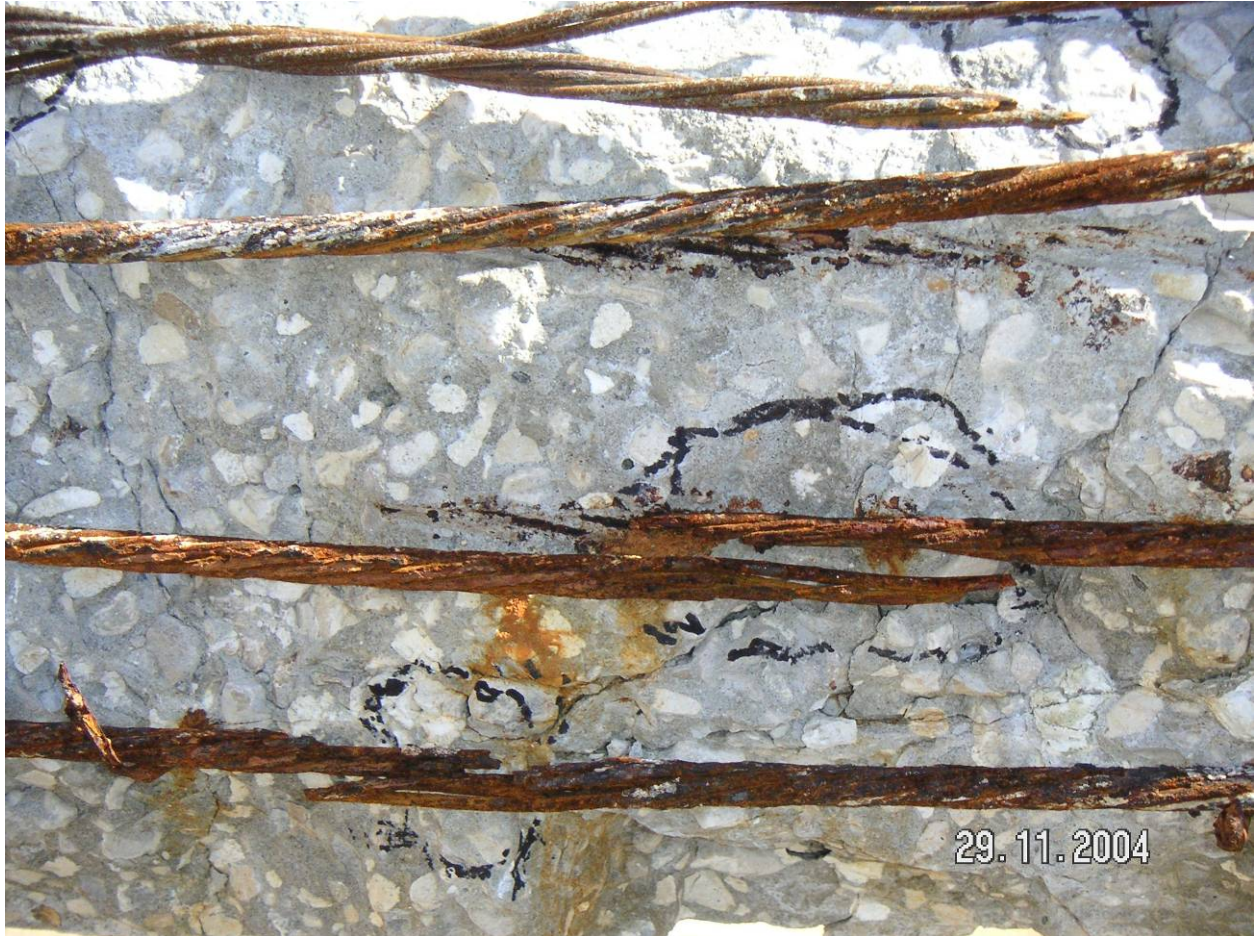
Figure 32 – Strand in bottom of pile 44-3CP. Corrosion severity increases in intensity from top to bottom. Wire breaks are distributed along a major flexural crack in the more heavily corroded strands.

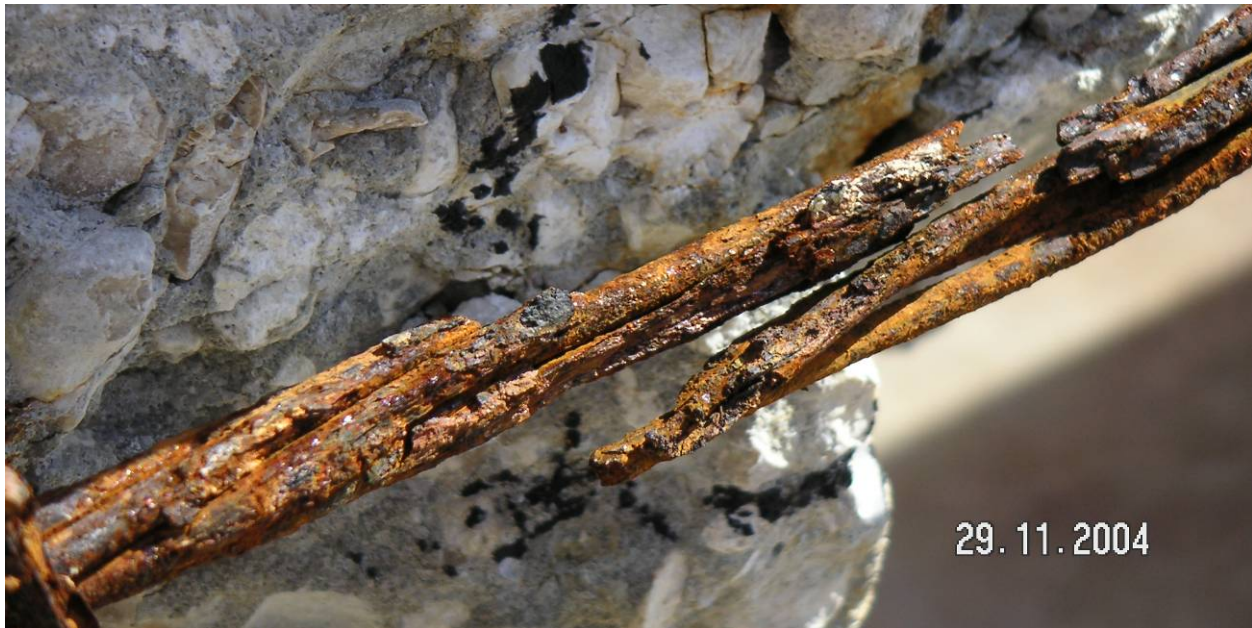
Figure 33 shows the behavior of a severely corroded strand when loaded to rupture. The wires generally ruptured at varying locations along the length of the strand. In contrast, Figure 34 shows the rupture pattern of an uncorroded strand taken from the piles in which the individual wire ruptures occur in very close proximity to each other. Furthermore, each wire exhibits the ductile necking and cup/cone fracture surface.

Figure 33 – Typical rupture pattern of severely corroded prestressing strand exhibiting fingernail splitting.

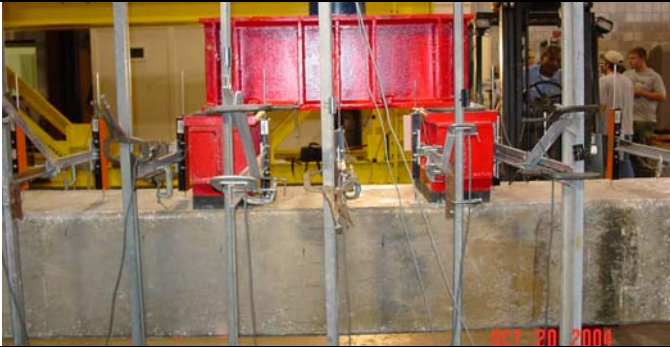
<b>Pre-Test Condition</b>	
Minimal to no damage was visible on this pile.	
<b>Pre-Test Photos</b>

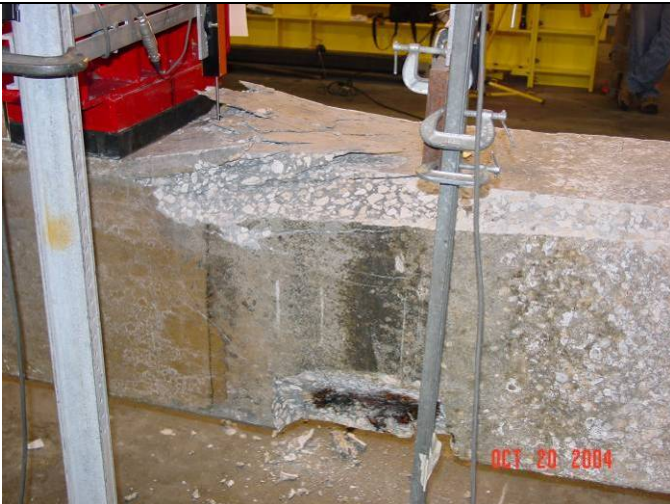
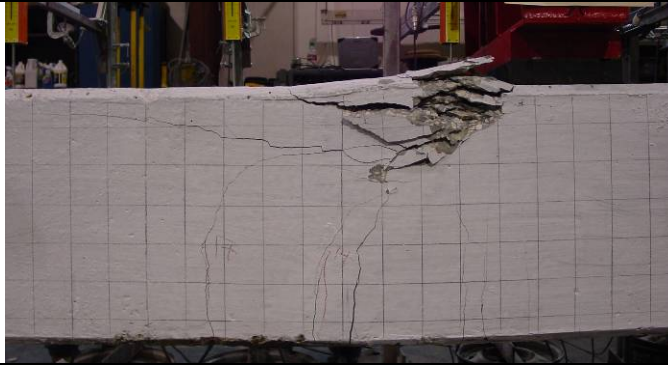
<b>Post-Test Condition</b>	
First crack appeared at 14 kips. Concrete 6 in below the top face of the pile just north of the north load point was crushed severely. Flexural cracks were present after unloading	
<b>Post-Test Photos</b>

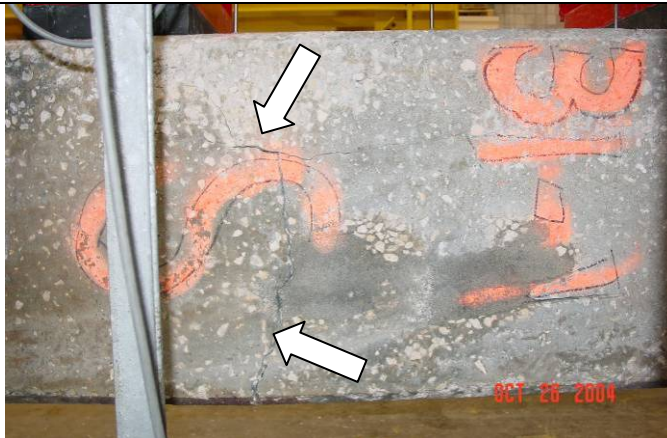
## 31-1

First crack appeared at 28 kips. The compression zone concrete was only slightly crushed. The pile showed compression zone crushing to a limited extent. The flexural cracks mostly closed after unloading.

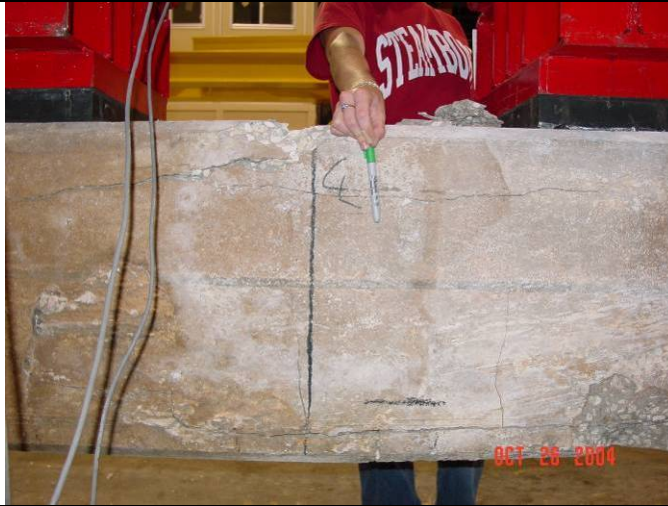
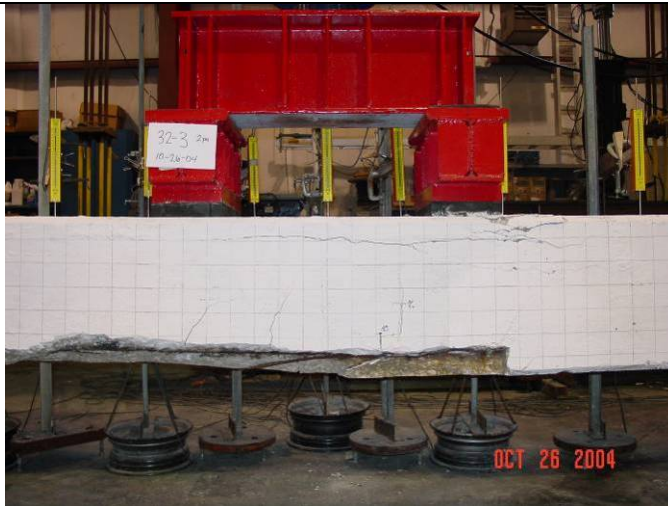
### 32-3J

The first crack occurred at 10 kips. The failure of this pile included a long horizontal crack from the north to the south support. Flexural cracks were also emanating from the missing concrete section in the tension zone. The concrete just to the south of the south load point was crushed in compression. The concrete in the tension region of the splash zone was removed after testing. All of the strands in this location were severely corroded. Five of the six strands had been corroded completely through and all of the wires broken.

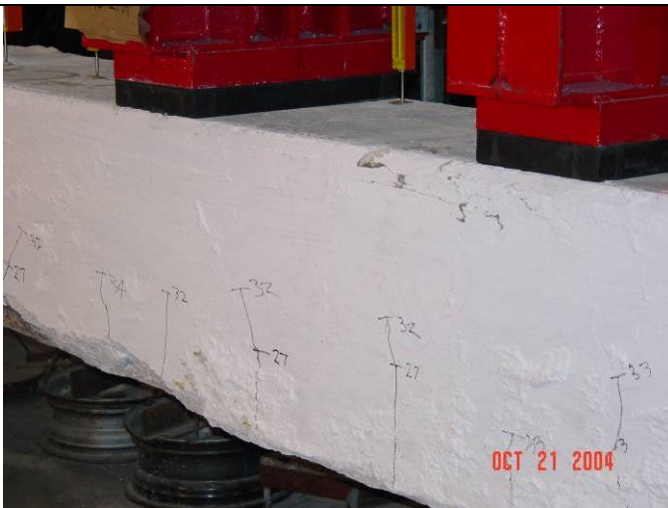
### 33-4J

There were flexural cracks visible on the pile. The concrete in the compression zone was only slightly crushed at the completion of the test.

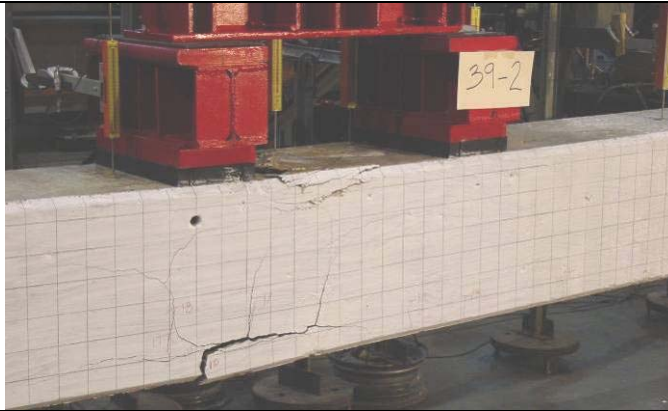
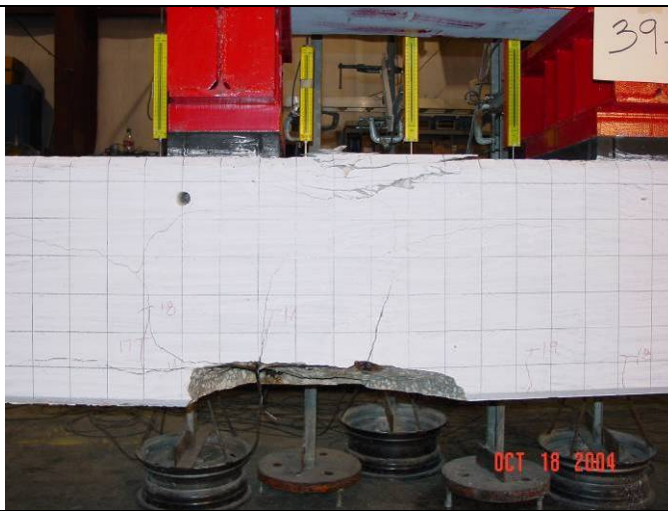
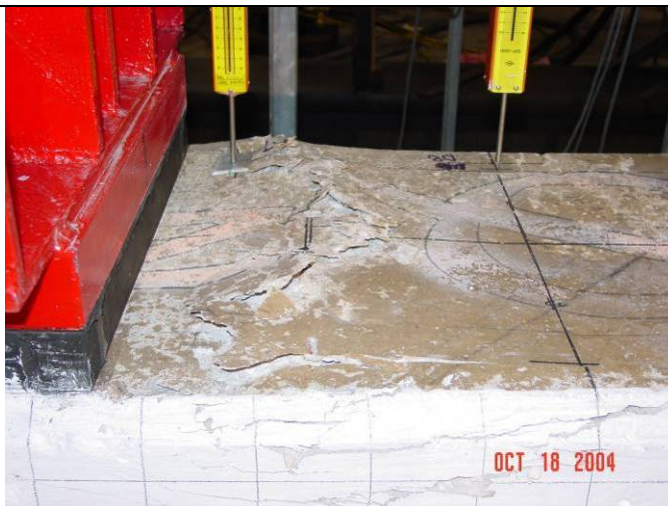
## 39-2

First crack appeared at 10 kips. Concrete 4 in below the top face of the pile began to crush. Flexural cracks emanating from one major crack just below the north support. This crack caused a large piece of concrete on the bottom face of the west corner to come off. This revealed corroded strands. After testing, the concrete in the tension zone of the pile was removed. This revealed that all of the strands had broken wires and one of the strands was severely damaged by corrosion. All of the strands had corrosion damage.

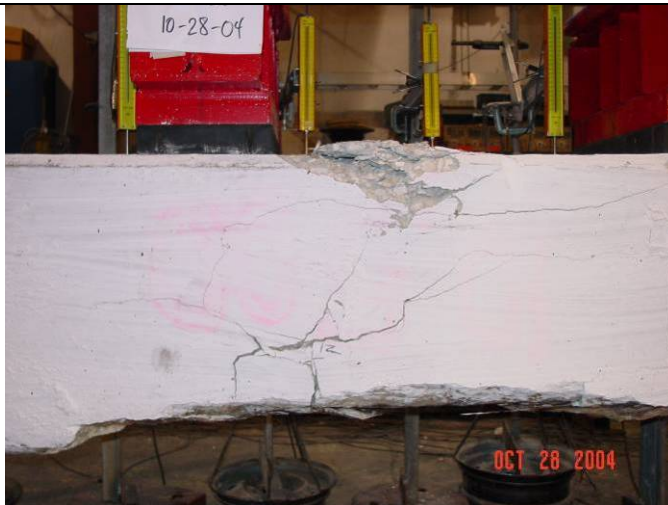
### 40-3J

First crack appeared at 12 kips. Flexural cracks appeared mostly under the North load point. The concrete of the top face began to crush. Large pieces of concrete spalled off on the east side of the pile exposing more corroded strands.

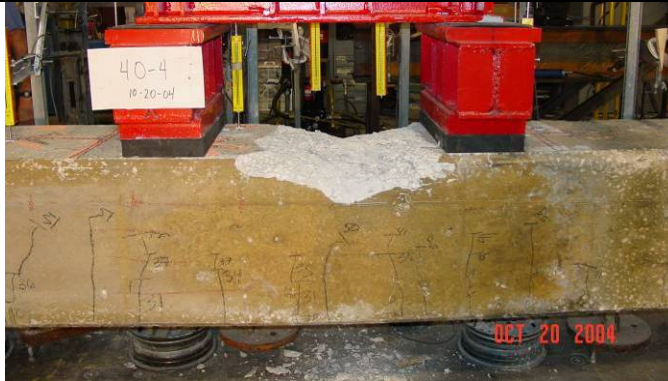
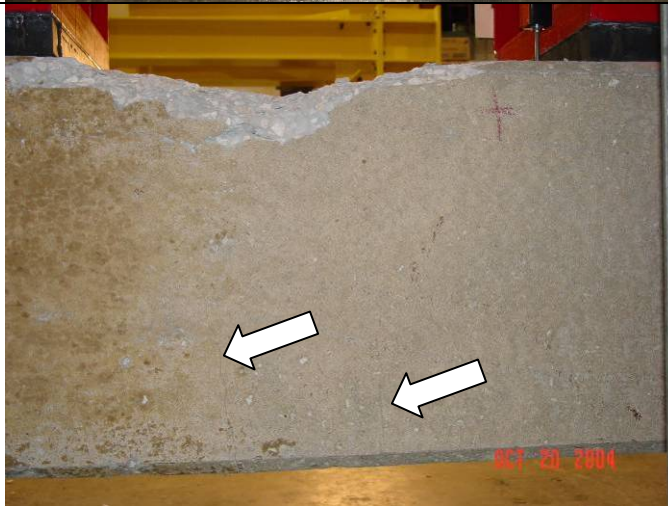
## 40-4

First crack appeared at 10 kips. Concrete on the top face of the pile, in between the load points was crushed. Flexural cracks were present but were not very large.
