Final Report

June 2006

UF Project No. 00051711  
Contract No. BD545, RPWO #27

## ST. GEORGE ISLAND BRIDGE PILE TESTING

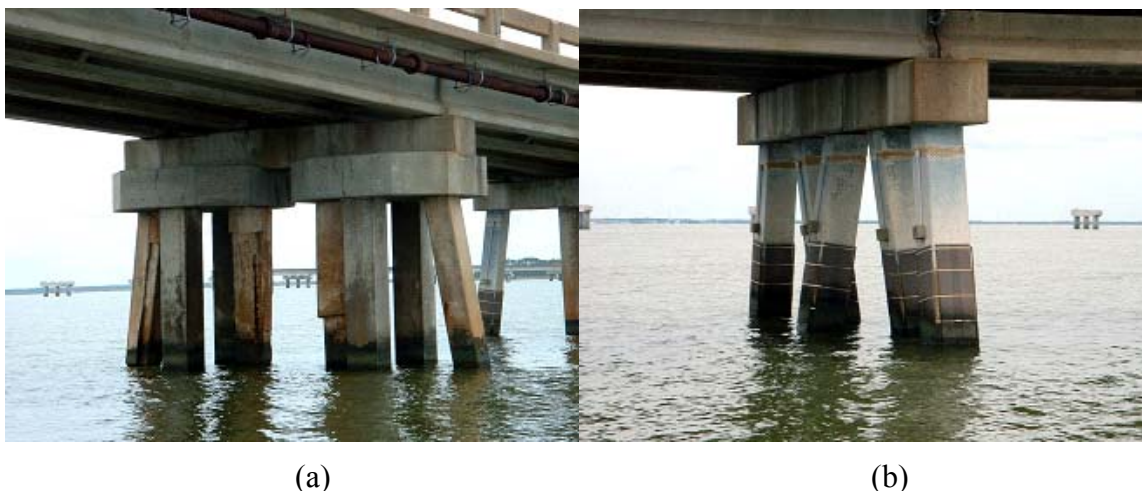
Figure 3 – Prestressed pile bents before bridge demolition. (a) “crutch bents” installed to relieve piles damaged by corrosion (b) cathodic protection system on existing piles

In 1994 extensive repairs were made to the prestressed piles including patching, installation of concrete jackets, and a galvanic cathodic protection system. In addition, a number of piles were so severely deteriorated that additional piles (termed “crutch” bents) were installed to share the bent loads. Figure 3a shows one such installation in which holes were cut in the deck to allow installation of the supplementary piles. Supporting cap beams were then cast under the existing cap beam to transfer load to the new piles. A three tiered galvanic cathodic protection was also installed as part of the repair process. Figure 3b shows the cathodic protection system in which the submerged portion of the pile was protected by a bulk zinc anode, the splash zone by a zinc mesh, and above the splash zone a sprayed zinc anode coating.

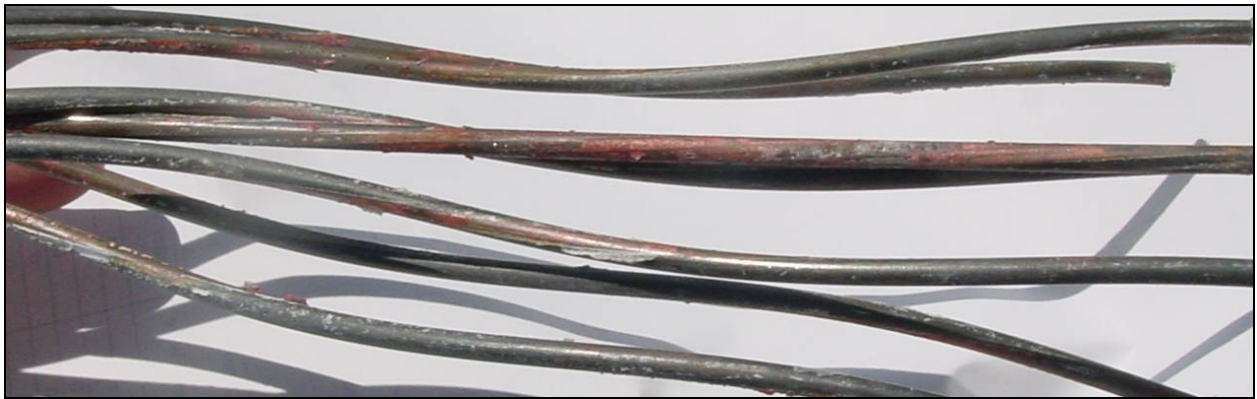
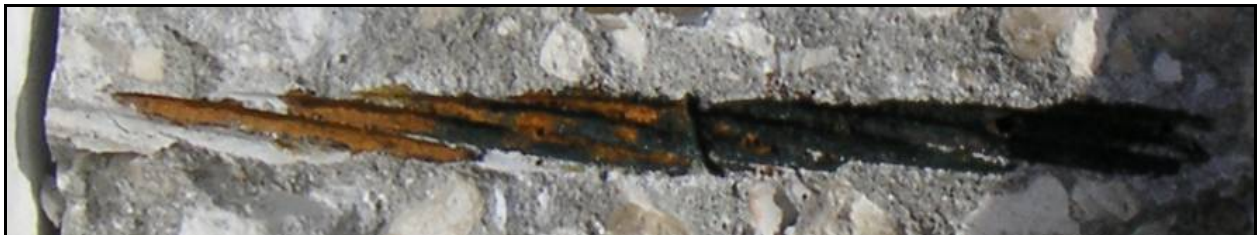
Strand samples taken from both piles generally exhibited light to moderate surface corrosion with spotty mild pitting (Figure 13a). The strand samples from Pile 21-4 showed corrosion primarily in the interstitial space between the outside and center wires. This pattern was consistent at all sample locations. In general, the cathodic protection system appeared to have done a reasonable job of protecting the reinforcement. Some of the strand samples pulled from pile 44-2 (Figure 13b) had surface corrosion on the outer wires. The strand shown in the figure exhibits some bleeding of corrosion product into the concrete as well as black corrosion product indicating a low oxygen environment. Note that the corrosion has the appearance of emanating from the tie wire.

Figure 13 – Corrosion on strand pulled from (a) pile 21-4 (b) pile 44-2.

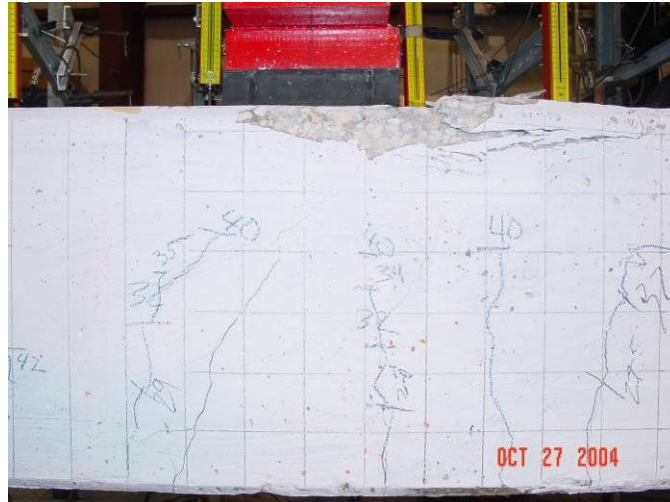
Figure 20 – Compression zone crushing and flexural cracking in pile 44-2

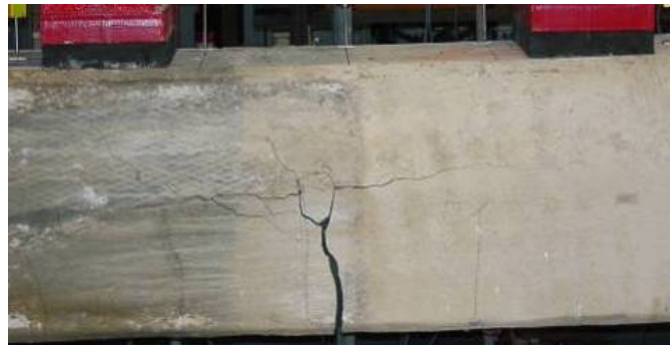
Figure 21 – Strand rupture of pile 44-3CP.

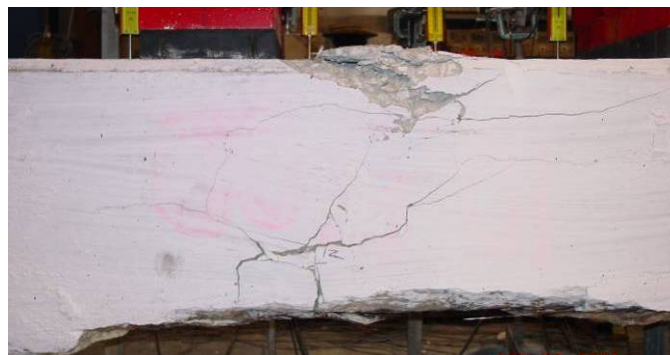
Figure 22 – Combination of strand rupture and crushing of compression zone on pile 40-3J.  
Spalling seen on bottom of pile was caused by corrosion of the strand in service.

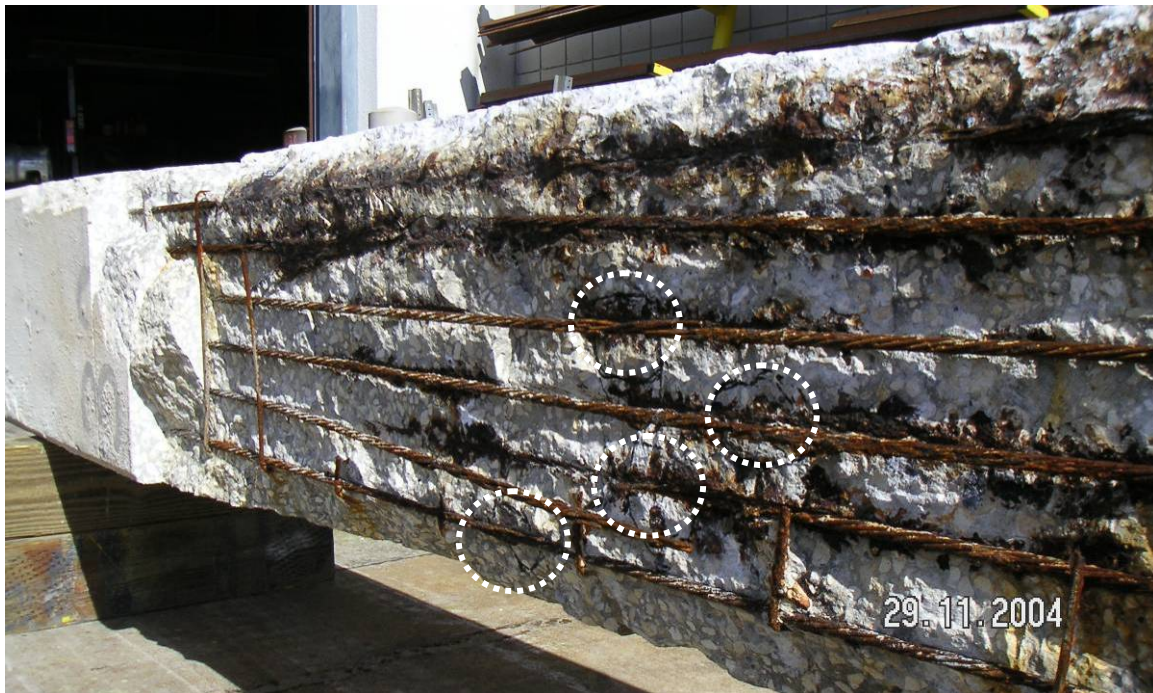
Severe corrosion was also noted in strand that appears to have been used for pick up points during pile construction and handling. Pick up points were noted in both 32-3J and 44-2. Figure 29 shows an example in which the pick-up point strand and pile strand have been nearly completely consumed by corrosion. The pick-up point strand, however, was in bright condition away from the pile strand and farther into the pile. Corrosion at these locations likely was initiated by chloride intrusion along the pick-up point strands where they exited the pile. The fact that the pick-up point was located in the splash zone accelerated this behavior.

Figure 28 – Pile 32-3J after excavation. Wire breaks are circled.

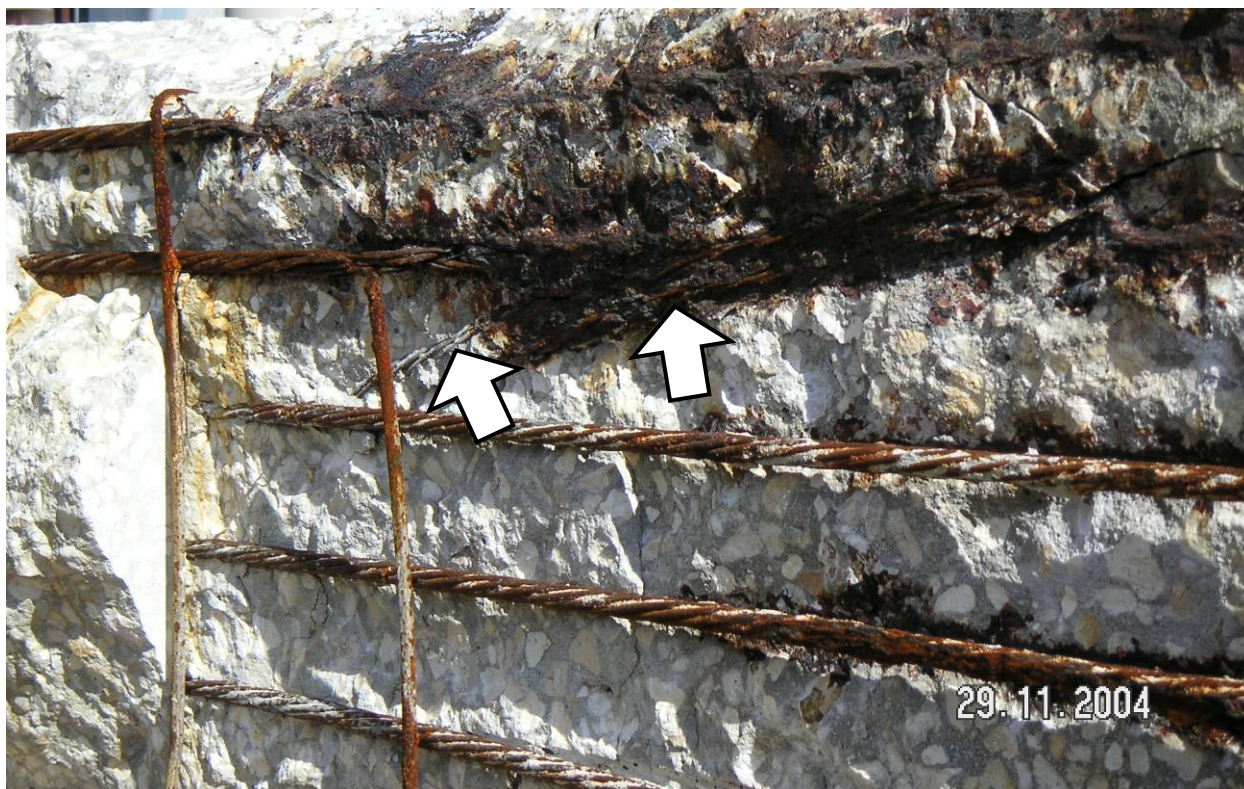
Figure 29 – Severely corroded strand from pick up point on Pile 32-3J. Prestressing strand in this area has been completely consumed by corrosion. Moderate to severe corrosion on the remaining strands as they enter the splash zone.

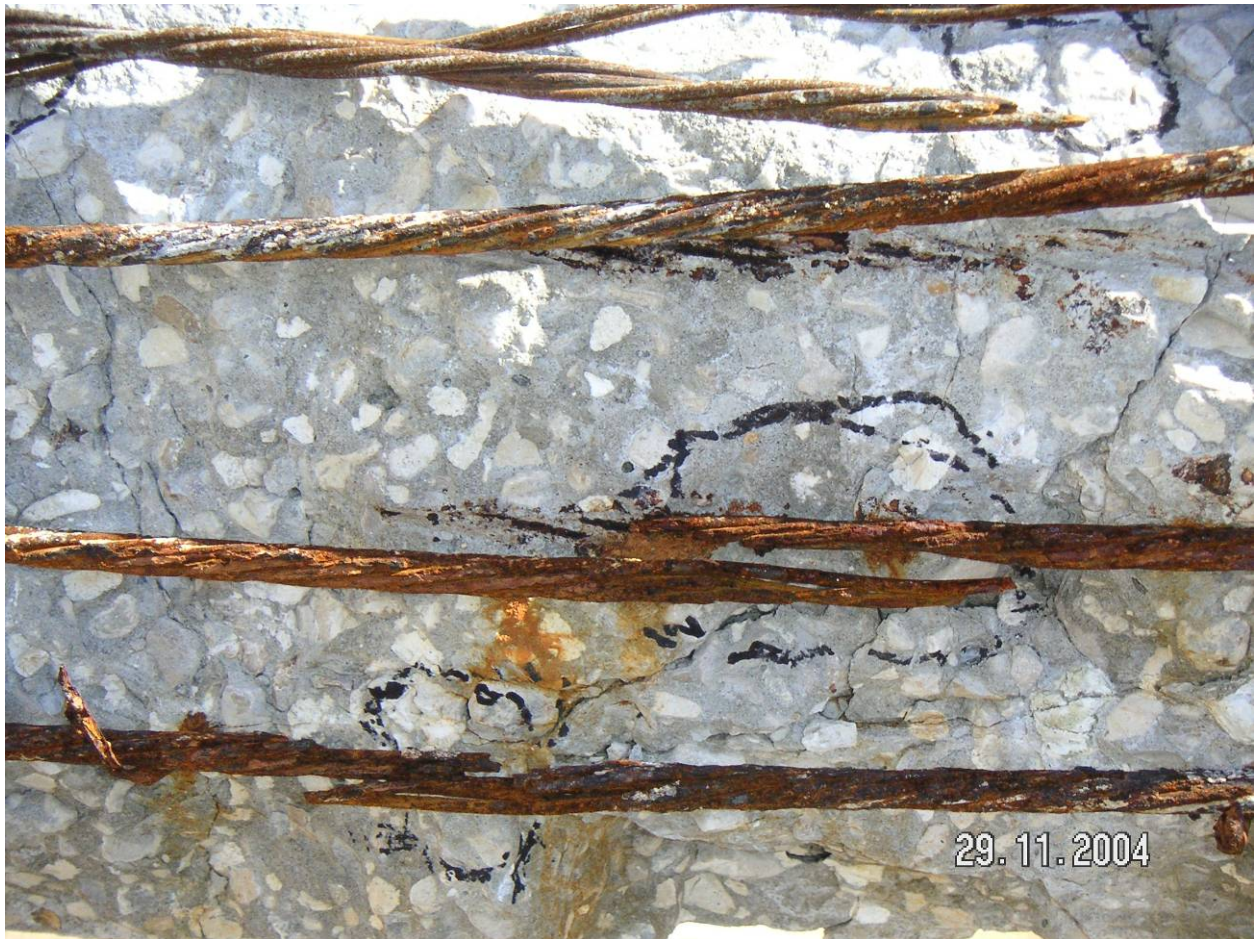
Figure 32 – Strand in bottom of pile 44-3CP. Corrosion severity increases in intensity from top to bottom. Wire breaks are distributed along a major flexural crack in the more heavily corroded strands.

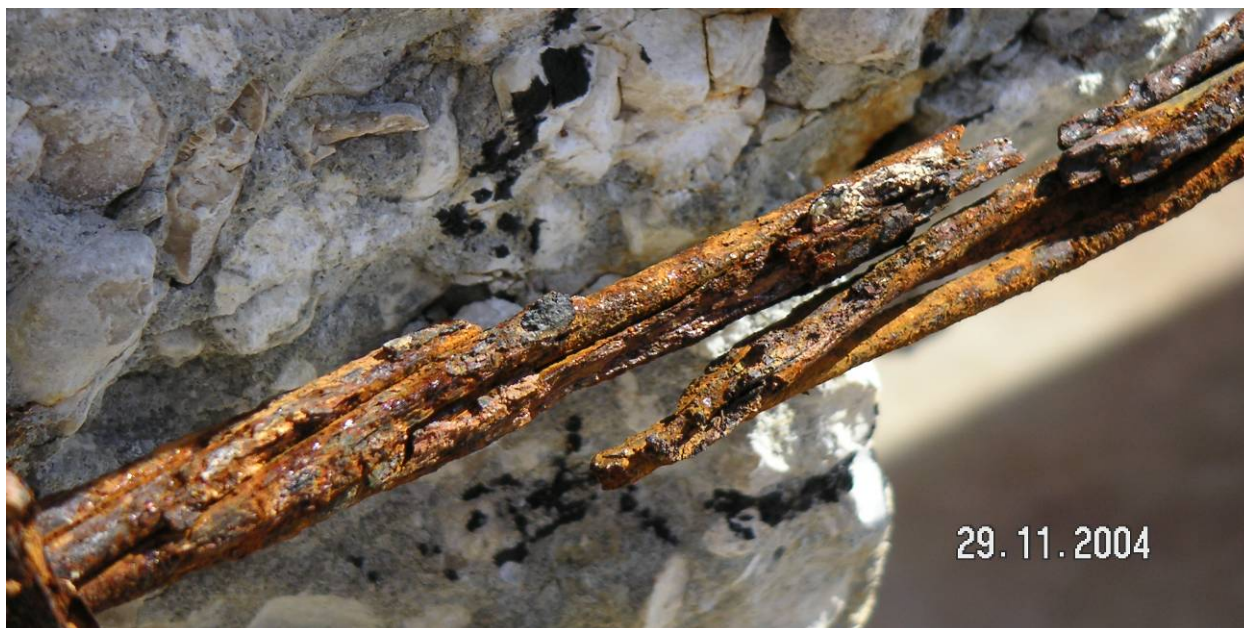
Figure 33 shows the behavior of a severely corroded strand when loaded to rupture. The wires generally ruptured at varying locations along the length of the strand. In contrast, Figure 34 shows the rupture pattern of an uncorroded strand taken from the piles in which the individual wire ruptures occur in very close proximity to each other. Furthermore, each wire exhibits the ductile necking and cup/cone fracture surface.

Figure 33 – Typical rupture pattern of severely corroded prestressing strand exhibiting fingernail splitting.

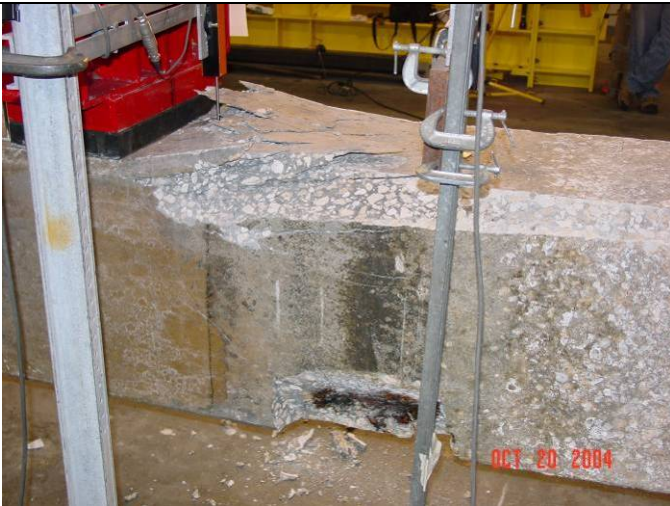
| First crack appeared at 14 kips. Concrete 6 in below the top face of the pile just north of the north load point was crushed severely. Flexural cracks were present after unloading | |

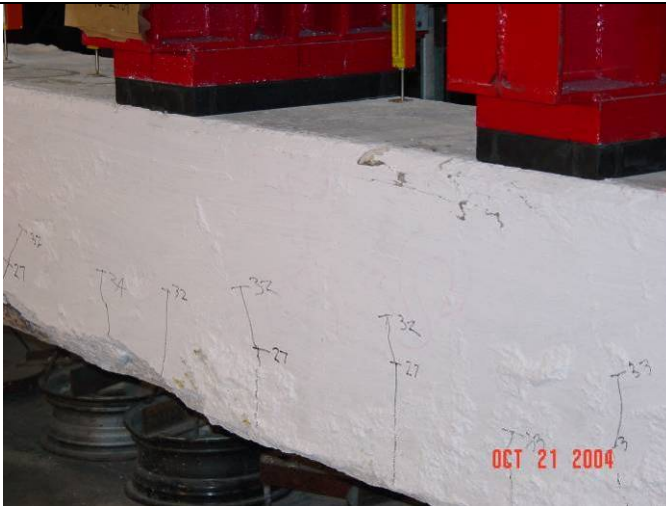
### 33-4J

There were flexural cracks visible on the pile. The concrete in the compression zone was only slightly crushed at the completion of the test.

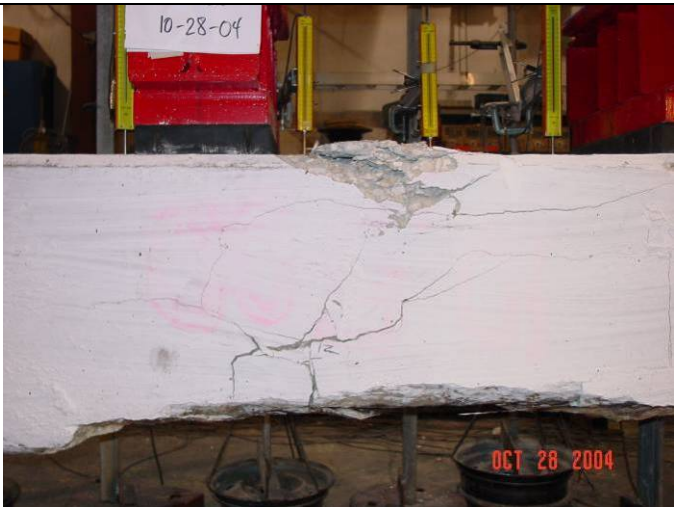
#### 40-3J

| <p>First crack appeared at 12 kips. Flexural cracks appeared mostly under the North load point. The concrete of the top face began to crush. Large pieces of concrete spalled off on the east side of the pile exposing more corroded strands.</p> | | |
