Florida LTAP Safety Circuit Rider Program

Final Report

FDOT Project BD545-52
UF52349

September 2009

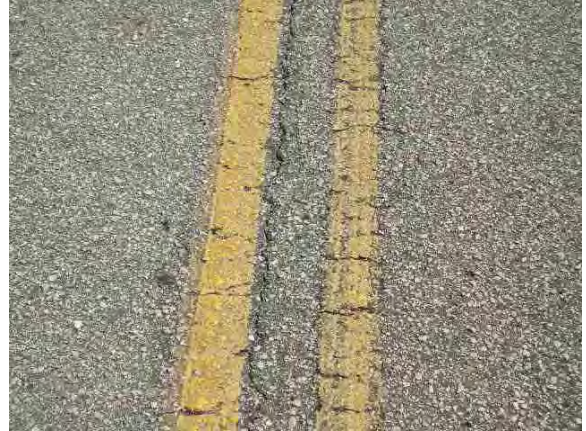
103 - Clay County, CR 315C and Bellamy Road, tangent section north of first curve northbound

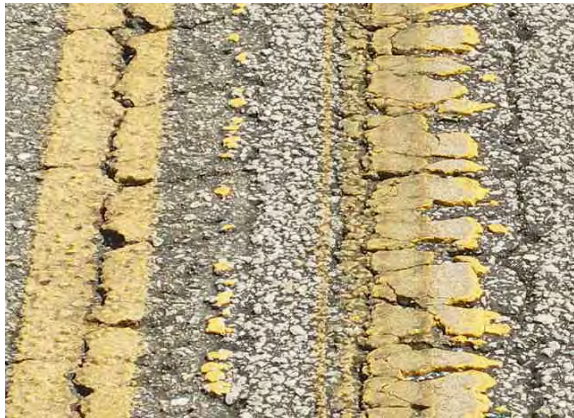
104 - Clay County, CR 315C and Bellamy Road, typical condition of centerline in the entire reviewed section

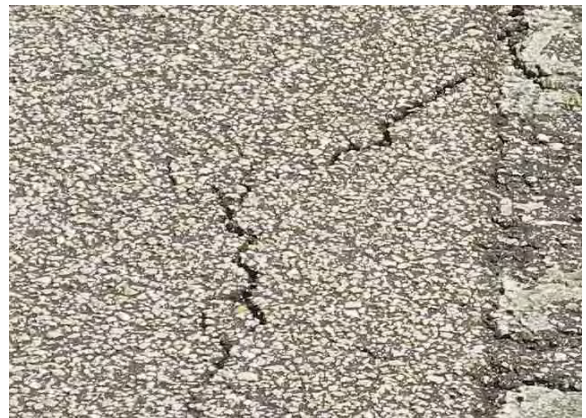
105 - Clay County, CR 315C and Bellamy Road, typical condition of centerline in the entire reviewed section

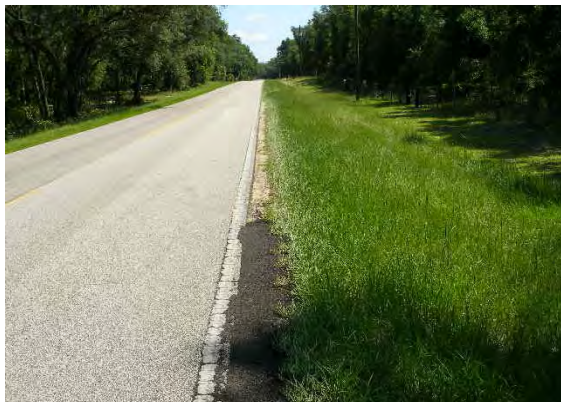
106 - Clay County, CR 315C and Bellamy Road, typical edge line condition in entire reviewed section

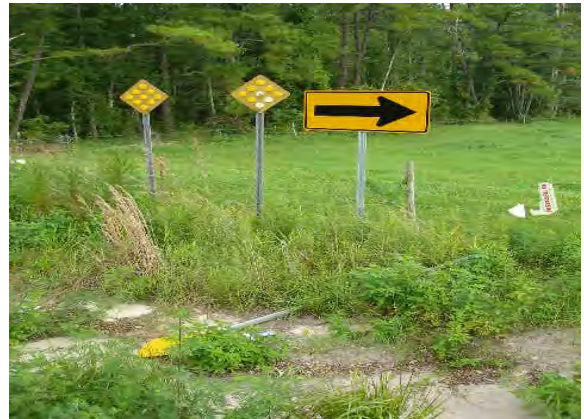
113 - Clay County, Mallard Road and CR 218, missing object marker, centerline and edge line through turn

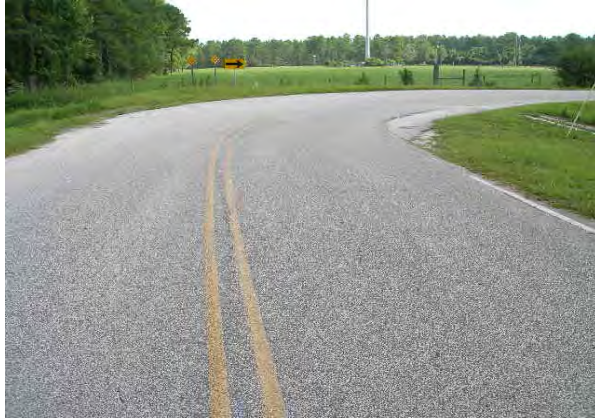
114 - Clay County, Mallard Road and CR 218, third object marker knocked down

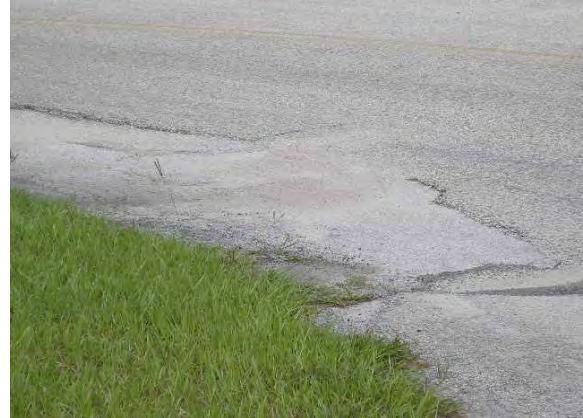
115 - Clay County, Mallard Road and CR 218, pavement markings through turn are worn

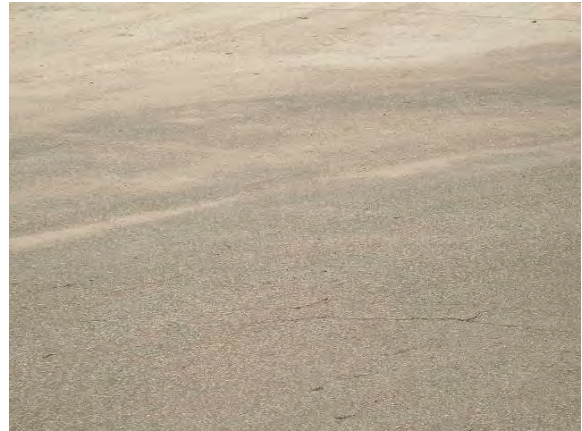
164 - Clay County, Thunder Road, STOP bar condition at western turn

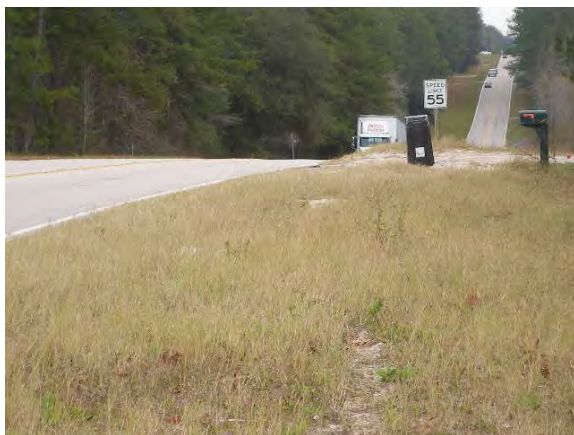
172 - Clay County, view of shoulder condition looking north from east side at Chicory Avenue. Shoulder is approximately 12 inches above the CR 215 edge of pavement

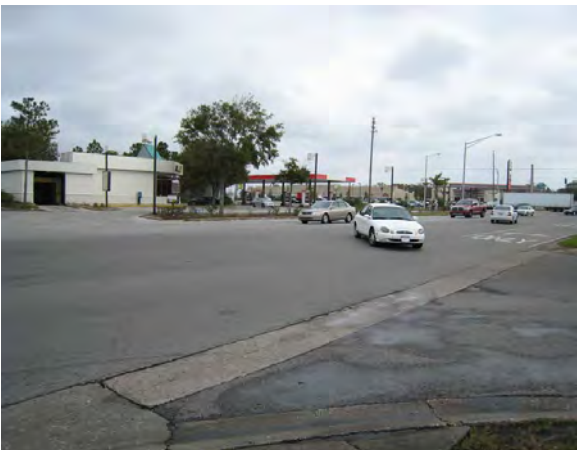
257 - Pasco County, Little Road (CR1) at Embassy Boulevard / Hilltop Drive, pavement markings worn and RPMs missing

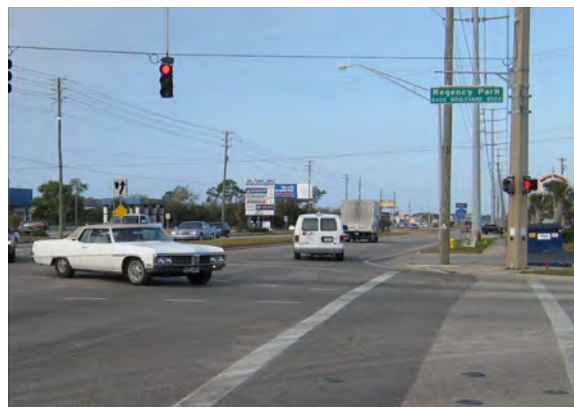
268 - Pasco County, Ridge Road (CR 587) at Regency Boulevard, bollards protecting utility pole by 7-Eleven driveway on westbound intersection approach have been damaged

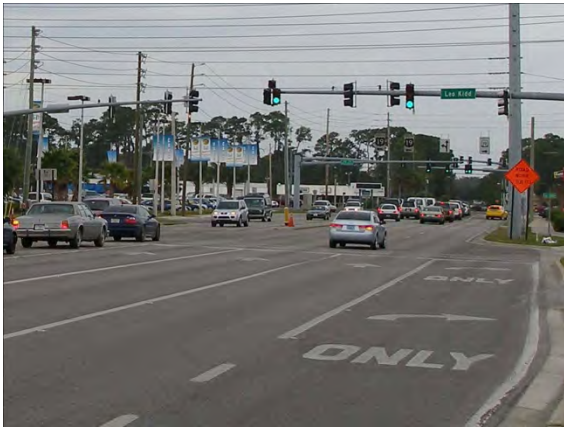
271 - Pasco County, Ridge Road (CR 587) at Regency Boulevard, pushbuttons not up to current standards making it difficult for pedestrians to tell which button controls which crossing

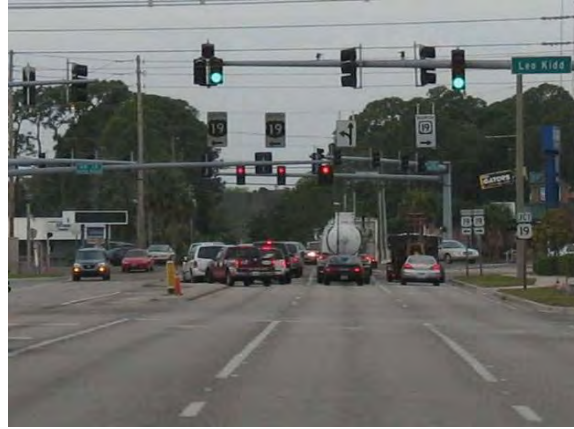
272 - Pasco County, Ridge Road (CR 587) at Leo Kidd Avenue, drivers observed speeding past Leo Kidd signal to make it through US 19 signal (500 feet away)

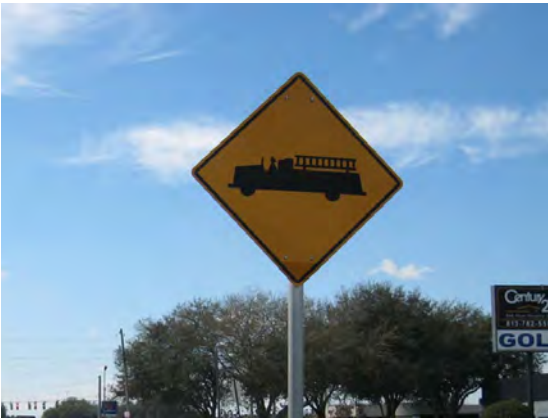
291 - Pasco County, SR 54 at Morris Bridge Road / Eiland Boulevard (CR 579), faded sign

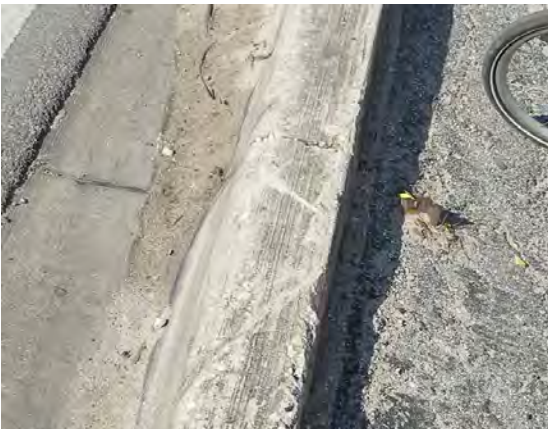
303 - Pasco County, SR 54 at Morris Bridge Road / Eiland Boulevard (CR 579), uncovered drains

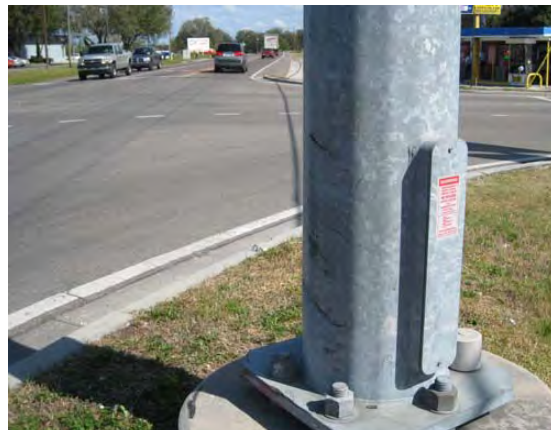
304 - Pasco County, SR 54 at Morris Bridge Road / Eiland Boulevard (CR 579), missing and/or broken delineators

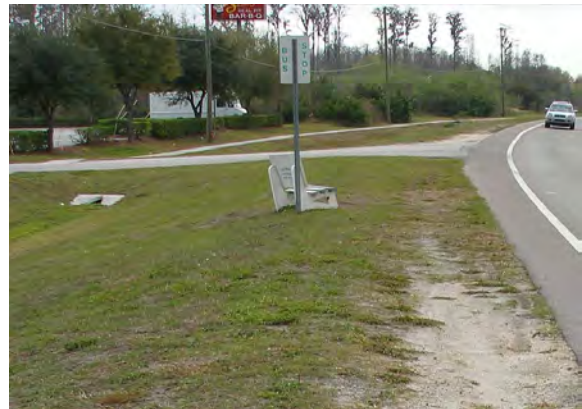
325 - Pasco County, Little Road (CR 1) at Rancho del Rio Drive, drivers observed using grass as a right turn lane to make a right turn on red on southbound approach plus intersection located on horizontal curve on Little Road

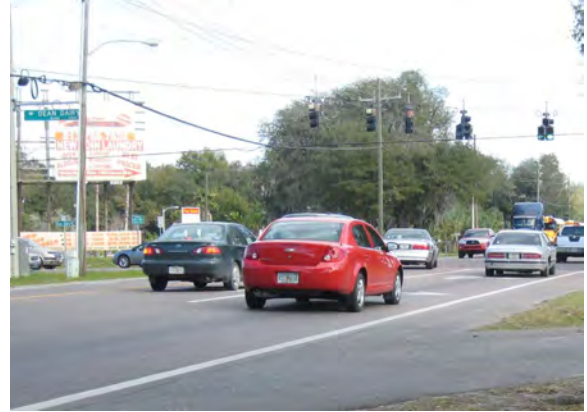
331 - Pasco County, SR 54 at Dean Dairy / Coats Road, vehicle conflict for vehicles attempting to make northbound left turn into business driveway approximately 150 feet north of intersection on Coats Road; conflict was also observed at driveways 200 feet south of Dean Dairy Road intersection

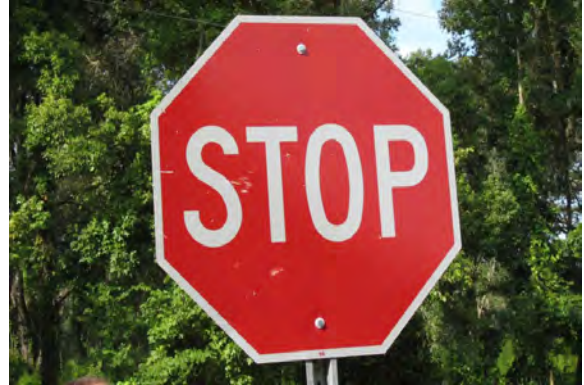
342 – Hernando County, Mondon Hill Road and McIntyre Road, worn STOP Bar

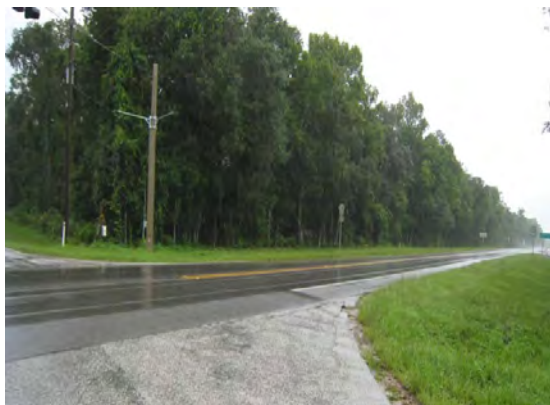
376 – Hernando County, Lake Lindsey Road at Ponce de Leon Boulevard, worn STOP bar

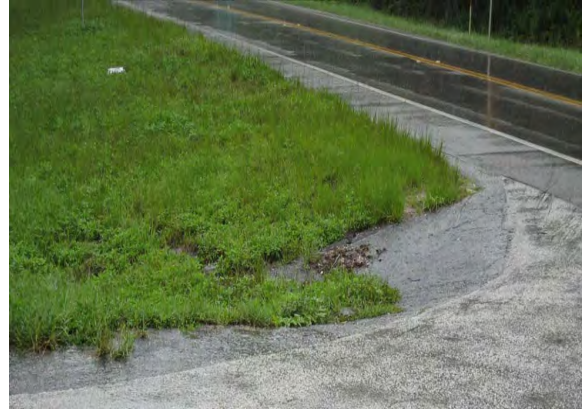
379 – Hernando County, Lake Lindsey Road at Ponce de Leon Boulevard, damaged intersection shoulders along with ponding
