## **Appendix C–SR-72 Tests**

## 1 Introduction

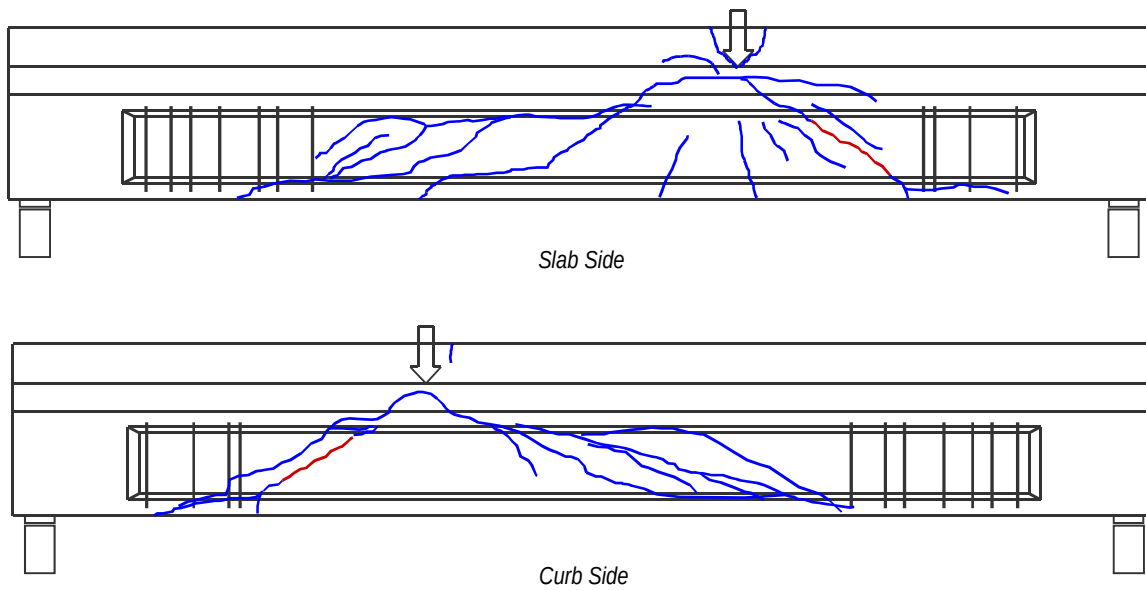
The girder behaved linear-elastically until the formation of cracks. Visible cracking was first observed in the web at a superimposed shear load of approximately 51kip (Figure 14). Although cracks were not visible prior to 51kip, data from rosette R7 indicates that the crack first formed at a shear of 41kip (Figure 15). At 58kip of shear, the initial crack in the web was observed to have joined with a flexural crack in the bottom flange. This load corresponds to the change in slope on the shear-displacement plot; the change in stiffness being attributed to cracking.

Referring to Figure 12, the abrupt changes in the shear-displacement curve between 65kip and 70kip correspond to the formation of additional cracks. Cracks formed farther from the load point and at shallower angles as the load increased. Comparing the final crack pattern with the location the transverse reinforcement (Figure 14), it is noted that with only one exception, the cracks did not cross transverse reinforcement. Thus, after cracking the load could not have transferred through truss action, but rather was carried through arch action. Girder X7 supported a maximum superimposed shear of 84kip. At this load a punching shear failure occurred in the slab and curb. Figure 16 is a photo of the curb side of X7 showing the location of the punching failure. The red strap in the picture is from the crane which was lifting the girder as the photo was taken.

Figure 14–X7 cracks (initial crack in red)

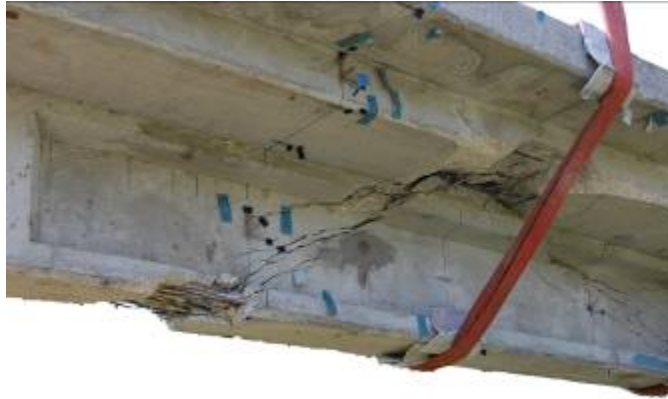
Figure 16–X7 punching failure bottom view

- Tied-arch behavior controlled the experimental strength of girders X7, X4 and I2A. Arches in these girders failed due to punching, flexural compression, and arch instability, respectively.

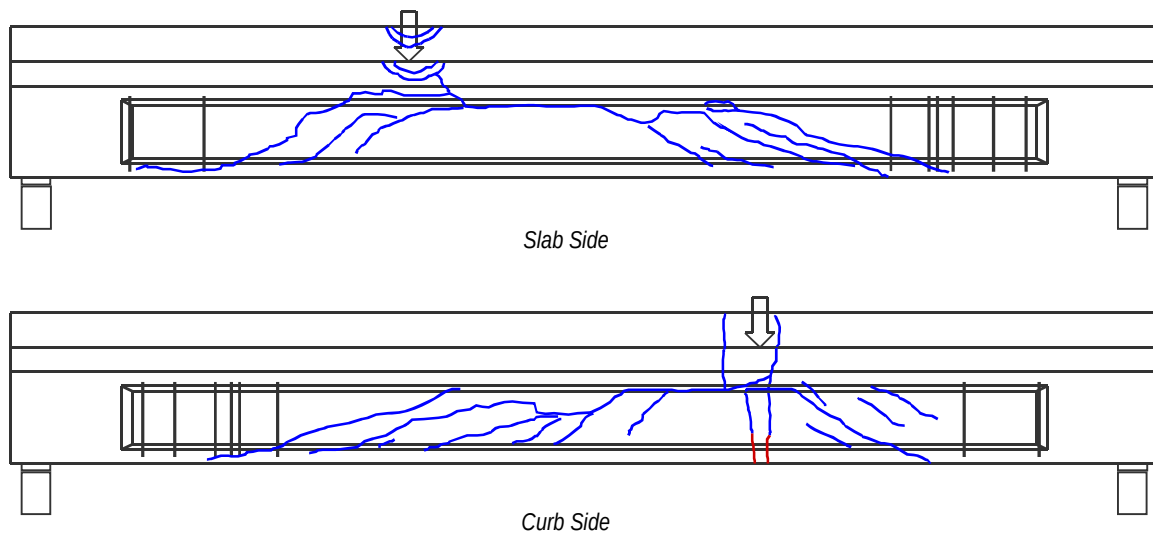
The abrupt changes in the shear-displacement plot at 62kip and 66kip correspond to the formation of incline cracks in the web. Cracks continued to form farther from the load point and at shallower angles as the load increased. At the final stages of the load test incline cracks had a maximum width of 1 in. As shown in Figure 20 vertical reinforcement was not engaged by the inclined cracks. The relatively large crack widths and absence of engaged vertical reinforcement suggest that the girder supported load by arch-action.

Figure 20–X4 cracks (initial cracks in red)

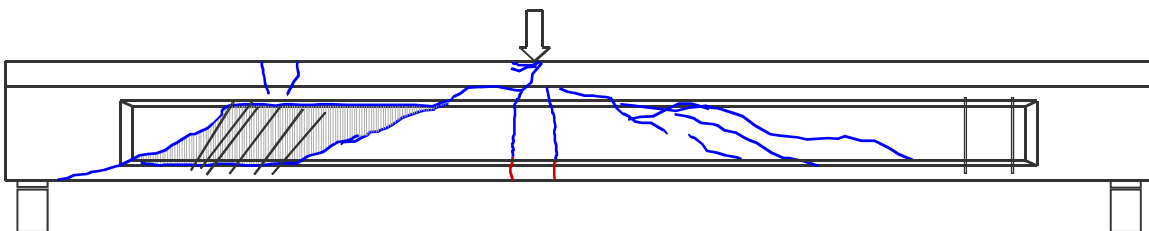
After evaluating I2A for effective prestress, the specimen was loaded to ultimate load. Load was applied at an a/d ratio of 4.5. Shear-displacement data from the ultimate load test is presented in Figure 27. Contrary to X4 and X7, girder I2A did not rotate about its long axis during loading. Flexural cracks reopened at a load 40 kip, corresponding to 22 kip superimposed shear. According to the shear-displacement plot, significant deviation from linear-elastic behavior did not occur until the shear reached 36k. Softening of the girder corresponded to the propagation of flexural cracks. The abrupt changes in the shear-displaced data at shear forces near 40 kip were due to the formation of inclined cracks in the web. As the load increased, additional cracks formed farther from the load point and at shallower angles. Cracking in the web between the load point and the near support was particularly severe, as noted by the shaded area in Figure 28 and shown in Figure 29.

Figure 28-I2A cracks (initial cracks in red)

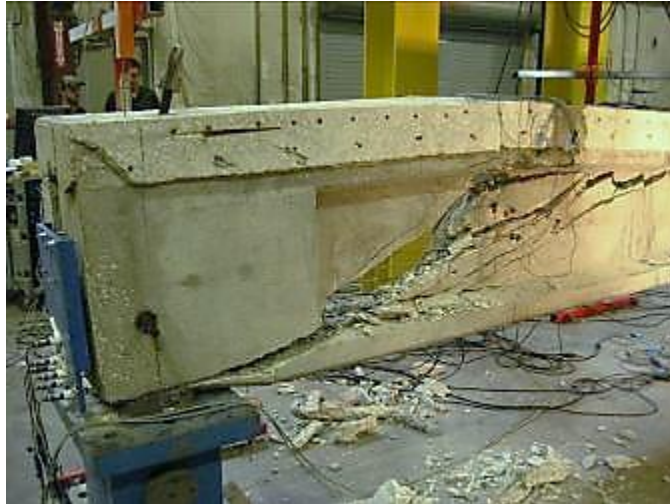
Failure was precipitated by the formation of tensile cracks in the top of the arch between the near support and load point. After the cracks formed, the arch became unstable, buckled upward (Figure 29) and lost load carrying capacity. Failure occurred at a superimposed shear of 51 kip. This behavior was captured by gage S1 (Figure 31) located on top of the girder. After inclined cracks formed in the web, the compressive strains on top of the slab at gage S1 decreased suddenly. As testing continued strain reported by S1 became tensile. This tensile action at the top of I2A resulted in cracking and instability of the compression load path. This type of failure has also been reported by Kostovos (1987).

Extensive cracking and spalling in the web exposed the transverse reinforcement (Figure 29). Orientation and spacing of the transverse bars were not consistent with the girder plans.

Rather than being oriented vertically, bars were inclined towards the load point. Also, the bars were spaced much closer than the specified 6" o.c. spacing.

Figure 29–I2A incline cracks in web

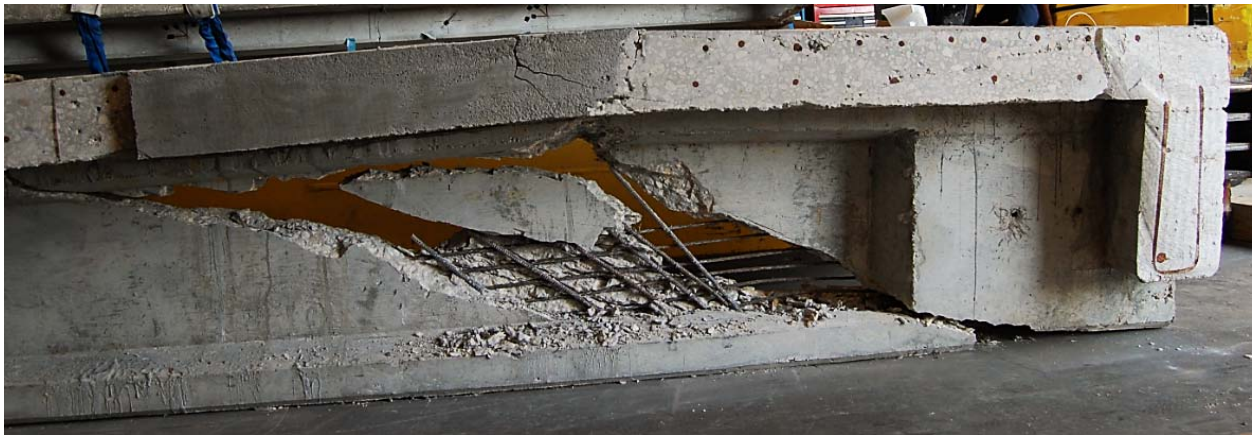
Cracks along the web-flange interface in the shear span prevented the transverse reinforcement from developing and carrying forces. On the far support side of the load, the cracks did not engage the transverse reinforcement. Incline cracks on both ends of the beam were too wide to allow force transfer by aggregate interlock. Without aggregate interlock and effective transverse reinforcement, the girder behaved as a tied-arch during the final stages of loading.

Figure 30–I2A transverse reinforcement-arch failure

because the specified reinforcement was already minimal compared to modern girders. It is recommended that similar girders in Florida be analyzed under the assumption that vertical reinforcement is absent. Alternatively, it is recommended that a cover meter or other means be used to locate vertical reinforcement for the analysis.

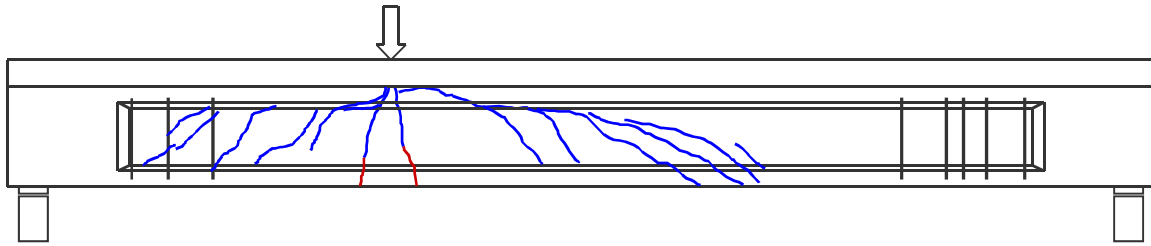
Comparing the locations of cracks and transverse reinforcement (Figure 33), it can be seen that cracks between the load and near support intersected transverse bars whereas cracks towards the far support did not. As the cracks towards the far support were large, it is unlikely that shear was carried by aggregate interlock at that end of the beam. Thus it is believed that the near side of the girder supported load by some combination of arch and truss action, and the far side supported load by arch action.

The limiting factor on ultimate strength of I2B was capacity of the web near the far support to withstand the formation and propagation of inclined cracks. Additional displacement beyond peak displacement would have resulted in failure of the truss and/or arch mechanisms; however it is unlikely that additional displacement would have accompanied load in excess of the previous peak. It is concluded that the girder strength was controlled by the web capacity, and it is presumed that the displacement capacity would have been controlled by failure of the arching action.

Figure 33–I2B crack pattern (initial cracks in red)

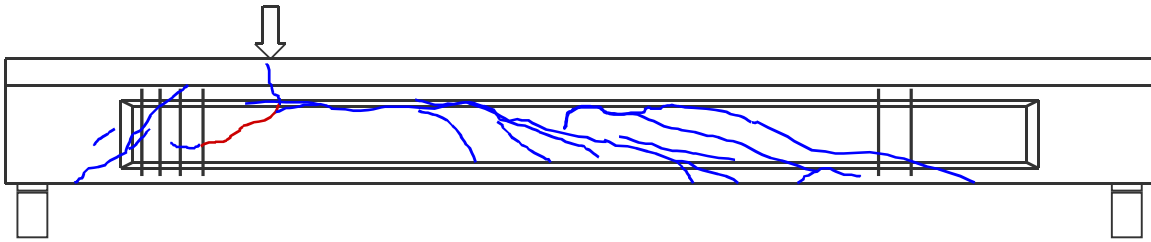
The first crack formed at a shear of 38 kip as reported by rosette R2 on the web (Figure 35). The initial crack was an incline crack in the web (Figure 36), and appears to have had little effect on the girder stiffness as measured by the shear-displacement relationship. Stiffness of the girder changed at a shear of 75 kip. This is the same load at which the inclined crack near gage R2 was first visually observed.

Figure 36—I4 cracks (initial crack in red)

Cracks towards the near support engaged transverse reinforcement (Figure 36). The transverse reinforcement slowed the propagation and opening of these cracks as compared to cracks at the far end of the girder. The shear load transferred to the near support is believed to have been carried by truss action. The shear transfer towards the far support was likely carried by arch action.

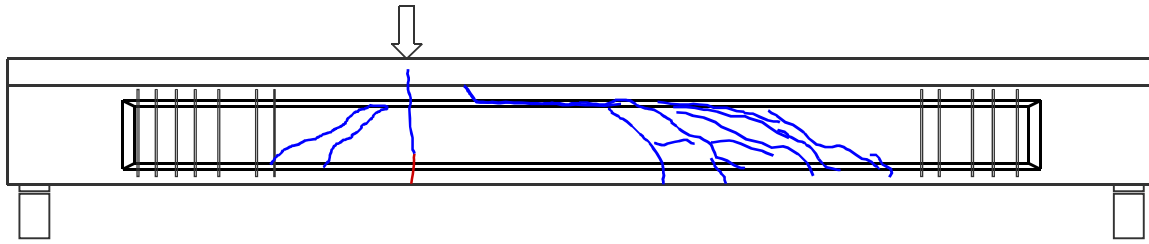
Comparing the cracks with the locations of transverse steel (Figure 36), cracks intersected transverse reinforced on the near side of the beam, but not on the far end. Shear was carried by truss action to the near support, and arch action to the far support.

The limiting factor on girder strength was capacity of the web on the far support side to withstand the formation and propagation of inclined cracks. Additional displacement beyond the tested peak would likely have resulted in failure of the truss and/or arch mechanisms, however it is unlikely the additional displacement would have resulted in that the loads in excess of the observed peak. Girder strength was controlled by the web capacity and it is presumed that displacement capacity would have been controlled by failure of the arch and/or truss mechanisms.

Figure 39–I6 cracks (initial crack in red).
