*Final Report*

## **Durability of In-situ Pipe Repair**

**Developed for the Florida Department of Transportation**  
Larry Ritchie, P.E., Project Manager

November 2011

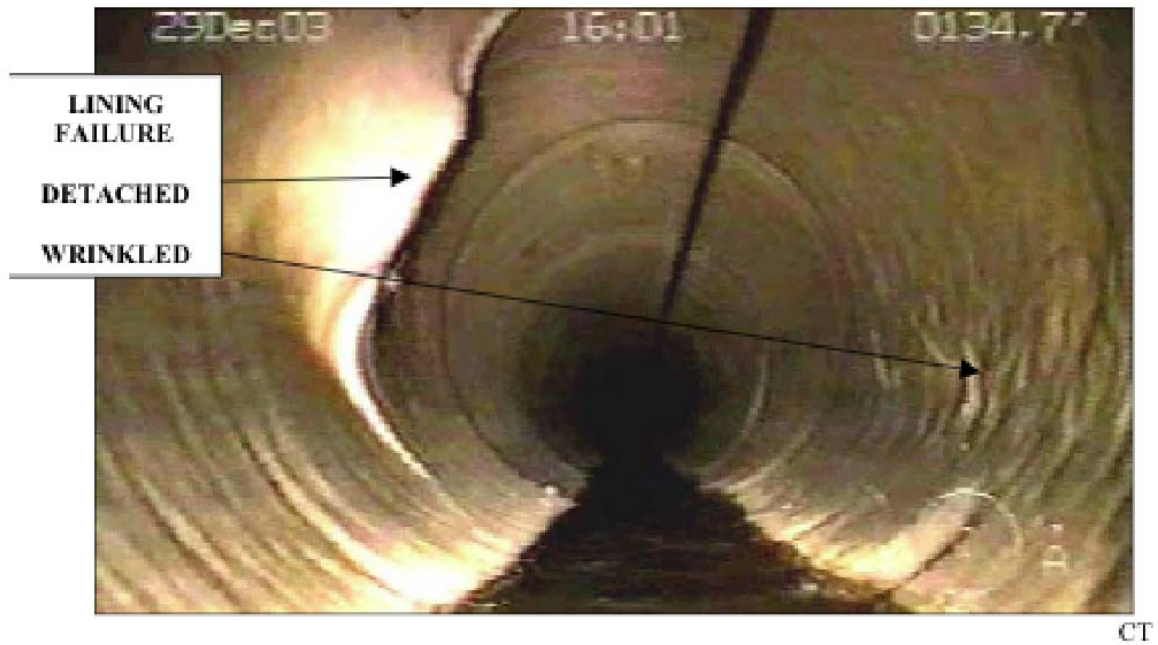
Lining no longer formed to original cross surface  
- Wrinkled (not smooth) Defective Surface

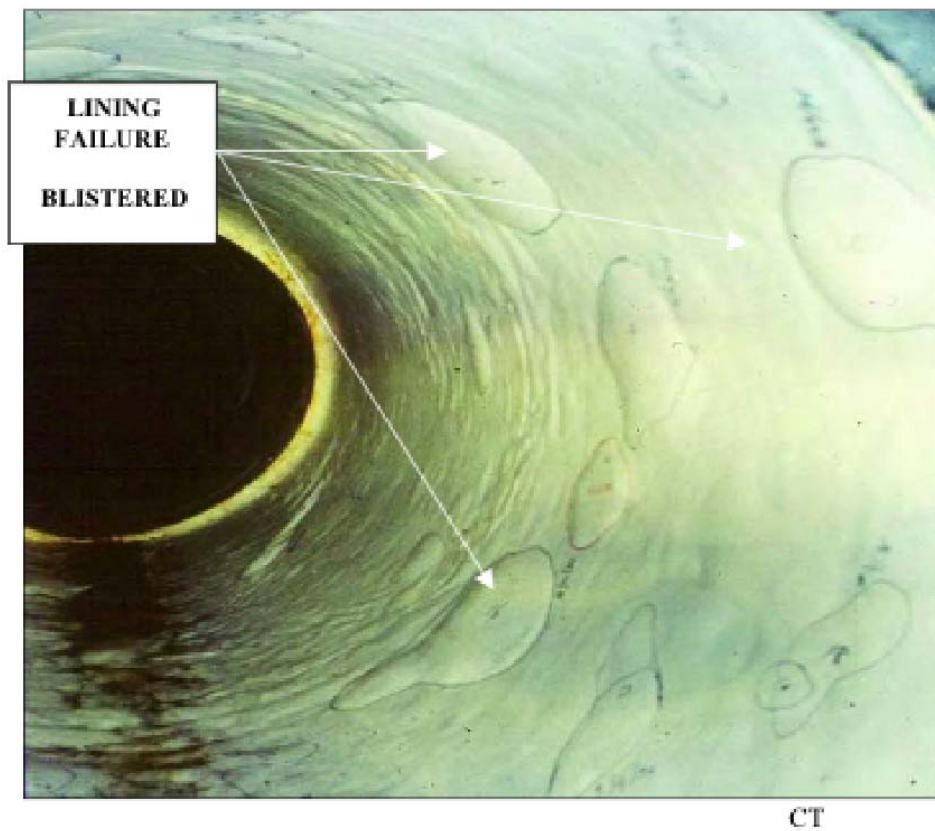
Lining surface has been damaged (not smooth).

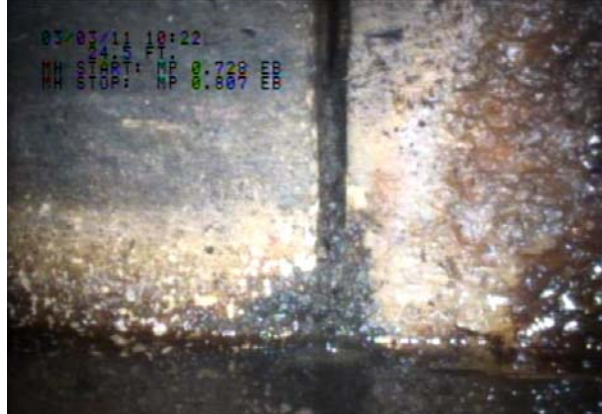
Figure 4-2. Screenshot from pipe inspection video of Site #000, showing a joint which was supposed to have been repaired with chemical grout but shows no evidence of grout.

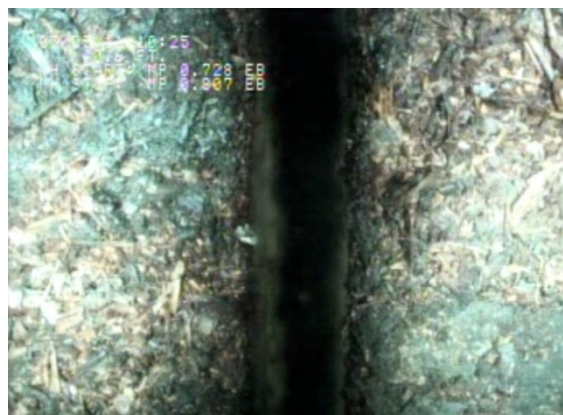
Figure 4-4. Screenshot from pipe inspection video of Site #000, showing a joint which was supposed to have been repaired with chemical grout. The orange spots may be remnants of grout.

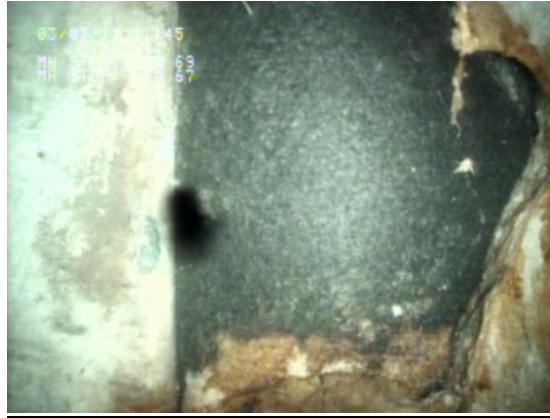
Figure 4-6. Screenshot from pipe inspection video of Site #001, showing a close up of a joint which has been repaired with chemical grout. Some remnants of the grout can be seen.

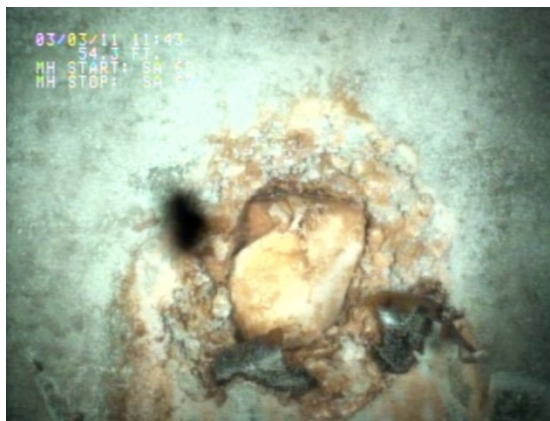
Figure 4-7. Screenshot from pipe inspection video of Site #001, showing a close up of a damaged point on the pipe which has been repaired with chemical grout.

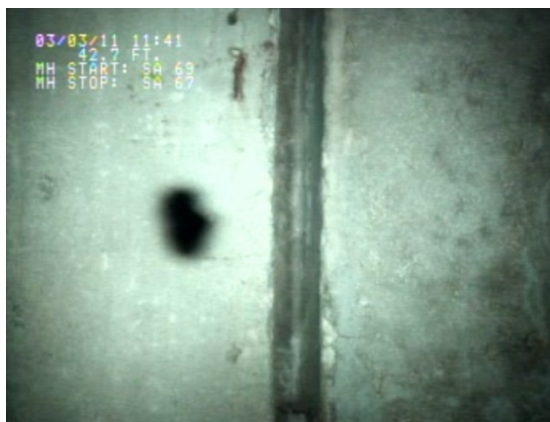
Figure 4-8. Screenshot from pipe inspection video of Site #001, showing a close up of a joint which did not show any separation and was not repaired with grout.

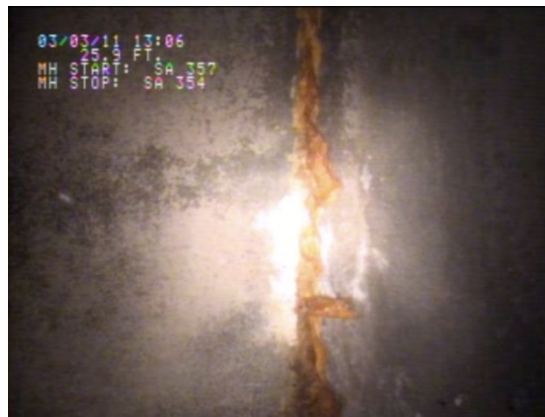
Figure 4-11. Screenshot from pipe inspection video of Site #000, showing a joint which has been repaired with chemical grout. Some remnants of the grout can be seen.

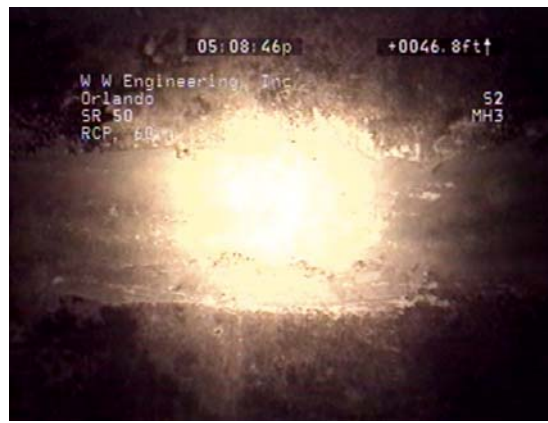
rover through the pipe, so the contractor walked the camera through the pipe. All joints along the pipes were grouted, but the grout seemed to be fading and slightly deteriorating. The appearance of the host pipe was good and the host pipes showed no cracking caused by the installation of the repair. All of the standing water could not be attributed to infiltration, but a small number of the repaired joints showed very light infiltration, according to the contractor. Some joints were holding up better than others. These failures appeared to be caused by the effect of time rather than by poor installation or implementation.

Figure 4-13. Screenshot from pipe inspection video of Site #003, showing a joint which has been repaired with chemical grout. The joint is completely sealed with grout.

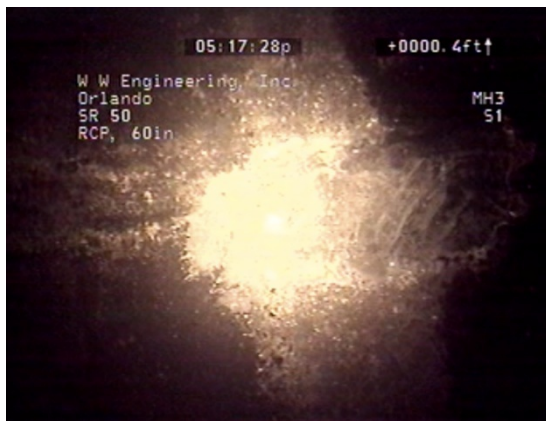
Figure 4-16. Screenshot from pipe inspection video of Site #004, showing a close up of a joint which has been repaired with chemical grout. The joint is completely sealed with grout.

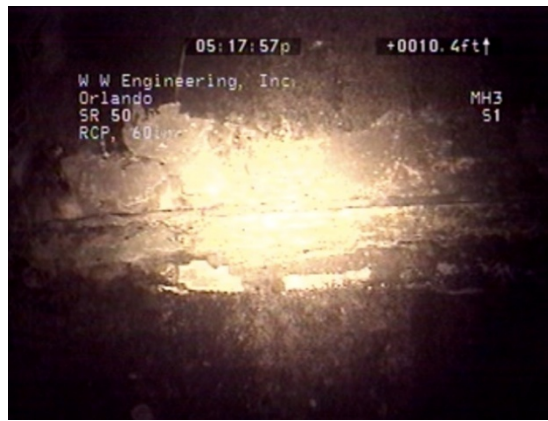
Figure 4-17. Screenshot from pipe inspection video of Site #004, showing a joint which has been repaired with chemical grout. The joint is completely sealed with grout.

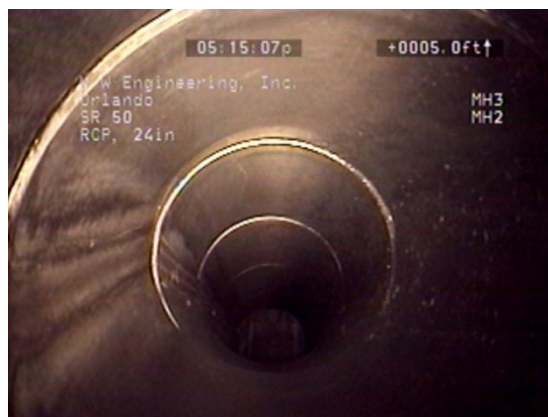
Figure 4-31. Screenshot from pipe inspection video of Site #007, showing the inside of the pipe and the sectional liner placed from joint to joint.

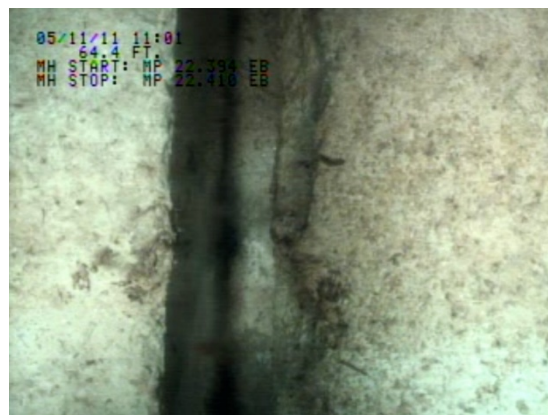
Figure 4-35. Screenshot from pipe inspection video of Site #010, showing a joint which was not repaired.

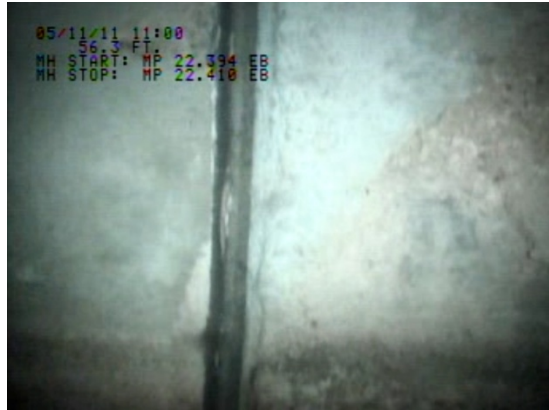
Figure 4-36. Screenshot from pipe inspection video of Site #010, showing a joint which was supposed to be repaired using an internal joint seal.

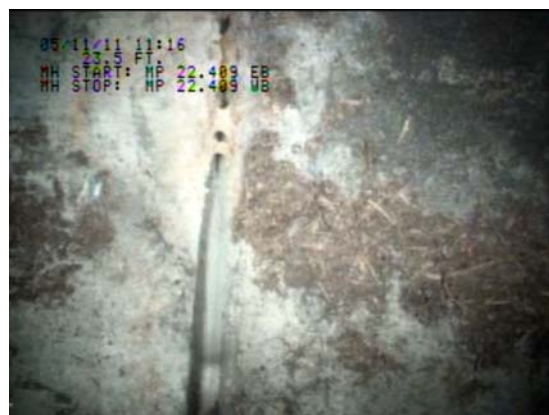
Figure 4-38. Screenshot from pipe inspection video of Site #011, showing a joint which was supposed to be repaired using an internal joint seal.

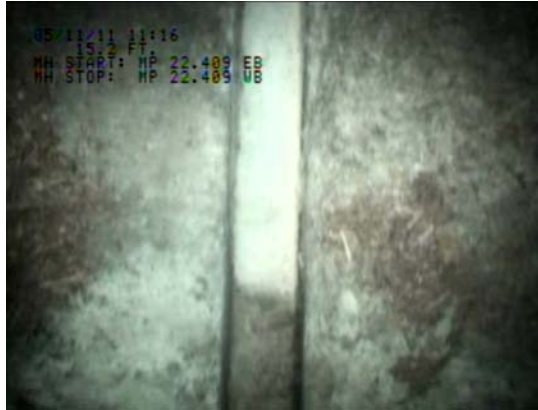
Figure 4-39. Screenshot from pipe inspection video of Site #011, showing a joint which was supposed to be repaired using an internal joint seal.

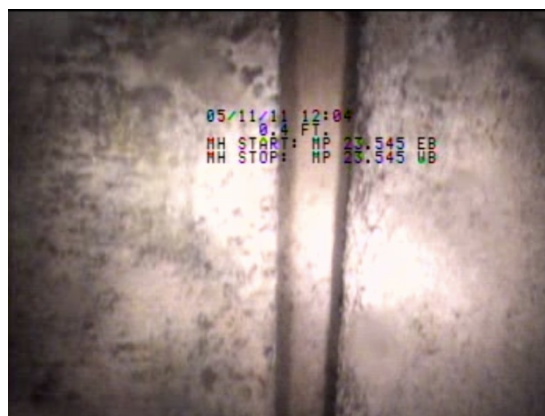
Figure 4-41. Screenshot from pipe inspection video of Site #012, showing a joint which was supposed to be repaired using an internal joint seal

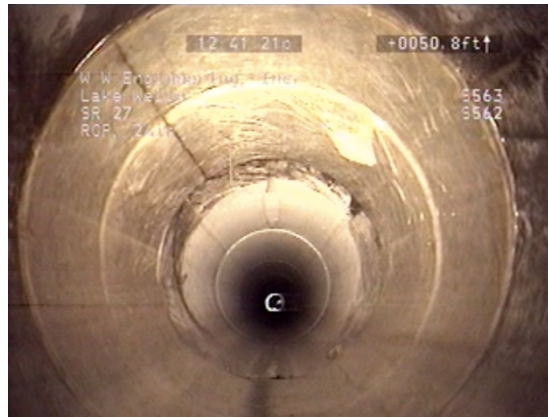
Figure 4-43. Screenshot from pipe inspection video of Site #015, showing the repair sleeve over the damaged section of pipe.

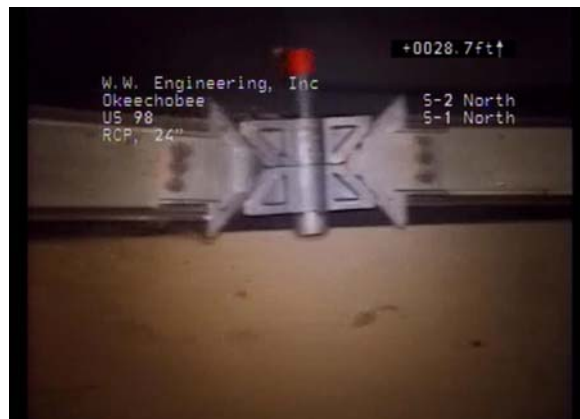
Figure 4-46. Screenshot from pipe inspection video of Site #005, showing a joint which has been repaired using an NPC Internal Joint Seal.

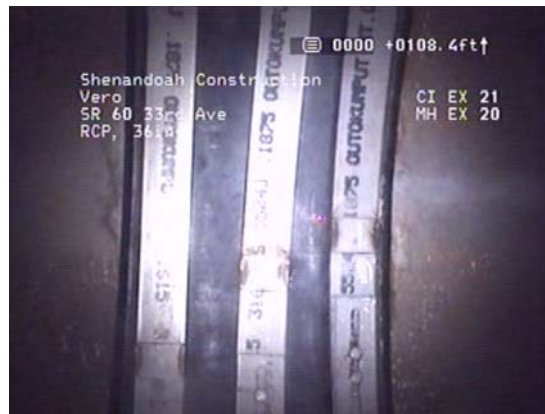
Figure 4-49. Screenshot from pipe inspection video of Site #005, showing a joint which has been repaired using a set of band seals.
