## Florida Department of Transportation Research

### Durability of In Situ Pipe Repair

BDK75 977-38

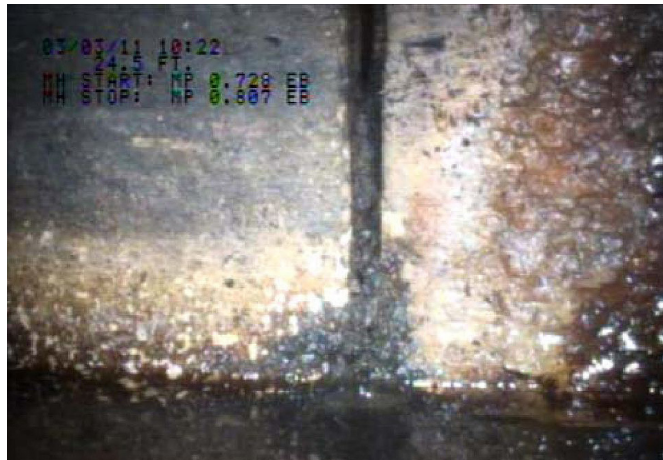
*Closed circuit view of a pipe repair. This joint had been repaired with chemical grout, but none remains, as shown by this inspection.*
