Florida Department of Transportation Research

Corrosion of Spiral Rib Aluminized Pipe

BDK84 977-11

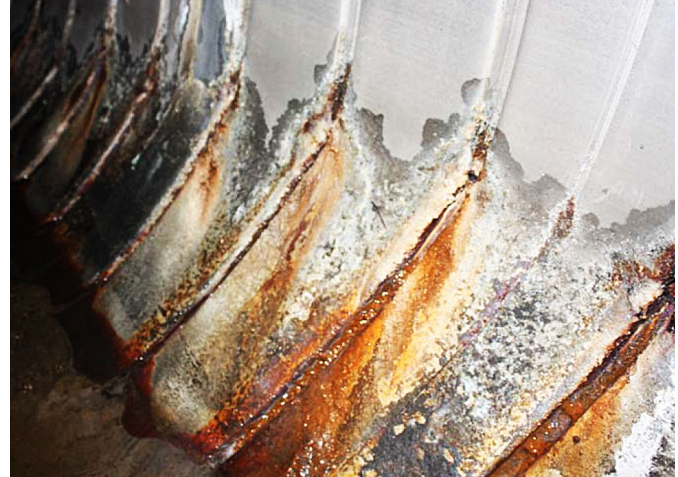
Extensive corrosion and mechanical damage are evident in this SRAP set in limestone backfill.

Investigating Mode B corrosion revealed that pH values high enough to dissolve aluminum's passive film can develop under exposure of limestone to flowing natural water. Under these conditions, extensive coating loss was observed over short time periods. In contrast, exposure to water in contact with sand did not result in alkaline conditions, and in the absence of mechanical deformation, aluminized steel remained essentially corrosion free. These findings substantiate for the first time an important vulnerability of aluminized steel in limestone soils and explain the rapid deterioration observed in the field under Mode B. The findings strongly support service guidelines to disallow the use of limestone bedding for aluminized steel pipe, including SRAP.
