## **FINAL REPORT**

### **Effects of Service Life of Aluminized Steel Corrugated Pipe with Visible and Not Visible Coating Deficiencies within the Lock System**

FDOT Contract Number: BDV25-977-62

PI: Christopher L. Alexander, University of South Florida, Tampa, FL.

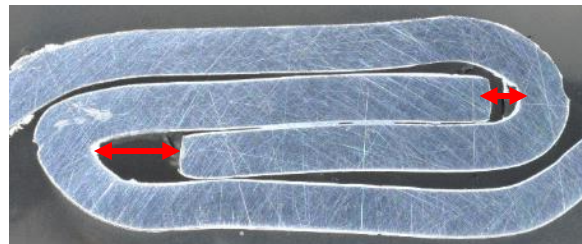
Figure 3.3. Loose lock-seam from Plant D galvanized steel pipe.

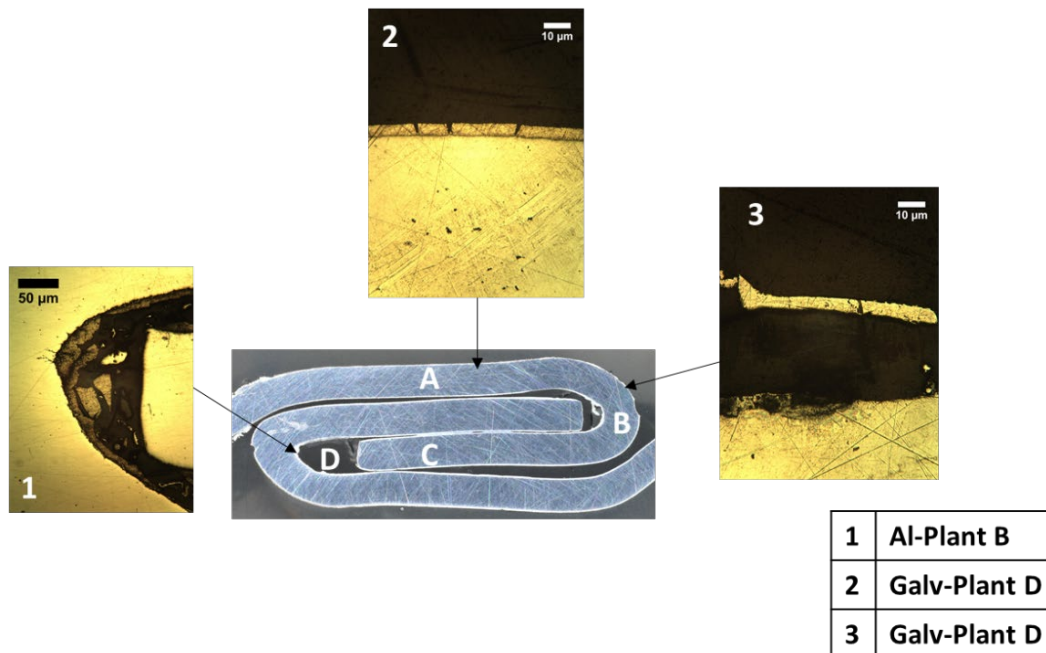
Figure 3.4. Common three types of coating defects in the lock-seam.

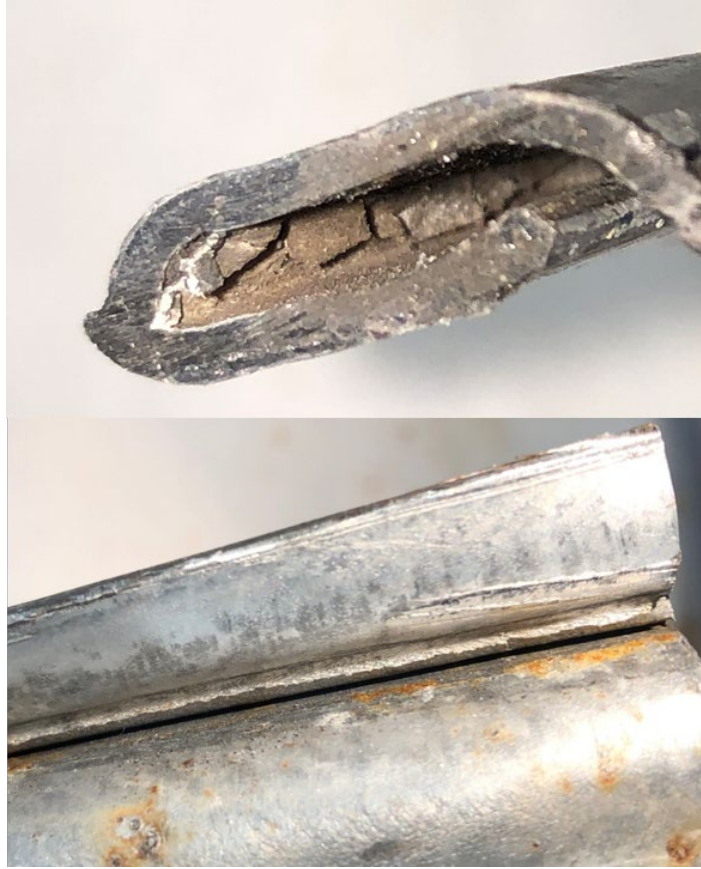
*Figure 3.5. Coating defects within the bends of a lock-seam.*

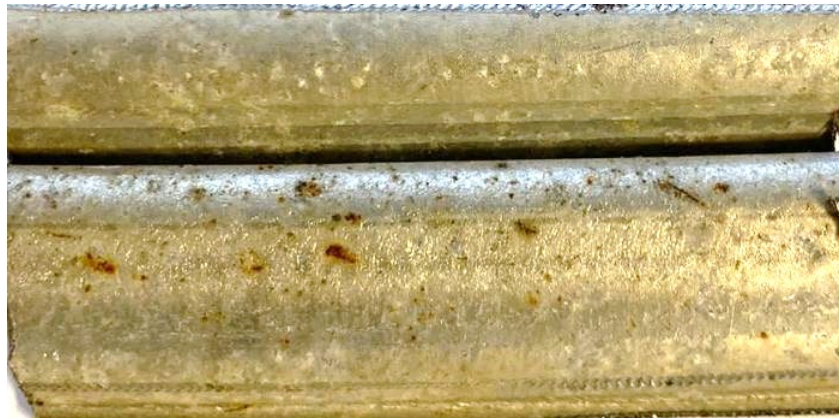
*Figure 3.11. Preexisting corrosion in the form of pits around the corrugations and the lock-seam aluminized steel from Plant A.*

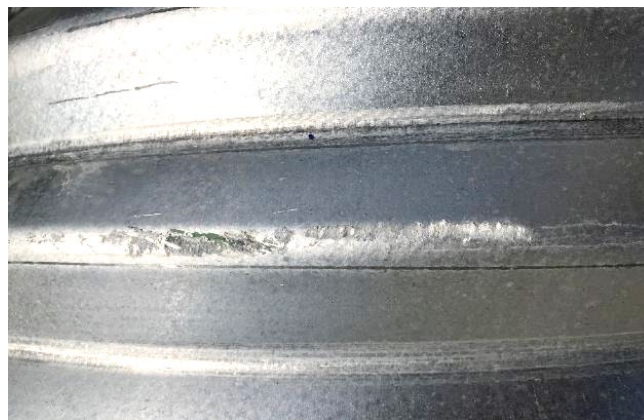
*Figure 3.12. Common scrapes in the lock-seam and the corrugations of galvanized steel from Plant B.*

Both of the aluminized and galvanized steel pipes had coating scrapes along the corrugations likely a result of transportation and handling as shown above in Figure 3.12. The scrapes did not seem to penetrate the full thickness of the coatings but did result in coating losses of as much as half the coating thickness. Figure 3.13 shows the two types of dents that are common in the metal corrugated pipes. Subfigure A shows an example of a bigger dent that is commonly located in the corrugations, while image B shows the smaller dents that are mostly located in the lock-seams. Figure 3.14 shows a metallographic image of a common coating break in the lock-seam. Not only is there a break in the coating but also delamination from the base metal around the break.

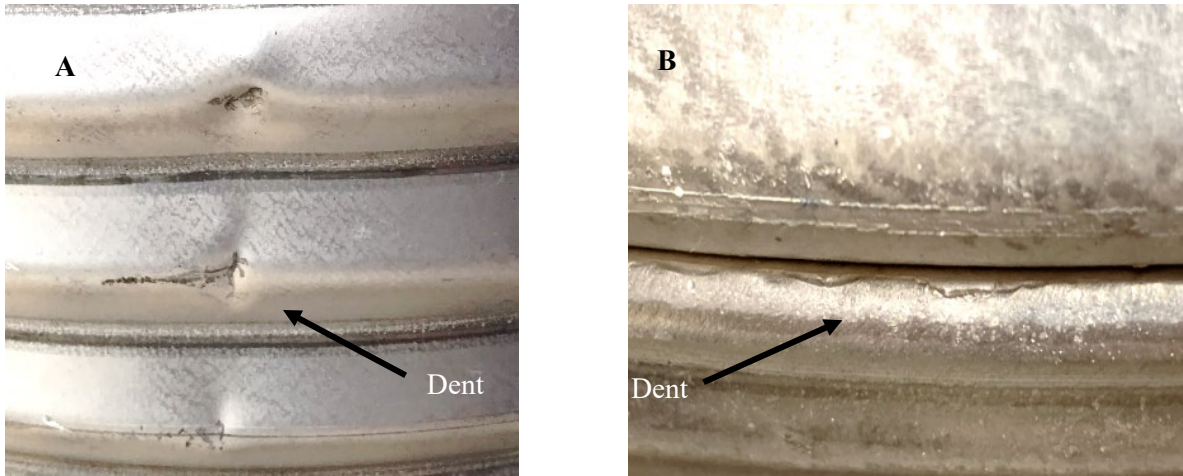
*Figure 3.13. Common dents that occur in the lock-seam in all pipe types in aluminized steel from Plant A.*

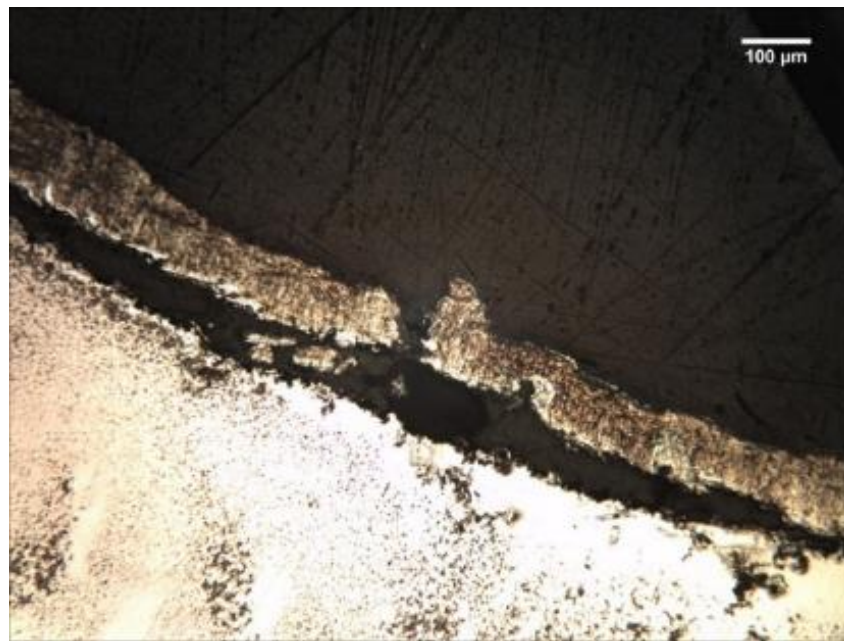
*Figure 3.14. Metallographic image of a common coating break in the lock-seam in PLANT A-Al.*

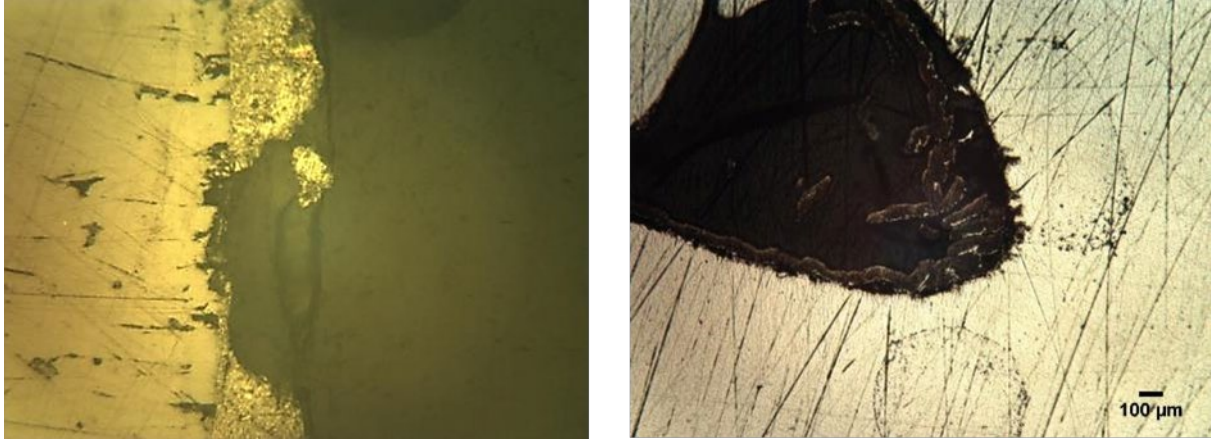
Figure 3.15 and Figure 3.16 show two types of defects in the lock-seam in the aluminized and galvanized steel pipes from Plant A. In both aluminized and galvanized steel, coating breaks and breaks in the intermetallic portions of the coating were observed in all lock-seams. Similar images were obtained from samples of lock-seams from the other plants as well. Since defects within the lock-seams were visible in all of the pipes analyzed, the remainder of the report presents only the size of the defects with only a single photo example from each plant.

*Figure 3.15. Metallographic images of coating break and shreds in aluminized steel pipe from Plant A.*

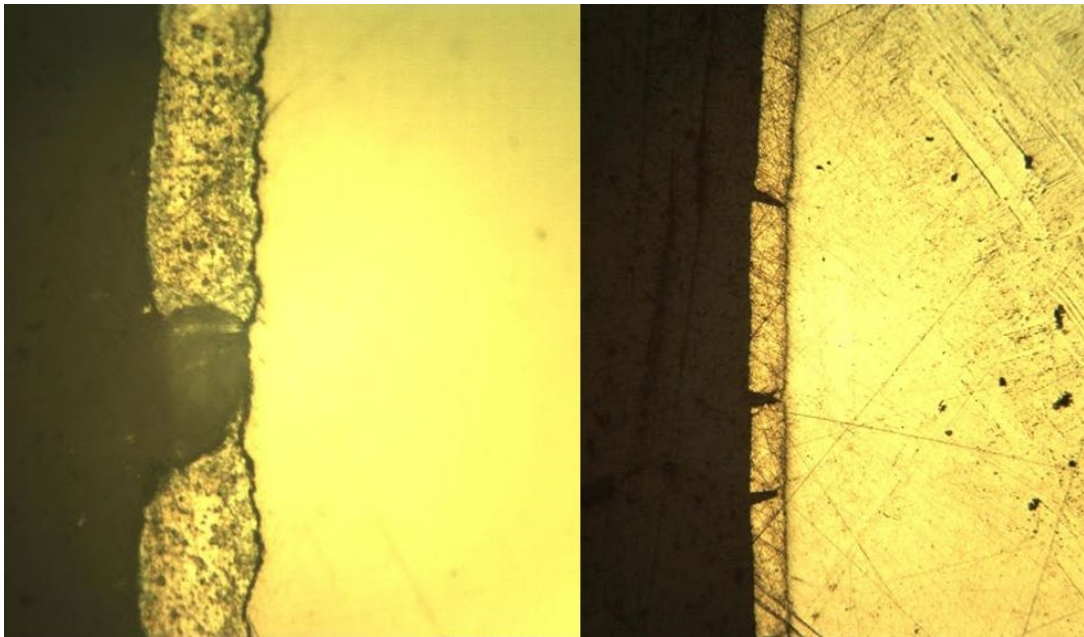
*Figure 3.16. Metallographic images of coating break and shreds in galvanized steel pipe from Plant A.*

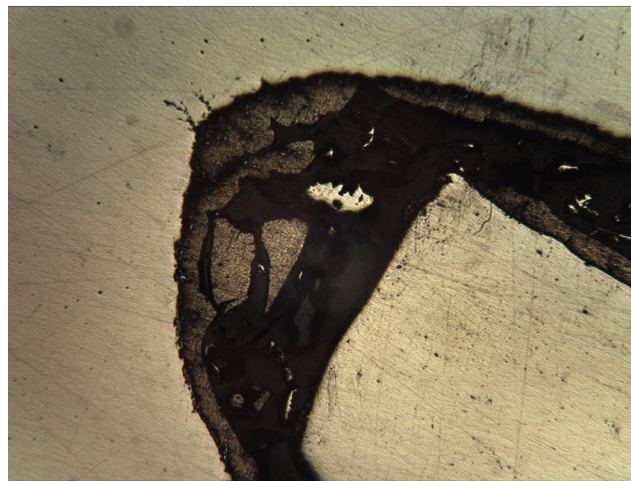
*Figure 3.17. Metallographic image of coating break and shreds in galvanized steel pipe from the Plant B.*

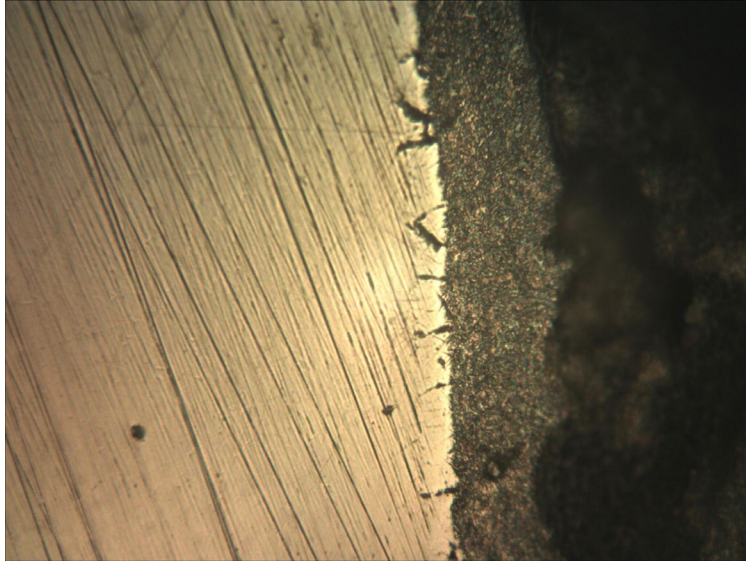
Figure 3.18 and Figure 3.19 show examples of coating defects within the lock-seams. In Figure 3.19 a metallographic image is shown of an intact coating but with breaks in the intermetallic layer. This would be the ideal result of formed lock-seams in which the forming only results in some damage to the brittle intermetallic layer but no damage to the metallic coating. Figure 3.19 shows again, coating shards within the fold of the lock-seams. This form of coating damage may be unavoidable due to the compressive action of the region.

*Figure 3.18. Metallographic image of coating break and shards in galvanized steel pipe from the Plant B.*

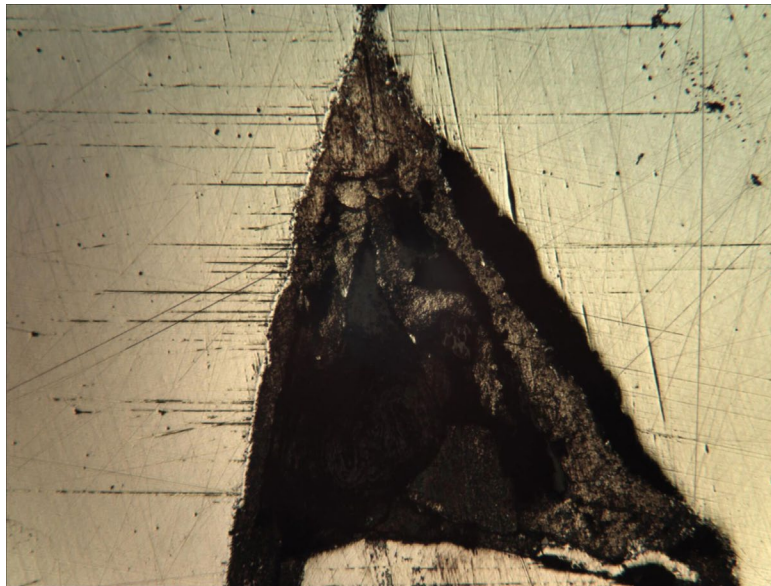
*Figure 3.19. Metallographic image of coating break and shards in galvanized steel pipe from the Plant B.*

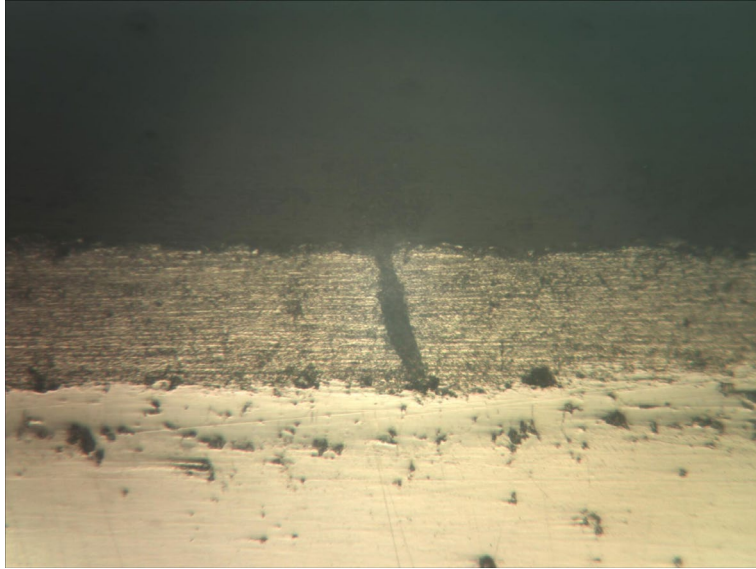
The additional coating of the sides of the pipe affected the quantification and detection of visible coating defects in the pipe. Despite this metallographic samples obtained still showed coating defects within the lock-seam of the pipes and pre-existing corrosion pits were observed on both aluminized and galvanized steel pipes. Figure 3.21 shows an example of a coating defect observed within the lock-seam of one of the pipes. In this particular case, there is a break in the outer coating layer but little visible damage to the intermetallic layer.

*Figure 3.21. Metallographic image of coating break and shards in galvanized steel pipe from the Plant B.*

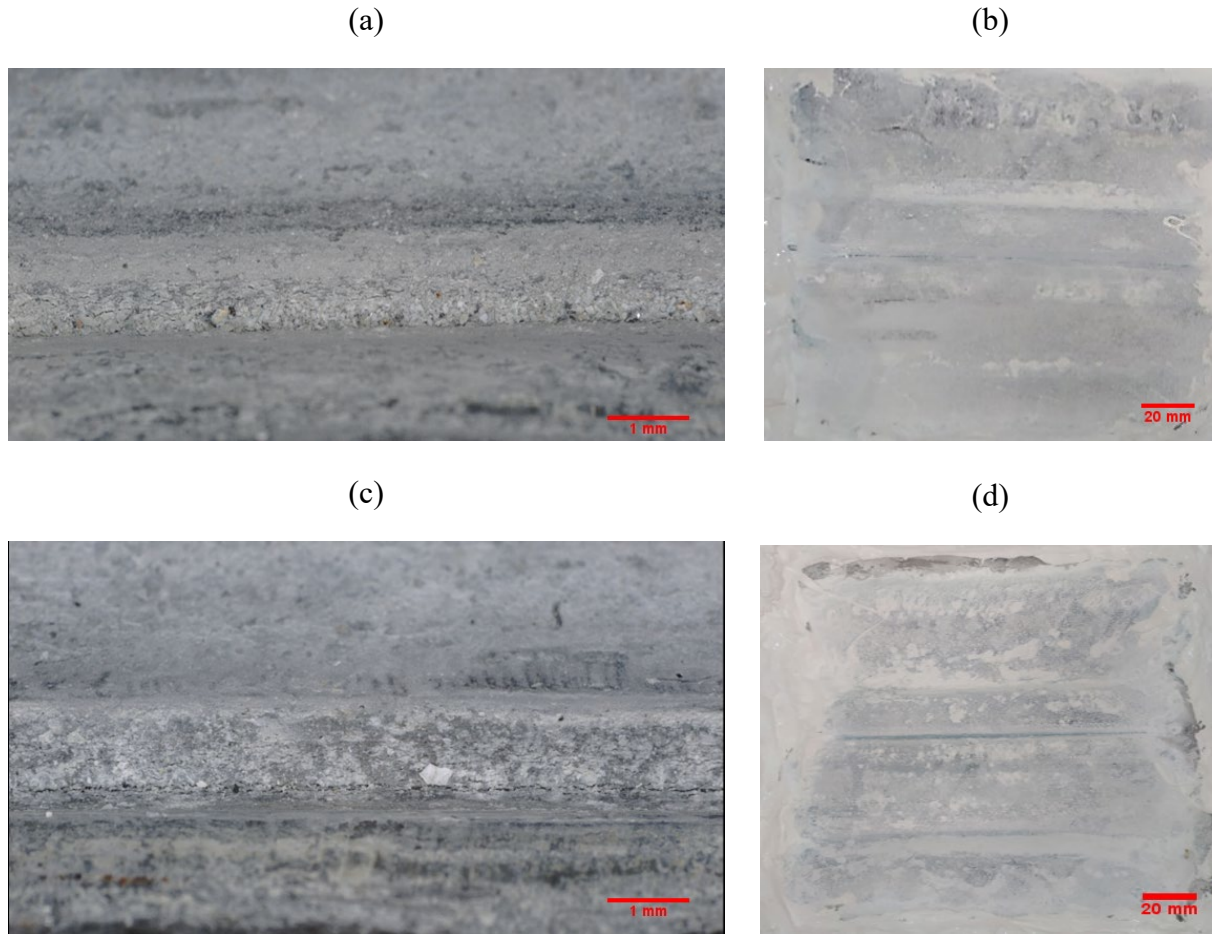
After 227 days of immersion, the samples were removed from the Plexiglas cells and visually assessed for corrosion damage. Figure 4.2 shows images of the exposed surfaces of the galvanized steel pipe sections in aggressive (Figure 4.2 b) and mild (Figure 4.2 d) solutions. In both cases, there is a substantial amount of zinc corrosion products with no signs of steel corrosion products, likely indicating that the zinc was able to provide sufficient sacrificial protection to any exposed steel. Within the lock-seam of the samples exposed to aggressive (Figure 4.2 a) and mild (Figure 4.2 c) solutions, there is not as much visible zinc corrosion products and again no signs of steel corrosion products. The fact that the zinc coating corroded more outside of the lock-seam provides verification that crevice corrosion does not seem to be of concern, at least within the time frame of the experiments. Therefore, the focus of the analysis will be on the aluminized steel samples.

*Figure 4.2. Galvanized steel long-term immersion cell after 227 days inside and outside the lock-seam: (a) Lock-seam of galvanized steel in aggressive solution; (b) surface image of the galvanized steel long-term sample in aggressive solution; (c) Lock-seam of galvanized steel in mild solution; (d) surface image of the galvanized steel long-term sample in mild solution.*

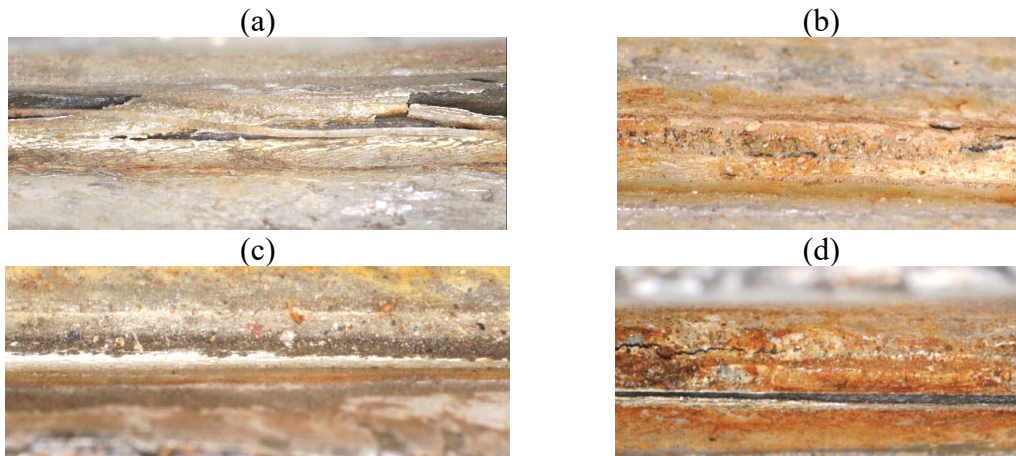
After visual inspection of the exposed surface of the lock-seam sections was completed, the seams were disengaged to determine the level of corrosion damage present within the confined regions of the lock-seams. Figure 4.5 and Figure 4.6 show images of the cut end and internal bends of the seams after unlocking. Generally, there were more corrosion products observed in the lock-seams for the samples exposed to the aggressive solution than the mild solution.

*Figure 4.5. Lock-seam images after immersion in aggressive and mild solutions for 227 days for Plant A and B: (a) Plant-A long-term immersion cell lock-seam in mild solution; (b) Plant-A long-term immersion cell lock-seam in aggressive solution; (c) Plant B long-term.*

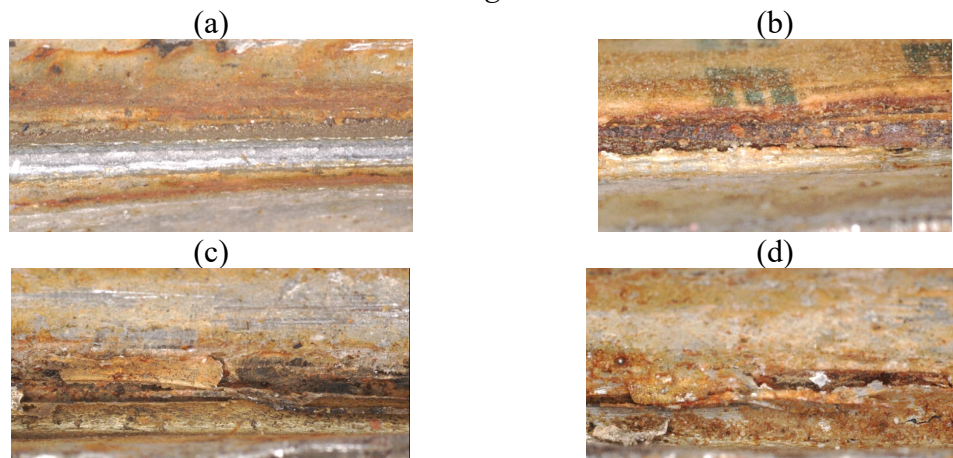
*Figure 4.6. Lock-seam images after immersion in aggressive and mild solutions for 227 days for Plant C and D: (a) Plant C long-term immersion cell lock-seam in mild solution; (b) Plant C long-term immersion cell lock-seam in aggressive solution; (c) Plant D long-term.*

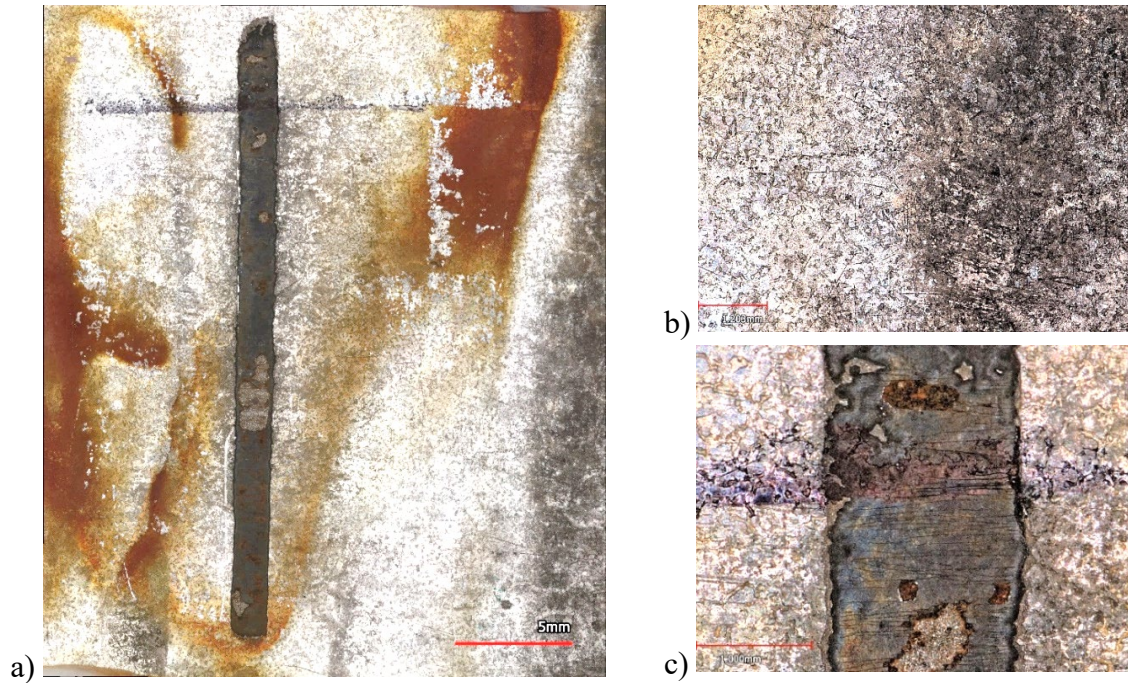
Figure 4.13. Crevice coupons of aluminized steel in a mild solution (A) after immersion of 90 days and the only sample with discoloration. a) inside crevice.; b) crevice entrance; c) defect.

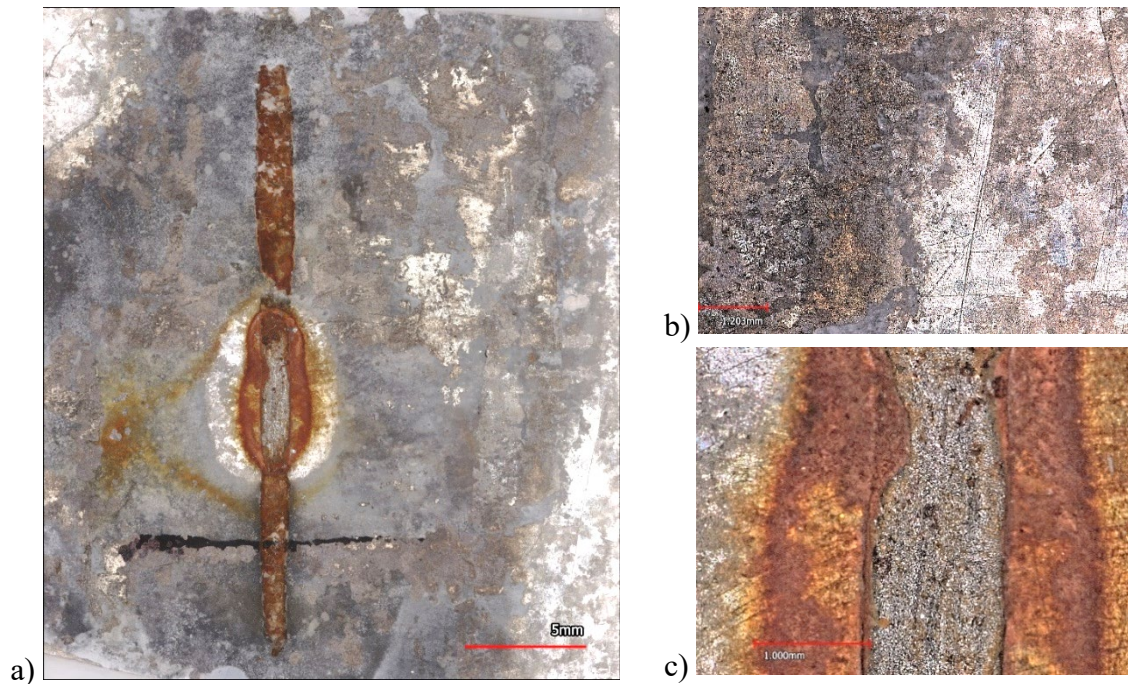
Figure 4.14. Crevice coupons of aluminized steel in an aggressive solution (A) after immersion of 90 days and the only sample with discoloration. a) inside crevice.; b) crevice entrance; c) defect..
